Case Study 7. Woodrock Guard Station Geoweb Ford**Location**

Central Wyoming. Bighorn National Forest. West Fork of the South Tongue River. 20 miles southwest of Sheridan, off Forest Highway 26 (East Fork South Tongue River Road).

Crossing Description

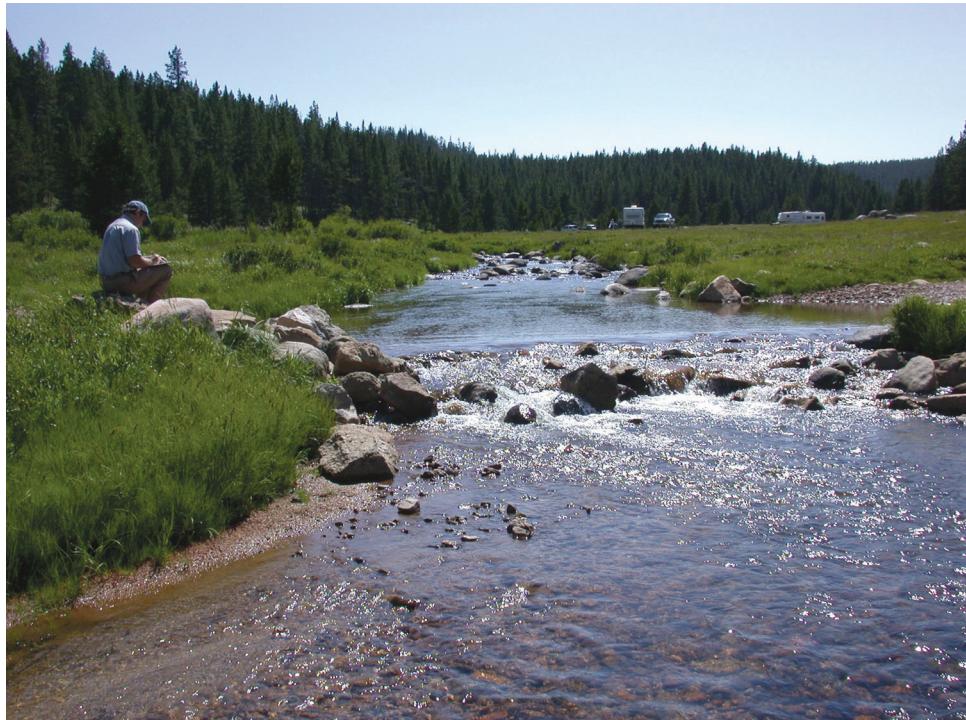
Figure A35. A boulder cascade was constructed at the downstream edge of the ford to control scour caused by placing the Geoweb very slightly above streambed elevation.

The intent was to set the surface of the filled Geoweb cells at the level of the finished streambed, matching stream slope. However, this is very difficult to do without diverting streamflow. The downstream edge of the Geoweb protruded an inch or two, so a rock energy dissipator was placed there. Scour occurred despite this, and in 1999 a larger boulder cascade control was constructed. This support structure creates a berm that backs water up on the crossing so that vehicles drive through deeper water than would otherwise be necessary.

There have been no major floods since the Geoweb was installed. As noted above, scour due to the fact that the Geoweb did not perfectly match stream grade necessitated construction of a boulder weir that now backwaters the ford. Erosion and consolidation of the approaches required the addition of rock, but compaction continued, and the crossing shape could not maintain itself. The boulder weir helps to retain the gravel surfacing necessary to protect the surface, but in many places, tire action appears to spin the gravel out of the top of the cells allowing the material to degrade (figure A39).

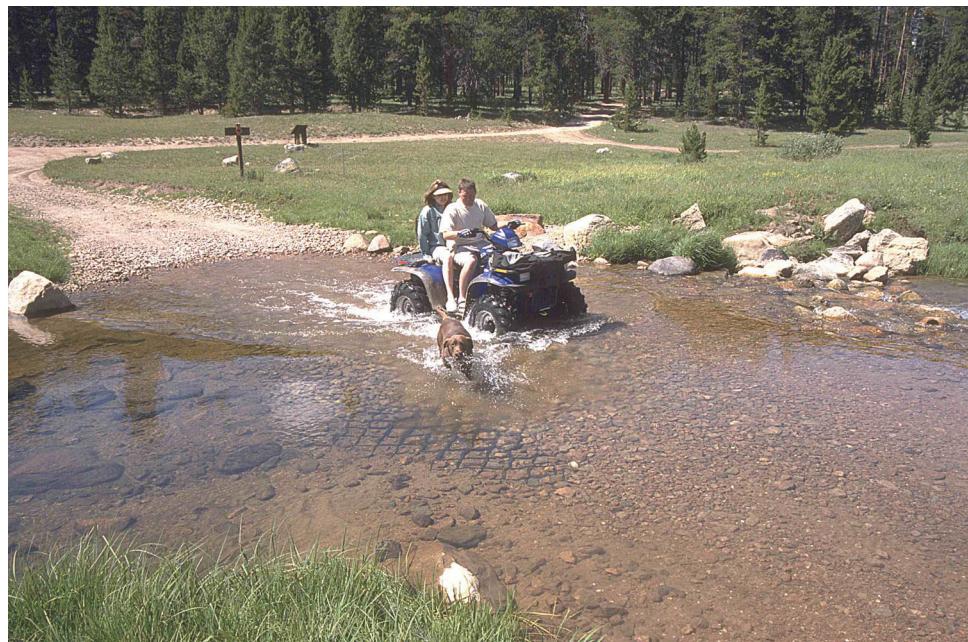
Figure A36. Ford is used by vehicles ranging from ATVs to motor homes.

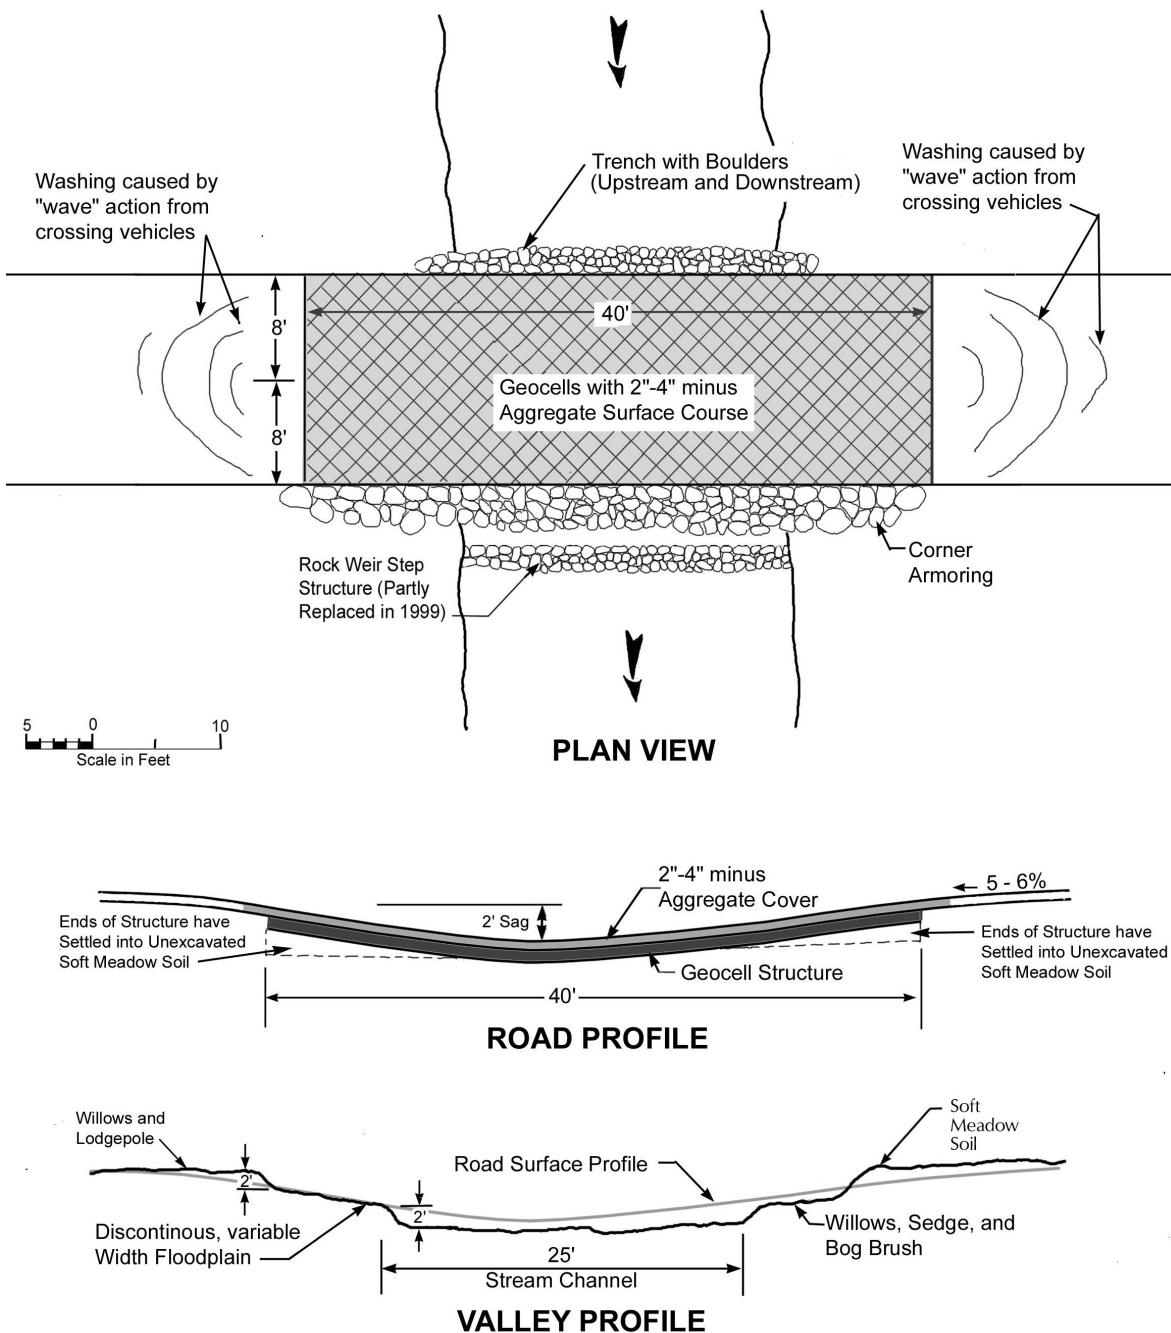
**WOODROCK G.S. - WEST FORK,
SOUTH TONGUE RIVER GEOCELL FORD**

Structure: To construct this ford, large rocks were removed from the existing crossing and it was excavated to a depth equal to the height of the Geoweb, 6 inches. This was done during low flow, but without diverting flow, so compaction was probably not achieved. The geotextile and Geoweb were stretched out, anchored with rebar and hooking clips, forming a 16 foot by 48 foot layer, and the cells were filled to the top with 1½-inch to 4-inch crushed rock. To prevent undercutting, the upstream edge was bent down into a deeper trench that was later filled with large rock. Four to 6 inches of clean 1½-inch to 4-inch rock cover most of the ford.

Figure A37. Plan view with valley and road profiles.

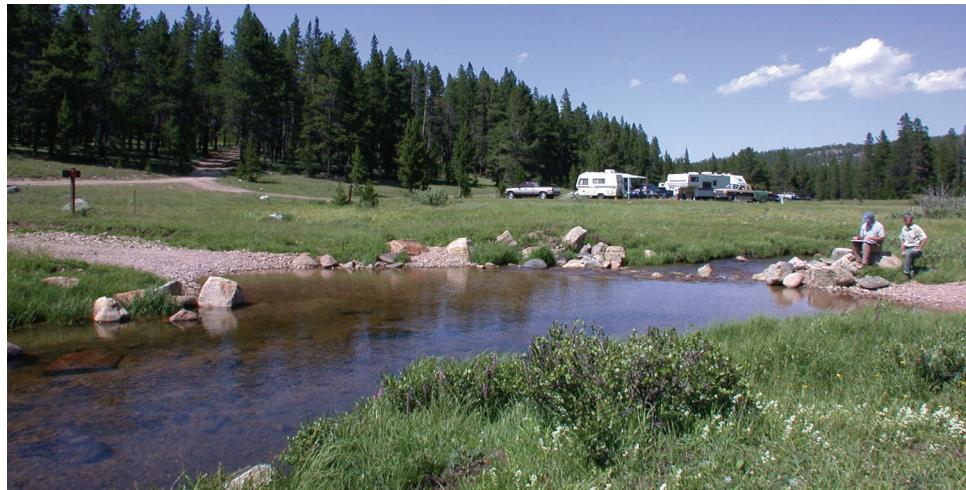
The original intent was to install the Geoweb to the elevation of the 100-year flood. As can be seen in figure A38, although the Geoweb originally extended higher, it has settled under traffic loads and probably does not fully cover the bankfull cross section. The stream widens out substantially at the crossing.

Figure A38. Soil compression on the approaches to the ford causes the stream to widen and lowers the elevation of the ends of the Geoweb mat. Currently the geocell mat protects only part of the crossing during high flows.

Bank stabilization and approaches: The road approaches slope into the crossing at about 5 to 6 percent. Even though 10 cubic yards of rock have been added to the approaches to raise the road grade, figure A38 shows that it is substantially wider than the natural channel. Riprap is placed downstream where the approaches cut into the streambanks.

Geocell fords are attractive for low-traffic and light-vehicle uses because they are inexpensive and quick to install. However, they require the same attention to foundation leveling and compaction as heavier structures do. In this case, construction without diverting the stream may have been responsible for the difficulty with matching stream slope, which then required building a downstream weir and backwatering the structure. The risk of losing the crossing shape because of traffic compressing the soft flood-plain soils also was not recognized. Those soils should have been compacted or overexcavated and replaced with firm material.

The final elevation of the geocells plus cover material is critical to the design. Initially the site should be overexcavated to the depth of the cells plus the anticipated depth of cover aggregate. Four to 6 inches of coarse, clean cover aggregate is recommended. Since this material will likely be removed during high flows, some cover aggregate will periodically have to be replaced.

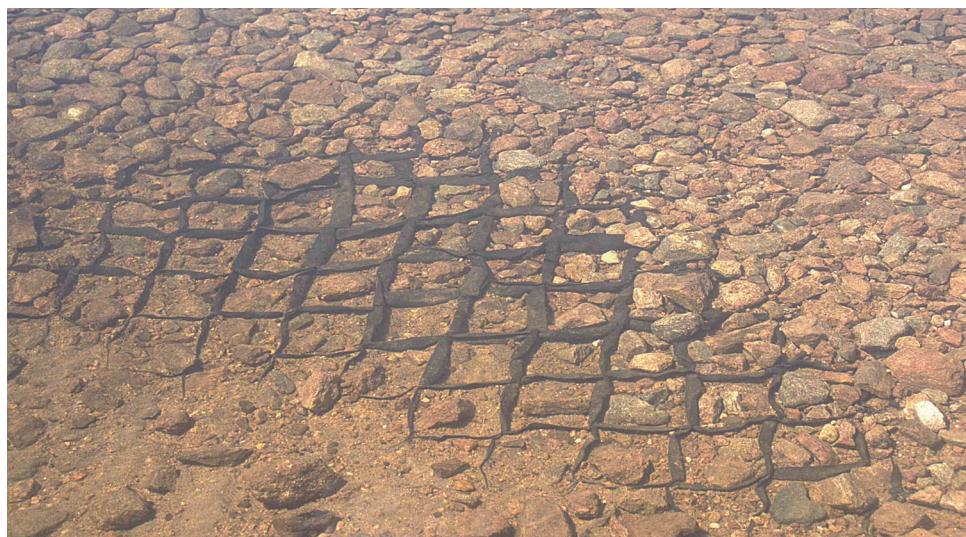
Figure A39. Geoweb exposed, probably by tire action.

Carefully weigh the speed and economy of installation against the drawbacks specific to this structure type. The geocells are damaged by traffic if not protected by a layer of gravel, and after high flows the gravel surfacing will need maintenance or replacement (see also figure A41 below). Generally, this design is not preferred for streams that experience high velocity flows or substantial traffic volume. The forest plans to replace this structure with one that will keep vehicles out of the water.

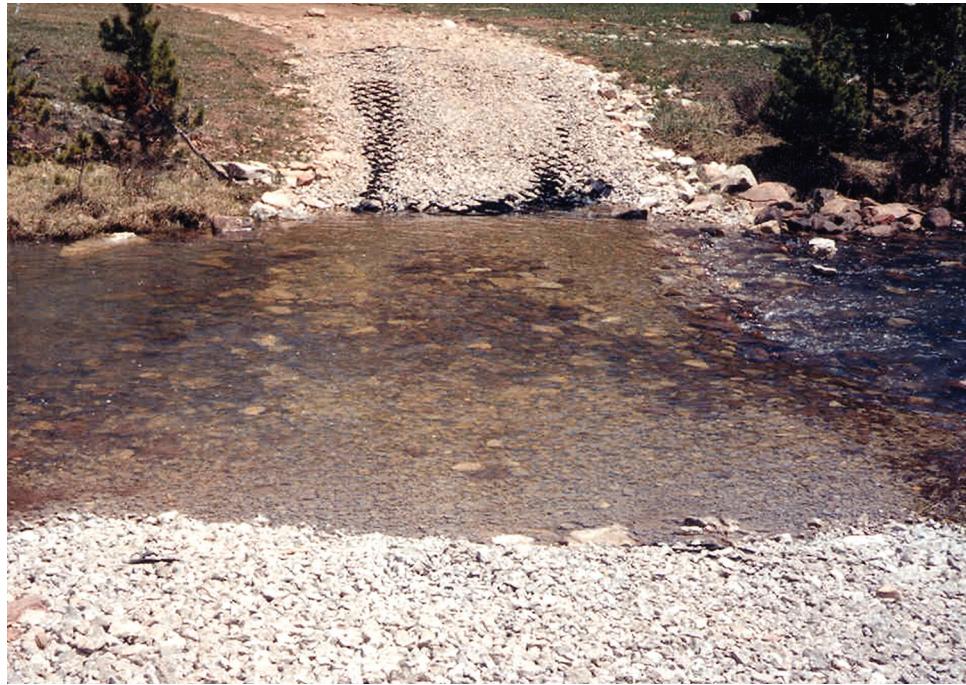
The Ashley National Forest has a successful temporary geocell (similar to Geoweb) installation on Little Brush Creek (figure A40). The material used for this ford is called “TerraCell”. The mats are 8-foot by 20-foot by 6-inches deep. Two mats were installed lengthwise across the stream.

The crossing accesses a road planned for storage within a few years, so the structure needed to last only 3 to 5 years. Traffic is mostly administrative and recreational, and is primarily 4-wheel-drive vehicles such as light duty trucks, all-terrain vehicles, and sports utility vehicles. As the photo shows, after only one year, some of the 4-inch minus surfacing had been lost from the geocells on one side of the structure, and the material was deteriorating. Rock was added during the summer of 2002. Nonetheless, in 2004 the site was in a similar condition (figure A41). More material has eroded out from the geocells on one side of the ford and the channel has widened locally.

The native (darker red) cobbles and gravels deposited on the crossing in figure A40 show the structure provides free downstream passage for debris and bed material. There is no reason to believe the ford would block fish and other aquatic species at the site going upstream. The forest is satisfied with the ford as a temporary crossing.

Figure A40. Little Brush Creek geocell ford in June 2002.

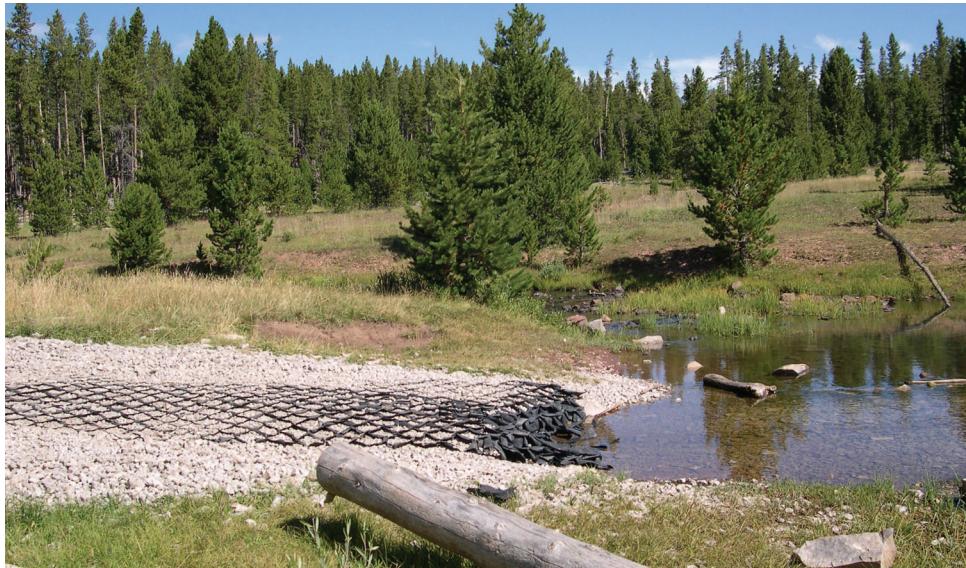
Figure A41. Looking upstream at erosion of one side of the ford in August 2004, 3 years after construction. Probably tire action and high flows have combined to pluck material out of the cells or undermine them. The ford is still intact and the geocells are covered by native bed material in the active channel.
