U.S. Department  
of Agriculture

Forest Service

# Low-Water Crossings: Geomorphic, Biological, and Engineering Design Considerations

October 2006

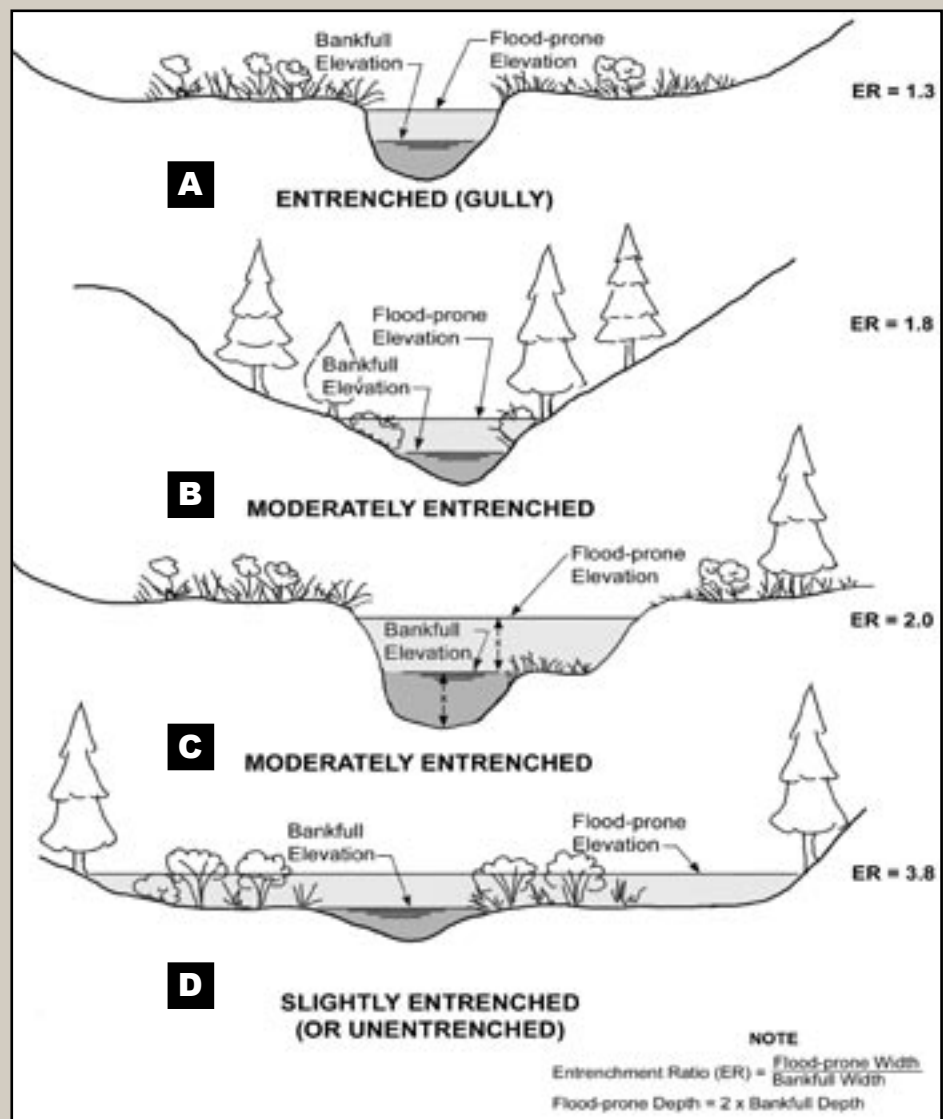
Figure 2.1—Channels with different entrenchment ratios.

The main limitations for low-water structures in entrenched channels are difficulties designing a mild vertical curve and stabilizing and draining a steep approach road (table 3-3). Potential limitations for low-water crossings in slightly entrenched channels are that flow obstructions in the main channel may cause aggradation and bank erosion. The stream may even shift location in some cases.

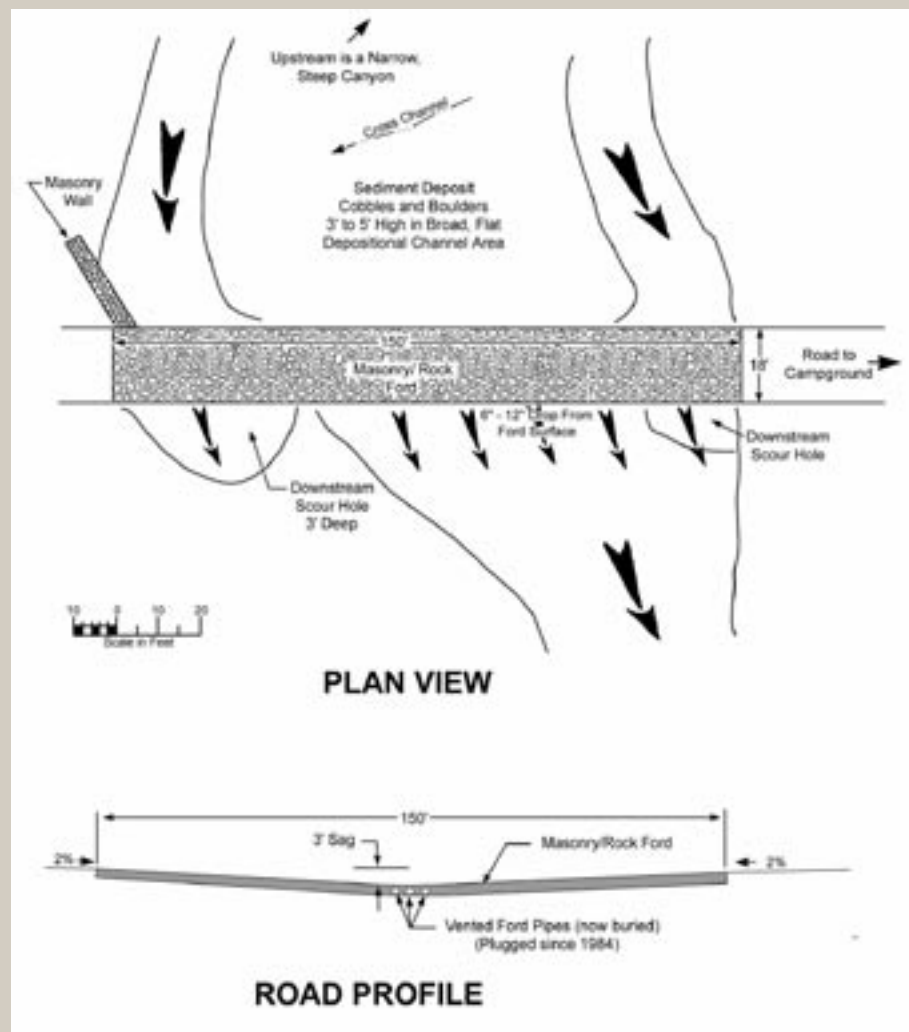
Figure 3.2—Sediment deposition and channel widening caused by the “damming” effect of a low-VAR ford. Tonto National Forest, Arizona.

In very stable streams, low-VAR fords may not have severe detrimental effects on channel stability. It is common, however, to see at least a fair amount of channel instability associated with these structures. When flow begins to exceed the vents' capacity, low-VAR fords begin to function like low dams. They backwater flow upstream of the structure, and where the stream is carrying a substantial bed sediment load, deposition reduces channel capacity and elevates the streambed. This frequently leads to bank erosion and channel widening. Sometimes, the aggraded stream may also shift its location across the valley floor when it seeks lower ground or a steeper grade (fig. 3.2). In channels that are already laterally unstable, low-VAR structures exacerbate the tendency for bank erosion and channel shift.

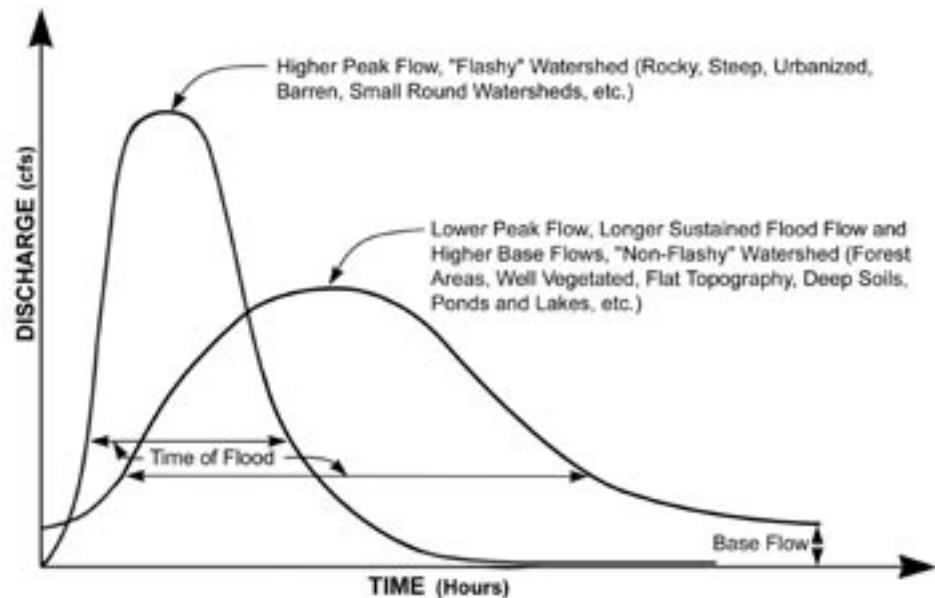
Figure 4.4—Hypothetical flood hydrographs for flashy and nonflashy watersheds.

Figure 4.4 shows flood hydrographs that illustrate the response of two hypothetical watersheds to the same rainstorm. In the flashy watershed, streamflow rises and drops rapidly and the traffic delay is brief. Such brief, sharp flow peaks are associated with small watersheds and areas with frequent bedrock outcrops, shallow soils, little vegetative cover, or urbanization. Desert areas receiving brief but intense thunderstorms often exhibit this “flashy” type of runoff. If we consider only hydrology, the flashy watershed would be more suitable for an unvented ford. The second watershed has deep soils and forest cover and most rainfall infiltrates the soil. In this watershed, the flow takes longer to peak, peaks at a lower flow rate, and is sustained over a longer period of time. Traffic delays on this stream, if they occur, would be longer. Thus this site may be less suitable for a ford.

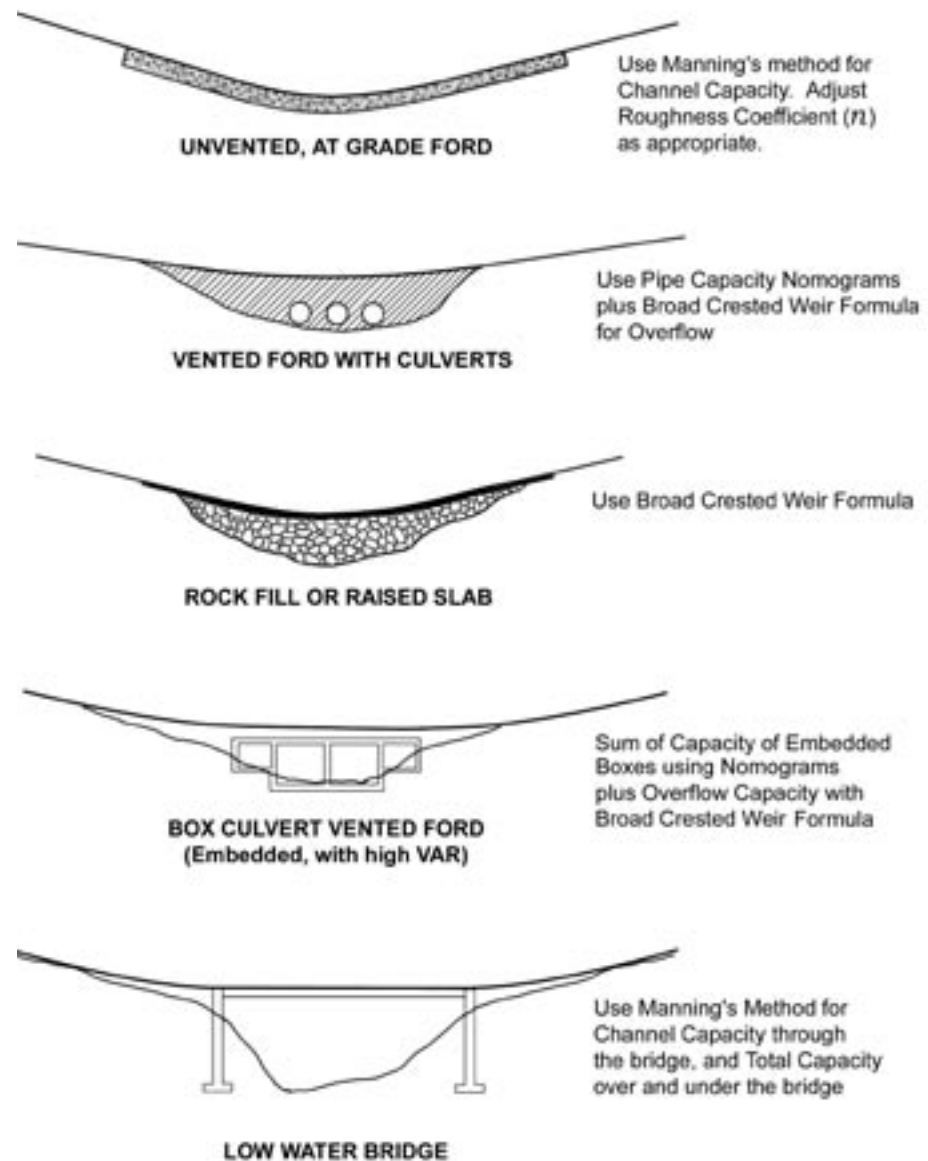
Figure 4.6—Low-water crossing types and applicable flow analysis methods.

as well as velocities through the structures. Figure 4.6 shows some typical low-water crossing types and hydraulic flow analysis methods most appropriate for those structures. Information about scour potential and scour protection measures is found in Section 4.7.

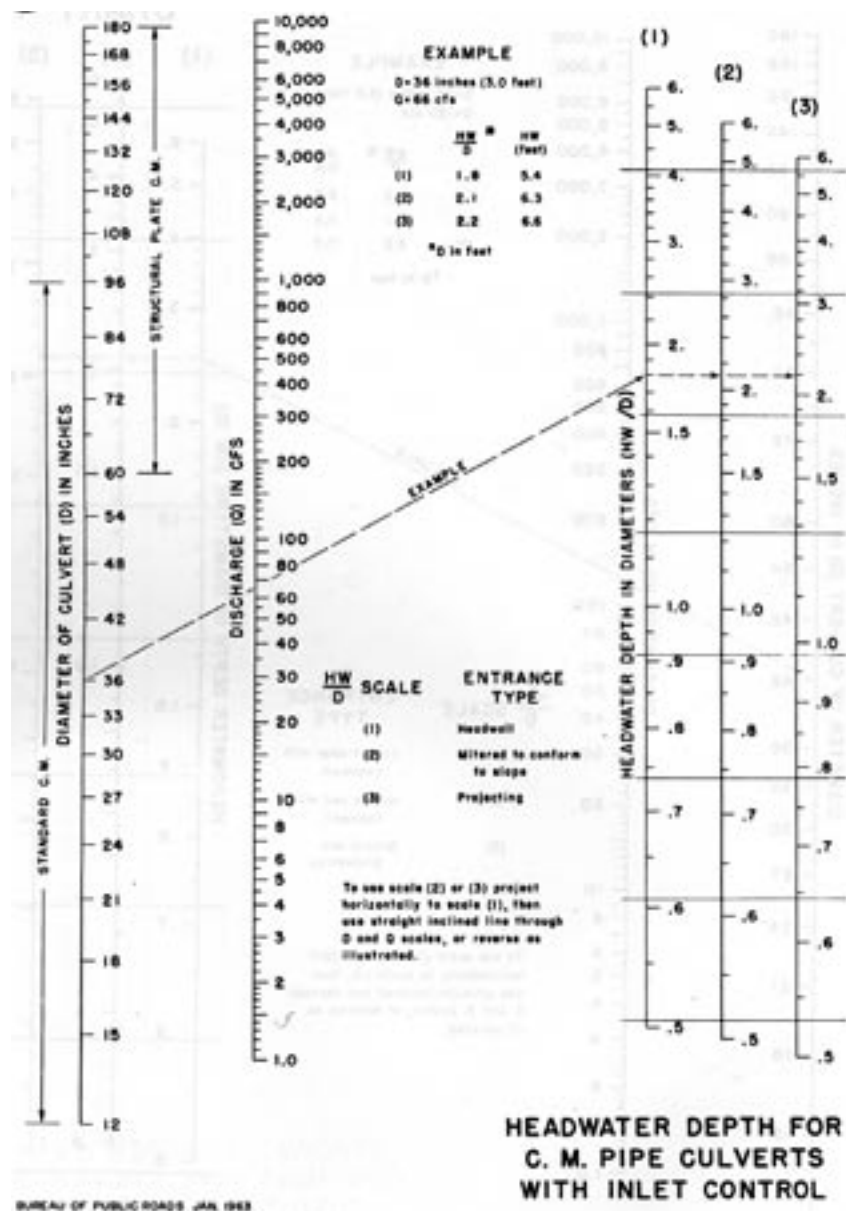
Figure 4.7—Corrugated metal pipe capacity nomograph. (Normann, 1985)

Figures 4.7 and 4.8 present the two HDS-5 nomograms most commonly used to determine capacity versus size for round corrugated metal pipe and concrete box culverts, with various inlet types and for varying headwater depth. These nomograms should be used for inlet control conditions, the condition most often encountered for upland pipe installations. These

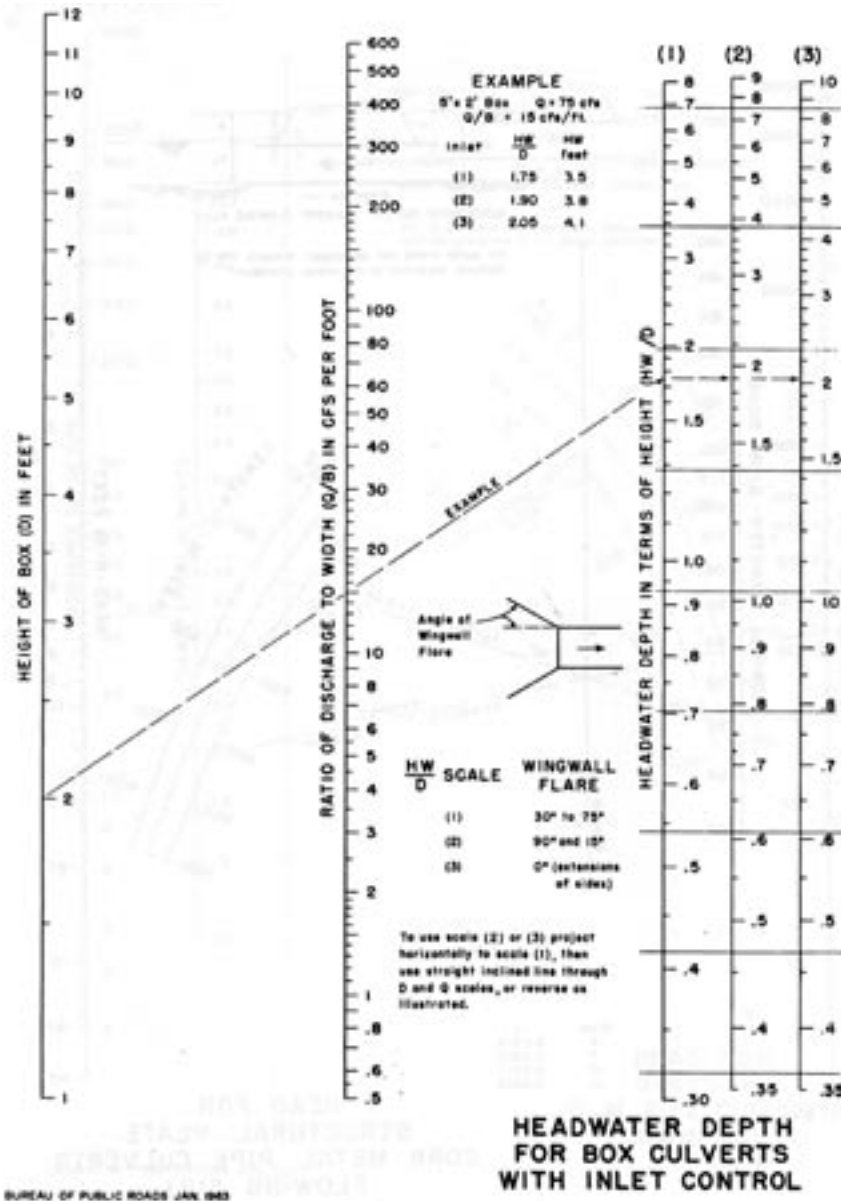
Figure 4.8—Concrete box culverts capacity nomograph. (Normann, 1985)

nomograms are strictly for fluid capacity. They are not valid for partially embedded pipes (which have a natural stream bottom for fish passage), nor do they reflect the size needed to pass sediment or debris. Therefore, use local experience and knowledge of the characteristics of the watershed and channel to estimate additional pipe capacity needed for sediment and debris passage

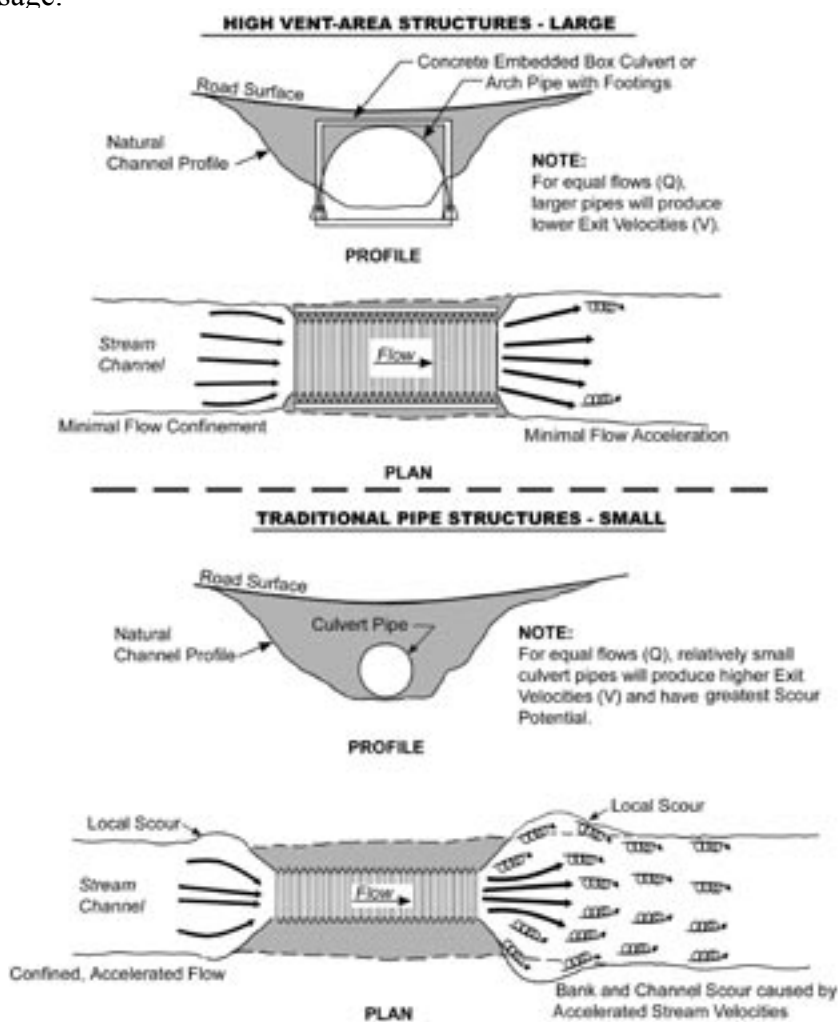
Figure 4.9—Outlet flow patterns and local scour from culverts of different widths.

Velocities accelerate when flow is confined and forced through a smaller area, such as in a channel constriction. Figure 4.9 shows the pattern of exit flow and velocities from small, constricting pipes as opposed to larger pipes. Traditional small culverts that constrict the channel and accelerate flow velocities can cause bank, fill, and channel scour, both at the pipe inlet and outlet. The higher velocity may also impede or prevent fish passage.

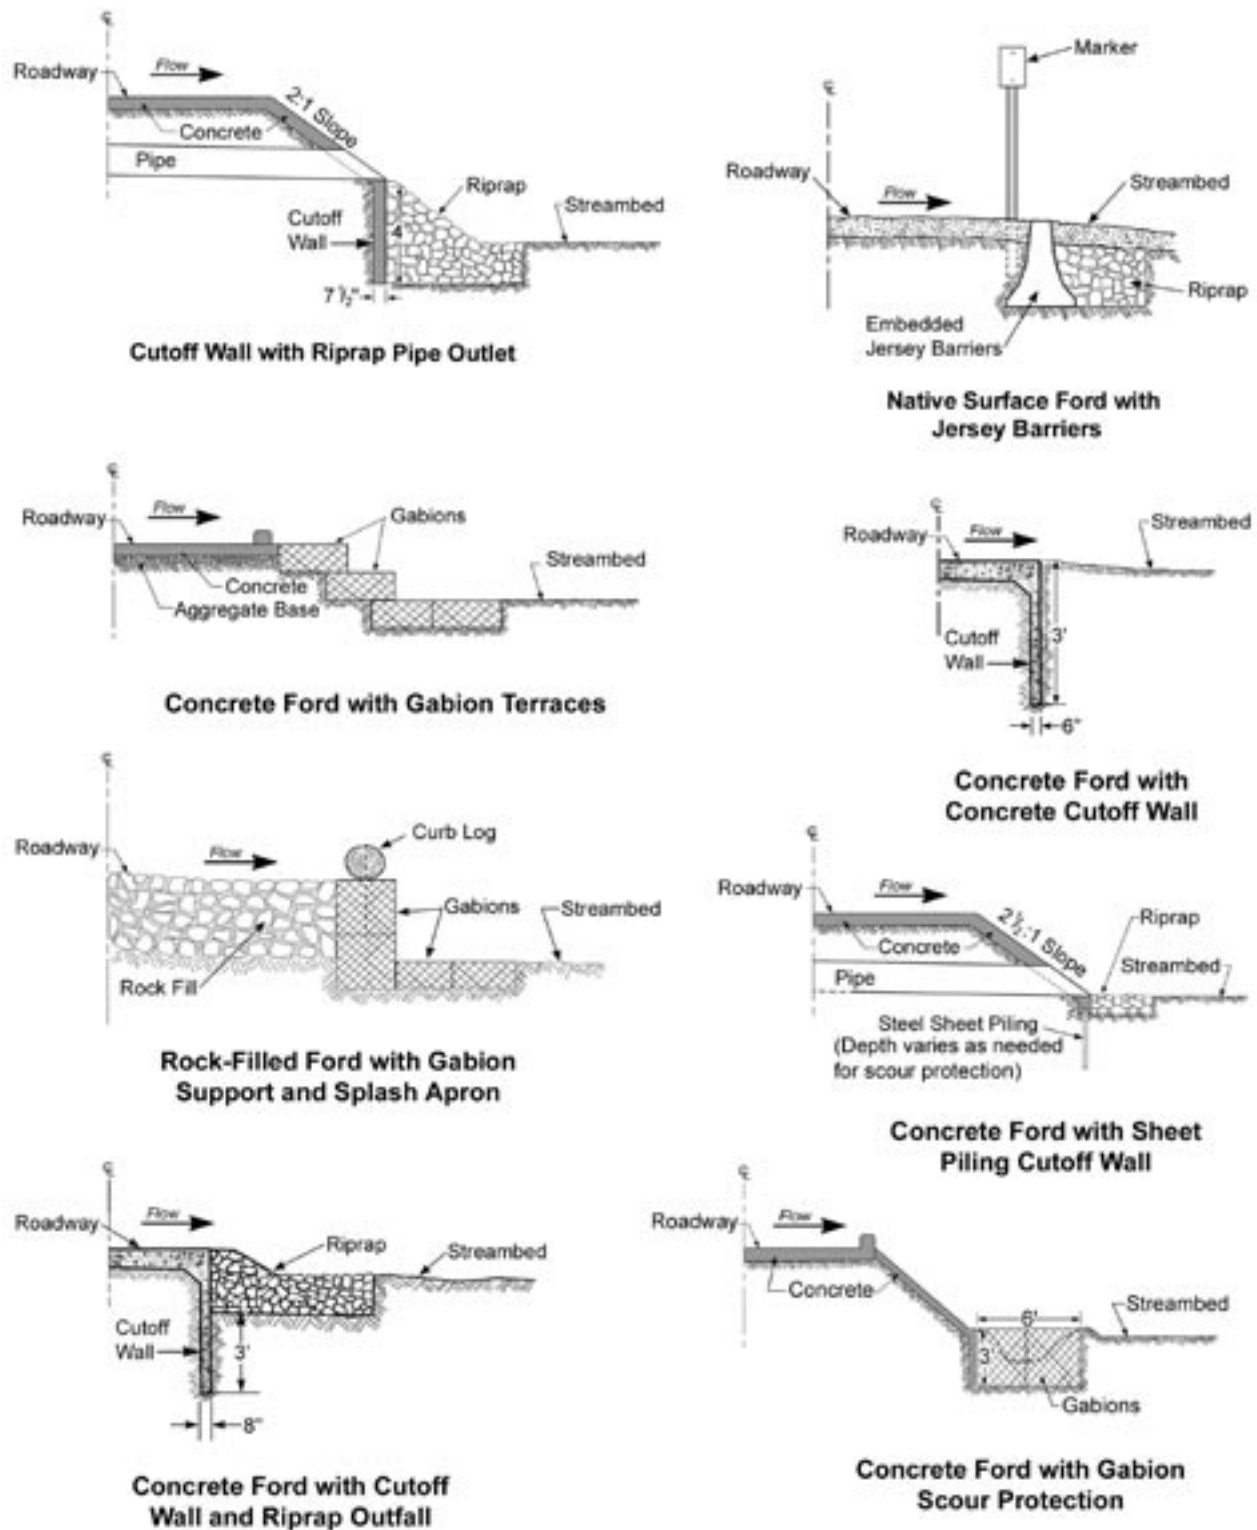
Figure 4.12—Common downstream protection measures used against scour on low-water crossings.

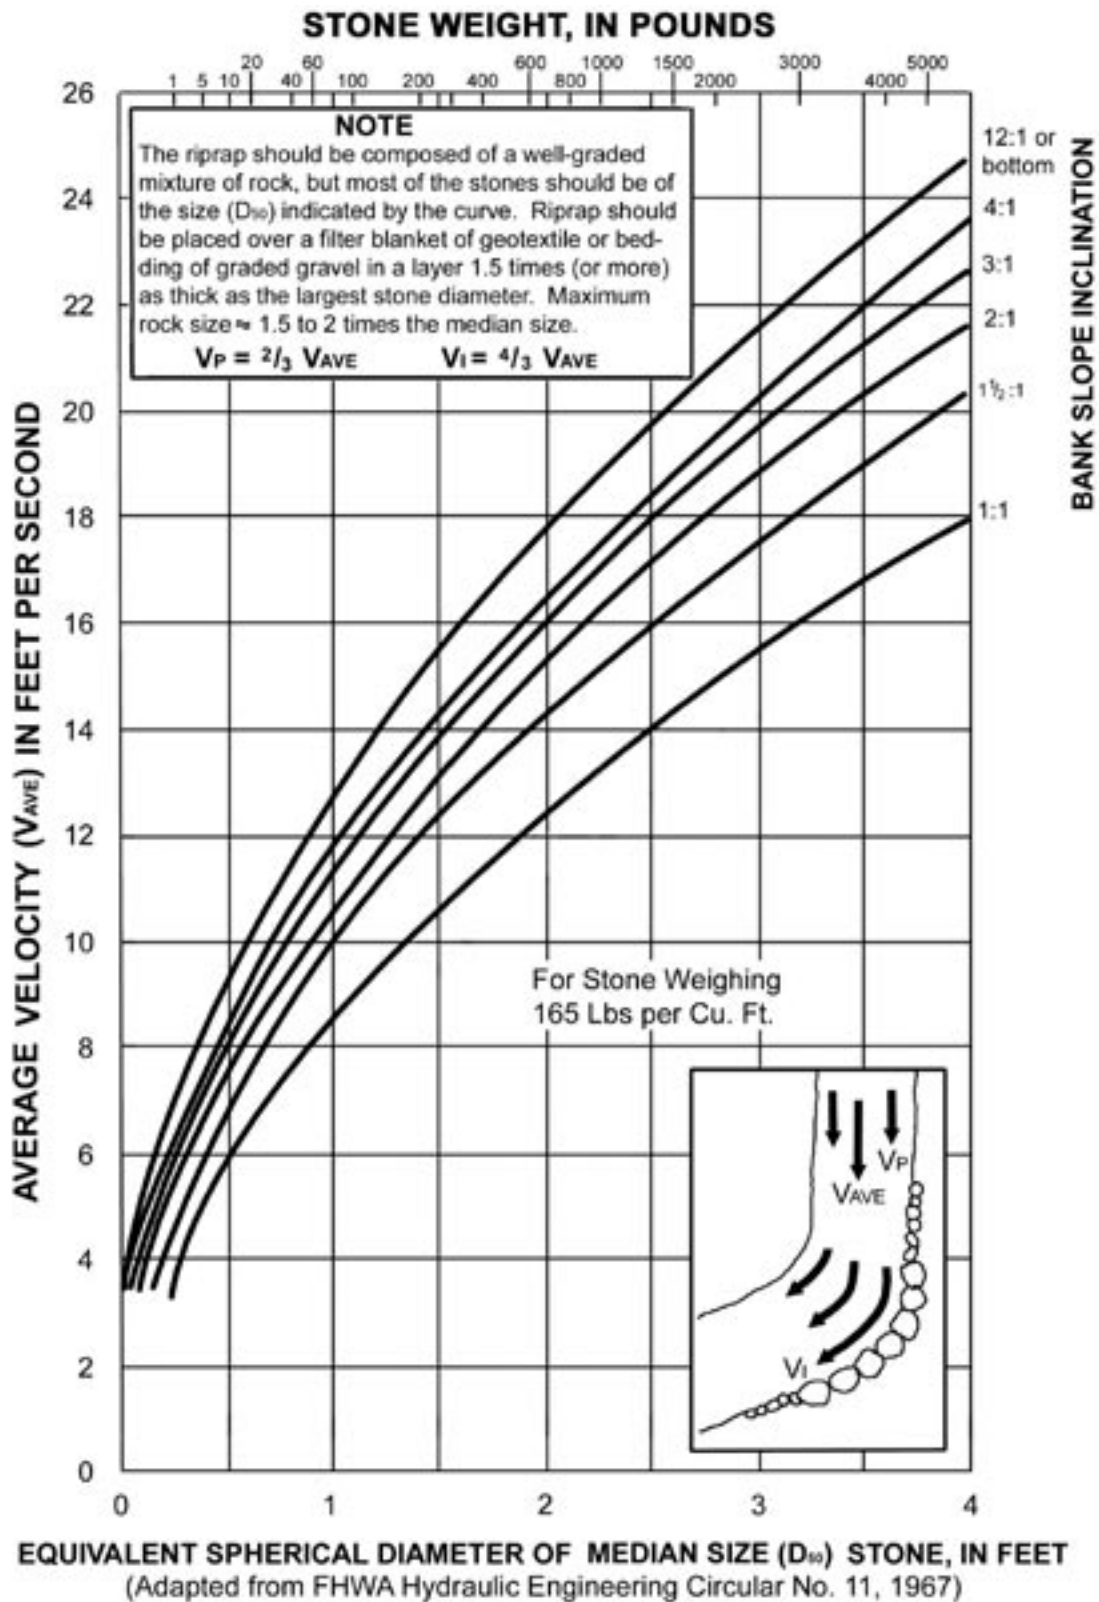
Figure 4.13—Size of stone needed to resist displacement by flowing water.

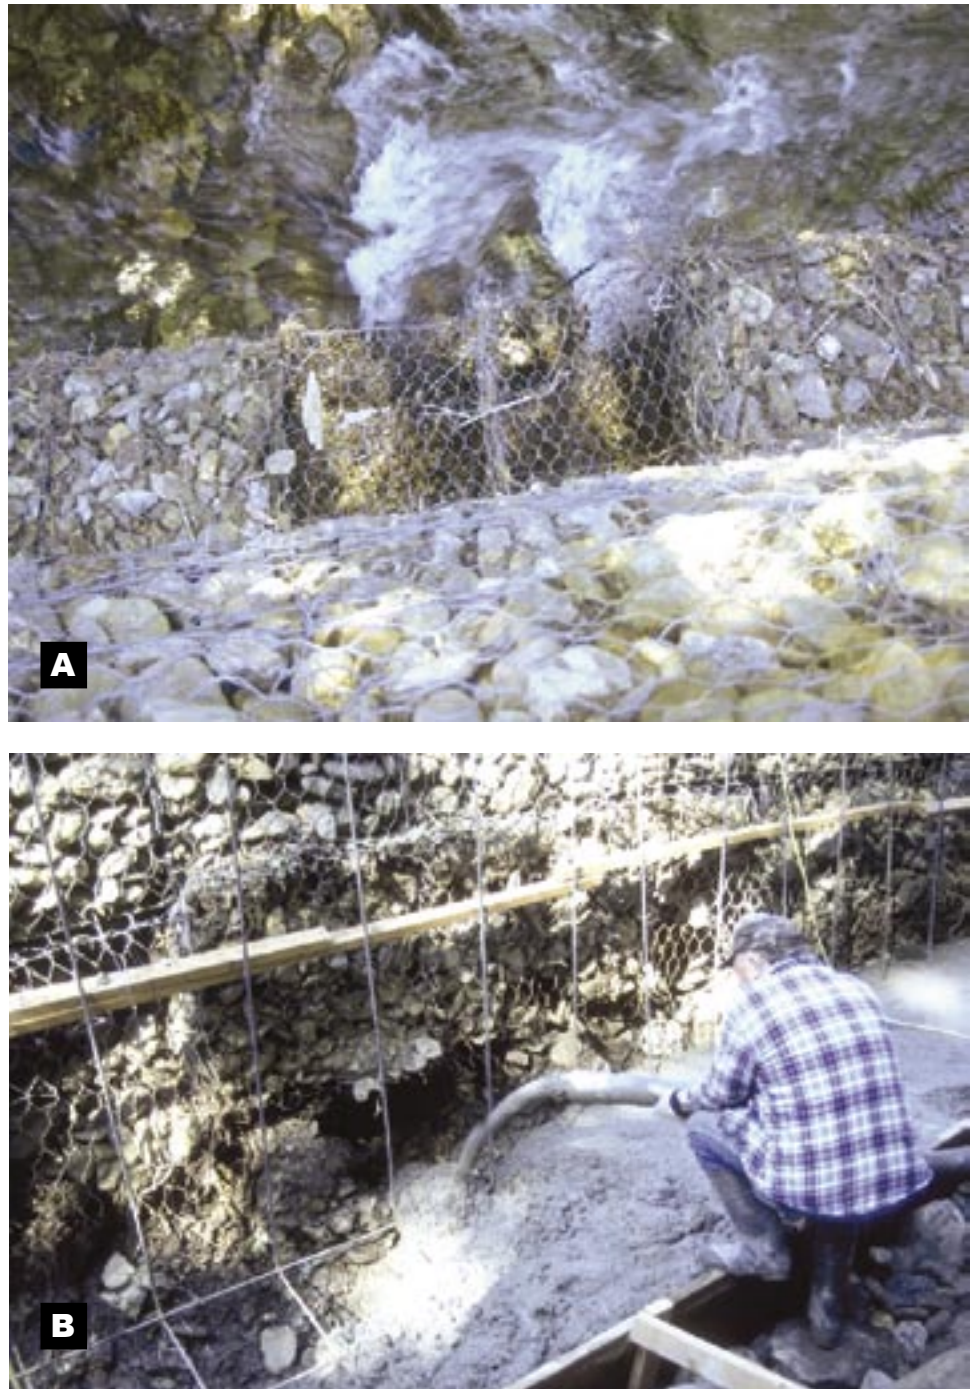
Figure 4.20—Gabion-basket failure and maintenance. a) Looking down at gabion baskets constructed to stabilize streambanks on Soda Creek, Plumas National Forest. Wire has rusted, allowing rock to wash away. b) To repair the stabilization structure, a concrete wall was poured in front of the damaged gabions.

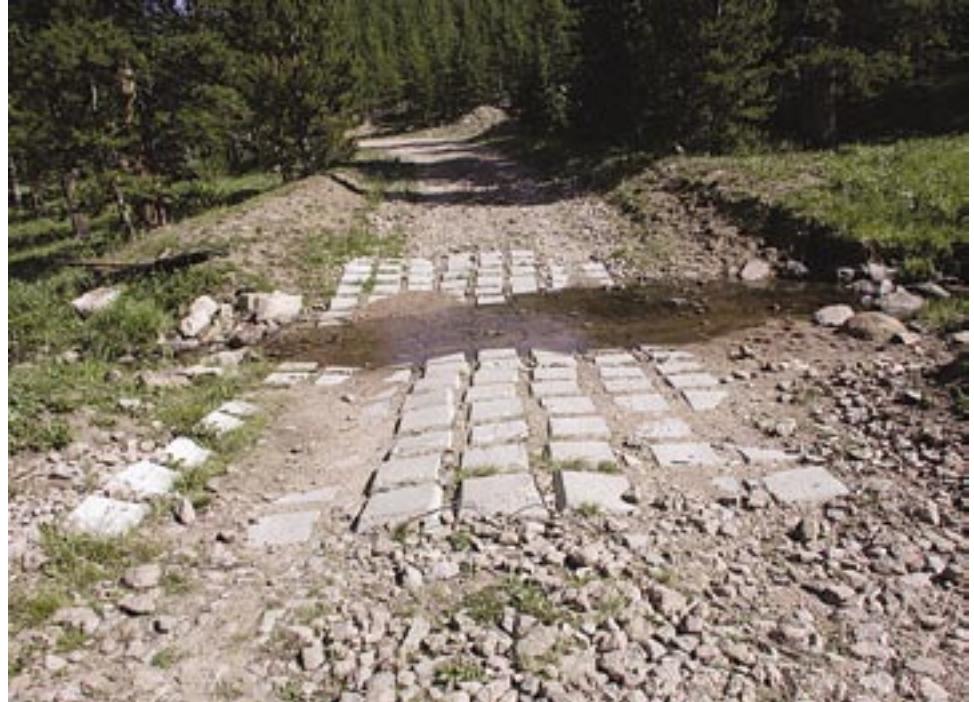
Figure 5.6—Cable concrete block ford, Bighorn National Forest, Wyoming. Note that mat should extend higher to protect the crossing adequately.

protection, such as riprap, may be needed along the downstream edge of the structure. The mats can be anchored in place simply with rebar and cable clamps, or with soil or rock anchors in a dynamic environment.

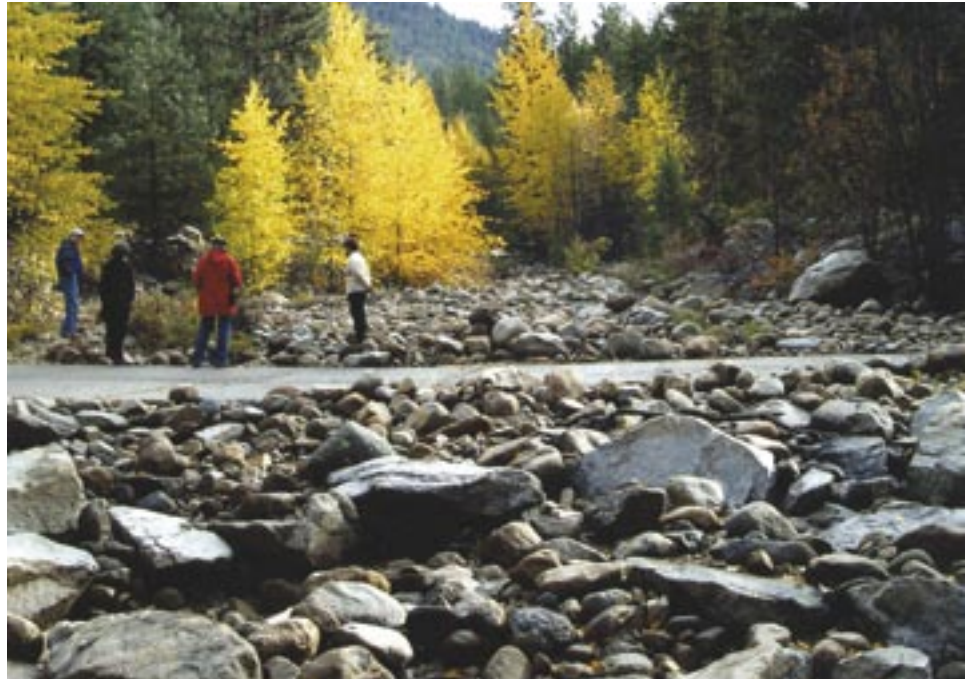
Figure A6—Vented ford plugged with boulders.

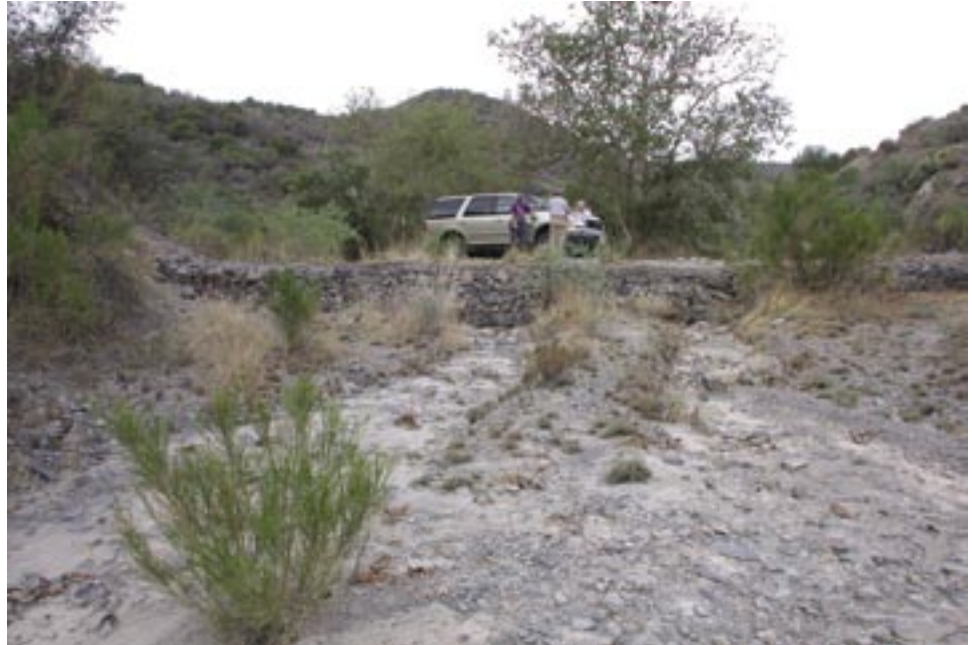
Figure A21. This jersey barrier-gabion ford on the 7-Springs Road on the Tonto replaced a bridge washed out in a flood.

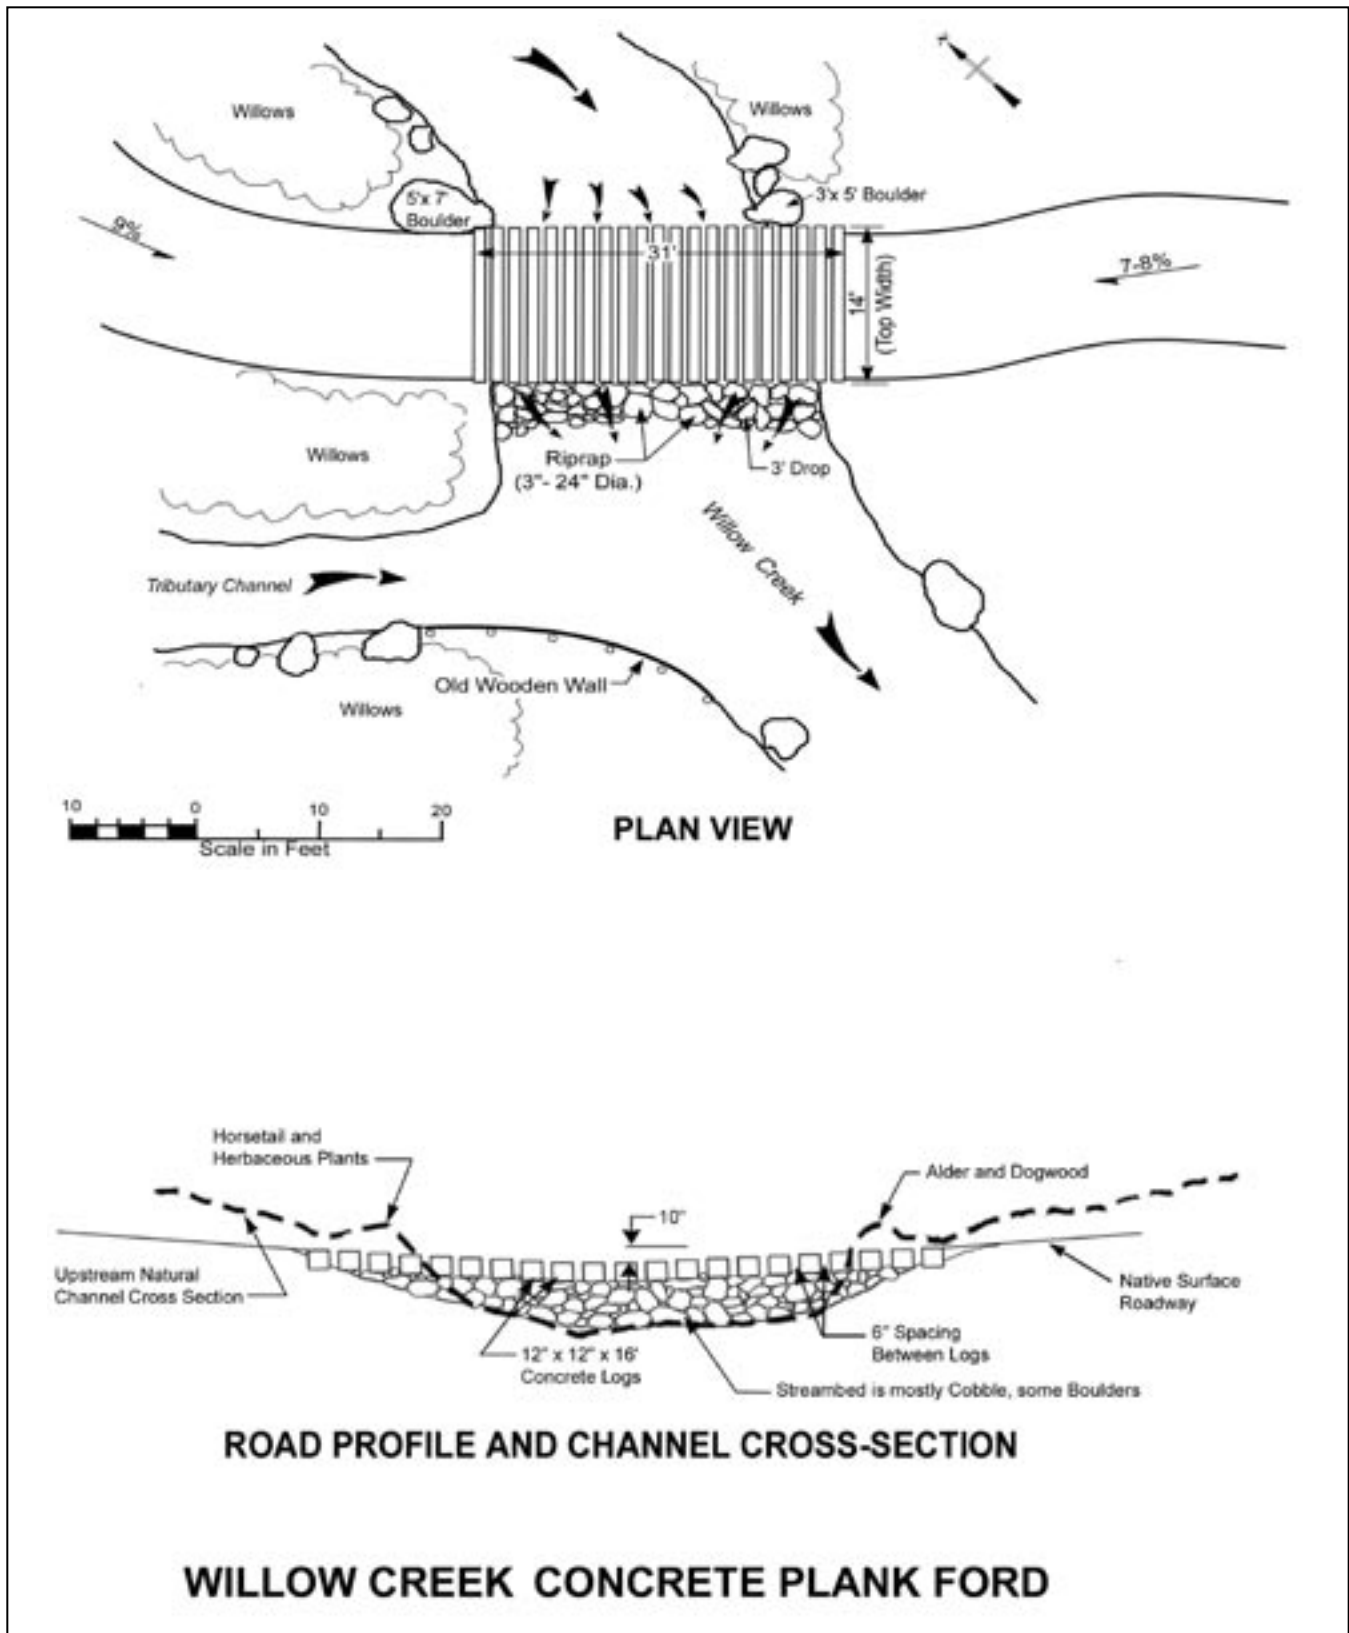
Figure A25. Site plan view and cross-section sketch.

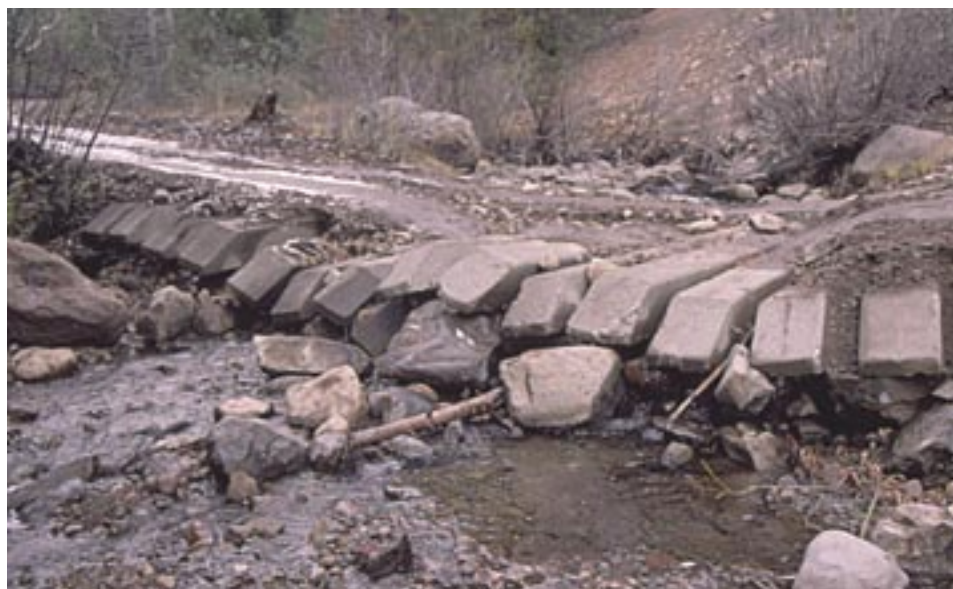
Figure A26. The crossing was damaged in the 1997 flood by scour of fine bedding materials under the planks. The planks had to be reset into coarser materials and the downstream edge protected with riprap.

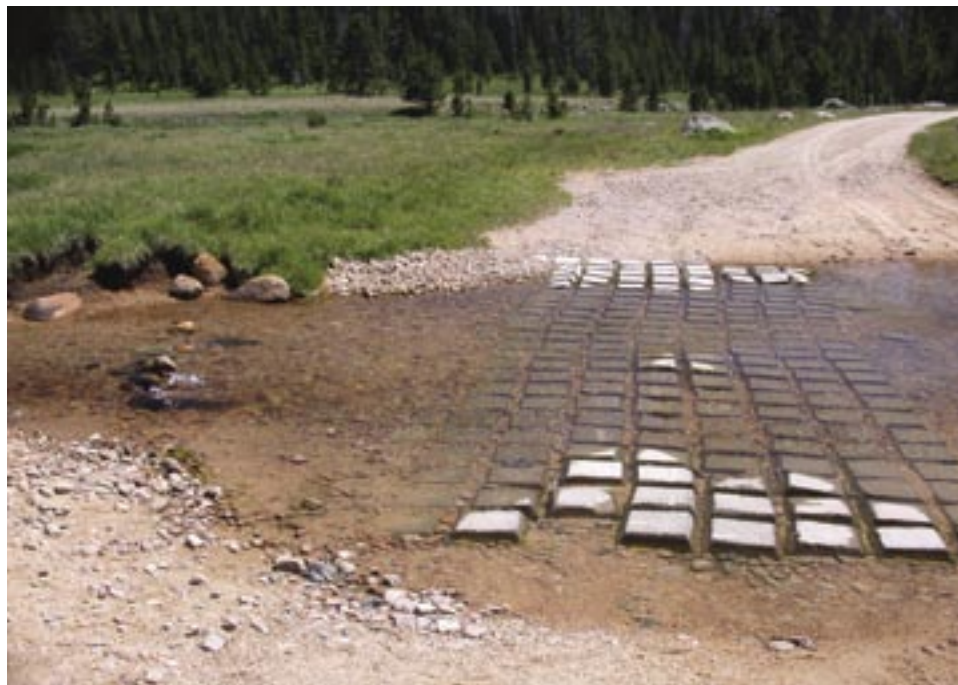
Figure A32. East Fork South Tongue River cable concrete block mat crossing. Note tilted blocks, exposed cables, and short mat length. Traffic is driving around the mat and the river has outflanked it.

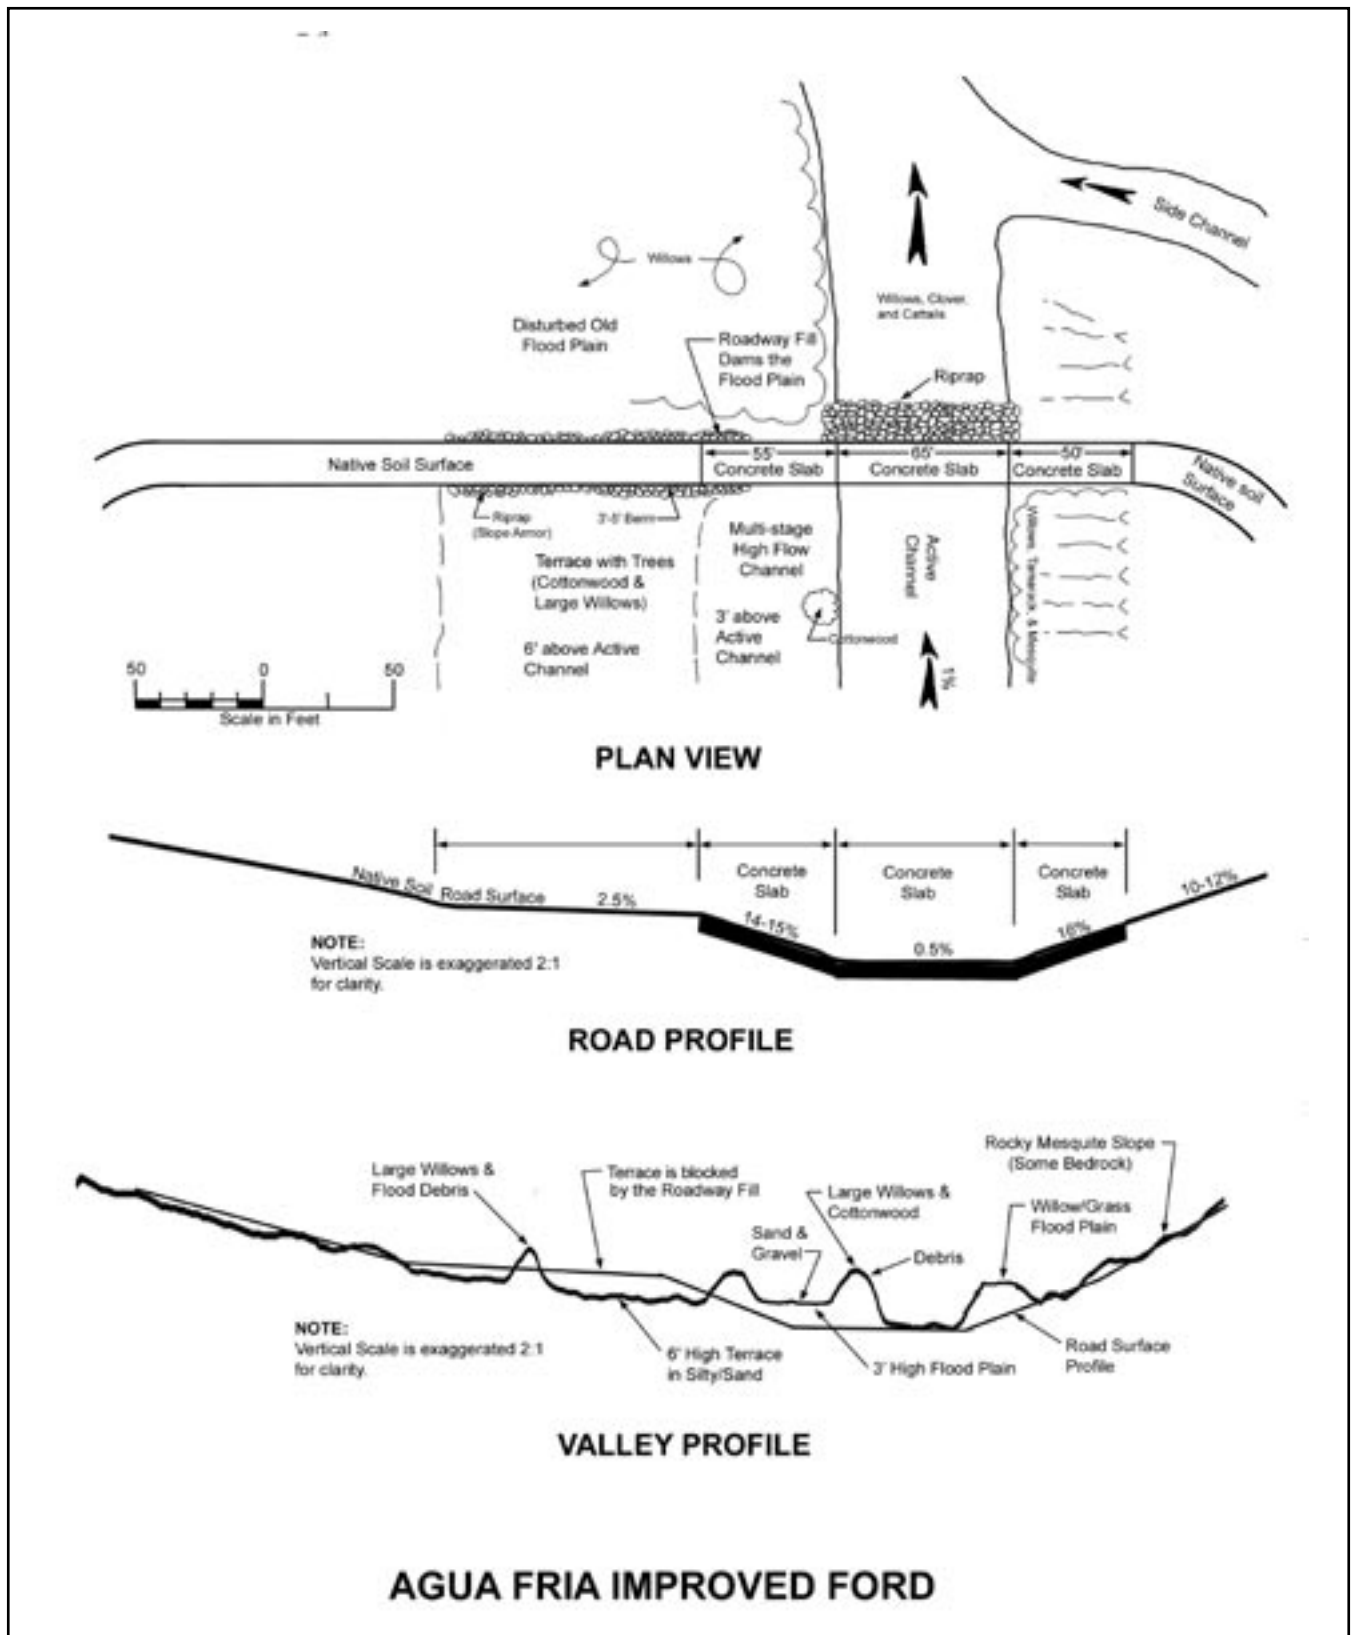
Figure A45. Site plan view and road and valley cross section sketches.

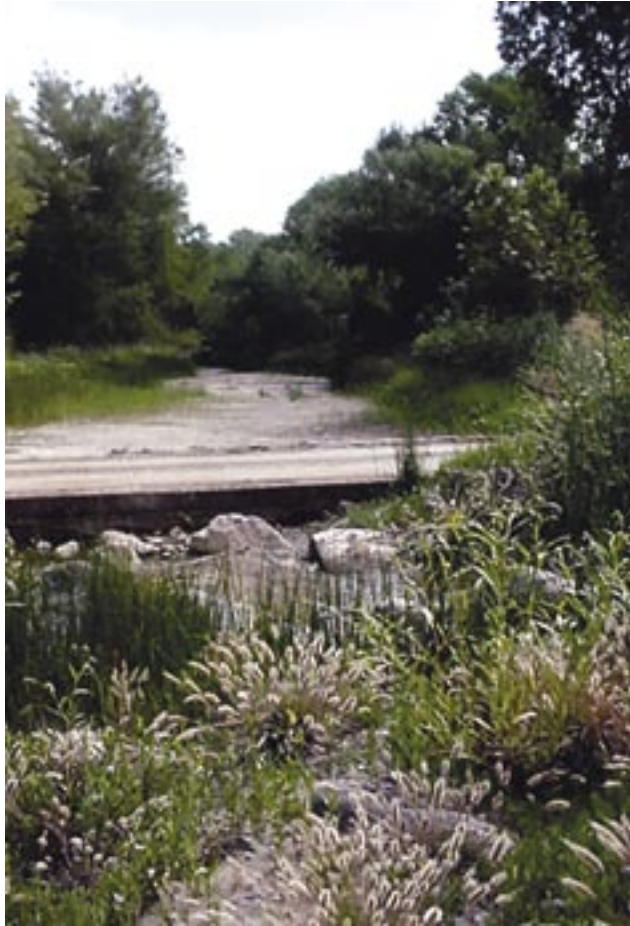
Figure A47. Looking upstream at ford and Agua Fria channel. Fish can move across the ford only when it is submerged.

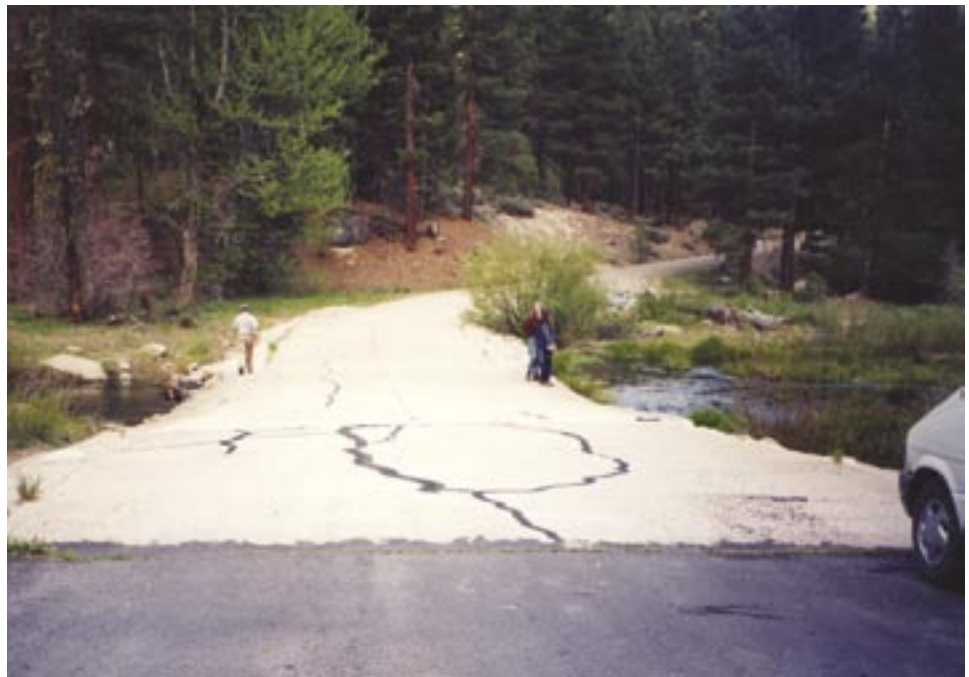
Figure A64. Babcock crossing roadway has a slight vertical curve.

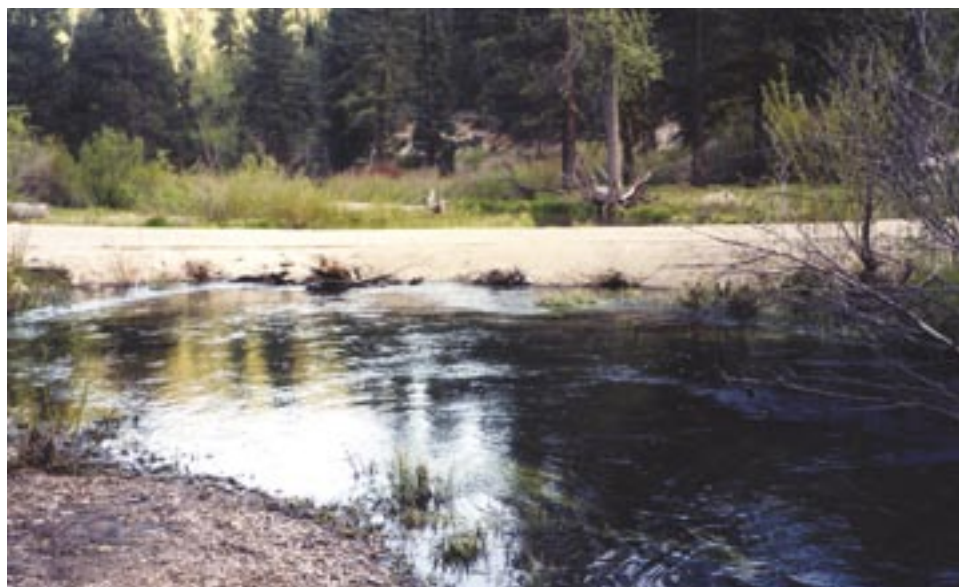
Figure A69. Small debris partially plugs the pipes.
