U.S. Department  
of Agriculture

Forest Service

# Low-Water Crossings: Geomorphic, Biological, and Engineering Design Considerations

October 2006

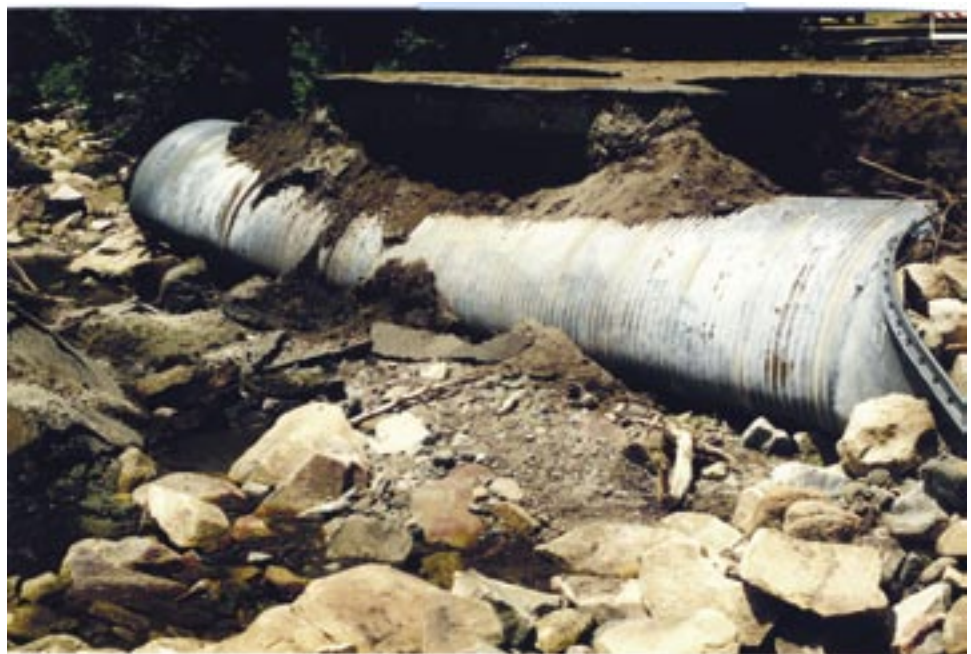
Figure A81. Typical flood damage at edge of North Fork Consumnes River valley after 1997 rain-on-snow flood.

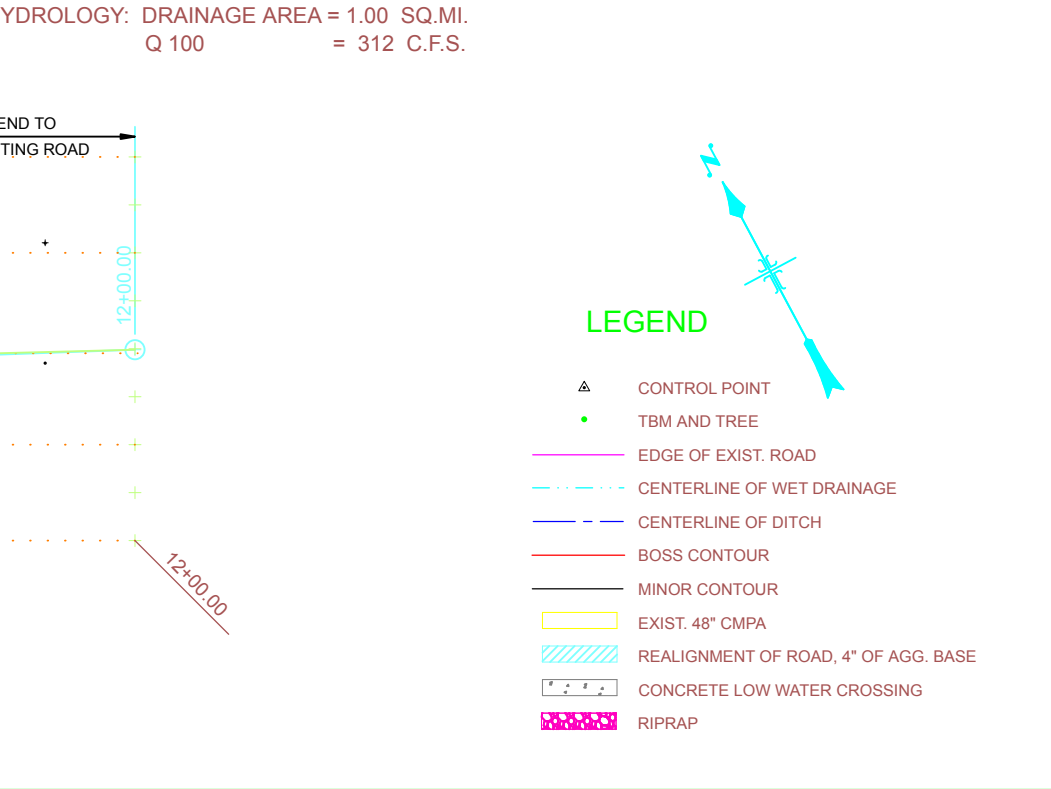
Figure A85. Site plan for McKinney Creek crossing, similar to Meiss Cabin Road box culverts but without the tilted floor.

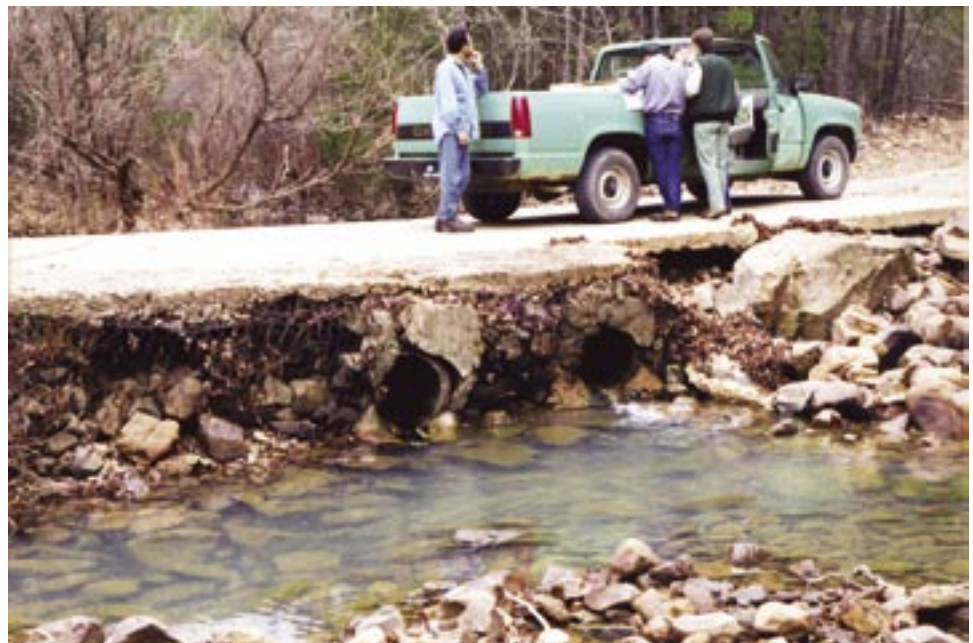
Figure A87. The previous crossing on road 887 at Rocky Creek was a gabion-culvert structure that was frequently damaged during high flows.

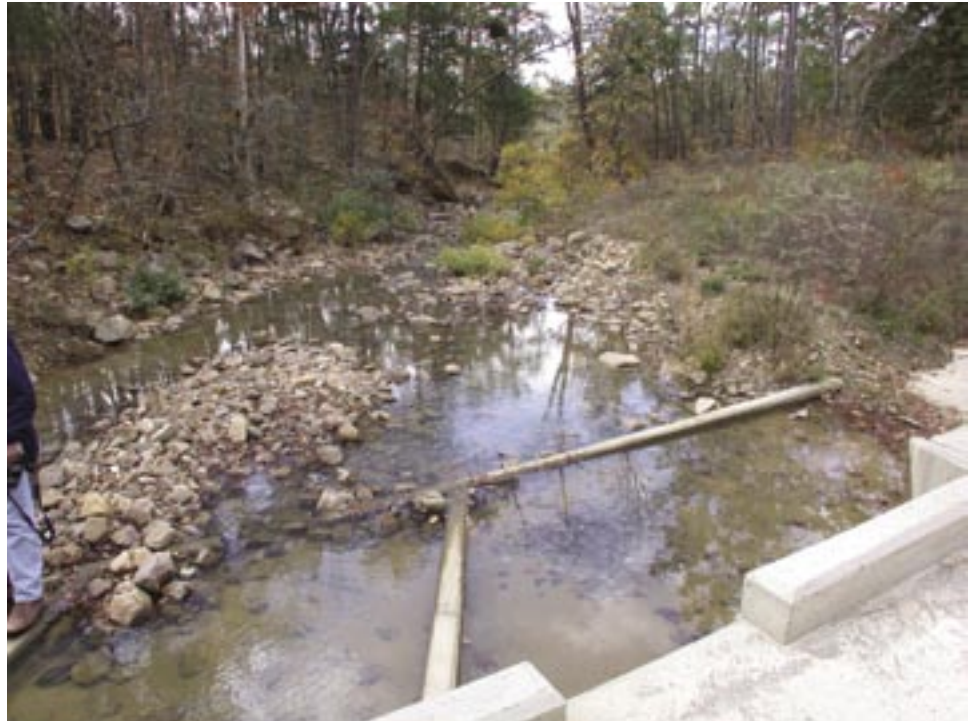
Figure A91. Looking downstream from ford. Note local channel widening.

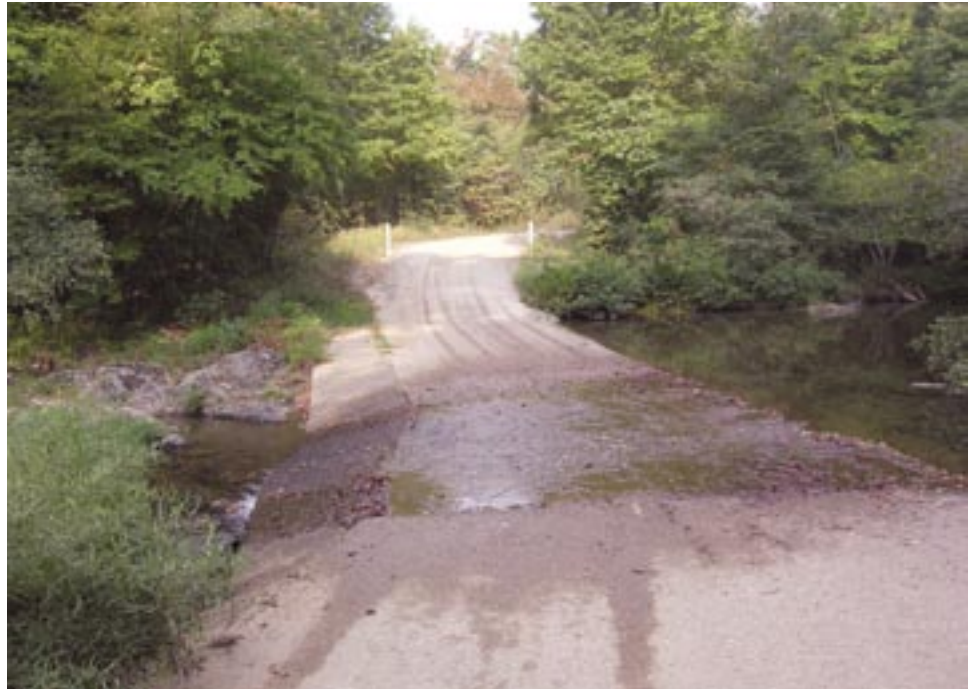
Figure A93. Unvented ford similar to the one replaced at FR 512 crossing on Long Creek, Ouachita National Forest.

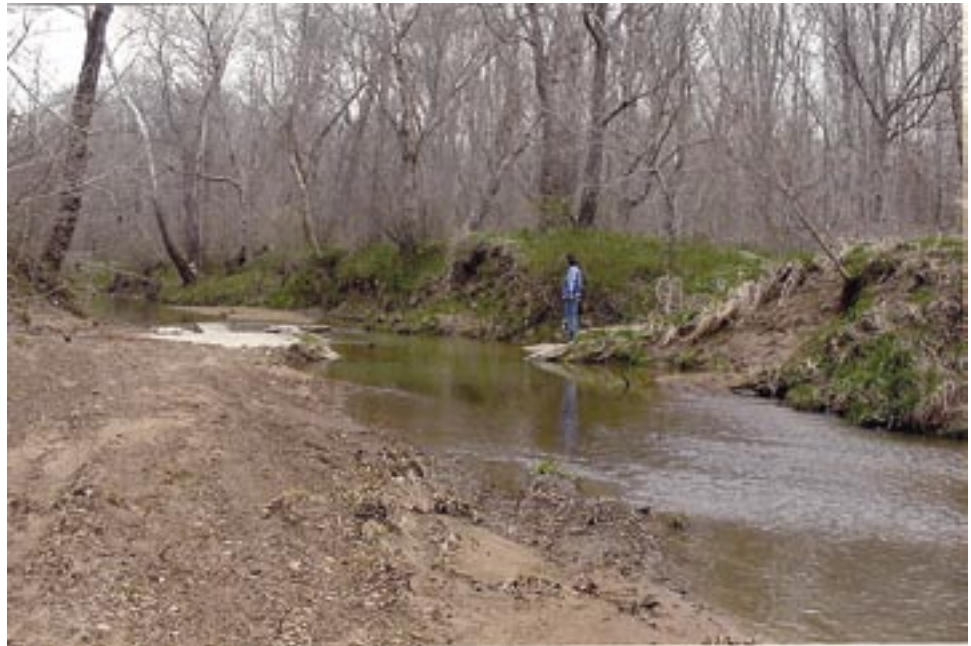
Figure A125. Looking upstream at failed Kinkaid Creek crossing, 2000. Stream slope is 0.3 percent.

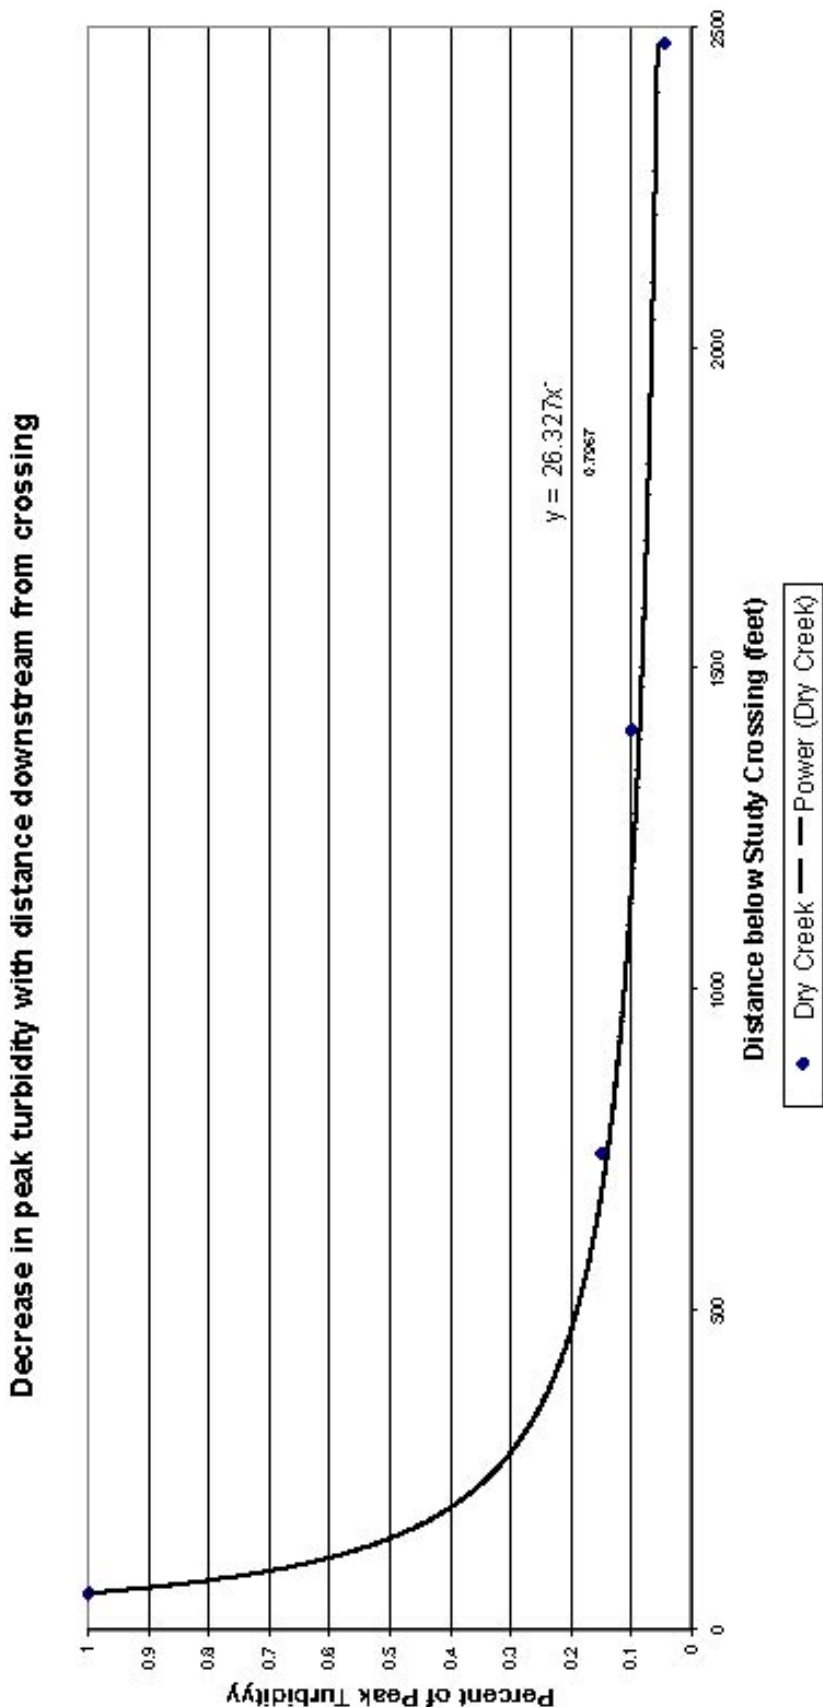
Figure D-2. Turbidity decrease with distance downstream. Dry Creek has four unimproved fords along a fairly uniform 1/2-mile length. These data represent turbidity measured at a downstream ford (the study ford) as a wave of riders crossed fords at different distances upstream. Peak turbidity data are reported as a percentage of peak observed at the study ford (study ford data shown as 100 percent). The other fords are at 750, 1,400, and 2,480 feet upstream of the study ford. (Deiter 2006)
