**ENGINEERING  
TECHNICAL  
INFORMATION  
SYSTEM**

Volume 3 Number 4 April 1971

### INSTALLATION OF A PREFABRICATED ALUMINUM BIN WALL

#### BLOWER TO ASSIST WITH BURNING DURING CLEARING AND GRUBBING OPERATION

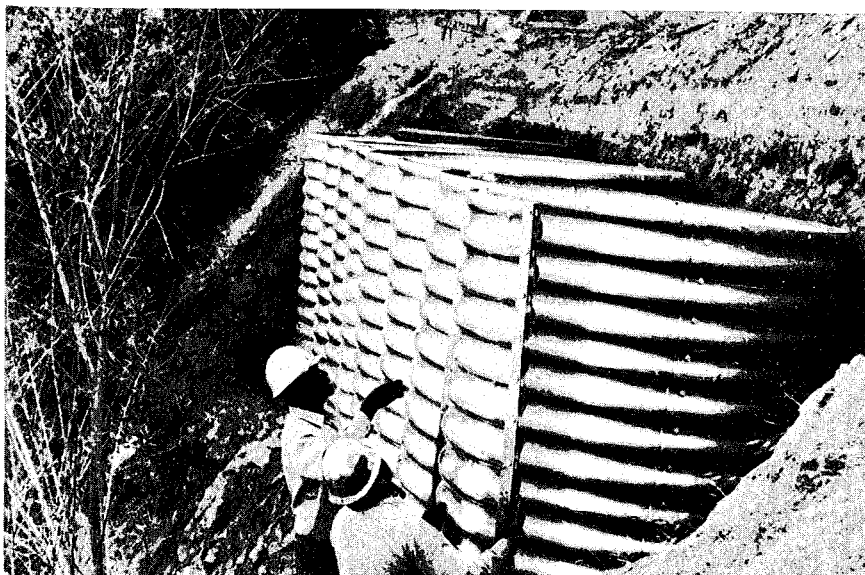
Figure 5. -- Positioning and bolting interstice facia sheets to bins.

The bin wall material was delivered in half-round sections for ease of shipment and handling. The half sections were easily handled by two men (see fig. 2). The sections were bolted together on the roadway and rope was tied around the circular bin to lower it into the excavation and position it easily by hand (see fig. 3). The arched fascia plates were then bolted onto the bins, giving them remarkable rigidity (see figs. 4 and 5).

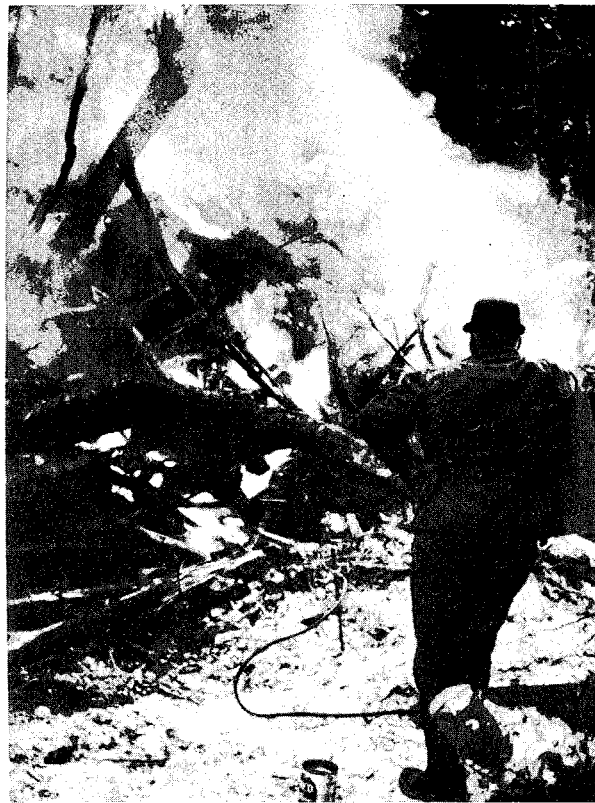
Figure 3. -- Blower in operation. Note—the nozzle spraying fuel oil into the fire.
