# Engineering Field Notes

*Rec'd 6/7/83*  
Volume 15  
January - March  
1983

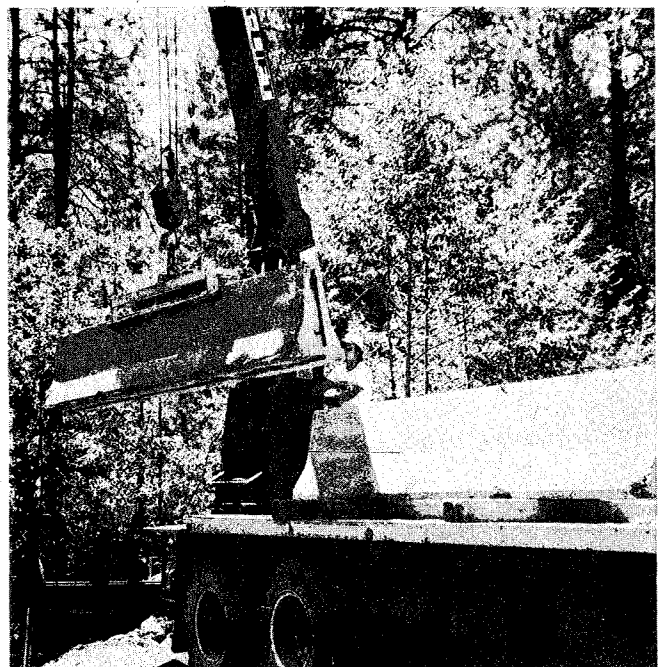
*Figure 1.--Precast concrete median (Jersey) barrier ready to be installed.*

The barrier sections, which are 12 feet 6 inches long and weigh approximately 5,000 pounds, are placed in the stream by using a loader or a boom truck. Longer sections are available; however, the increased weight requires the use of even larger equipment.

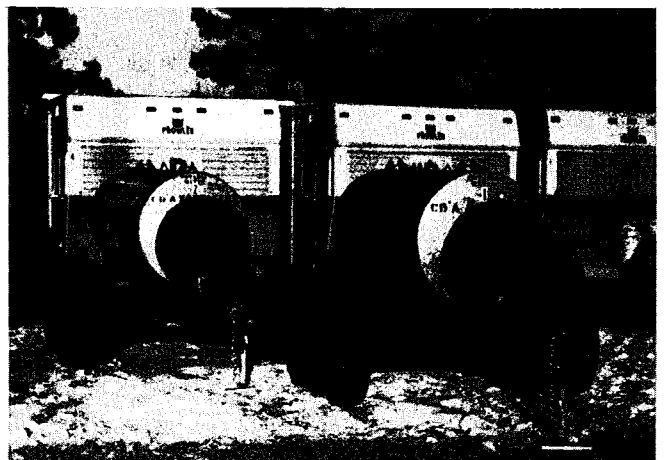
*Figure 1.--Portable water tanks, in place, front view.*

One solution to these problems is the portable water tank (figures 1, 2, and 3). Criteria for the tank were developed by engineering personnel on the Idaho Panhandle National Forests. The tank is made of galvanized steel, is 36 inches in diameter and 6 feet long, and has a nominal size of 300 gallons. Interior baffles in the tank inhibit the weight from shifting while traveling with partial loads. The tank is filled through a convenient flip-up cap at the top, and water is withdrawn and drained through a double hose bibb outlet at the bottom rear of the tank. The tank's trailer is equipped with dual axles, automobile tires, fenders, lights, and electric brakes. The tank and trailer can be towed easily by a half-ton pickup truck. To use, the tank is filled at a safe water source, such as a ranger
