# Engineering Field Notes

Volume 30  
September–December  
1998

# Risky Business

**Bill Renison**  
**North Zone Engineer**  
**Mt. Baker-Snoqualmie National Forest**

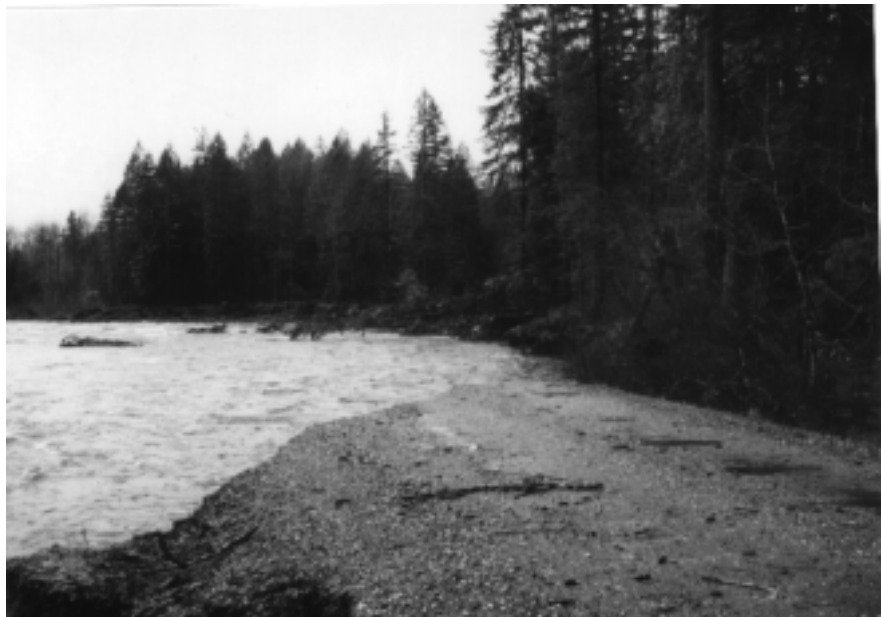
**Figure 7.** *Suiattle River scours about a quarter mile of road.*

As shown in figures 7–9, most of the primary access roads within the forest are located on the floors of canyons and adjacent to major streams. A major portion of repair, restoration, and prevention work is associated with primary routes. Figure 10 provides examples of the challenges of providing cross drainage for major streams due to high energy and debris flow. The forest has approximately 35 concrete fords that have proven effective in reducing debris on the surface and damage at the outlet (figure 11).

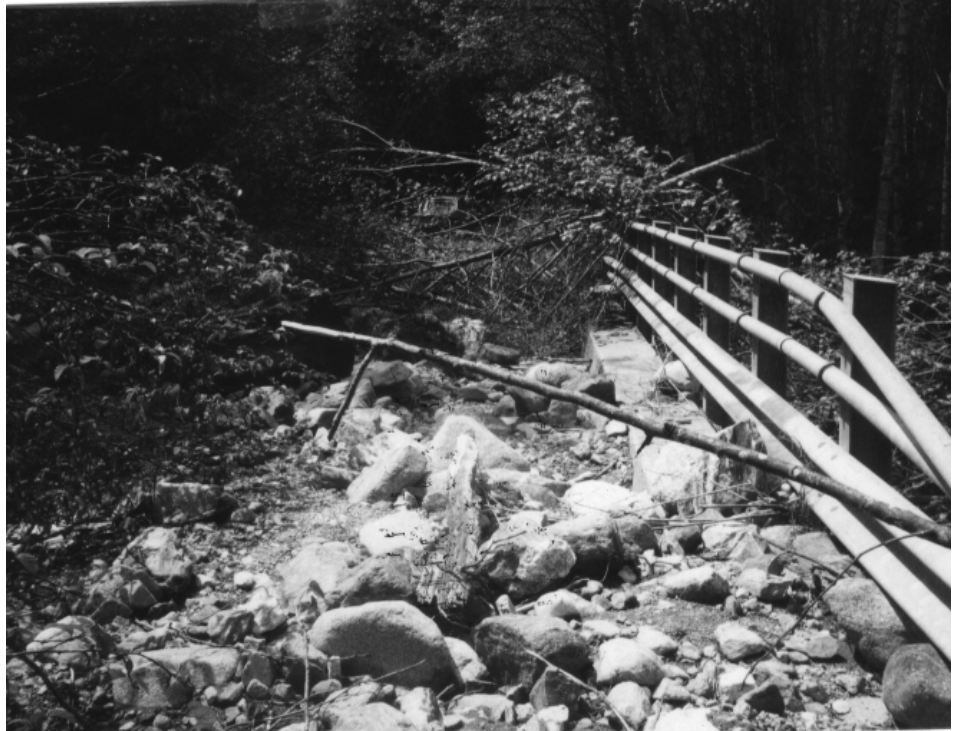
**Figure 8.** *Bedal Creek flows over the top of a bridge.*

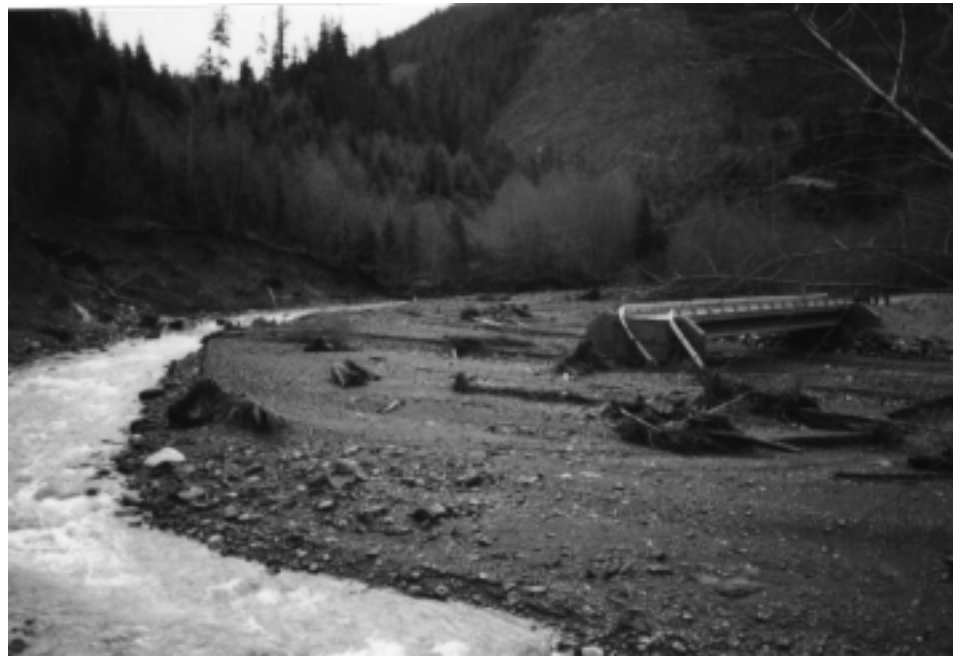
**Figure 9.** *Canyon Creek skirts around a 100-foot bridge, removing the entire approach.*

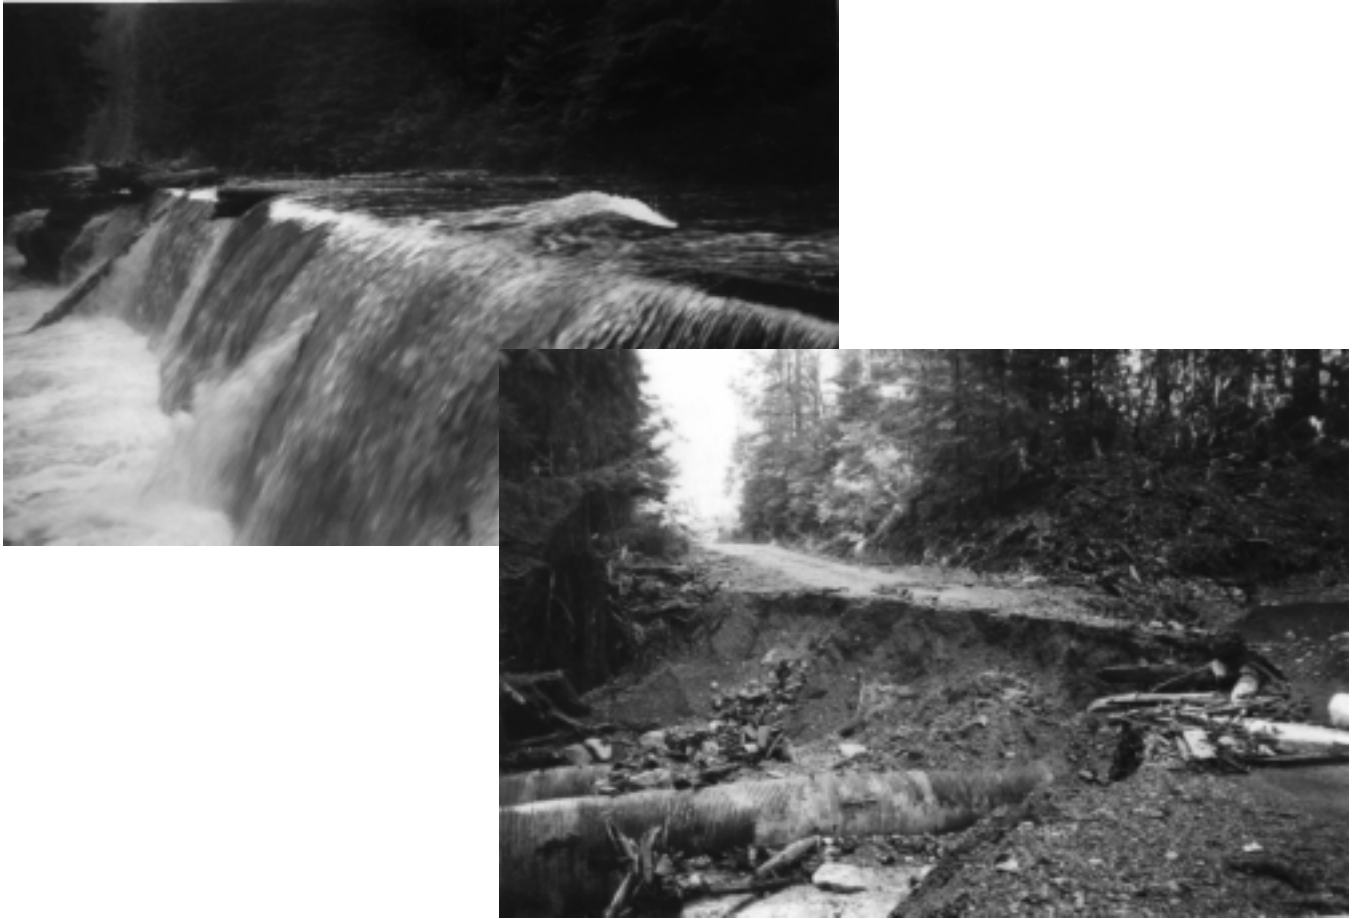
**Figure 10.** *Providing cross drainage for major streams is a challenge due to high energy and debris flow.*

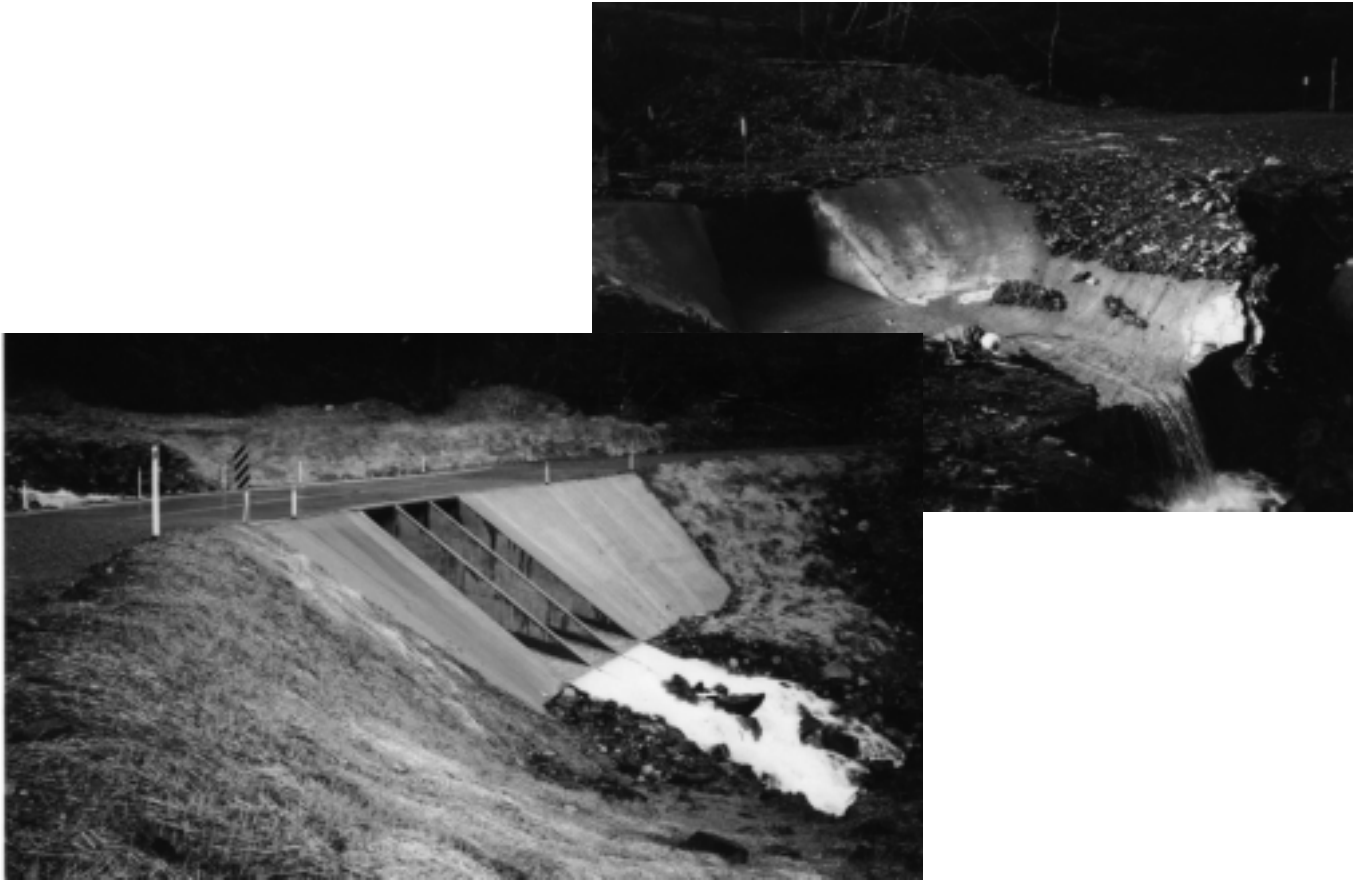
**Figure 11.** A ford follows a storm, with debris on the surface and minor damage at the outlet (upper-right photo). Subsequent designs include large riprap at the outfall as an energy dissipator (lower-left photo).

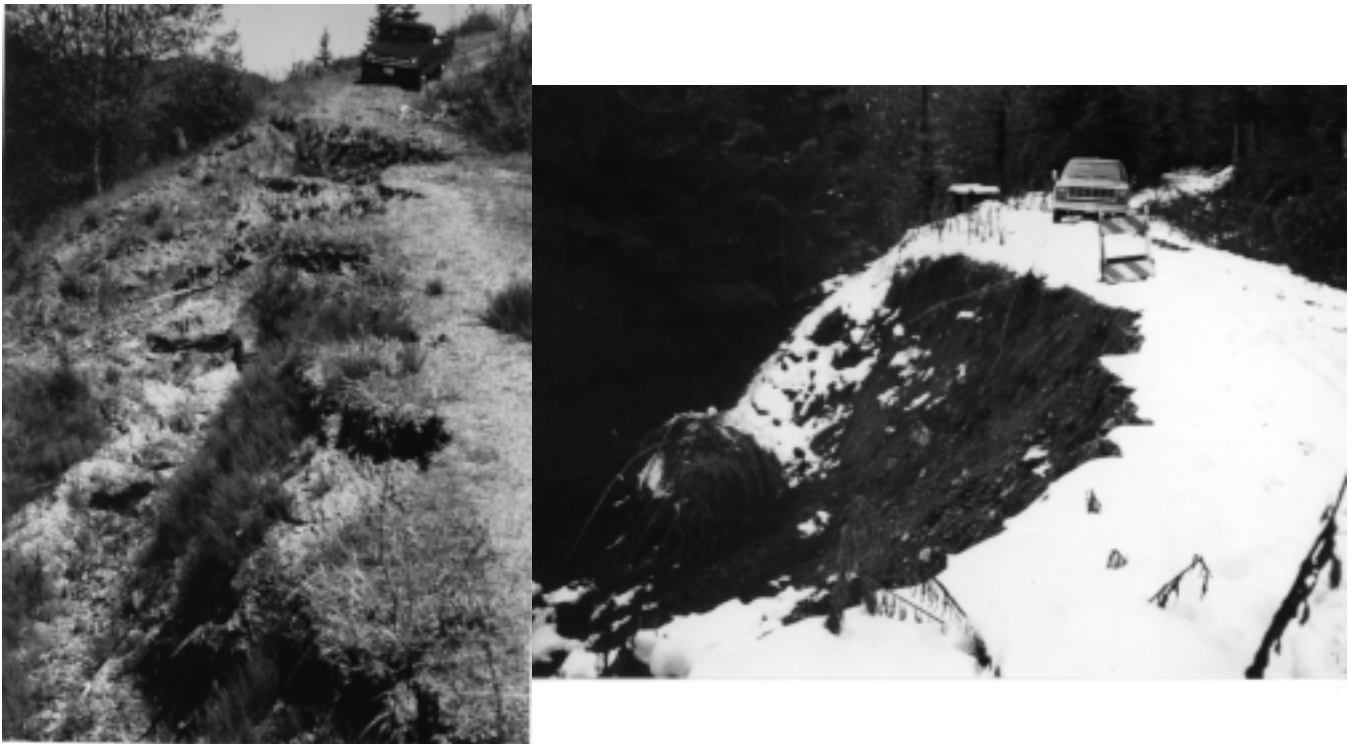
**Figure 12.** Slumping and side-cast failures are typical along hundreds of miles of local road on the forest.

It is now estimated that about one-half of the 1,100 miles will be treated for some level of storm protection before closure. Figures 12–14 are examples of the 1,100 miles of level 0 and 1 roads that have been evaluated for risk. These show typical failures on level 0 and 1 roads, a road closing naturally, and a road with full decommissioning treatment. Roads having the highest risk will be done first and will probably have the highest unit cost. But, instead of an average cost of \$10,000 per mile, the expected average will be closer to \$2,000. Obviously, the risk of failures will be far higher, but it is planned risk—a strategy to balance the highest needs with available dollars.

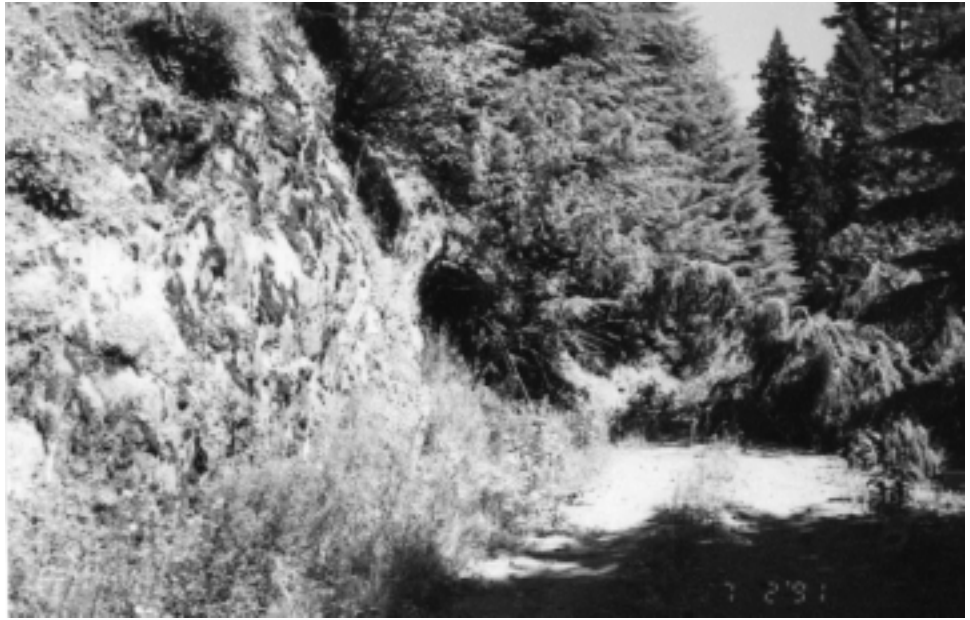
**Figure 13.** A low-risk road is being closed naturally by vegetation and windfalls.

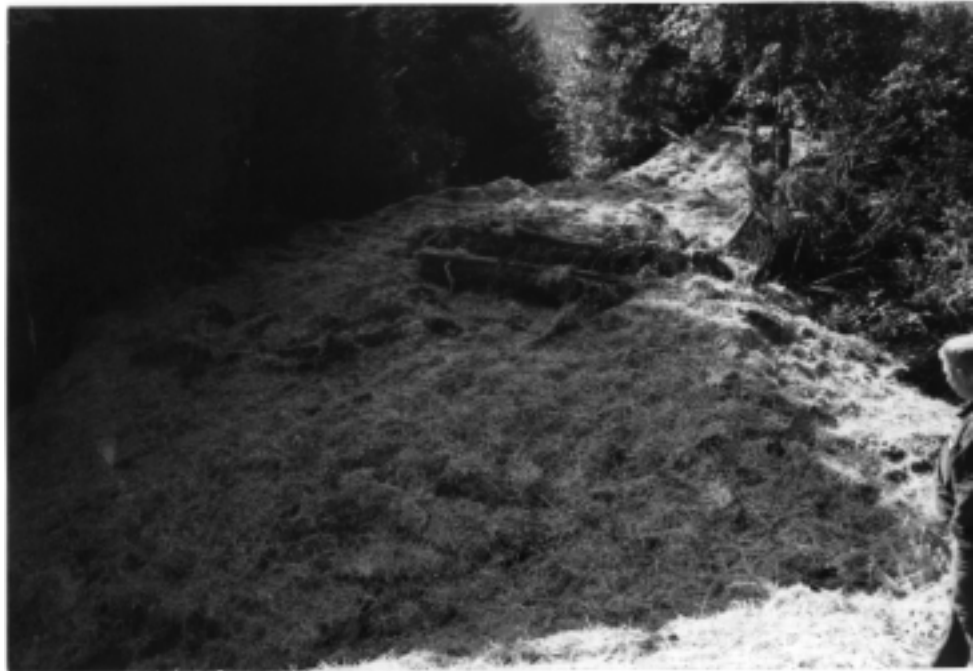
**Figure 14.** A decommissioned road has been seeded and mulched with straw.
