Monitoring Road Decommissioning in the Mann Creek Watershed: Post-storm Report Payette National Forest

January 27, 2011

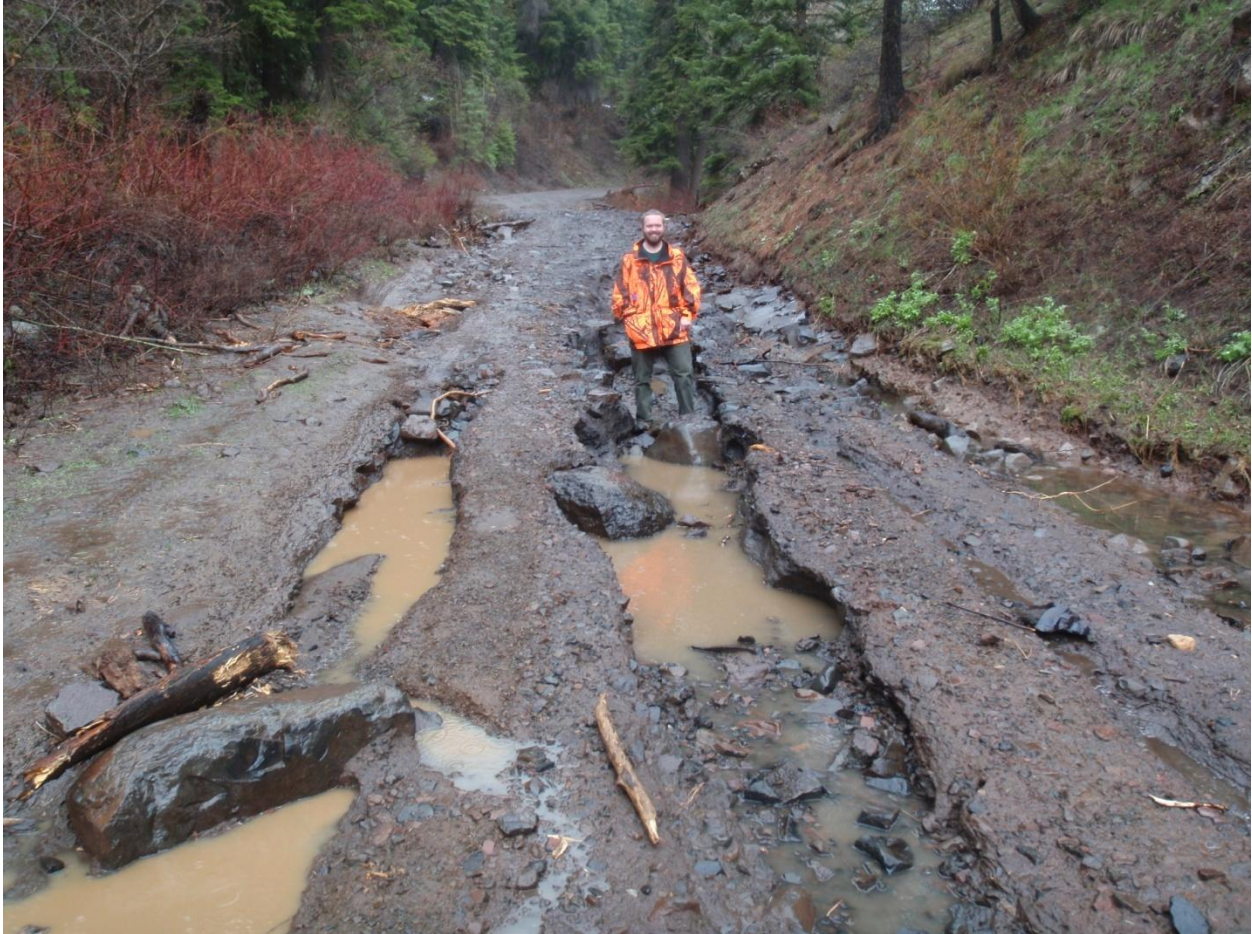
Figure 3: Damage from the April storms. The author is standing in a gullied wheeltrack where flood water was diverted down the road from the stream crossing behind the author's head.

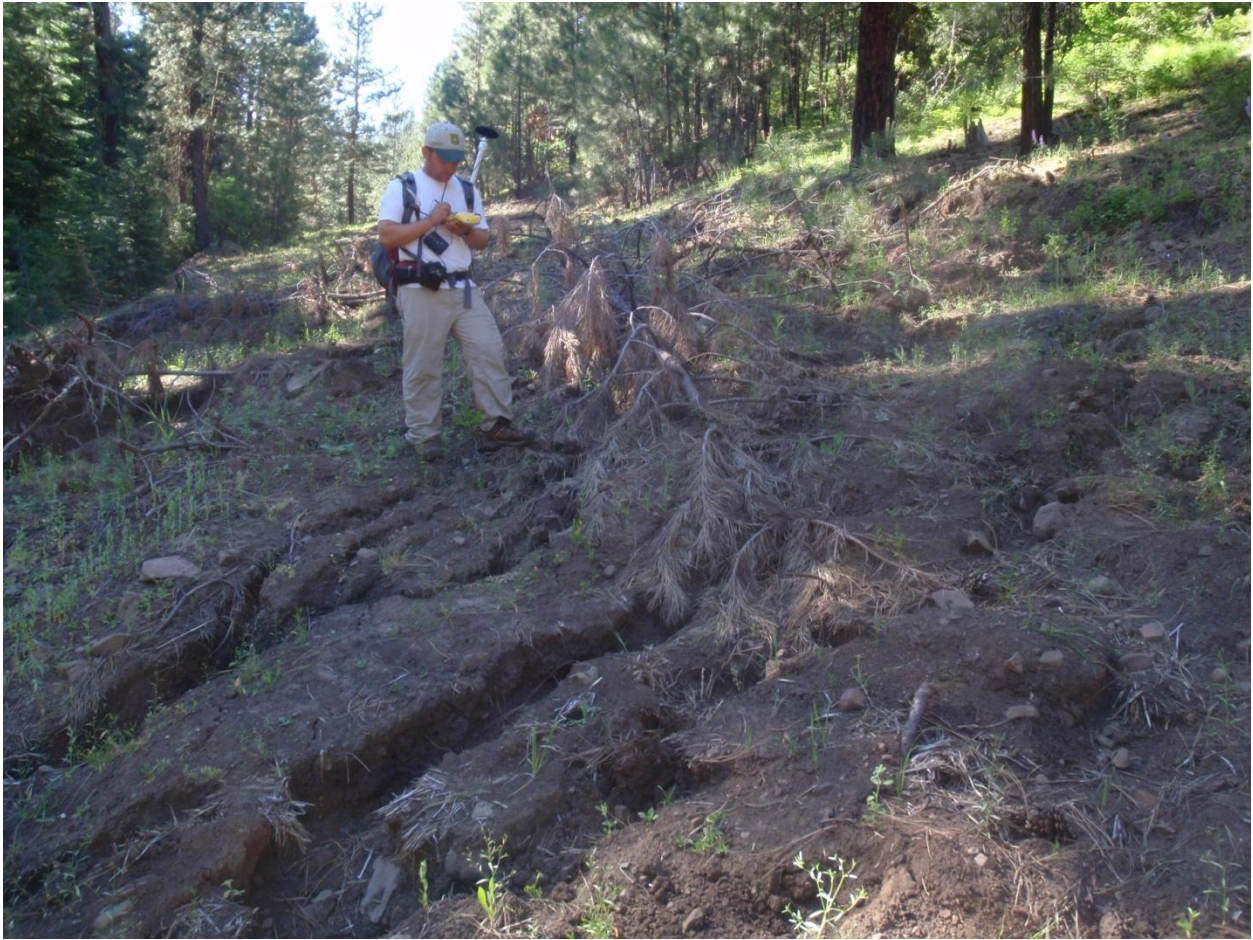
Crews surveyed the decommissioned roads in late June and early July to determine what changes were caused by the storms. Most storm-related damage consisted of rills and small gullies in the recontoured surface (Figure 5); these rills were, with few exceptions, limited to the fill material and did not extend onto the hillslope below the recontoured road. Where these met size criteria for gullies, eroded sediment volumes were estimated and recorded. Most of these rills and gullies were concentrated between 4,500 and 5,000 ft elevation. The estimated volume of these rills and gullies is 600 ft³ (~28.6 metric tons). This type of erosion was expected given that the recontoured roads consisted of unconsolidated fill with less vegetation than surrounding hillslopes.

Figure 5: Rills and small gullies on the recontoured road surface.

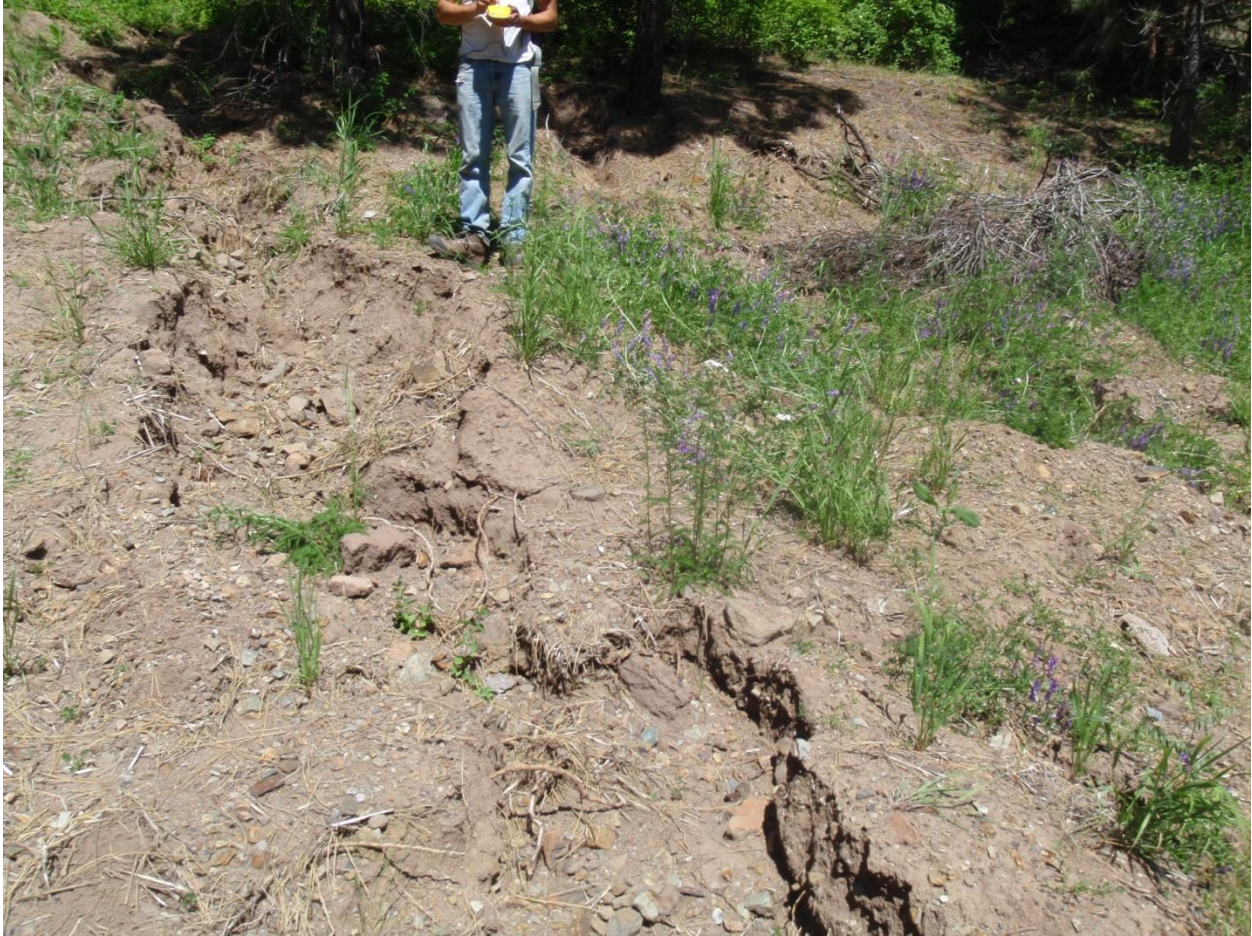
Crews found one gully that extended beyond the recontoured surface where the road crossed a swale (Figure 6). They also found two small landslides where recontoured fill had slumped

Figure 6: Gully crossing recontoured road.

Following the storm event, only one gully was located along the treated roads and nine gullies were recorded along the control roads. All of these were new gullies. The gully found along the treatment roads (along the decommissioned 50019) is located where a wet swale crosses the road and likely delivered concentrated flow during the storm event. This gully begins just

above the recontoured road and extends onto the hillslope just below recontoured road. It has a volume of $\sim 17 \text{ ft}^3$.

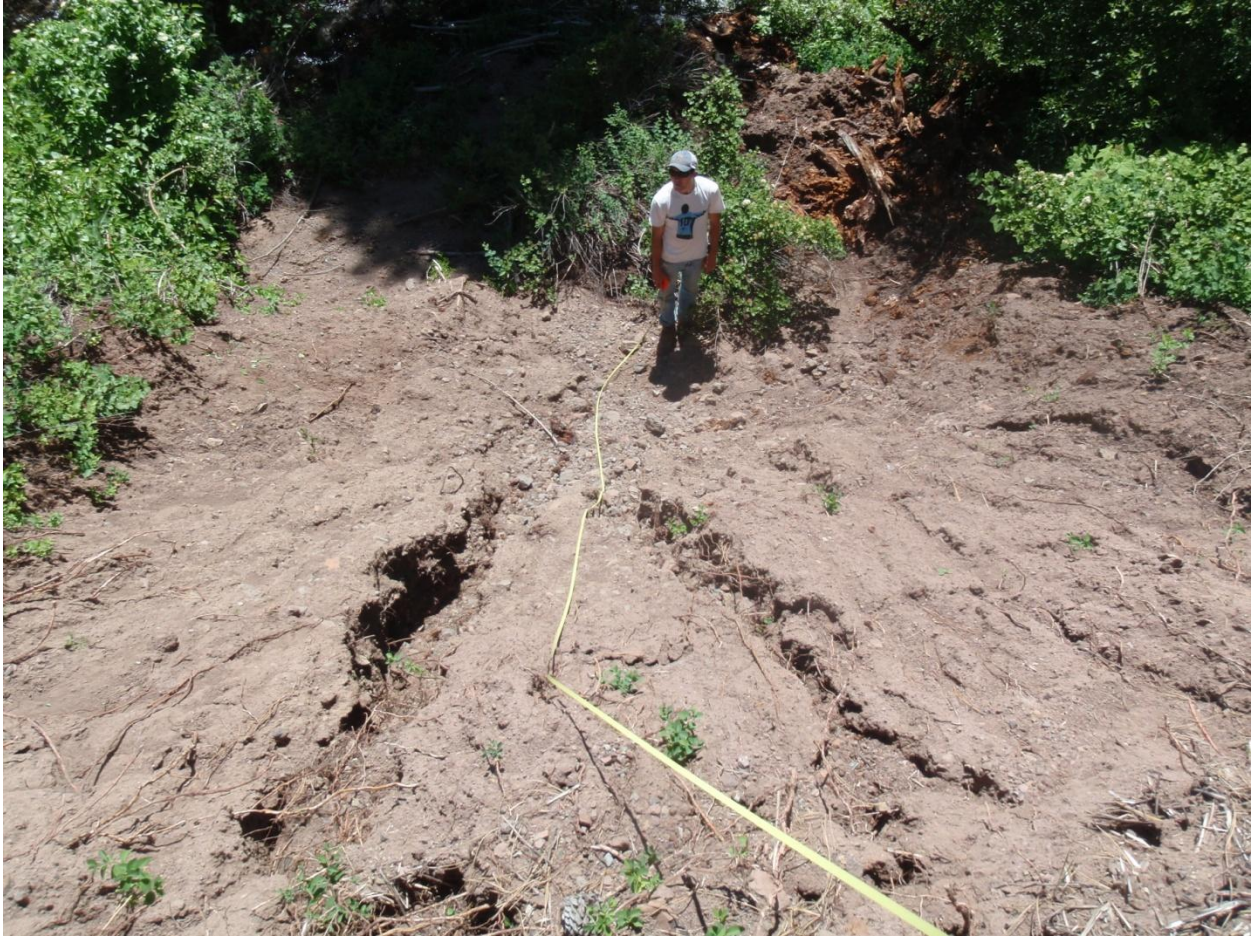
(Figure 7). The combined estimated volume of the gully and both landslides is $\sim 6,000 \text{ ft}^3$ (~ 286 metric tons).

Figure 7: Slump in recontoured fill. View is from top of scarp.

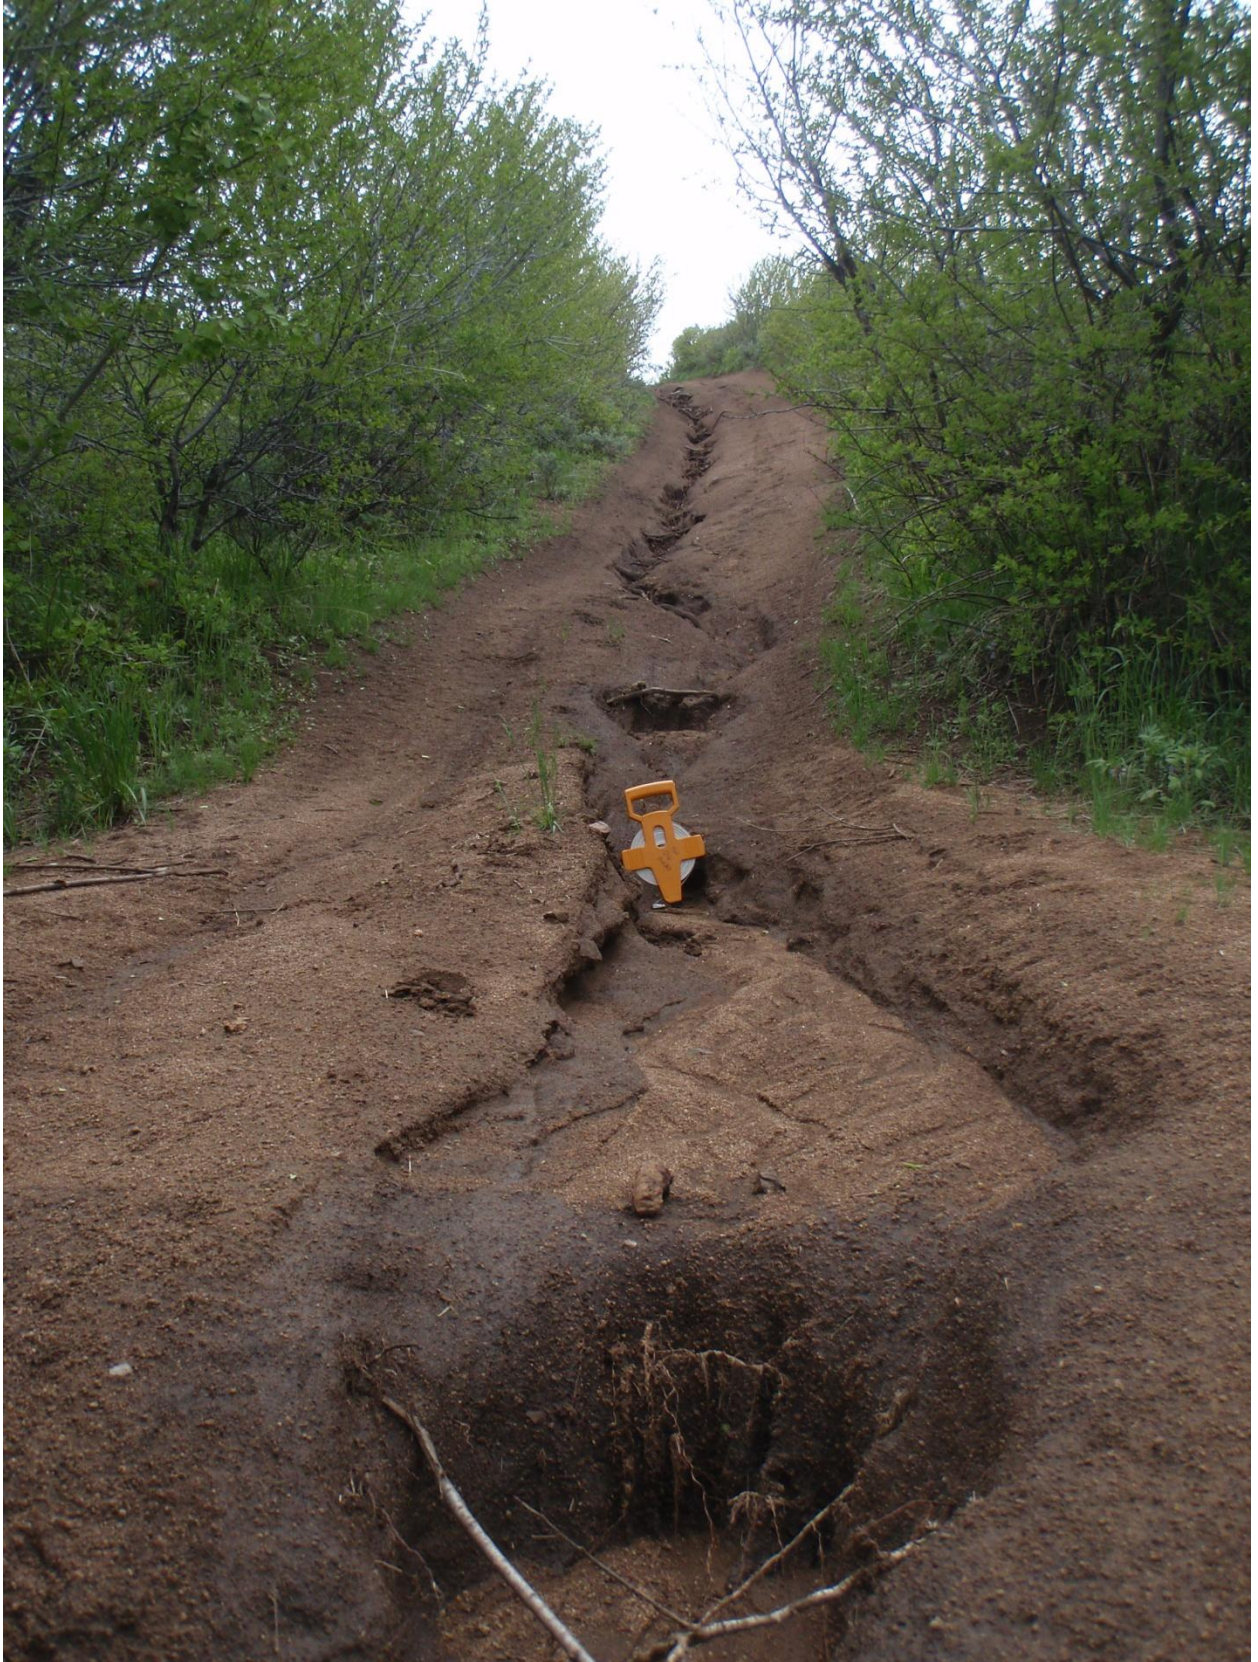
A crew surveyed the control roads on June 10 and 11. Repair work had already been completed on the lowest portion of the 50009 road; hence this portion was not surveyed after the storm. Damage generally consisted of longitudinal rills or gullies along the road surface or ditch (Figure 8), new non-engineered drains (Figure 9) and fill erosion (528 ft³ or ~25.2 metric tons), and gully formation (Figure 10). In 2009, 13.4% of the road surface was recorded as being in other than “good” condition (13.1% rutted, 0.3% rocky); after the storm, 53.8% of the road surface was in less than “good” condition (52.3% rilled or eroded, 1.5% rocky).

Figure 8: Gullied flowpath on control road 500100500.

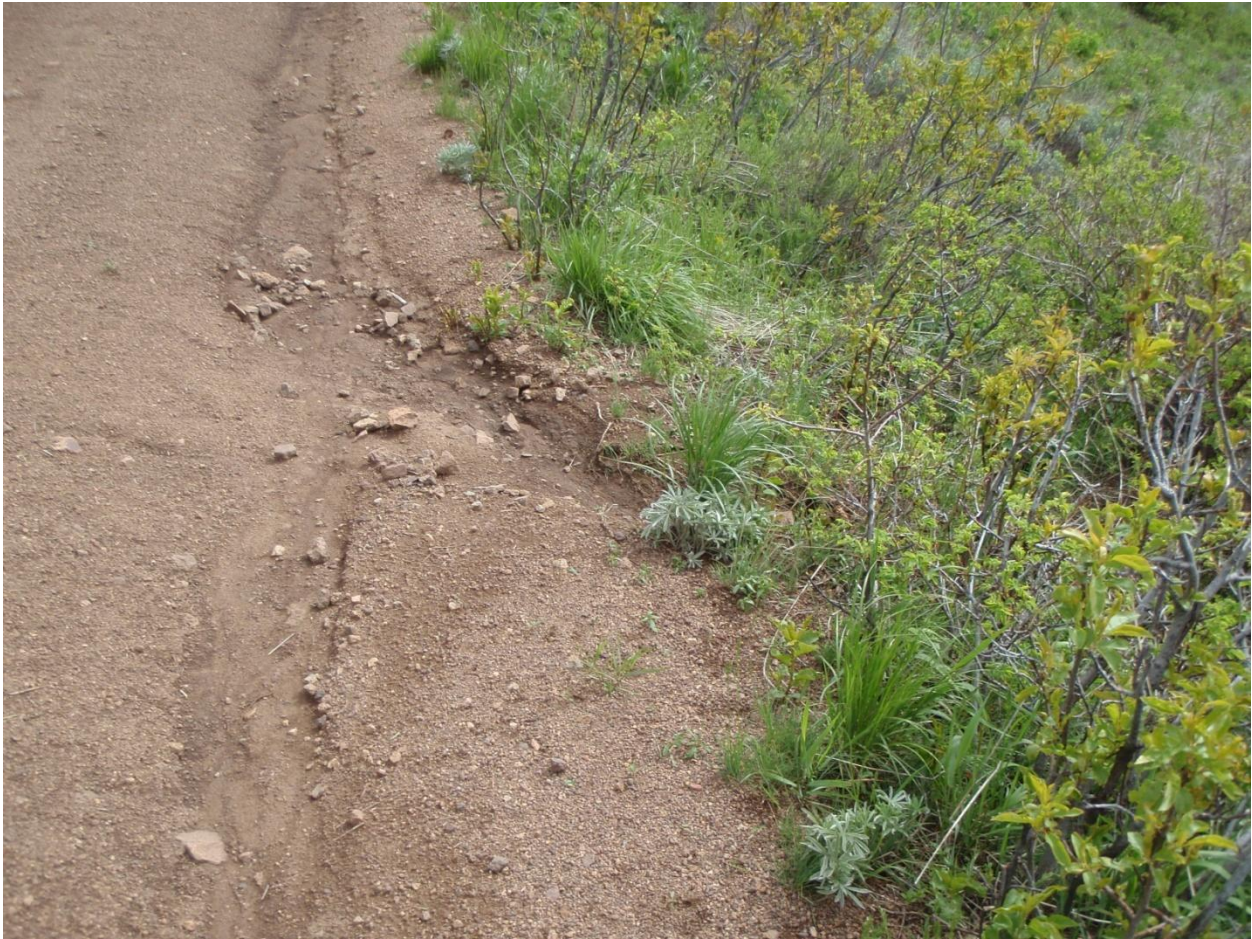
Figure 9: Non-engineered drain formed along control road.

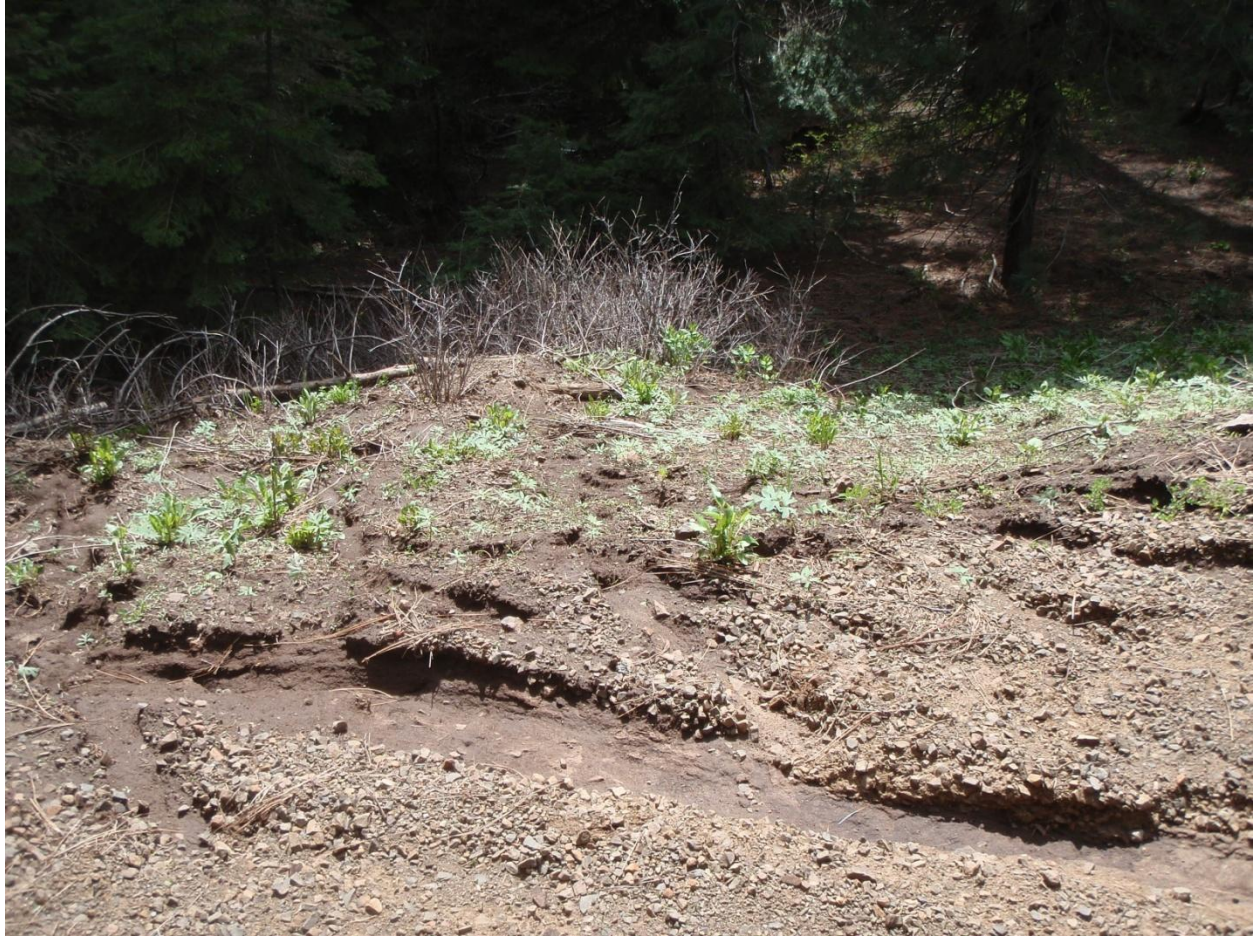
Figure 10: Gully and rills along control road. These extend from the road surface across the fill and onto the hillside below.

Nine gullies were located along the control roads. All of these gullies extend across the road fill slope onto the hillslope below the road and initiate at drain points (two ditch relief culverts and seven non-engineered drains) along the road. The total volume of these gullies is $\sim 103 \text{ ft}^3$.

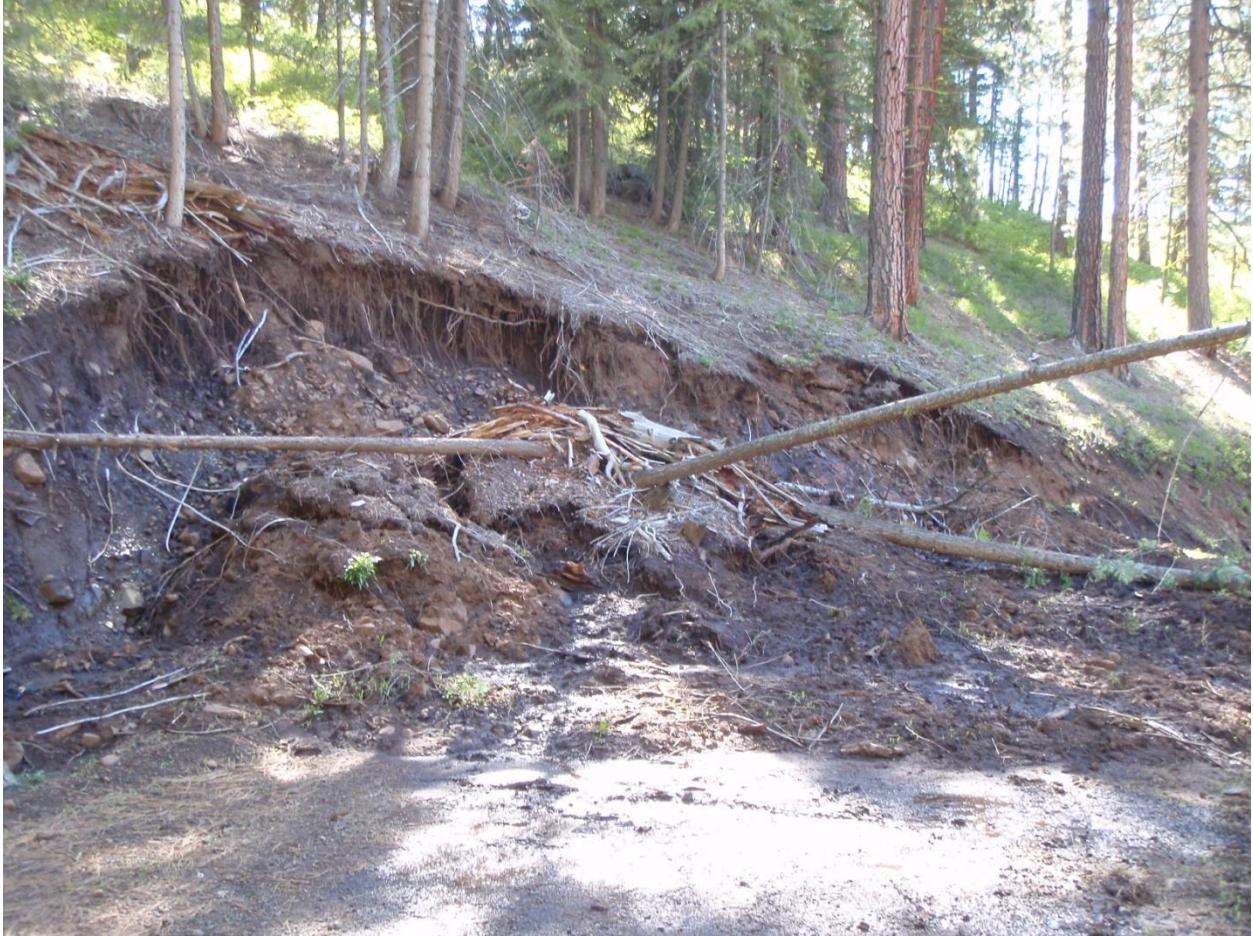
Nine gullies were found totaling 100 ft³, or ~4.9 metric tons, along with one large cutslope failure (~35,600 ft³ or ~1,700 metric tons; Figure 11).

Figure 11: Cutslope failure along control road 50029/50473/50007?.

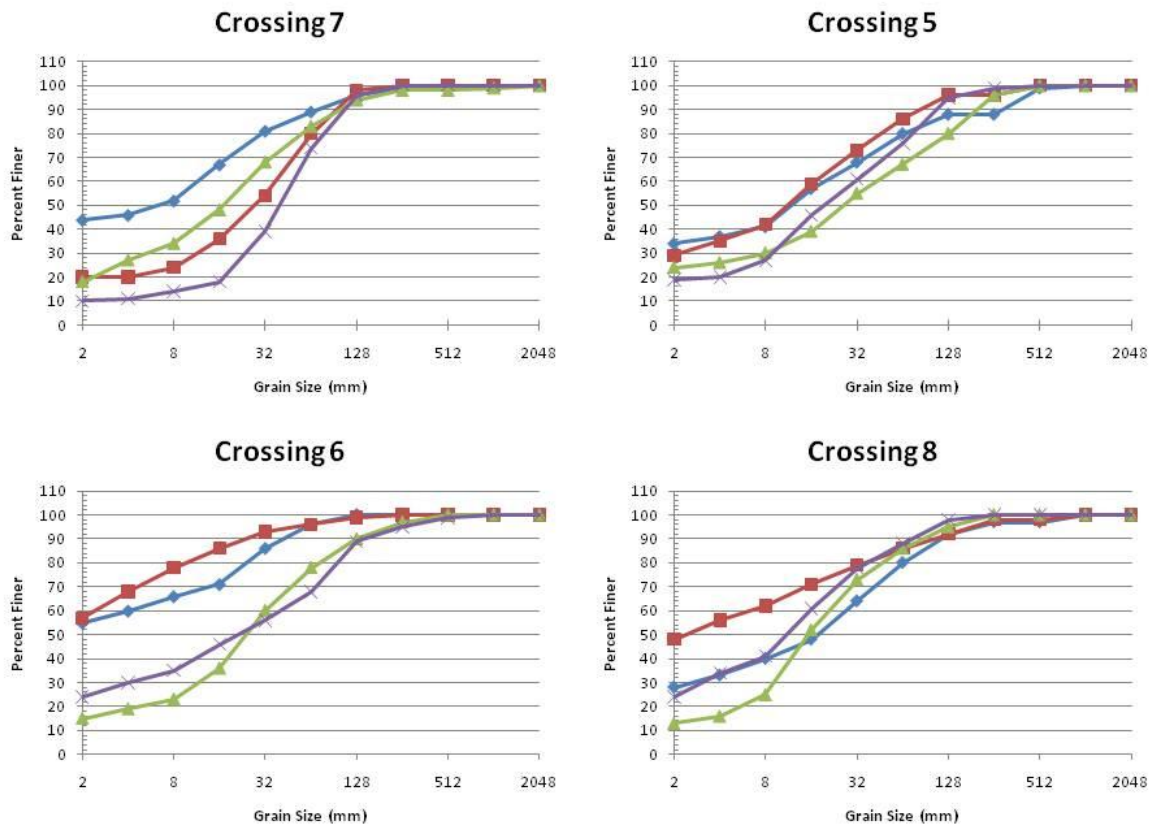
Excavated stream crossings are at various states of adjustment following the storm event and spring runoff. Most of the examined crossings follow the expected response where excess fines in the crossing following excavation are being, or have been, removed. This indicates that the bedload more closely resembles that of the natural channel upstream of the crossing. The pattern is more advanced and more clearly defined in higher-order channels than in lower-order channels because of greater stream power and longer flow durations. Increased stream power does not predict greater erosion, only quicker sorting and removal of excess fines from the stream bed within the excavated crossing. Three of the 1st-order channels show an opposite pattern where the bedload has become significantly finer than post-treatment, but also remain significantly finer than upstream reaches. Some likely reasons include a lack of significant adjustment (crossing 5), scour through the disturbed sediment into undisturbed colluviums (crossing 6), or entrapment of fines by large anchor clasts (crossing 8).

Figure 18 shows the bedload grain-size distributions for four different 1st-order stream crossings, including the three described above, that are not adjusting as expected.

Figure 18: Sediment size distributions from four other crossings. Crossing 7 shows incomplete adjustment along the expected trend and textural coarsening of the upstream reach following high flows. Crossing 5 shows a lack of any significant adjustment to bed sediment. Textural fining observed at crossing 6 was due to incision into underlying colluviums; at crossing 8 textural fining was due to entrapment of fines by large keystone clasts.
