**Date of Report: October 18, 2022****BURNED-AREA REPORT**

MOOSE FIRE 2022  
and  
OWL FIRE 2022

SALMON-CHALLIS NATIONAL FOREST

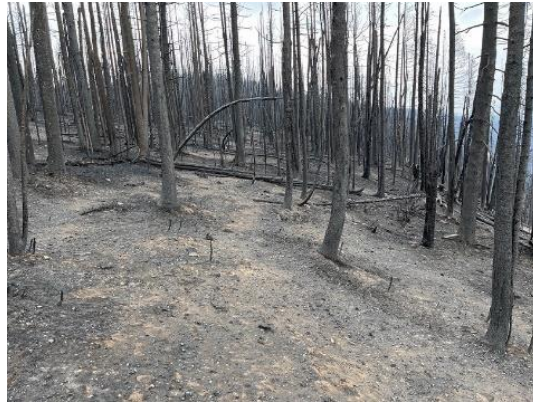
High Intensity/High Severity

Along the Ridge Road above Wallace Lake, in Lodgepole Pine/Spruce/Fir cover types (9/15/22).

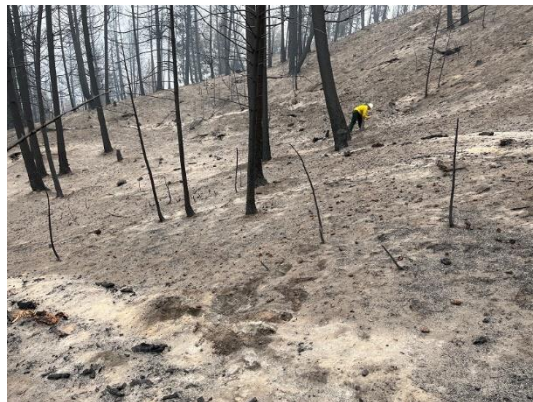
High Intensity/Moderate Severity

Mid-elevation slopes in the Pine Creek drainage, in Douglas Fir cover types (9/12/22).

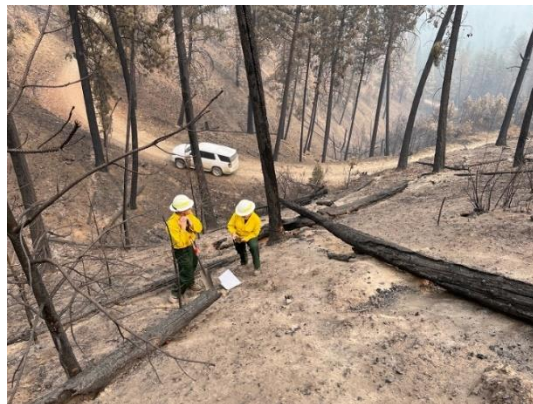
Moderate Intensity/Moderate Severity

Steep Gully along FR032 in the Pine Creek drainage, in Douglas Fir cover types (9/12/22).

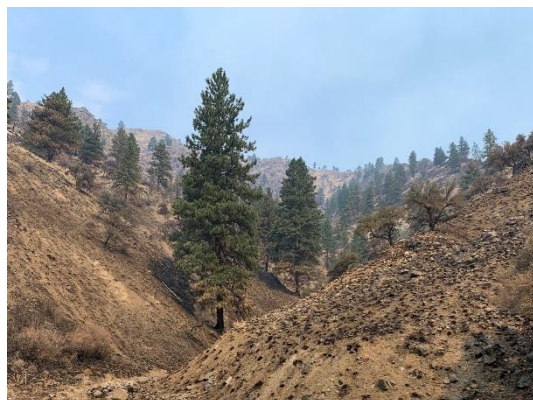
Low Intensity/Low Severity

Open grass/conifer cover types at low elevation on south-facing slopes along the Salmon River Road (8/16/22).

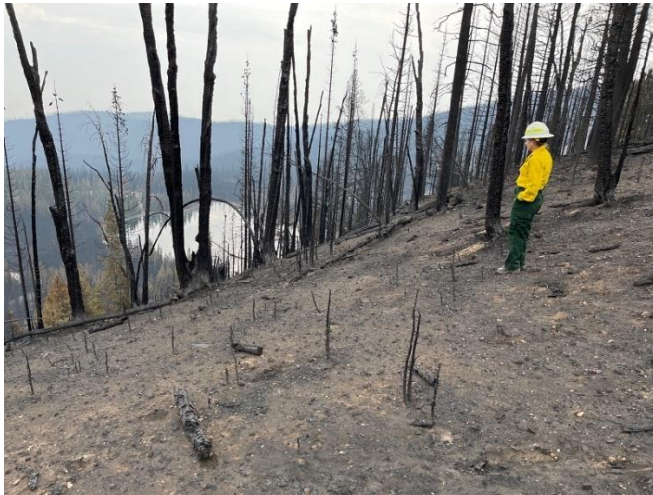
- 1) Wallace Creek: The Wallace Creek watershed above the Stormy Peak Road burned at 52% high severity and 42% moderate severity. The headwaters consist of a steep headwall, below which lies the 8-acre Wallace Lake along a tributary to Wallace Creek. Wallace Lake would attenuate high flows to some degree, but only in that tributary. Most of the riparian vegetation along Wallace Creek upstream of the Stormy Peak Road was consumed, and the channel is likely to become highly unstable. High flows, sediment, and dynamic channel movement are expected.

*Wallace Lake from the top of the ridge (9/15/22)*

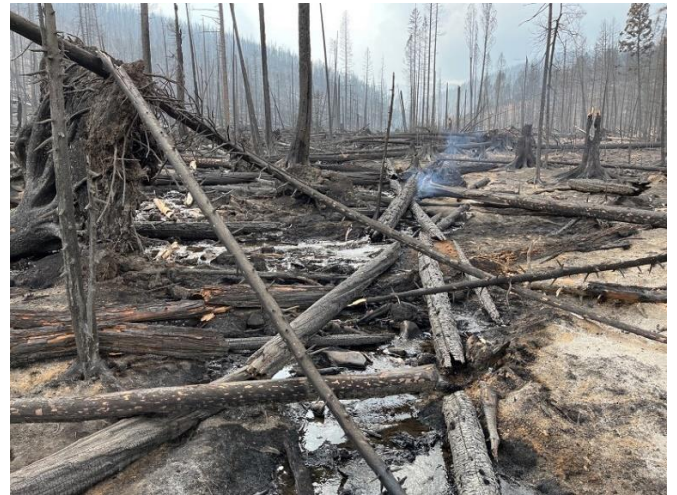
*Wallace Creek 600 feet upstream of FR023 (9/15/22)*

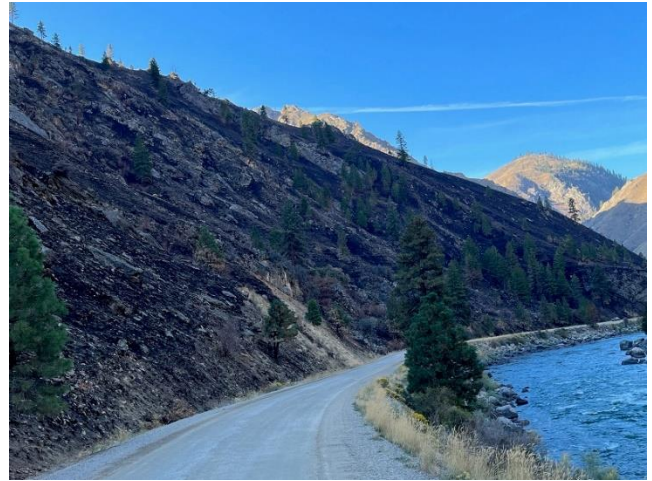
- Salmon River Road (FR60030): The fire burned adjacent to the Salmon River Road downstream of North Fork over a distance of 6.7 miles adjacent to the paved section of the Salmon River Road (Deadwater to Indian Creek) and 6.5 miles adjacent to the unpaved section of the Salmon River Road (Pine Creek to Panther Creek). This road provides vital access to private property and a number of USFS recreation sites down-river. De-stabilization of the steep slopes above the road in these locations will lead to a considerable increase in erosion, rockfall, and potentially mass wasting events affecting the road. Both of these sections of road include in inside ditch that catches material and provides drainage. Additional drainage structures are present where 22 small drainages intersect these sections of the road. With the likely influx of material from these de-stabilized hillslopes into the ditch and onto this road, it is important that proper drainage is maintained in order to prevent damage or loss of the road, particularly during storm events.

*Salmon River Road just upstream of Panther Creek, with steep, burned hillslope and inside ditch (10/5/22).*

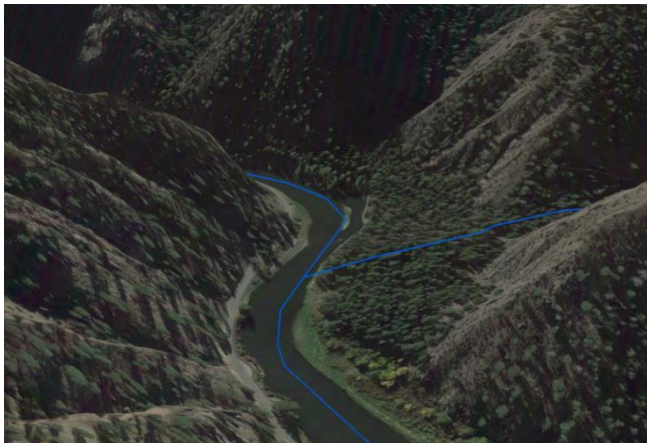
- Salmon River Road (FR60030): High severity burn that occurred in drainages on the opposite side of the river from the Salmon River Road has the potential to result in debris flow events into the Salmon River. Several locations were identified where debris flow fan deposits from the opposite side of the river could deflect the flow of the river into the bank along the Salmon River Road, potentially causing bank erosion, bank loss, and/or loss of the road. Options for mitigating these risks to the road are very limited, as it is not possible to determine the exact location and magnitude of any potential impacts, and it is not feasible to reinforce the bank along the road in all of these locations.

*A debris flow from Sawlog Gulch (right), much of which burned at moderate and high severity, could push the Salmon River against its northern bank and impact the Salmon River Road (left) (image from Google Earth).*

Options for mitigating these risks to the road are very limited, as it is not possible to determine the exact location and magnitude of any potential impacts, and it is not feasible to reinforce the bank along the road in all of these locations.

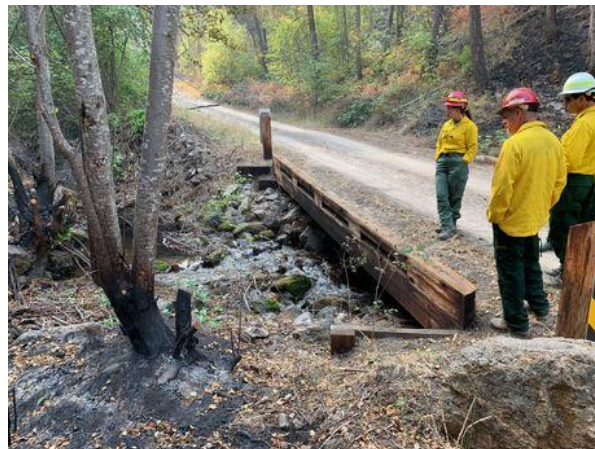
- Pine Creek Road (FR60032): The Pine Creek watershed burned at 16.1% high severity, with most of this high severity burn occurring in the upper headwaters. The potential exists for debris flow events to occur in the headwater tributaries of Pine Creek, which could potentially impact the main stem of Pine Creek. The Pine Creek Road crosses Pine Creek at 5 locations (4 bridges and 1 culvert) within the 1.8-mile long, steep, narrow section of the drainage downstream of Pine Creek Ranch, and the Salmon River Road crosses Pine Creek with a bridge at its mouth. With the exception of the Salmon River Road crossing, these crossings were determined to be at moderate to high risk of overtopping, loss of the structure, and/or damage to the road bed in the case of a flood or debris flow event, as a result of relatively high gradient (6% average valley gradient), and low freeboard of the bridges, alignment issues, and the narrow nature of the canyon with the road in close proximity to the Pine Creek channel. Intact riparian vegetation along this section of Pine Creek is likely to attenuate flood flows, catch debris, and lessen these potential impacts. Some of these bridge are light and set on grade jam beams, making them more susceptible to being lifted and moved off the footings by a debris jam

or flood flow. These bridges also carry a phone line that serves private property at the Pine Creek Ranch. A total of 24 belt deflector drainage structures are also in place along this section of road to control drainage. It is important to maintain proper drainage along this road, particularly at these crossings, in order to prevent loss of the road and stream crossing structures.

*Assessing the lowermost bridge on Pine Creek Road #032 (9/7/22)*

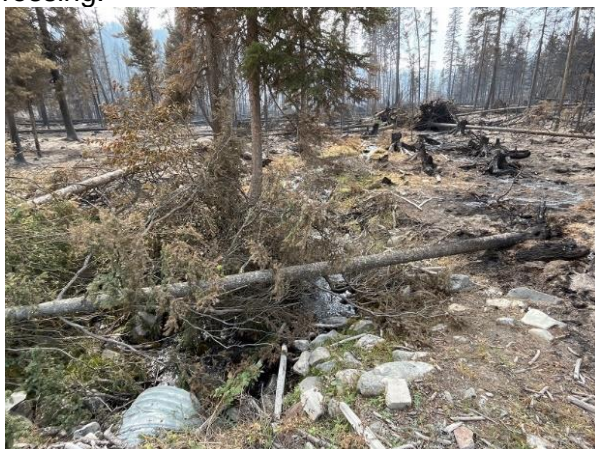
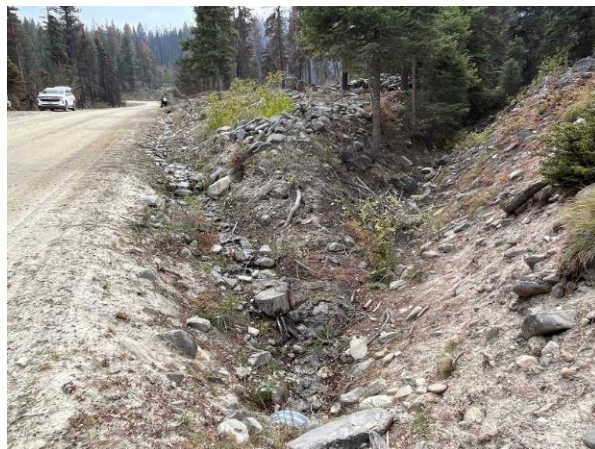
- Stormy Peak Road (FR60023):** The heavily used Stormy Peak Road provides vital access to a large portion of the Salmon-Challis National Forest for a variety of uses. The largest risk to this road occurs at the crossing of Wallace Creek. The Wallace Creek drainage above the Stormy Peak Road burned 52% at high severity, and 42% moderate severity. Erosion, flooding, and debris flows in this drainage are likely to occur and may result in dynamic changes affecting the Stormy Peak Road. The road currently includes a 27-inch x 35-inch culvert on Wallace Creek, in addition to an inside ditch that drains under the road in another 18-inch culvert. These culverts likely do not provide enough capacity for the expected increased streamflows, sediment, and debris during post-fire conditions in this drainage. Wallace Creek averages 10% gradient or greater in the mile upstream of this crossing. With the riparian area completely burned and excessive downed logs in the channel as a result of the fire (*see photo on page 10*), dynamic changes are likely to occur in this channel. The valley width at the crossing is greater than 300 feet, and the potential also exists for the channel location to migrate at the road crossing.

*Left: Wallace Creek culvert at FR023, looking upstream. Right: Relief culvert on FR023. The Wallace Creek culvert is at the location of the vehicle. The inside ditch carries some flow to the relief culvert (9/15/22).*

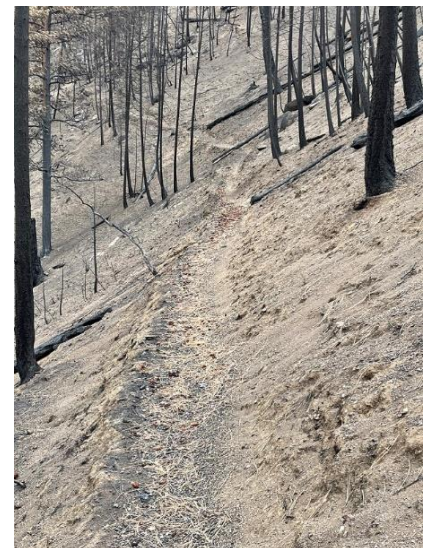
**Moose Fire:** A total of 75.2 miles of trails exist within the burned area (this excludes 10.6 miles of snow trails on roads). These trails consist of motorized and non-motorized trails that are generally used for hiking, mountain biking, motorcycle/ATV use (where allowed), stock use, hunting access, grazing access, and outfitting. Many portions of these trails are at risk of erosion and potentially loss of trail investment as a result of increased post-fire runoff, soil erosion, and/or debris flows. The highest risk to trails occurs where trails are situated within any high severity burned area, or within or below steep slopes burned at moderate severity. High risk may also occur to trails that are located adjacent to streams in drainages that burned at moderate and high severity. It is important to implement drainage control on these trails in order to prevent loss of the trail investment. The trail segments shown in the table below were determined to be at high risk.

*Right: A portion of the Stormy Peak-Virginia Trail #6176 in high/moderate severity burned area of the Moose Fire (9/30/22).*

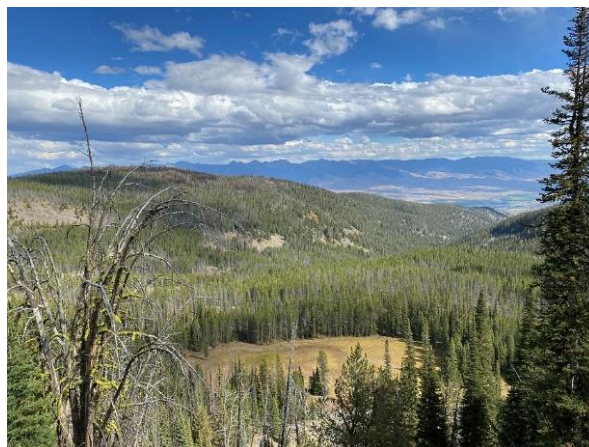
Moose Fire: The Municipal Watershed for the City of Salmon includes the drainages of Jesse Creek, Pollard Creek, and Chipps Creek. Chipps Creek joins Pollard Creek, Pollard Creek then joins Jesse Creek, and these drainages are collectively known as the Jesse Creek Watershed, draining a total of 12,344 acres of mostly Forest Service land upstream of the water treatment plant for the City of Salmon. The Moose Fire only burned 7.8% of the Salmon Municipal Watershed, in a forested portion of the upper drainage of Jesse Creek. No fire occurred in the Pollard Creek or Chipps Creek drainages. Only 1.1% of the Salmon Municipal Watershed burned at high severity, and 2.1% burned at moderate severity. This watershed provides a clean and relatively consistent supply of water for the City of Salmon, which has a water treatment plan on city lands near the mouth of the Jesse Creek canyon. Because of the small percentage of the watershed that burned and the limited amount of high severity burn, post-fire impacts to water quality and water quantity are likely to be minimal. The springs located at the head of Jesse Creek, where much of the perennial streamflow is produced, were not affected by the fire and will continue to provide high quality water. The potential for increased sediment production as a result of the fire is low. Any

increased sediment loads are likely to be captured in the quarter-mile long section of Jesse Creek that flows sub-surface beneath talus, or the sediment retention pond maintained by the City upstream of the diversion to the water treatment plant. The fire may also result in minor impacts to water quality in the short term.

*Looking down from the head of Turner Gulch (Jesse Creek Watershed), 9/29/2022. A small amount of burn can be seen on the ridge between Turner Gulch and Jesse Creek.*
