January 2014

Willow-Parks Watershed Analysis

Shasta-McCloud Management Unit
Shasta-Trinity National Forest

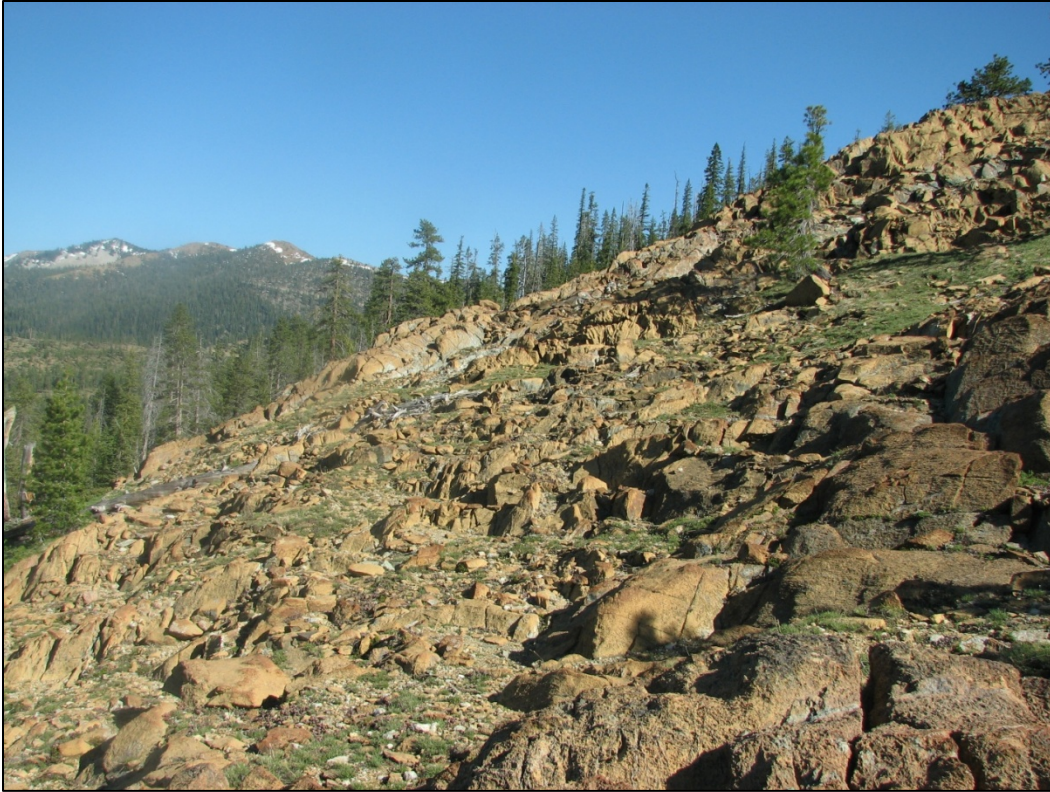
PHOTO 1-1: ULTRAMAFIC ROCK OUTCROPS (PERIDOTITE).

Hazards to human health from asbestos can occur when soils and rock are disturbed by motorized vehicles when the soil is dry. Coarse grained gabbro (pegmatite) with large crystals up to 4 inches in diameter is exposed in road cuts along the Parks Creek road immediately west of Stuart Springs. The cleavage faces of these crystals reflect sunlight and create a sparkling effect to morning travelers along the road. Gold deposits were formed in the South Fork of Willow Creek (Dewey Mine), where gabbro of the China Mountain Pluton intrudes peridotite of the Trinity Terrane. These deposits were mined for many years.

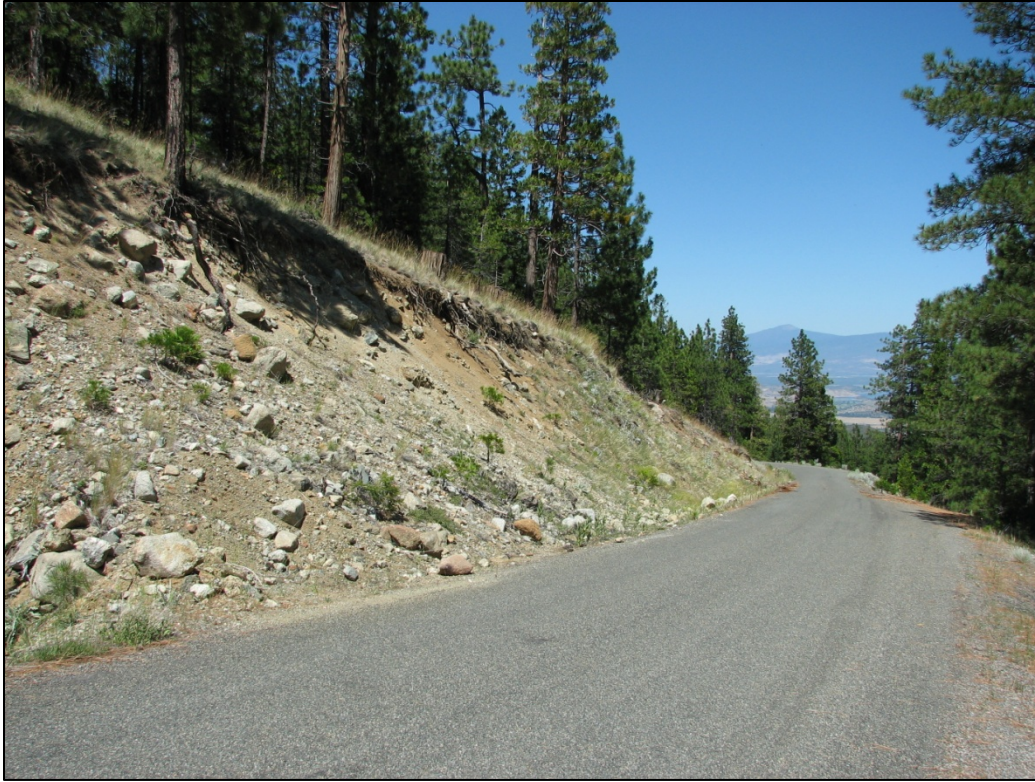
PHOTO 1-2: GLACIAL MORaine ALONG PARKS CREEK ROAD.

Many of the moraines have been cemented by mineral rich groundwater percolating through the deposits, making them quite hard and similar in appearance to concrete or cement (Lindsley-Griffin, 1982). This has resulted in local place names like “Cement Banks”, or “Cement Bluff”. The moraines on valley floors and on other gentle slopes are generally stable, but those plastered on steeper valley walls are subject to landslides. For example, one active landslide (a slump), over an acre in size was identified in glacial deposits on the west valley wall of Eddy Creek during field reconnaissance for the WA. This feature is on the west side of Eddy Creek at elevation approximately 6,400 feet, and the bench at the head of the slide (in the center of the field of view on Photo 1-3 is slowly moving downslope, and taking the large 3’ diameter conifers with it.

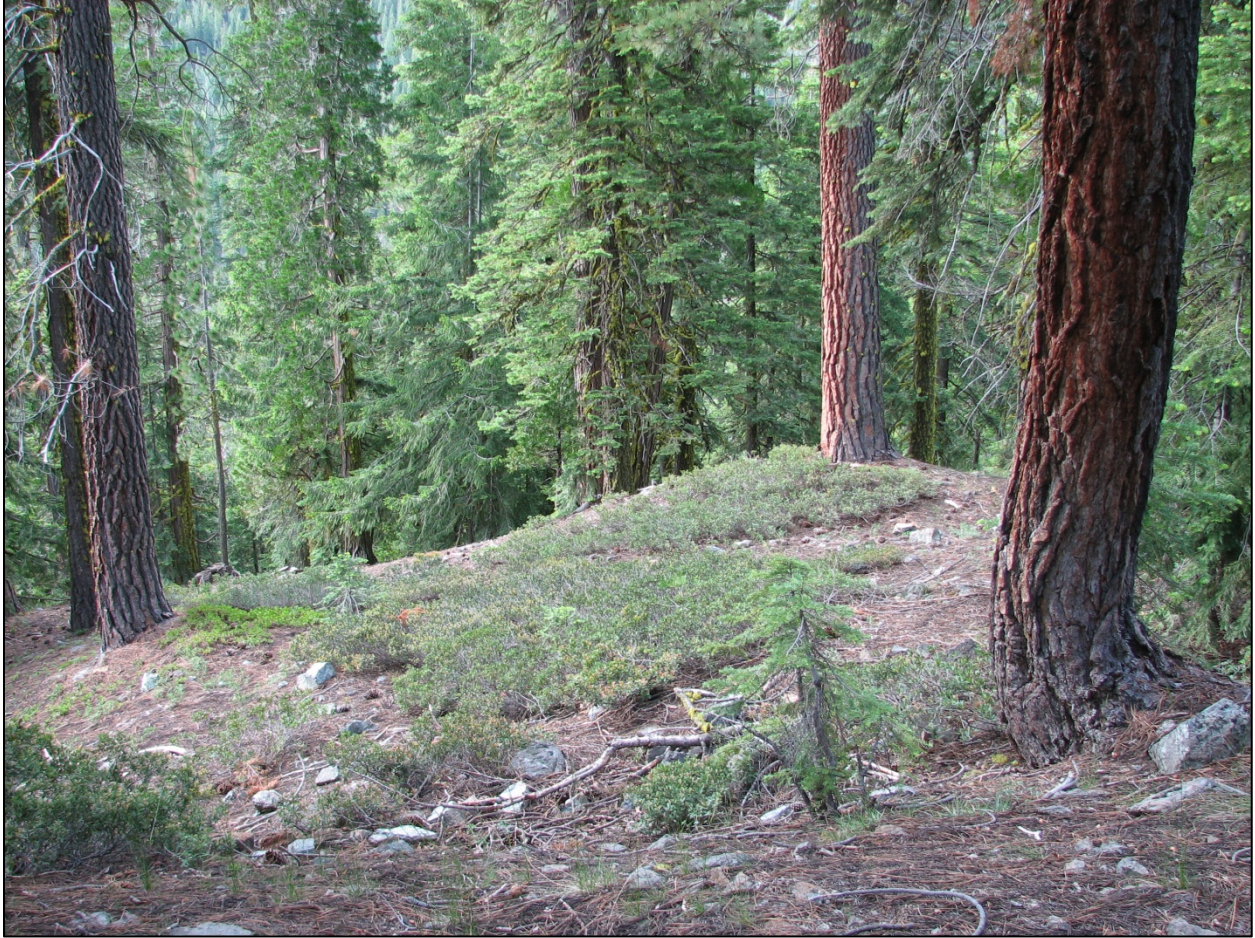
PHOTO 1-3: ACTIVE LANDSLIDE DEVELOPED IN GLACIAL MORaine DEPOSITS.

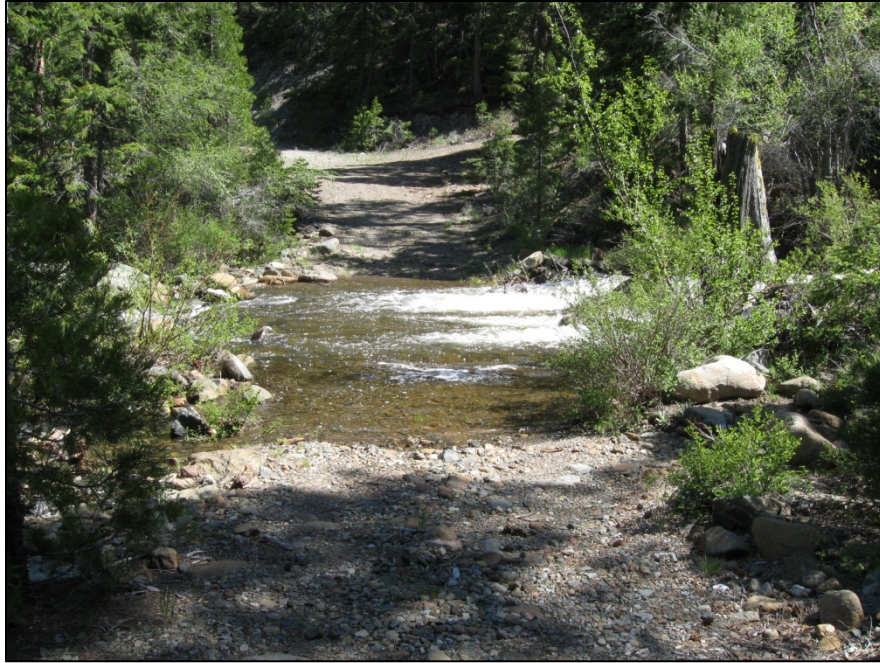
PHOTO 3-14: A FORD WATER CROSSING (NORTH STATE RESOURCES 2010).

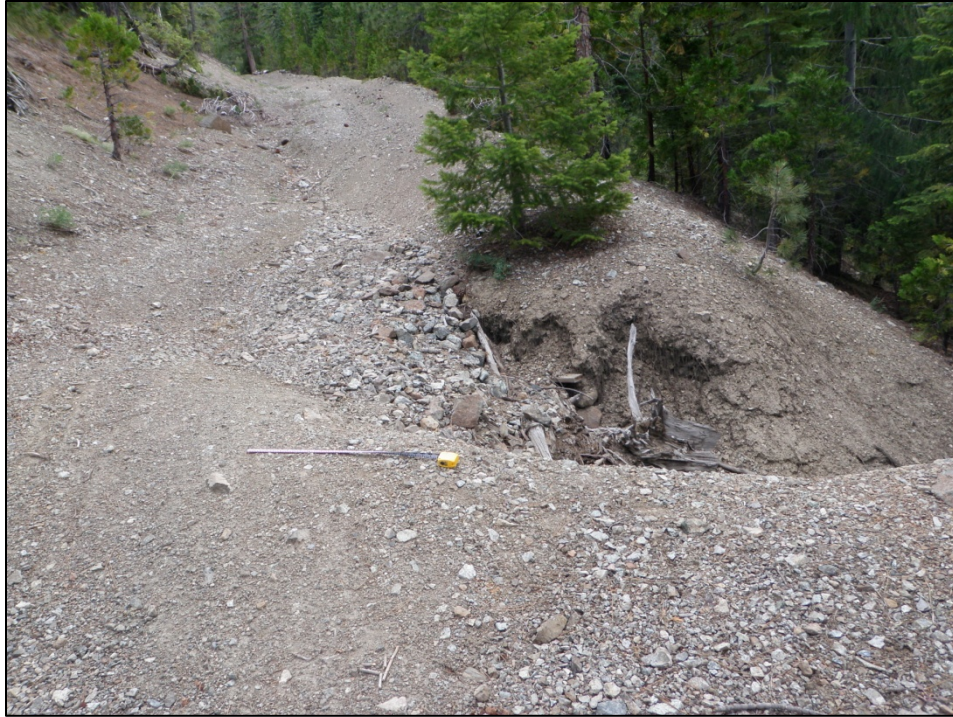
PHOTO 3-15: A LACK OF MAINTENANCE AND EROSION CONTROL CREATES POOR ROAD CONDITIONS AND SAFETY CONCERNS (NORTH STATE RESOURCES 2010).

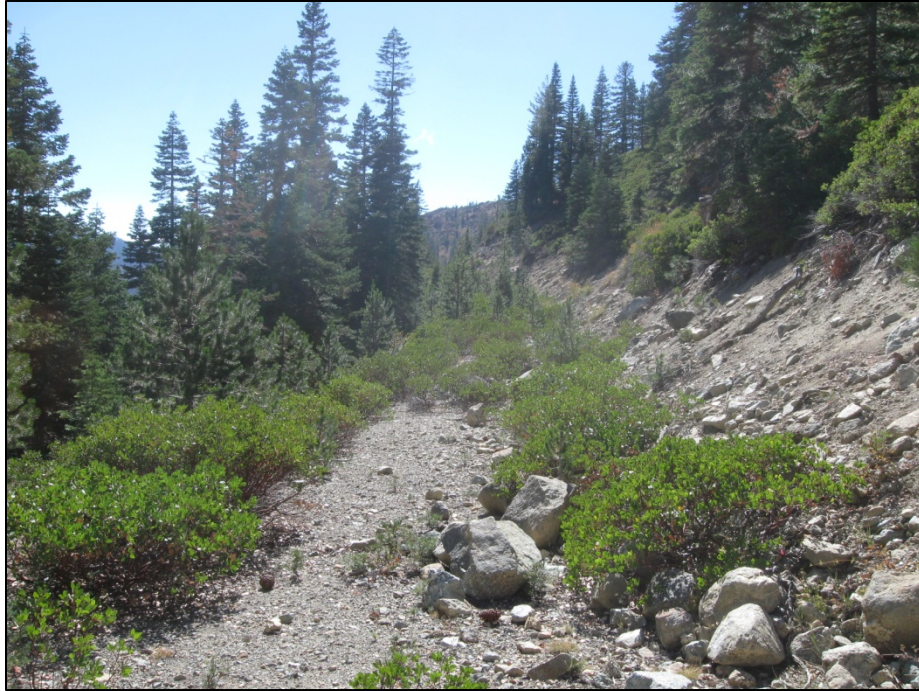
PHOTO 1-16: SLIDE MATERIAL AND VEGETATION HAVE CLOSED THIS ROAD (NORTH STATE RESOURCES 2010).

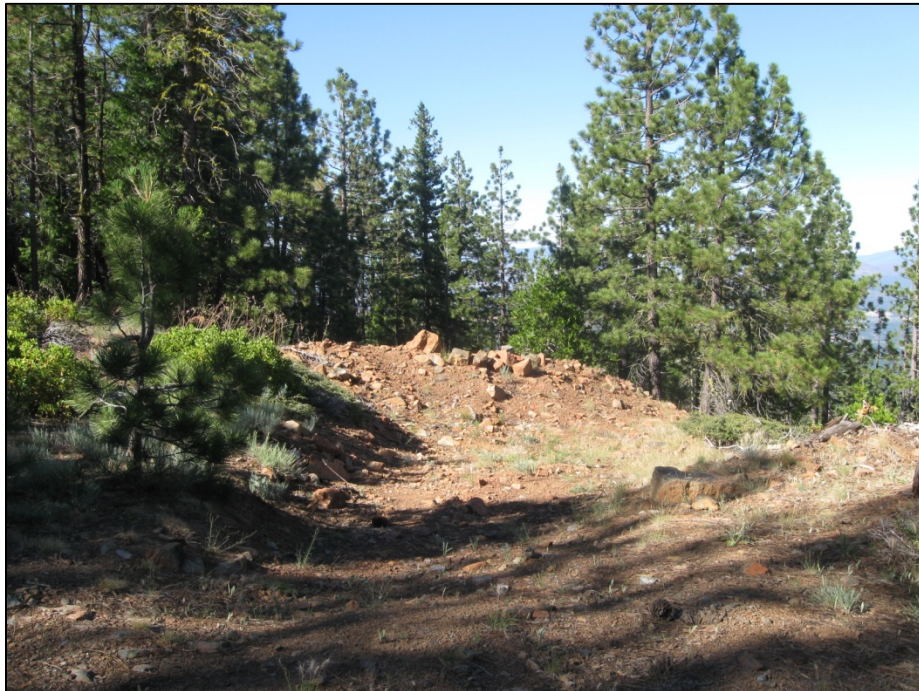
PHOTO 3-17: A FUNCTIONING ROAD CLOSURE BERM (NORTH STATE RESOURCES 2010).

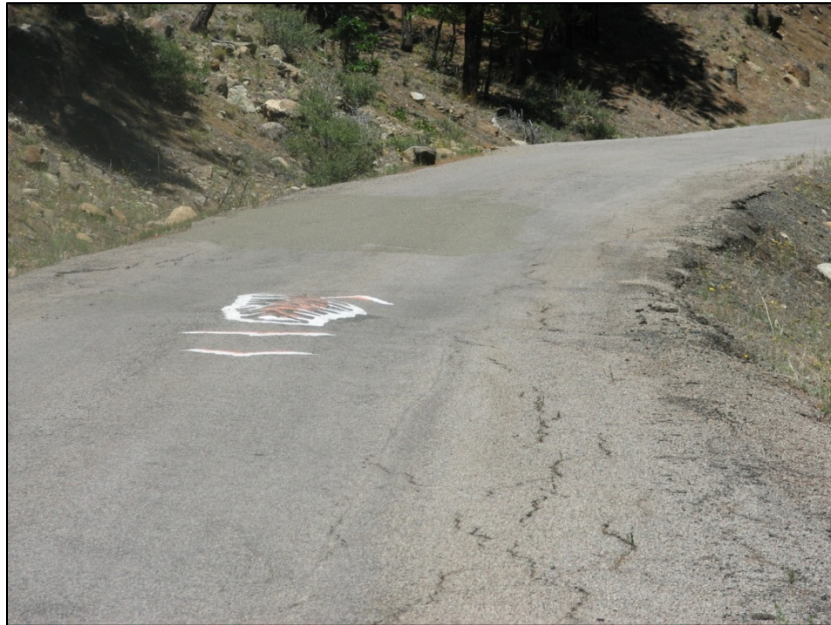
PHOTO 3-22: PARKS CREEK ROAD 42N17- SETTling OF FILL AND BUCKLING OF PAVEMENT NEAR STEWART SPRINGS.

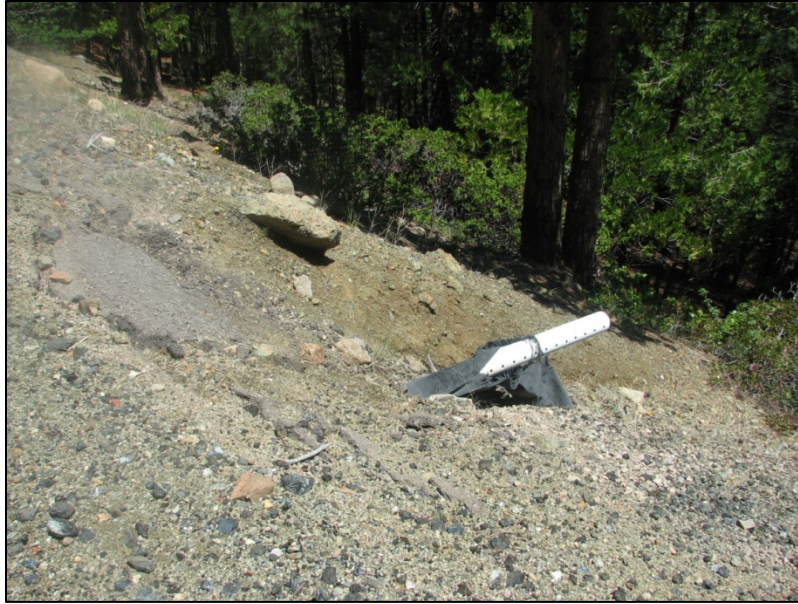
PHOTO 3-23: PARKS CREEK ROAD 42N17- PERFORATED PIPE BELOW ROAD (EARLIER ATTEMPT AT DEALING WITH SUBSURFACE WATER) WHERE FILL IS SETTLING.

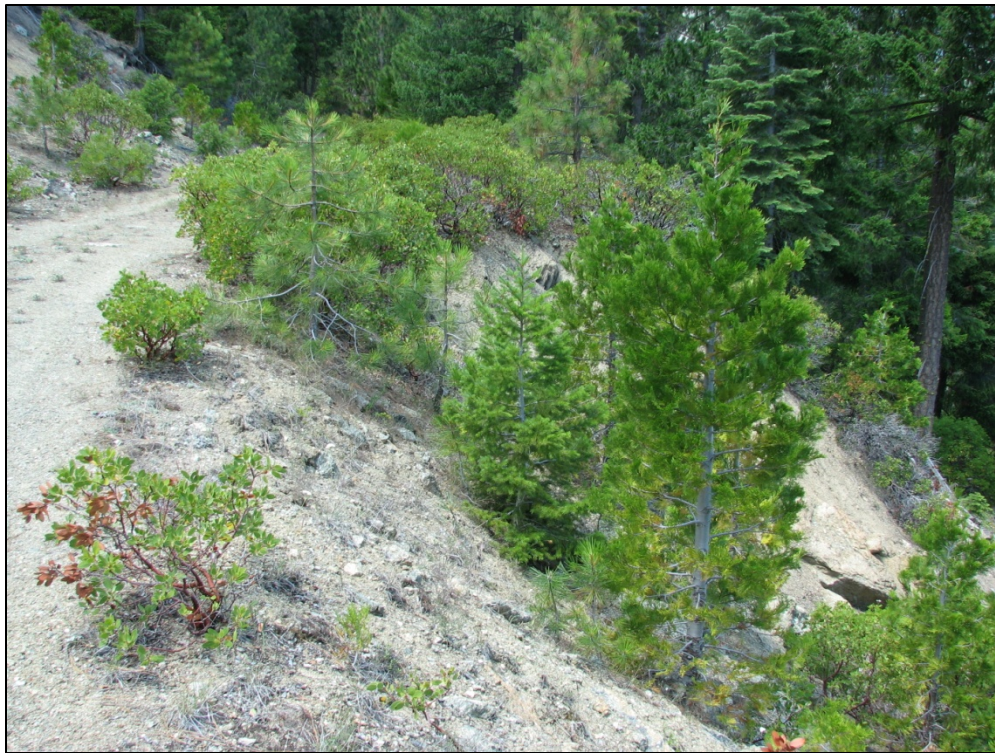
PHOTO 3-24: FILL FAILURE ABOUT 20 YEARS OLD ALONG ROAD 41N16Y.

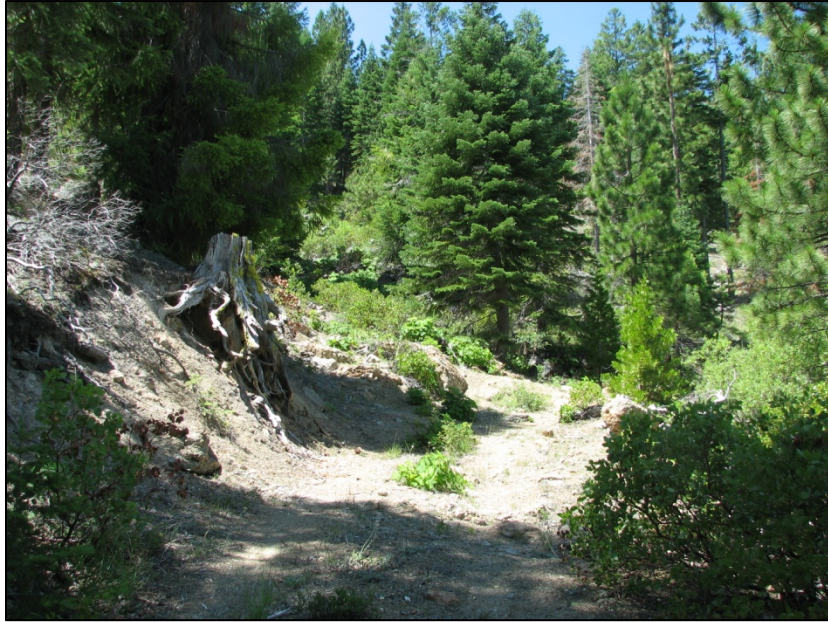
PHOTO 3-25: LANDSLIDE RUBBLE ON ROAD 41N16Y.

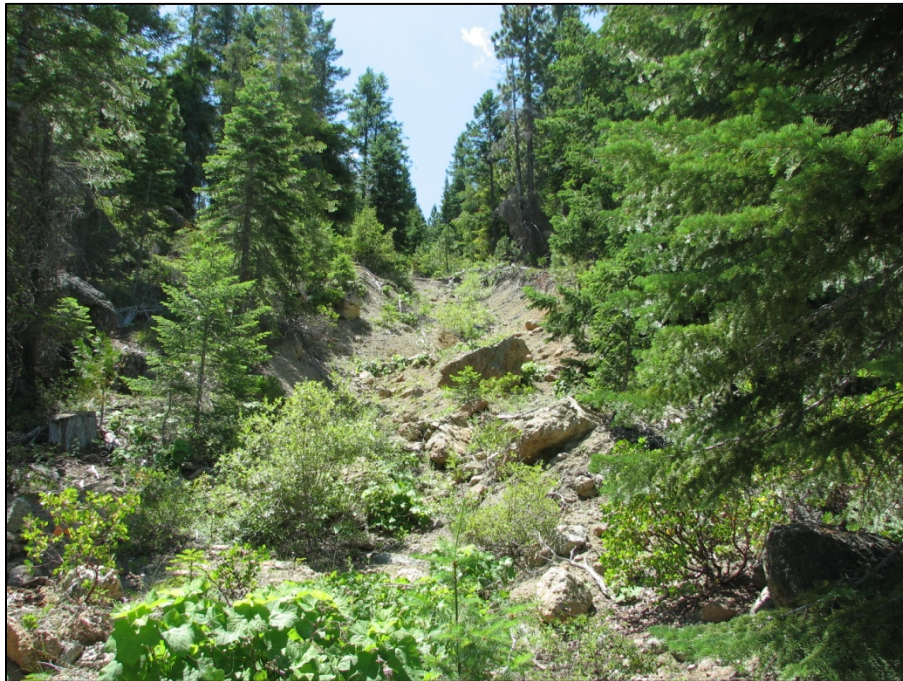
PHOTO 3-26: LANDSLIDE ABOVE ROAD 41N16Y- VIEW UPHILL.

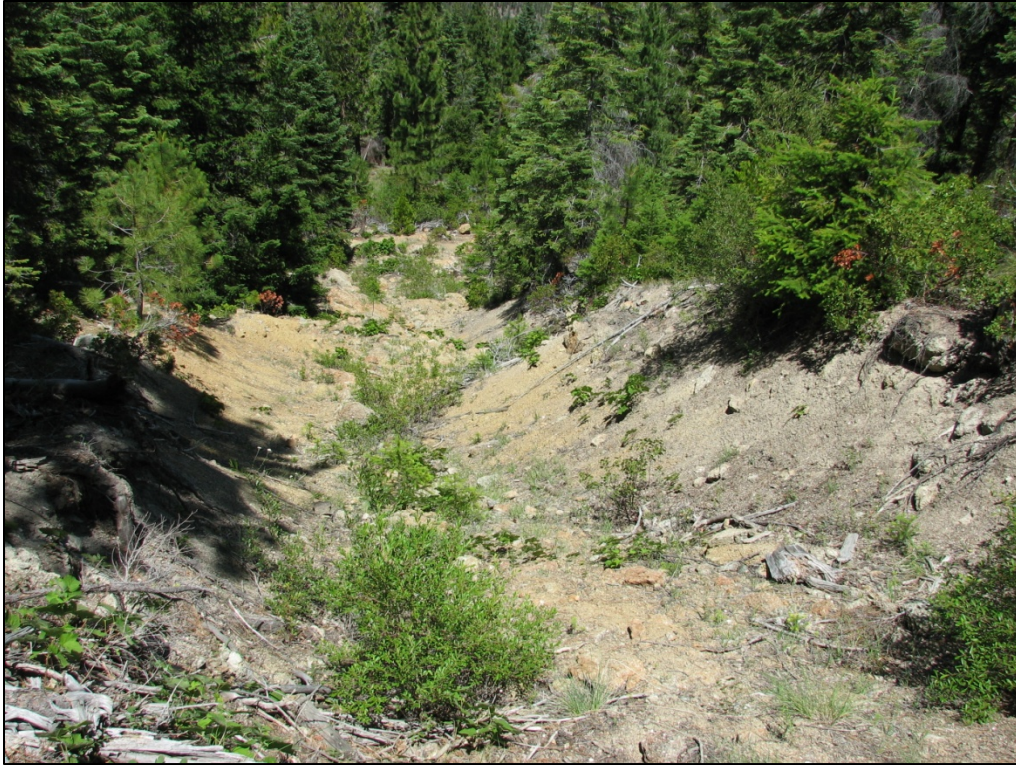
PHOTO 3-27: LANDSLIDE ABOVE ROAD 41N16Y- VIEW DOWNHILL, DEBRIS COVERS THE ROAD AT THE BOTTOM OF PHOTO.

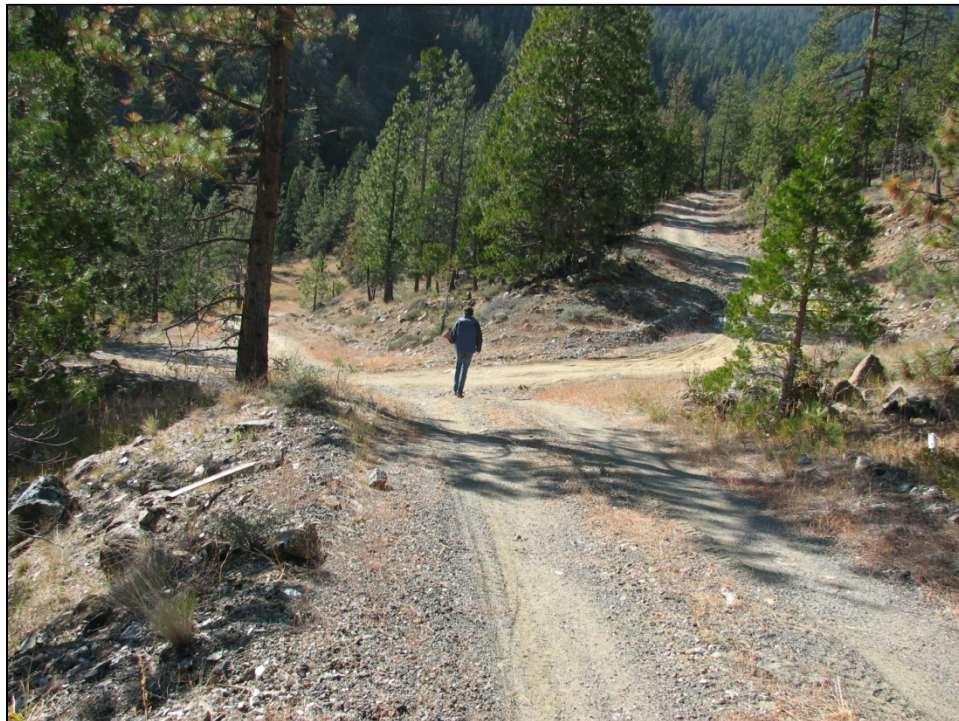
PHOTO 3-29: ROAD 42N19- MANY SWITCHBACKS MAKE IT DIFFICULT TO CONTROL ROAD RUNOFF.

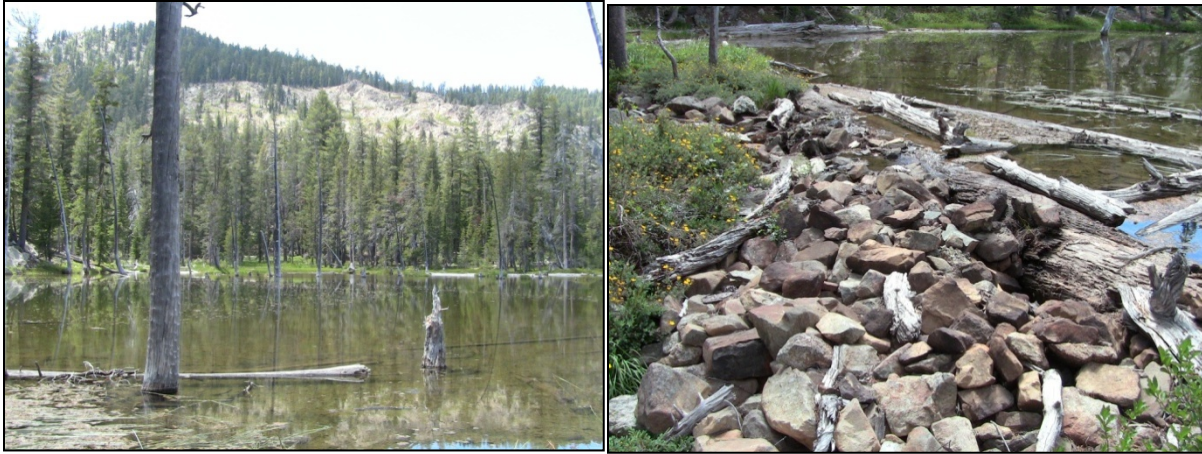
PHOTO 3-32 AND 3-33: UPPER CALDWELL LAKE AND CONSTRUCTED ROCK DAM (2012).

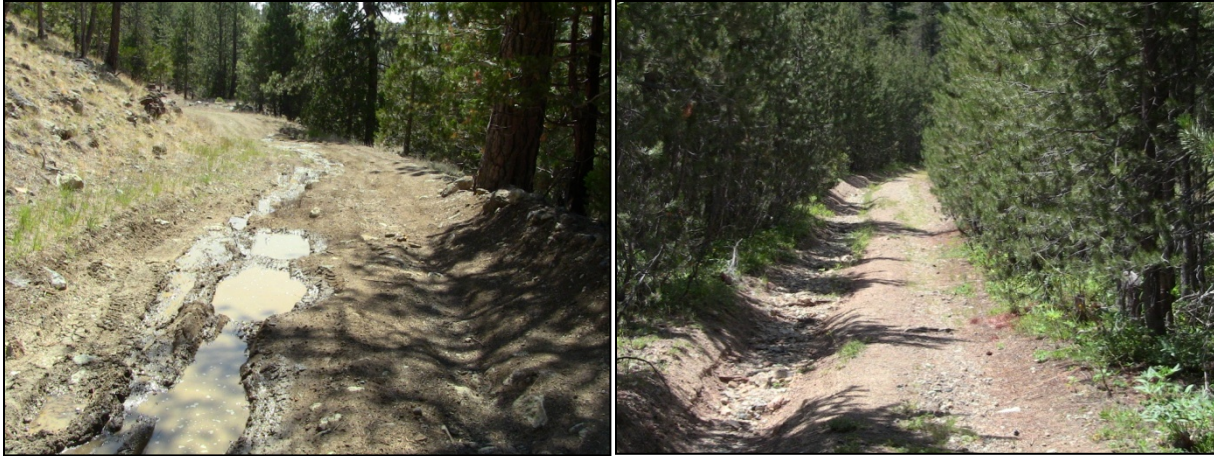
PHOTO 3-34 AND 3-35: DRAINAGE ISSUES ON ROADS 42N19 (LEFT) AND 41N74 (CALDWELL LAKES ACCESS).

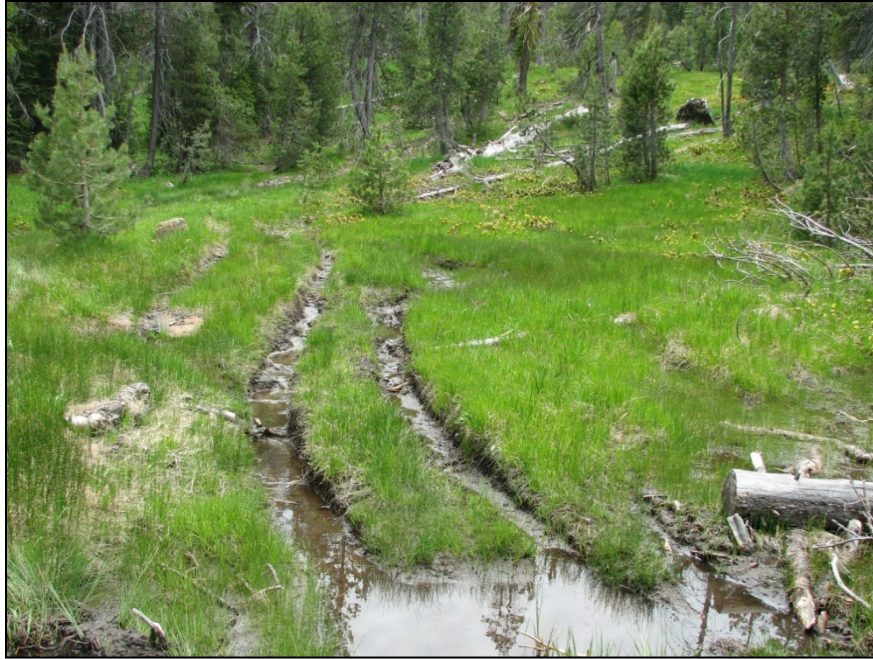
PHOTO 3-36: OFF-ROAD VEHICLE USE AND RUTS CREATED IN WET MEADOWS IN EDDY CREEK DRAINAGE.

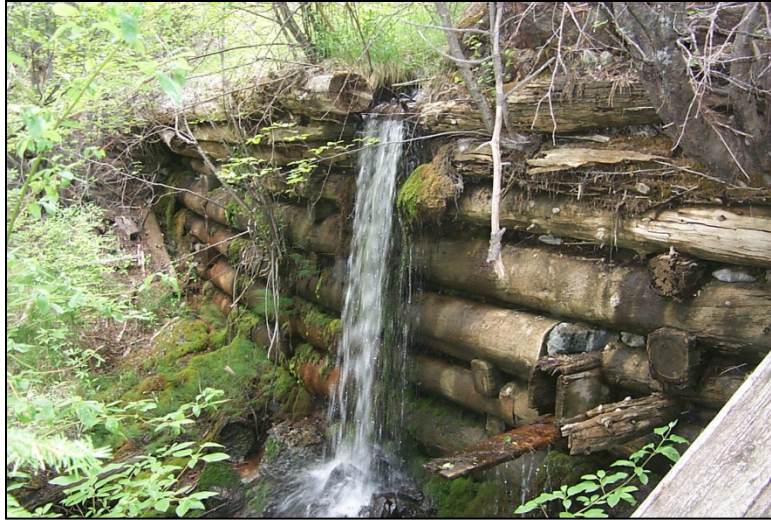
PHOTO 3-37: OLD LOG DAM ON SOUTH FORK WILLOW CREEK ASSOCIATED WITH HISTORIC MINING OPERATIONS, 2001.

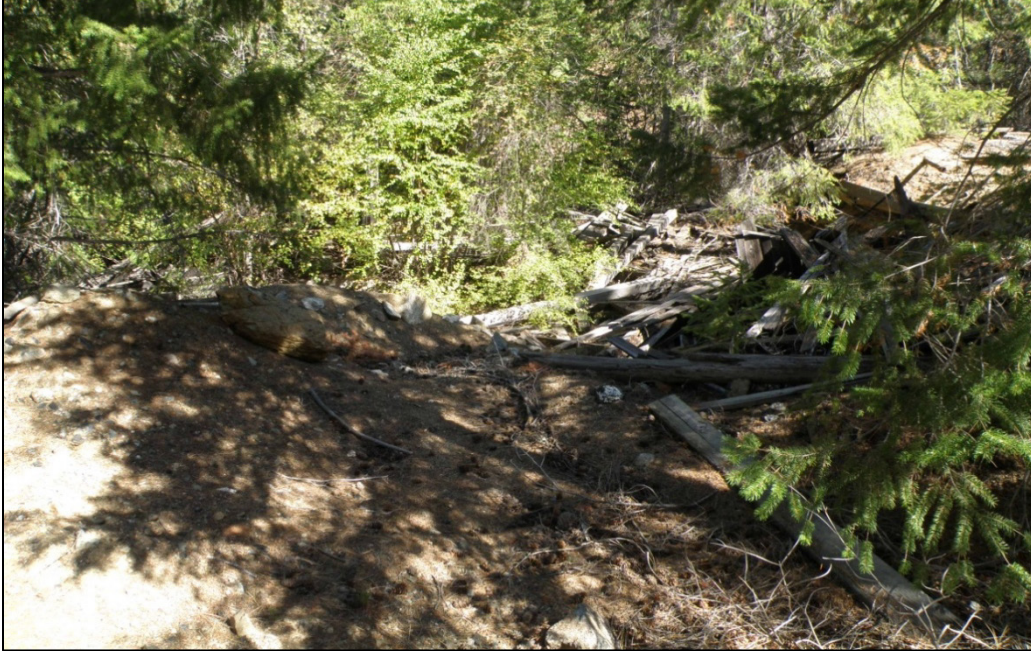
PHOTO 3-39: RUNOFF AREA AND CYANIDE PROCESSING PLANT AT DEWEY MINE. PHOTO IS TAKEN FROM DEWEY MINE ROAD.

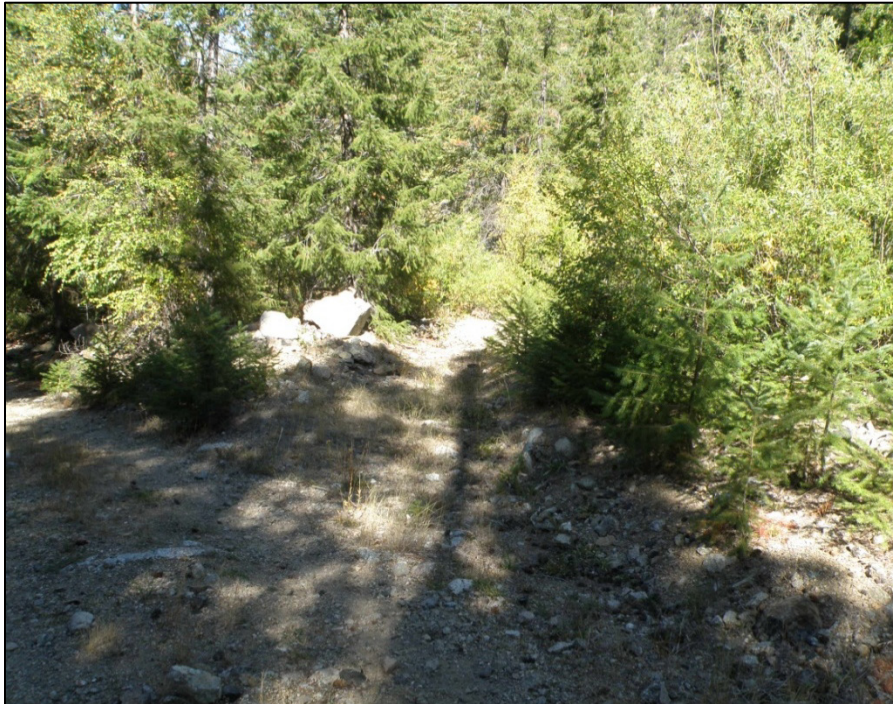
PHOTO 3-40: ROLLING DIP ON DEWEY MINE ROAD, UPSTREAM FROM THE MAIN CYANIDE PROCESSING PLANT.
