# **Upper Truckee River Reach 5 Restoration Project**

## **Effectiveness Monitoring Report**

**April 3, 2019**

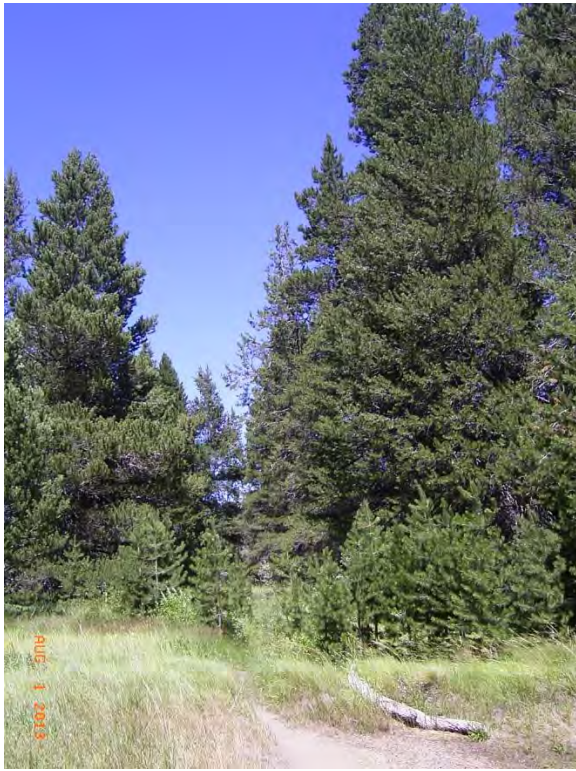
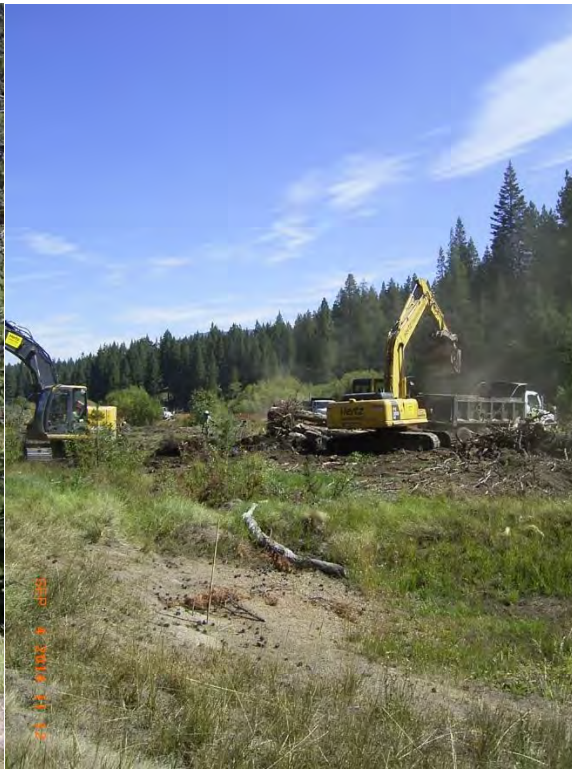
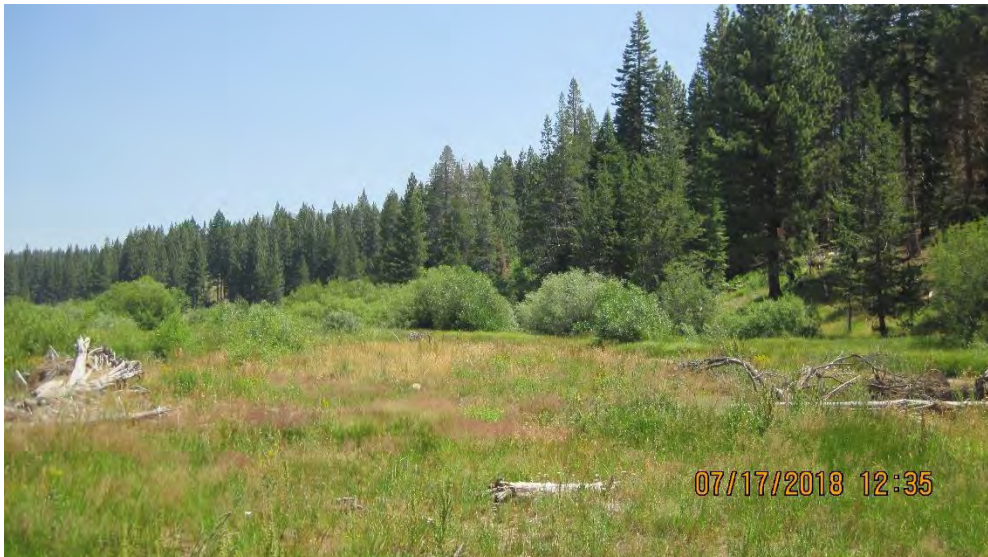
Photo point 4 – Trees converted to meadow

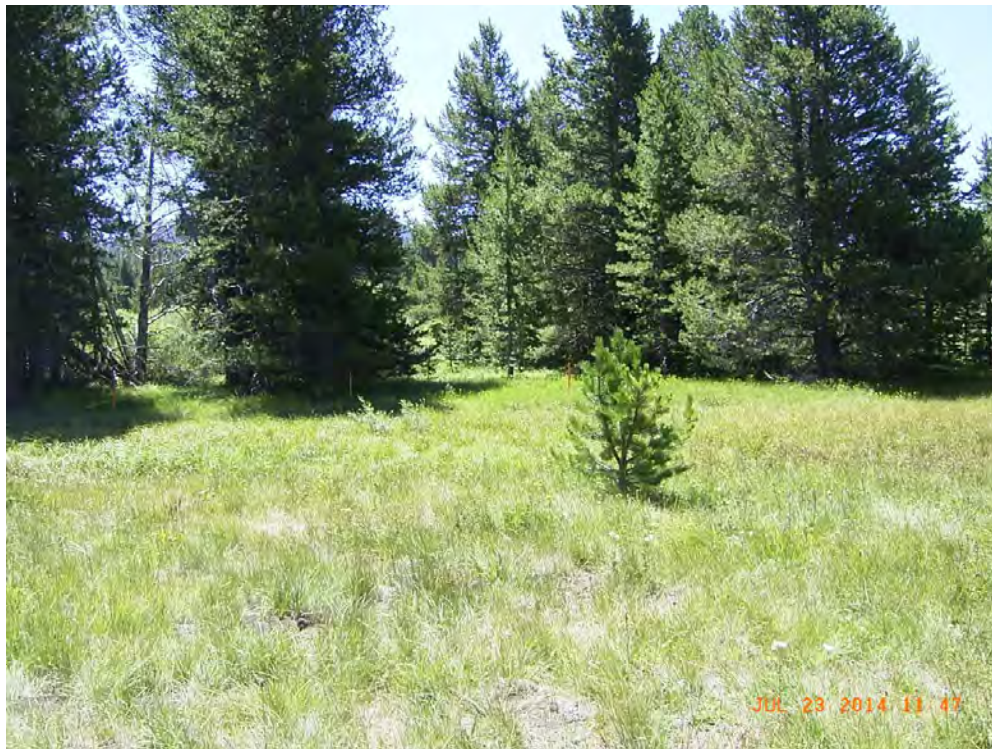
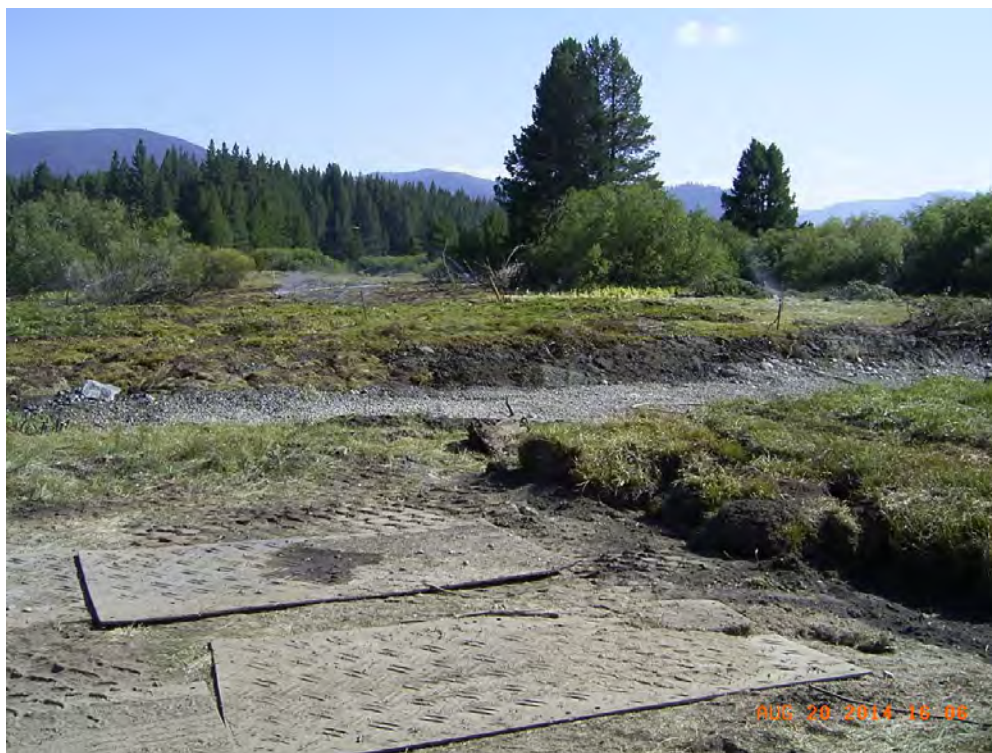
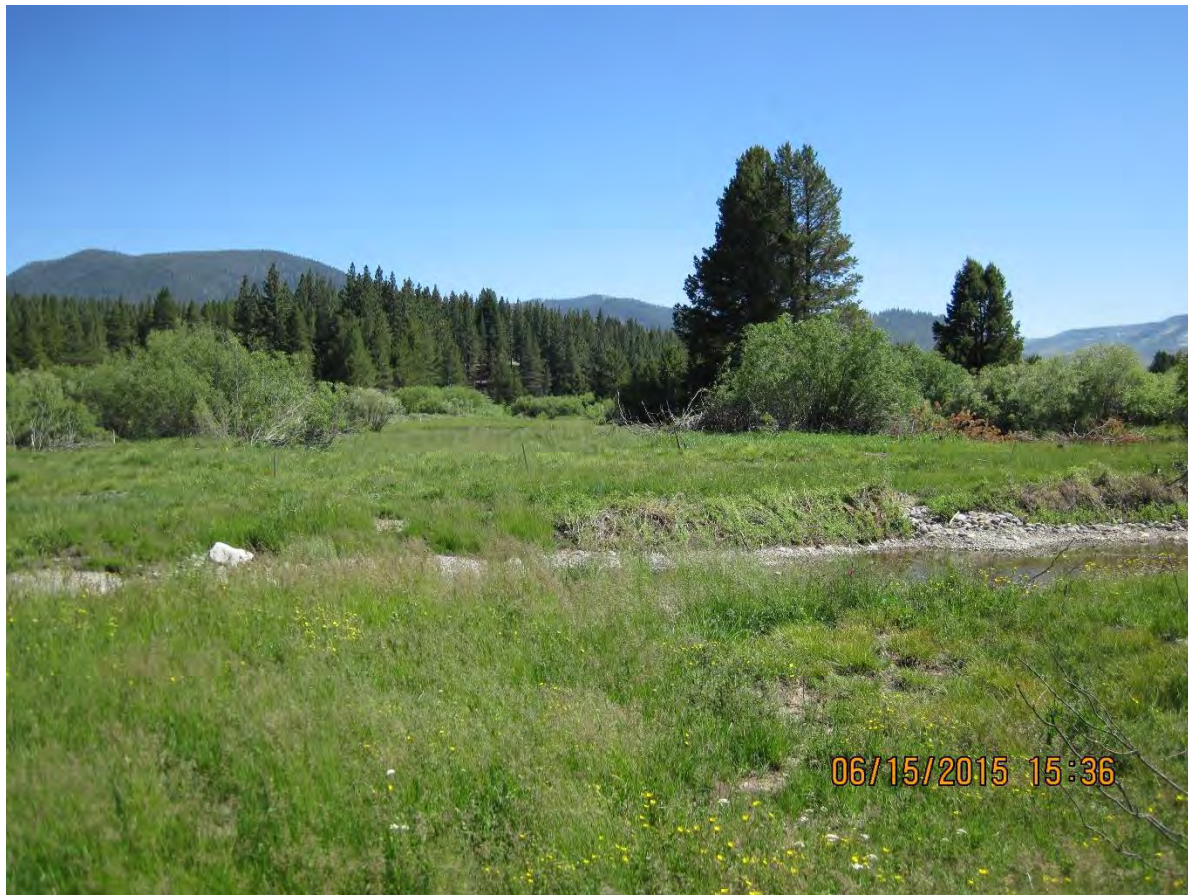
Photo point 8 – Looking across the meadow/channel

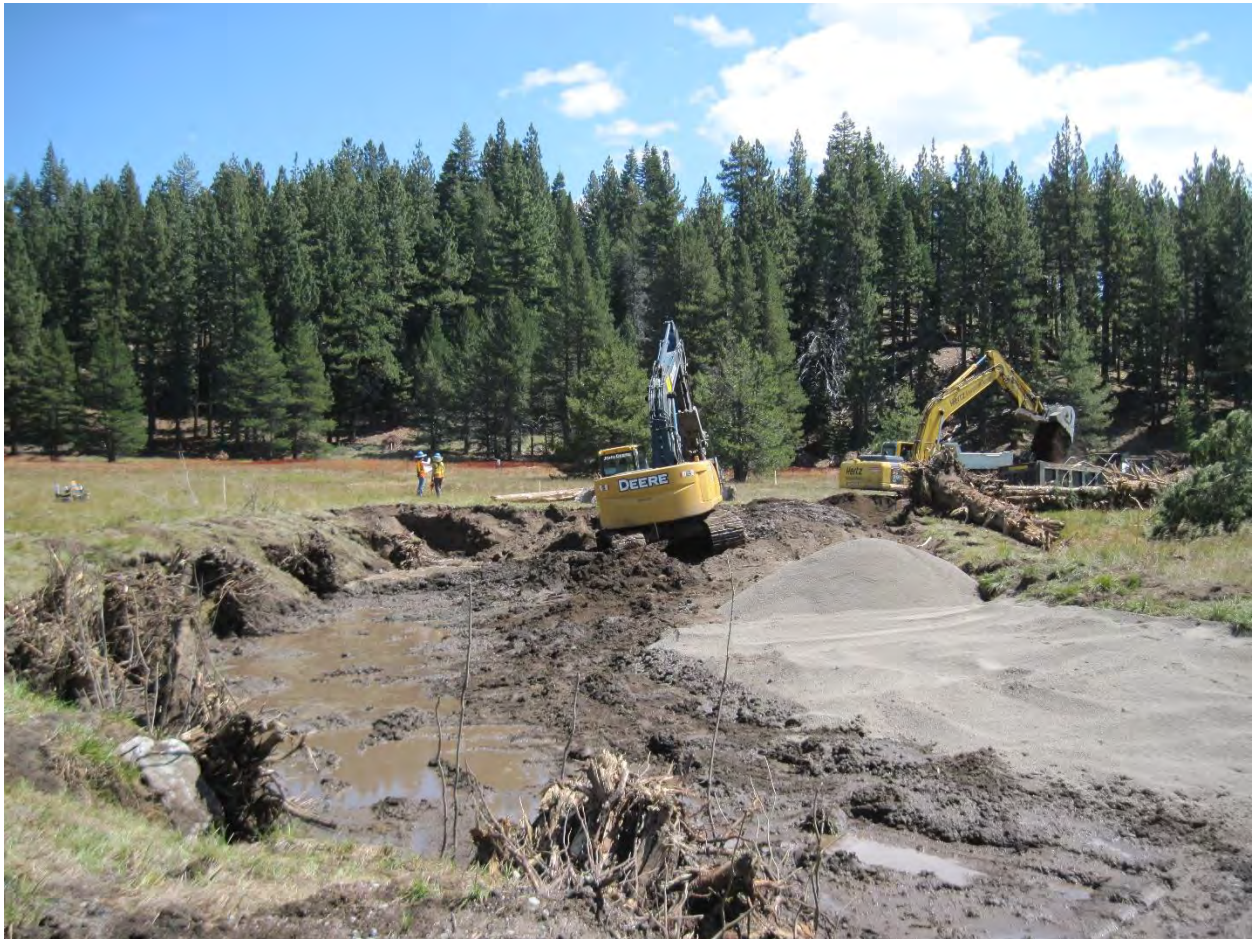
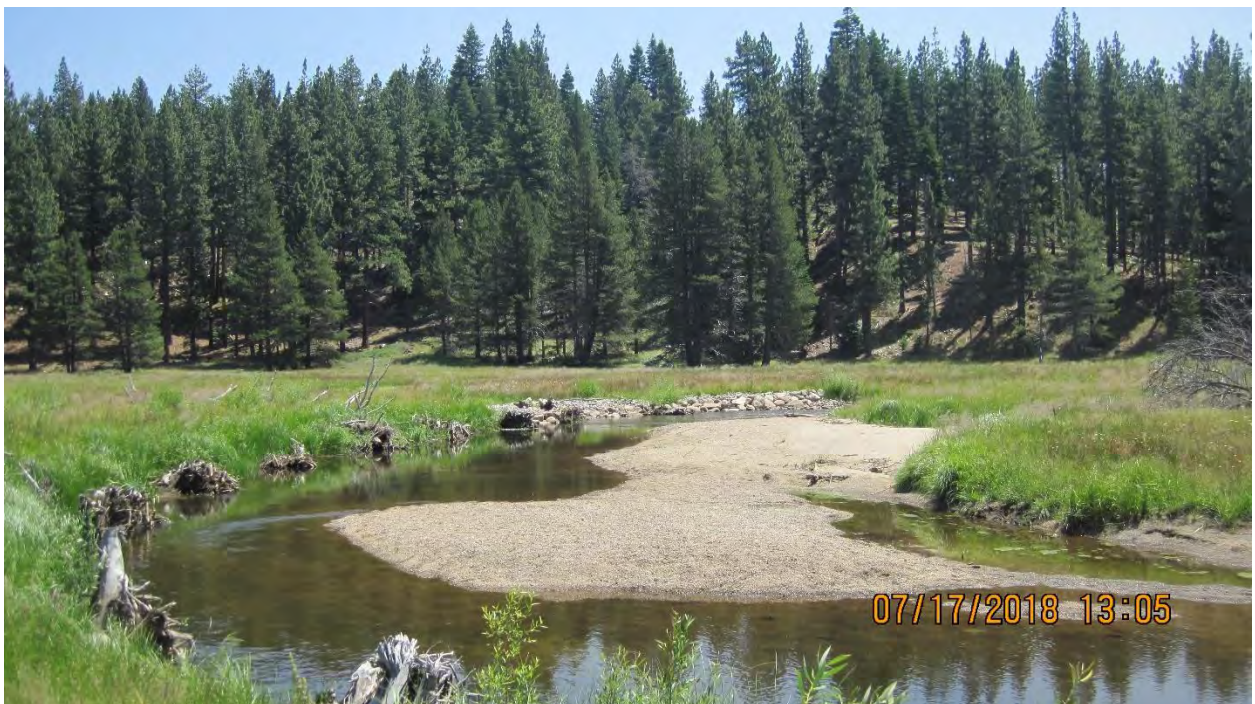
Photos of rootwad revetment pool bank treatment during construction and 2 years post-project

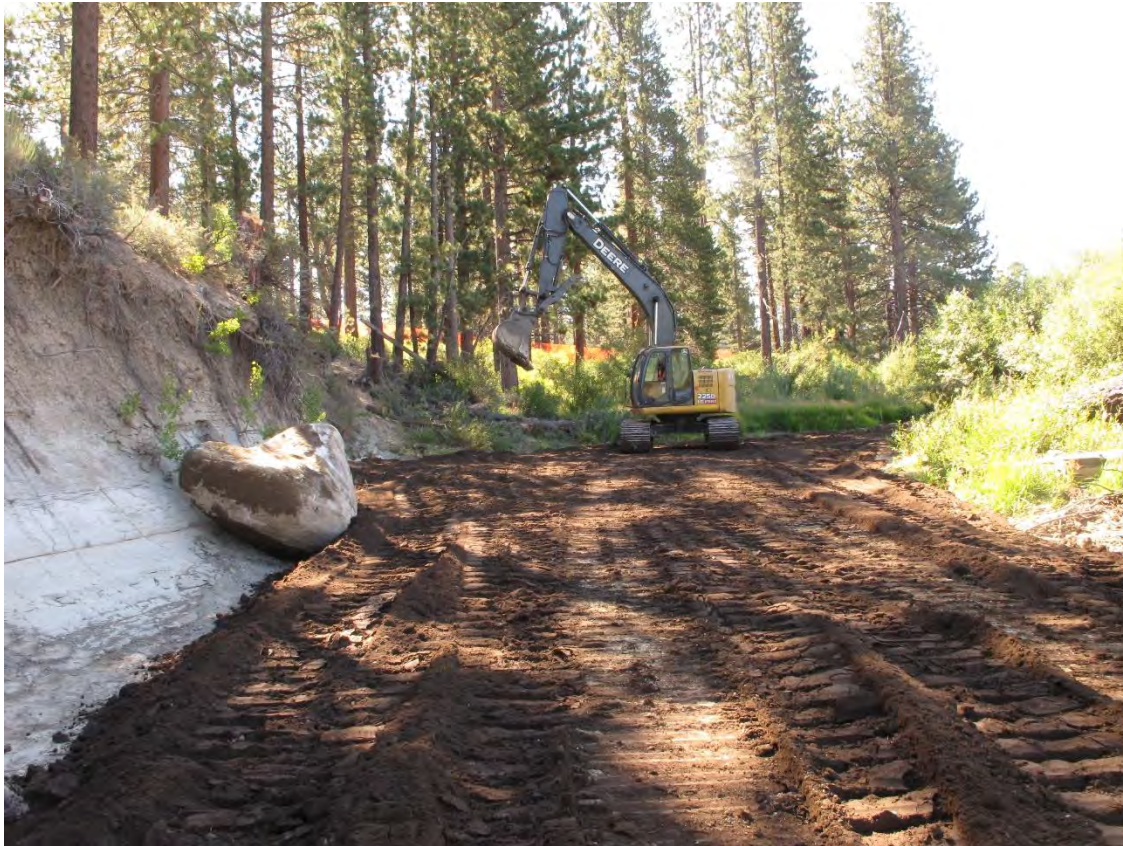
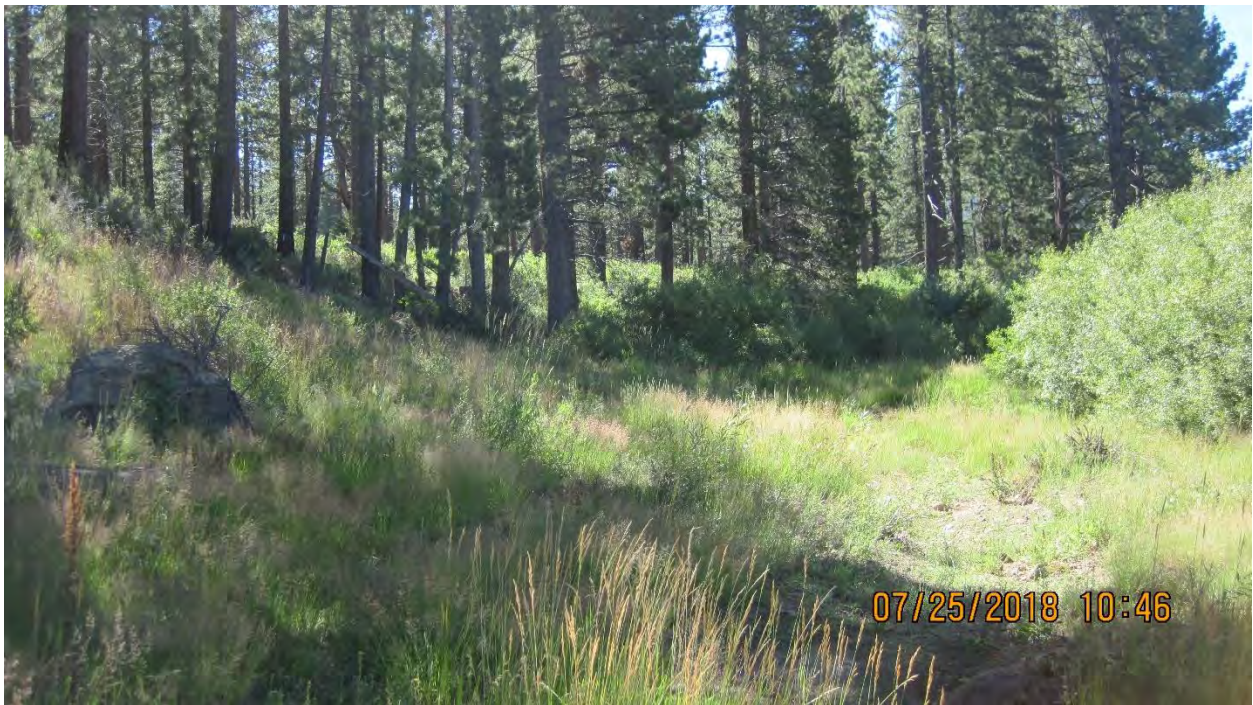
Photos of northern inset floodplain and former channel backfill during construction and 2 years post-project

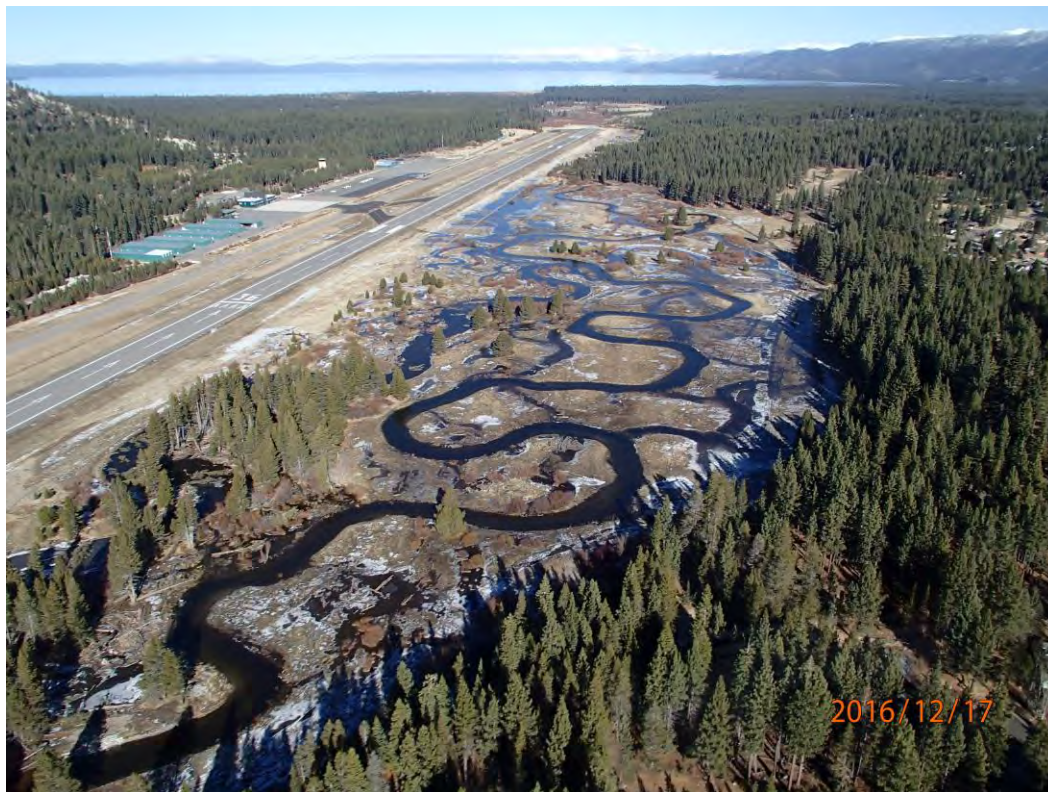
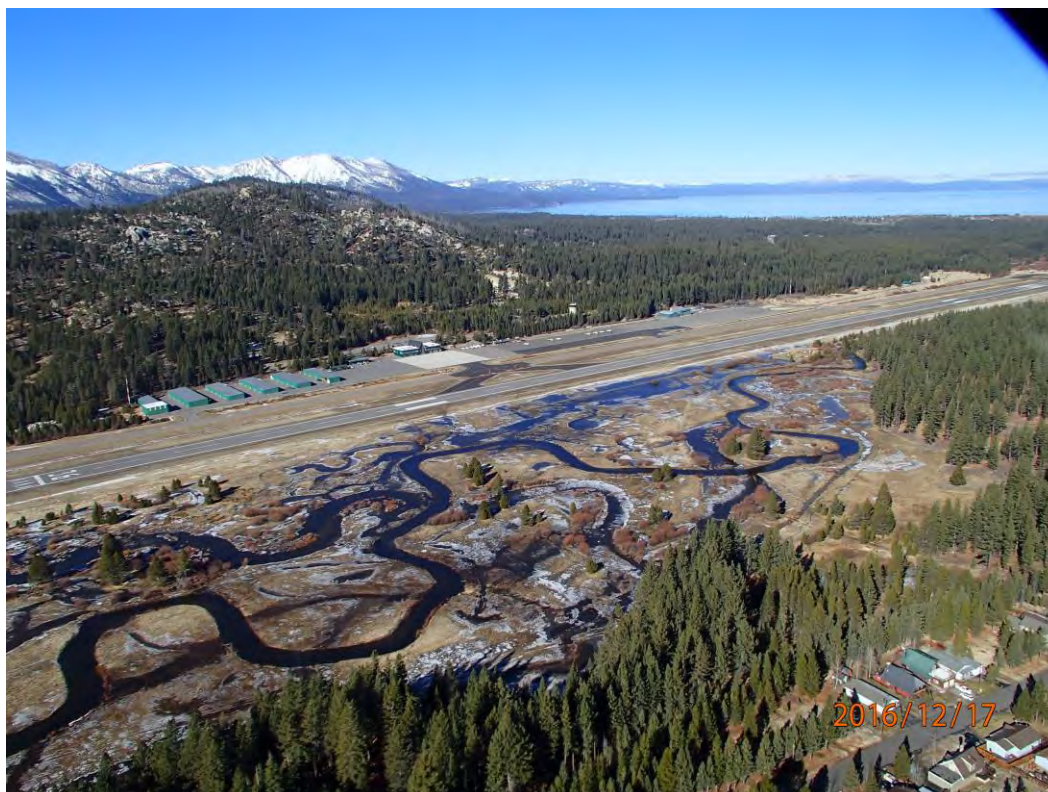
Aerial photos from 12/17/2016, approximate 350 cfs flow

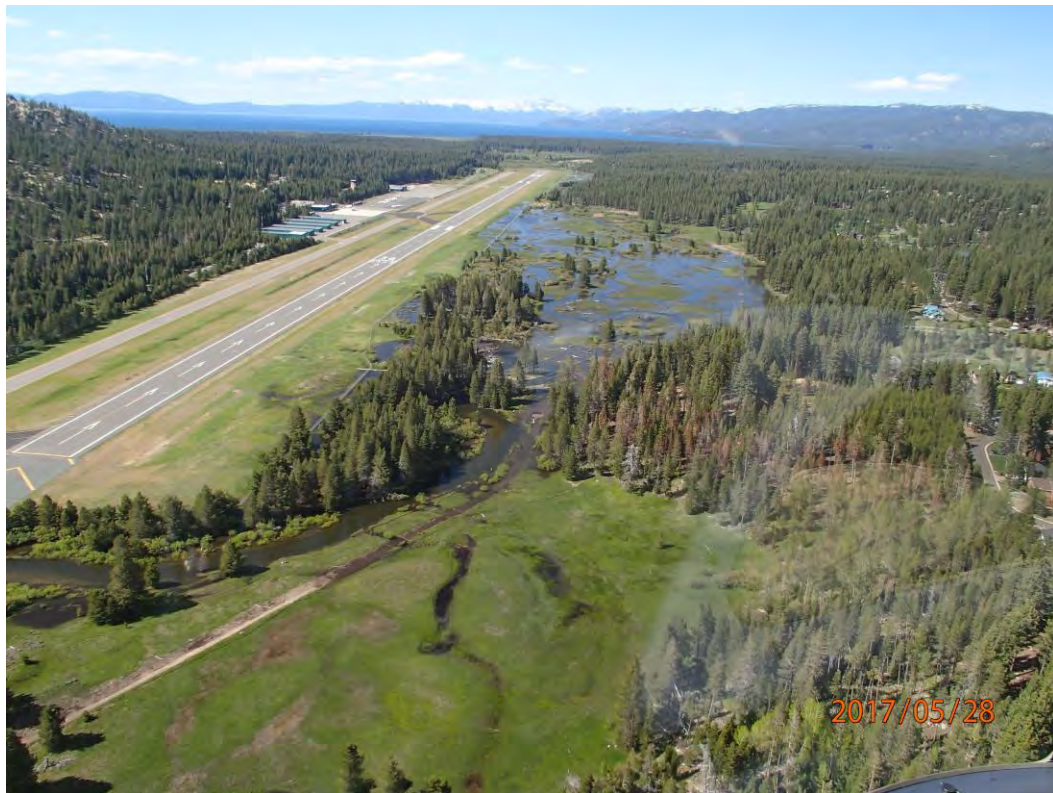
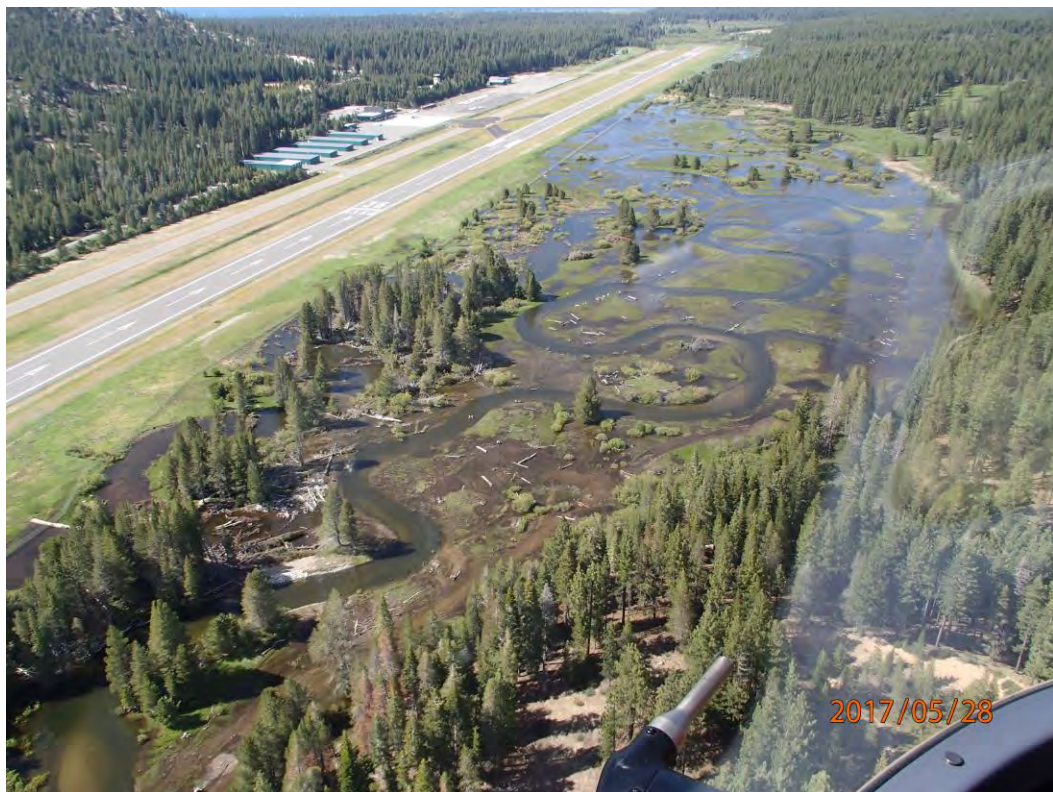
Aerial photos of Reach 5 project area from 5/28/2017, approximate 775 cfs flow

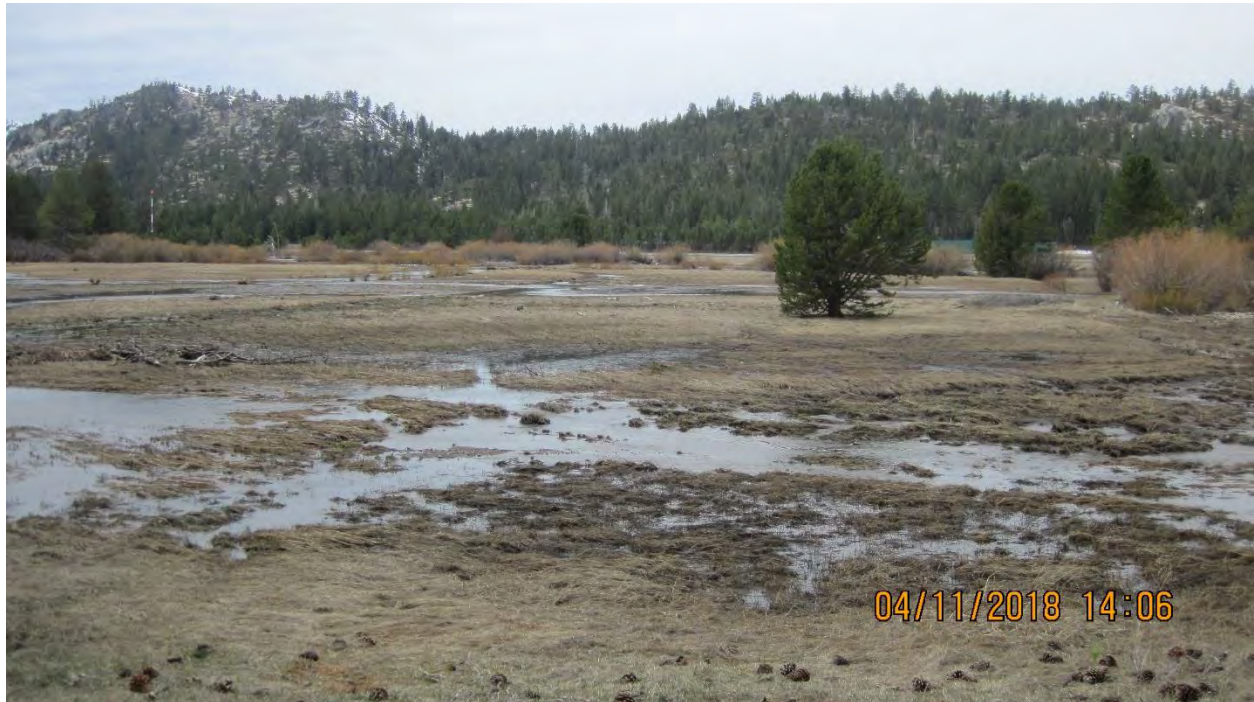
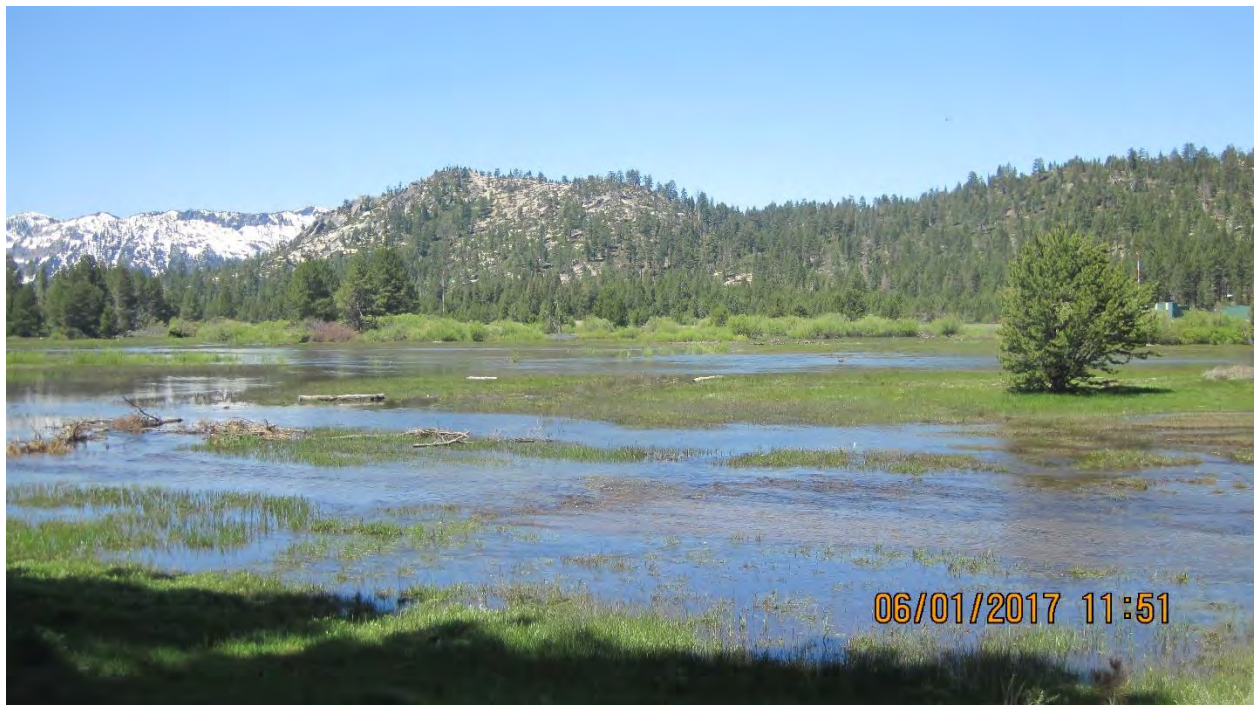
Overlook of Reach 5 project meadow from April 11, 2018 at approximately 400 cfs flows (above) and from June 1, 2017 at approximately 800 cfs flows (below)

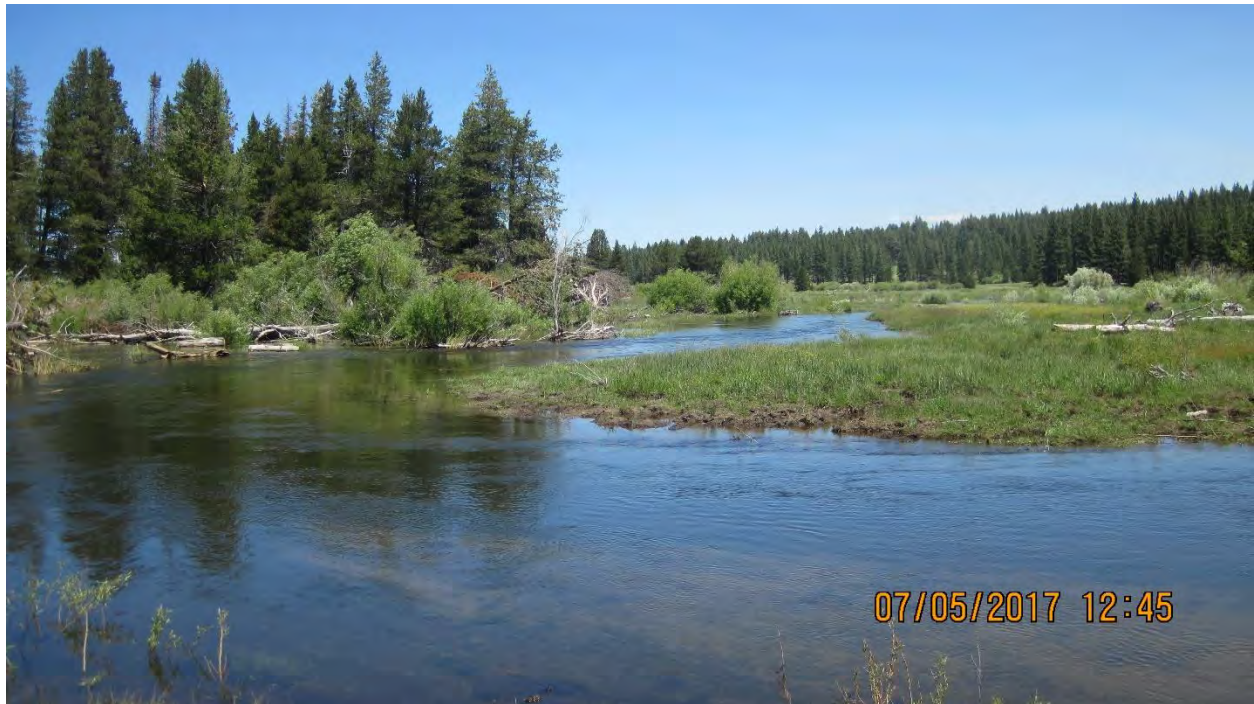
Looking downstream from left bank near upstream end of project area on July 5, 2017 at approximately 400 cfs flow.

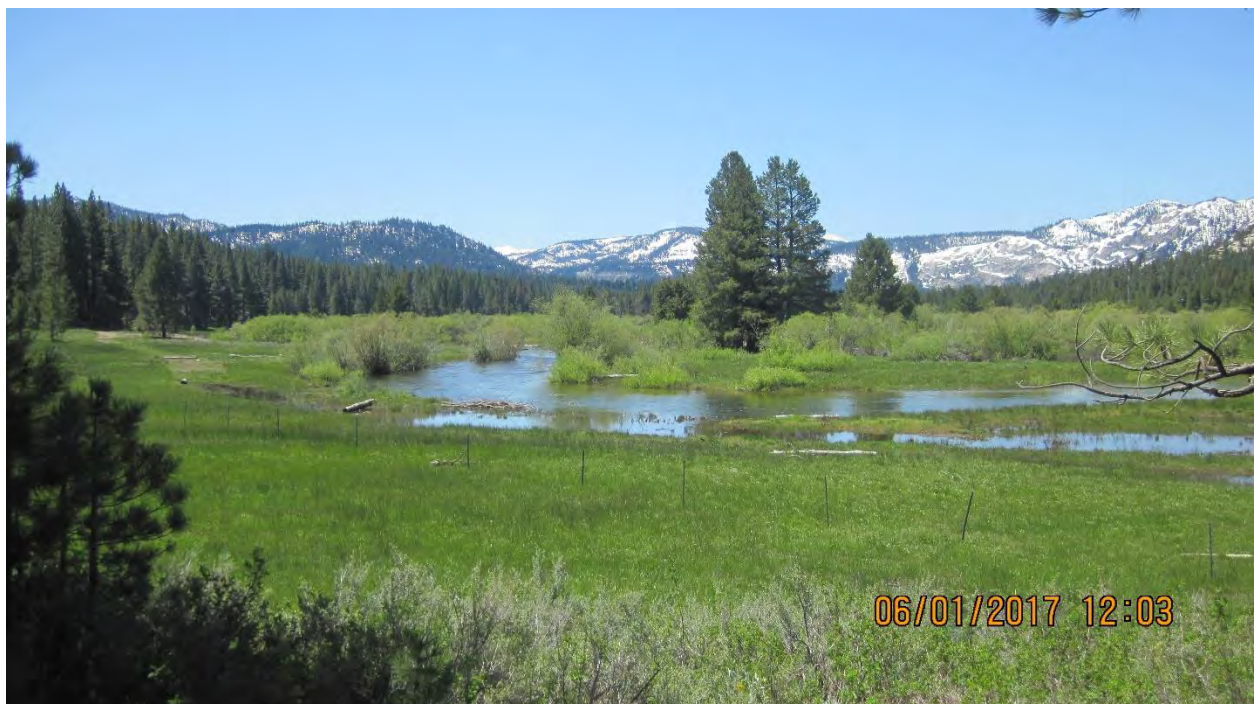
Looking north into meadow near downstream end of project area from right bank forested terrace on June 1, 2017 at approximately 800 cfs.
