# **Cookhouse Meadow Restoration Five-Year Effectiveness Assessment**

**USDA Forest Service**

**Lake Tahoe Basin Management Unit**

**November 2013**

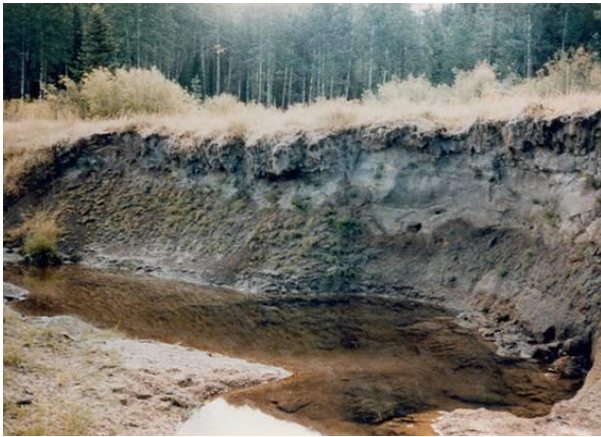
To improve grazing in the early 1900's, the stream channel had been moved from its historic location along the southern perimeter of the meadow to a new path through the middle of the meadow. The re-located channel was much straighter (less sinuous), which increased the velocity of the stream flowing through the meadow. The faster flows eroded the streambed, down-cutting and incising the stream channel deeply into the meadow. In many areas, the stream channel resembled a steep-walled gully much more than a natural watercourse (Figure 1).

Figure 1 Steep-walled streambank in 1981.

By the Rosgen Classification system (Appendix A), the stream channel was classified “G4”, which meant it was deeply entrenched though it had moderate sinuosity. The Forest Service stabilized the streambanks in the 1980's. However, the streambed remained two to ten feet deeper than its natural position. The incised stream channel continuously drained the adjacent meadow, reducing meadow wetness and flooding patterns, vegetation and wildlife diversity, and sediment retention.

To restore connectivity between the stream and adjacent floodplain, 2,400 feet of new stream channel was constructed. The new channel's geomorphic form (depth, width, gradient, and sinuosity) was designed so that the stream would flood the adjacent meadow frequently, allowing the meadow to function more effectively in slowing floodwaters and filtering out sediment. Most of the old stream channel was filled in with soil that came from digging the new channel. Portions of the old channel were left unfilled to serve as ponds for amphibians. The bare ground surfaces of the filled channel reaches were re-vegetated with a combination of sod mats and sod plugs harvested from the meadow. Two years after completion of the project, many attributes of meadow and stream function had improved (Norman and Immecker, 2009).

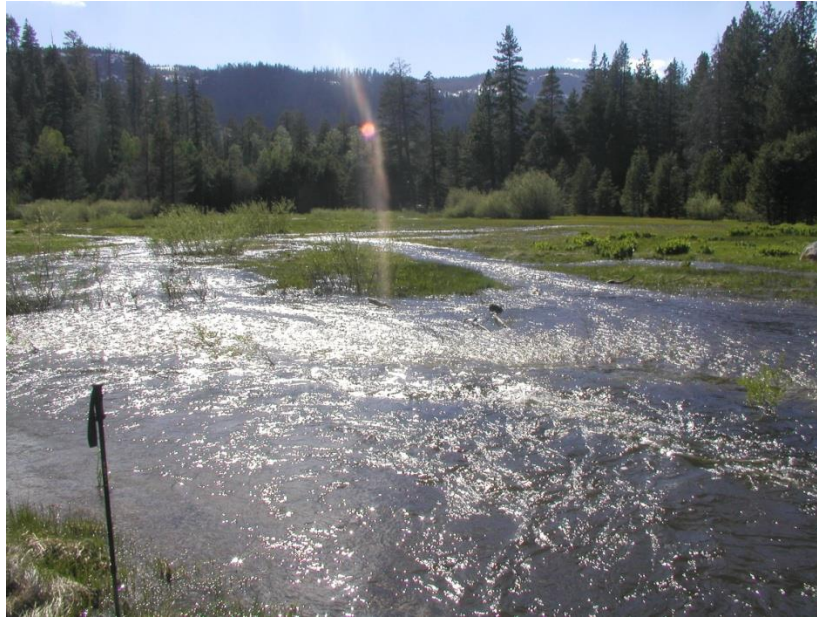
**Figure 3 – June 21, 2011 view of channel and overbank flow at 75 cfs (facing downstream)**

Observations and measurements were made on June 18-19, 2011, when gaged flow ranged from 50 to 60 CFS, which is twice the bank full discharge. Floodplain and channel margin deposits were identified visually as fresh surfaces forming a veneer over the previous year's vegetative growth. We also identified newly deposited sediments accumulating along channel margins.

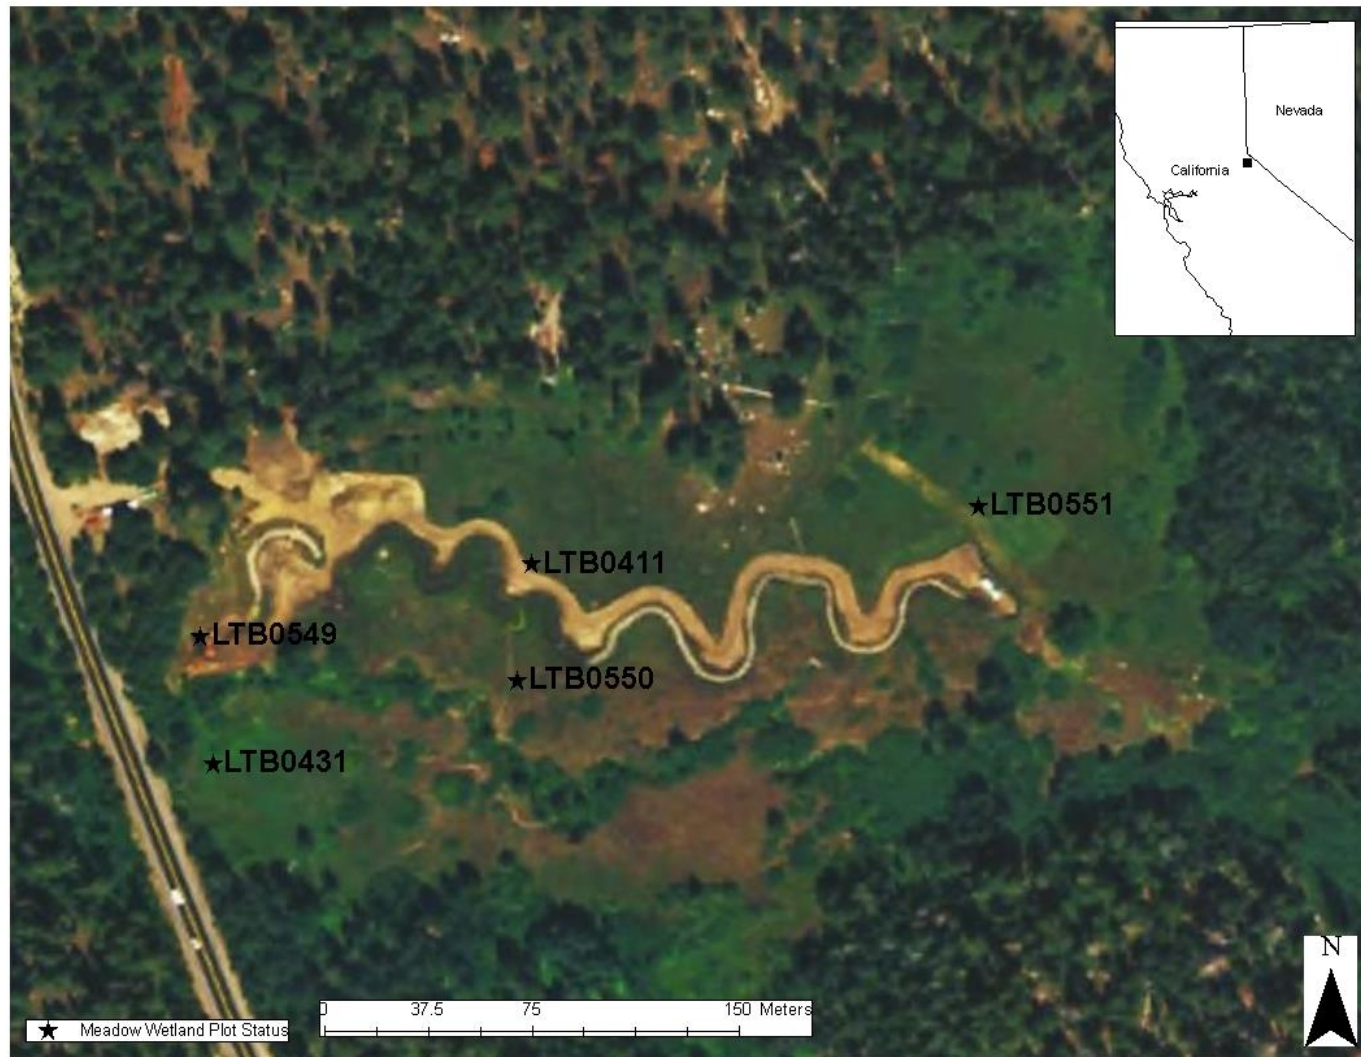
Five status Forest Service Region 5 Range monitoring plots (Wiexelmann, 2011) were established pre-project implementation in 2004 and 2005 (Figure 5). Measurements per standard protocols were taken at the monitoring plots one year (2007), three years (2009), and five years (2011) post project implementation.

**Figure 5** - Locations of the five vegetation meadow plots at Cookhouse Meadow. Aerial imagery is from 2005.

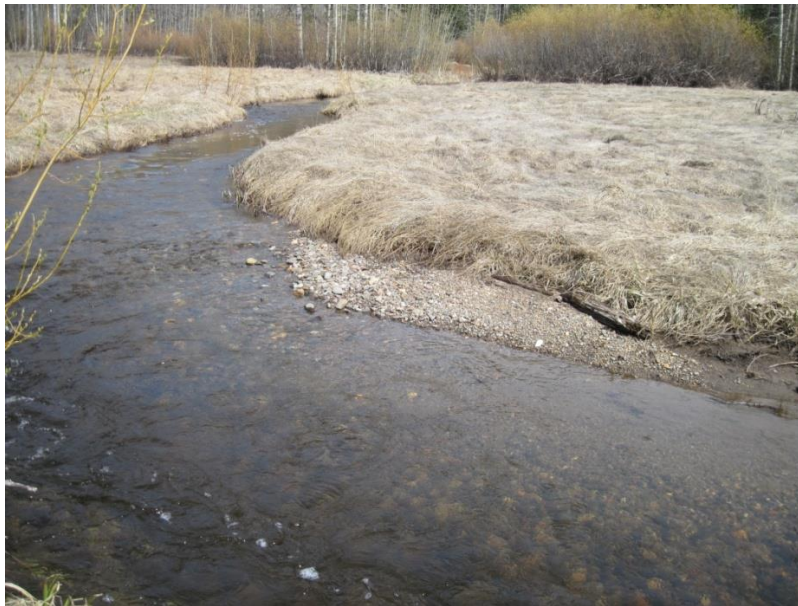
Figure 10 illustrates the change in overall thalweg elevations. The thalweg is the deepest point of the channel at any given point. Plots show that minor changes in the thalweg have occurred since 2008, with one noticeable area of riffle scour to a downstream shift in pool – riffle position as shown in the Reach 1 thalweg survey. Change in mean bed elevation (Figure 11) shows net aggradation of the channel since 2008, once again mostly in the form of point bar formation. The photo in Figure 12 illustrates this process of point bar formation.

**Figure 12 – Point bar formation in Cookhouse Meadow in May, 2012**

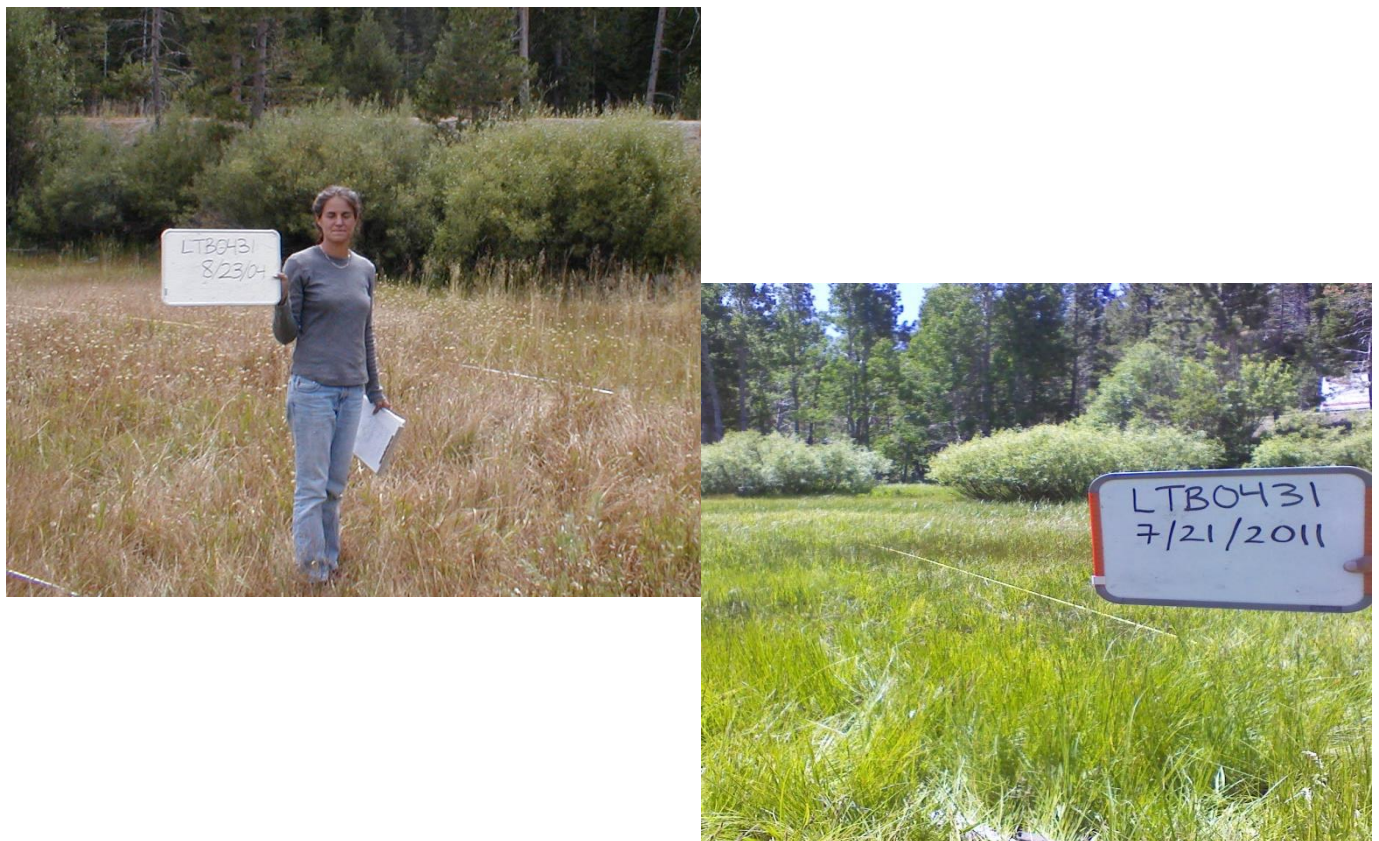
Quantitative and qualitative (Figure 16) results suggest there has been an increase in meadow species indicative of wet meadow conditions. Future monitoring could determine if either conifer encroachment or increasing frequency of *Poa pratensis* continues; this may provide some insight into management consideration for future projects. Potential considerations could include better sub-soiling of compacted soils to reduce conifer encroachment and potentially increase the spread of sod or native seed within the project area to reduce *Poa pratensis*.

**Figure 16: Cookhouse Meadow Vegetation Monitoring Plot #0431 (2004, 2011).**
