## Restoration Effectiveness in Blackwood Creek – Reach 6

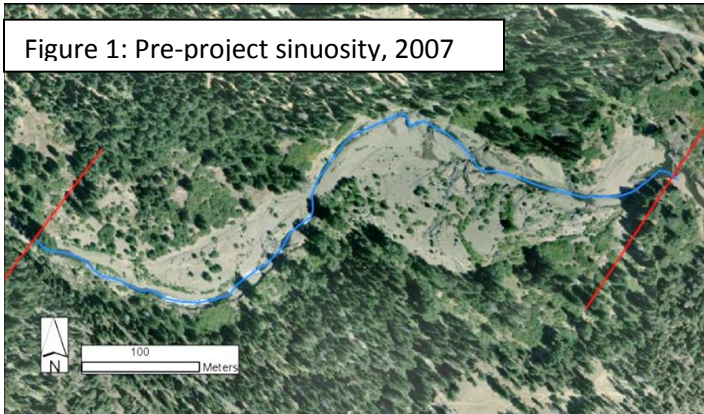
Figure 1: Pre-project sinuosity, 2007

As a result of restoration this reach has changed from one dominated by processes of net degradation (channel erosion), to one dominated by processes of net aggradation (floodplain deposition). Post project measurements of sinuosity (2.1:1) and bank stability (95%) indicate the restored reach currently exceeds the Blackwood TMDL targets. Figures 1 and 2 illustrate the increase in channel sinuosity as a result of restoration. Post project observations during spring runoff also indicate that floodplain inundation has occurred to some degree every year since the project was completed. Overall, the increases in pool quality metrics (depth, frequency, and ratio to riffles), lower % riffle fines, lower cross section width-depth ratios, and significantly less relative channel confinement, all suggest aquatic habitat has been significantly improved. Habitat metric values in the project area are statistically comparable to established reference reaches in

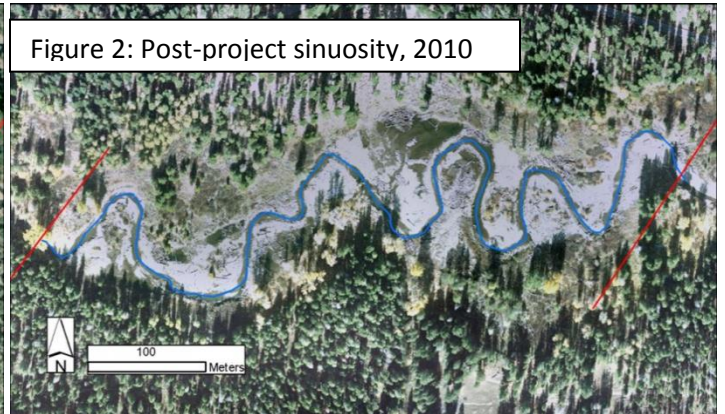
Figure 2: Post-project sinuosity, 2010
