September 2012

# Upper West Fork Hood River Watershed Restoration Action Plan

**Mt. Hood National Forest  
Hood River Ranger District**

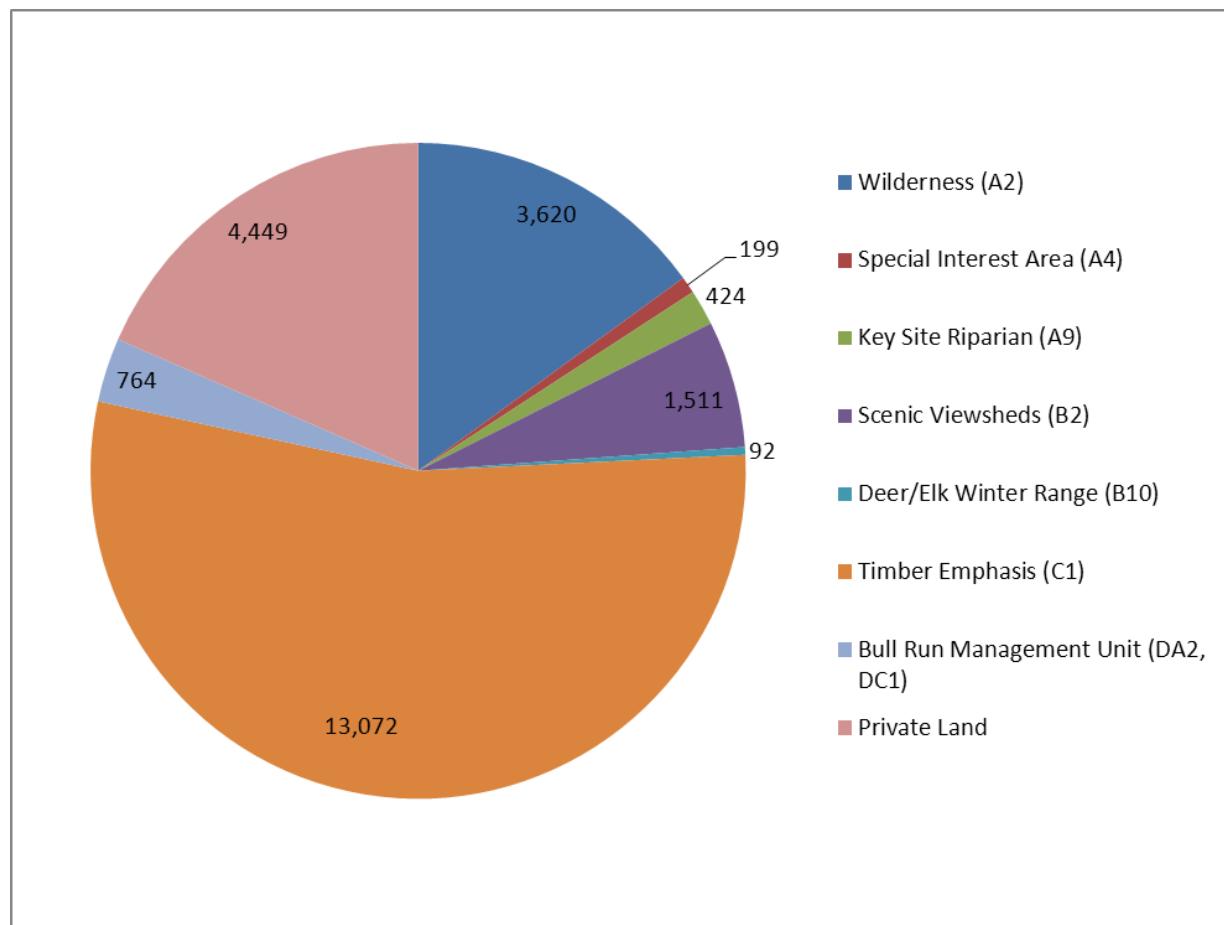
**Figure 3.** Mt. Hood National Forest LRMP land allocations within the West Fork Hood River 5<sup>th</sup> field watershed.

National Forest system lands located within the Upper West Fork Hood River 6<sup>th</sup> field watershed encompass a variety of land designations (Tables 1 and 2; Figure 3). From a MHNF Land and Resource Management Plan (LRMP) perspective most of the watershed is timber emphasis, wilderness, and private land. Specific management direction for each of these land allocations can be found in the LRMP (USDA 1990). In regard to the Northwest Forest Plan (NWFP), the primary land allocations are matrix, congressional reserves, and late successional reserves; these land allocations are overlain by riparian reserve and Tier 1 Key Watershed allocations. Specific management direction for each of these land allocations can be found in the Record of Decision (ROD) for Amendments to Forest Service and Bureau of Land Management Planning Documents within the Range of the Northern Spotted Owl, i.e. Northwest Forest Plan (USDA and USDI 1994).

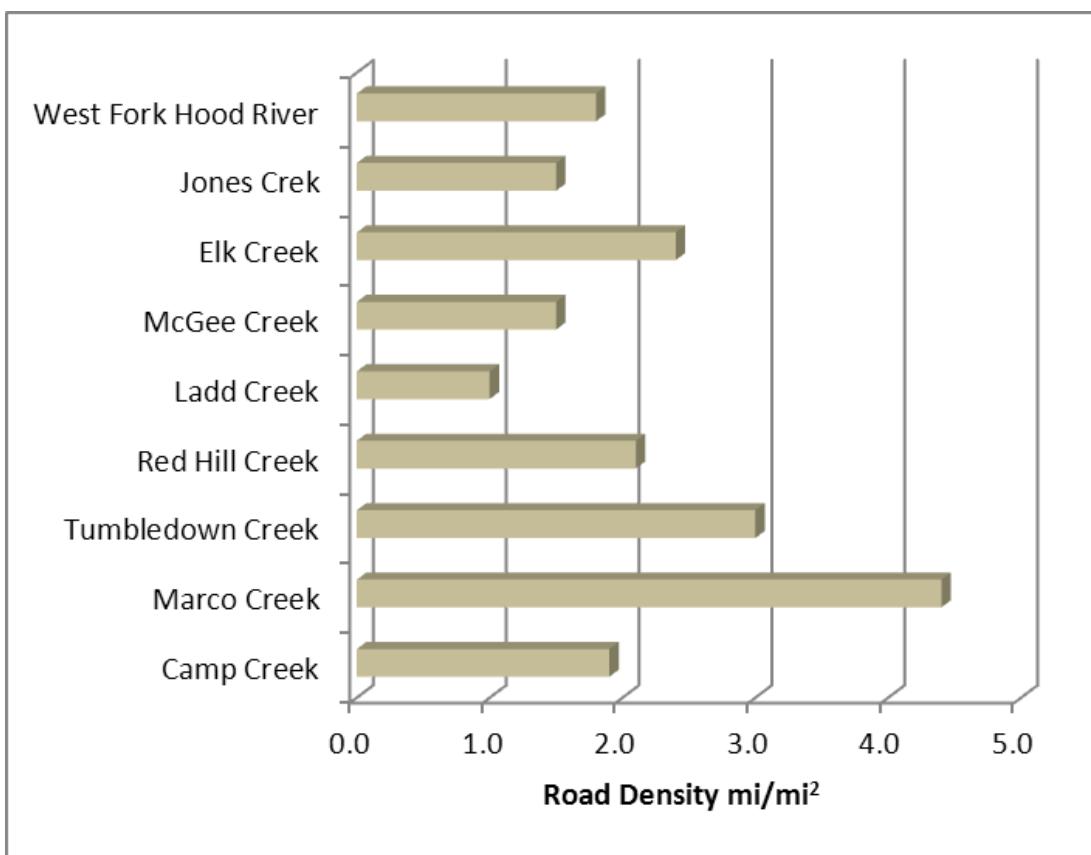
**Figure 4.** Current road densities in 7<sup>th</sup> field watersheds that make up the Upper West Fork Hood River 6<sup>th</sup> field watershed.

Higher road densities in Marco and Tumbledown Creeks are due to FSR 1600 switchbacks that climb through the area. The majority of road surface through both sub-watersheds is comprised of less erosive asphalt material indicating surface erosion is not a major concern despite the high road density. The Forest Service Watershed Erosion Prediction Project (WEPP) Model was run on an example road segment to illustrate different erosion rates for these different road surface types. Local soil types and weather conditions were used in the model run. A 200-foot, high use

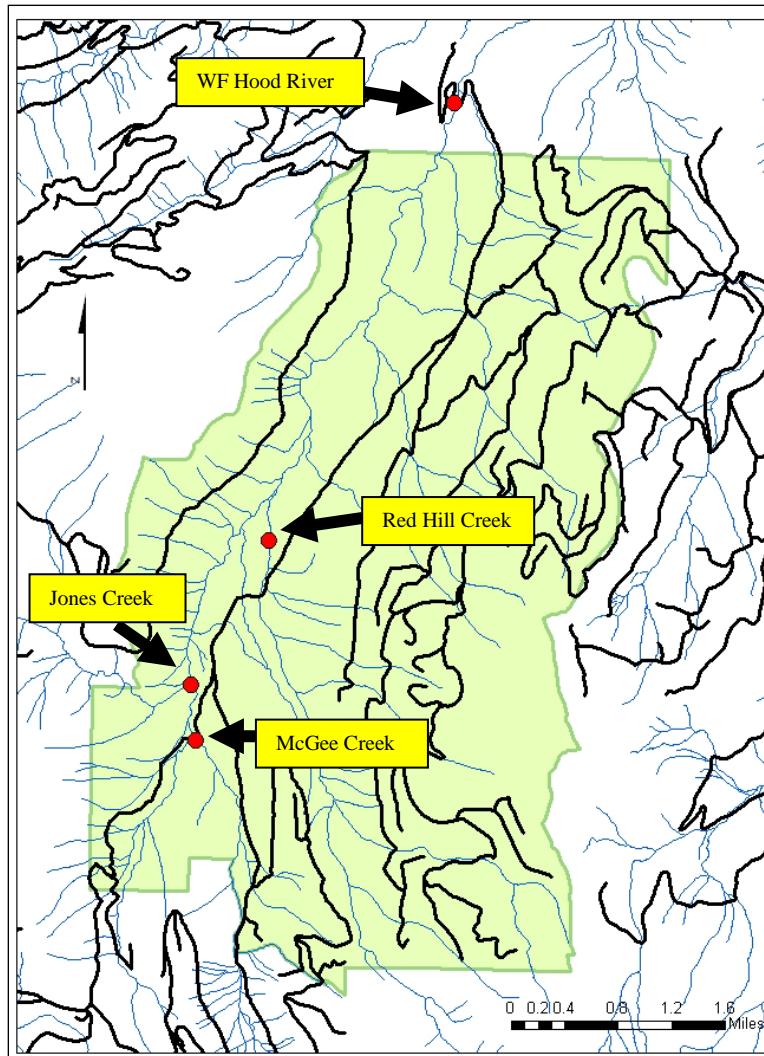
**Figure 5.** Water temperature monitoring sites located within the Upper West Fork Hood River 6<sup>th</sup> field watershed. Sites are indicated by red circles and the Red Hill Restoration Project planning area is shown in green.

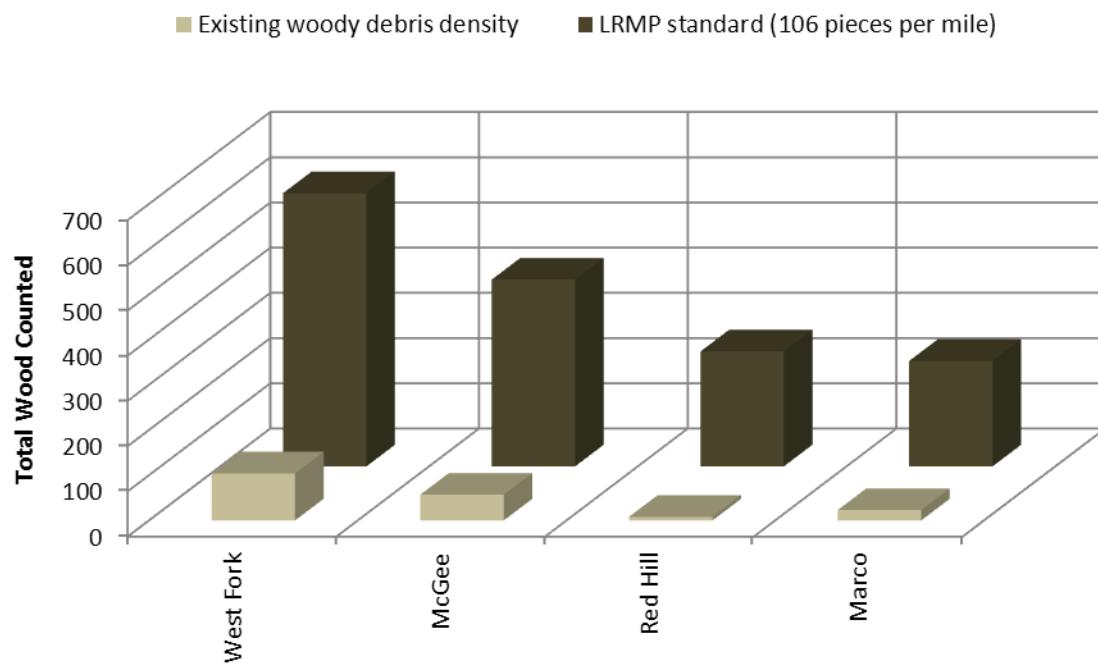
**Figure 6.** A comparison of existing large in-channel wood density with LRMP standards for four streams within the Upper West Fork Hood River 6<sup>th</sup> field watershed.

The LRMP (USDA 1990) has a standard of 106 pieces of suitable large wood per mile of stream (FW-095). For eastside streams, all pieces of large wood should be at least 35 feet long with 80

percent at least 12 inches in mean diameter, and at least 20 percent of large wood pieces should be over 20 inches in mean diameter. With the exception of McGee Creek in the lower 1.3 miles, none of the stream reaches surveyed in the sub-basin met the standard (Figure 6). The West Fork Hood River, Red Hill Creek and Marco Creek were well below Forest Plan standards; McGee Creek within the MHNF (the Forest boundary is at river mile 1.3) was also below standard, but not to the degree of the West Fork Hood River and Red Hill Creek (USDA 2011b, 2011c, 2002, 1997, 1996a).

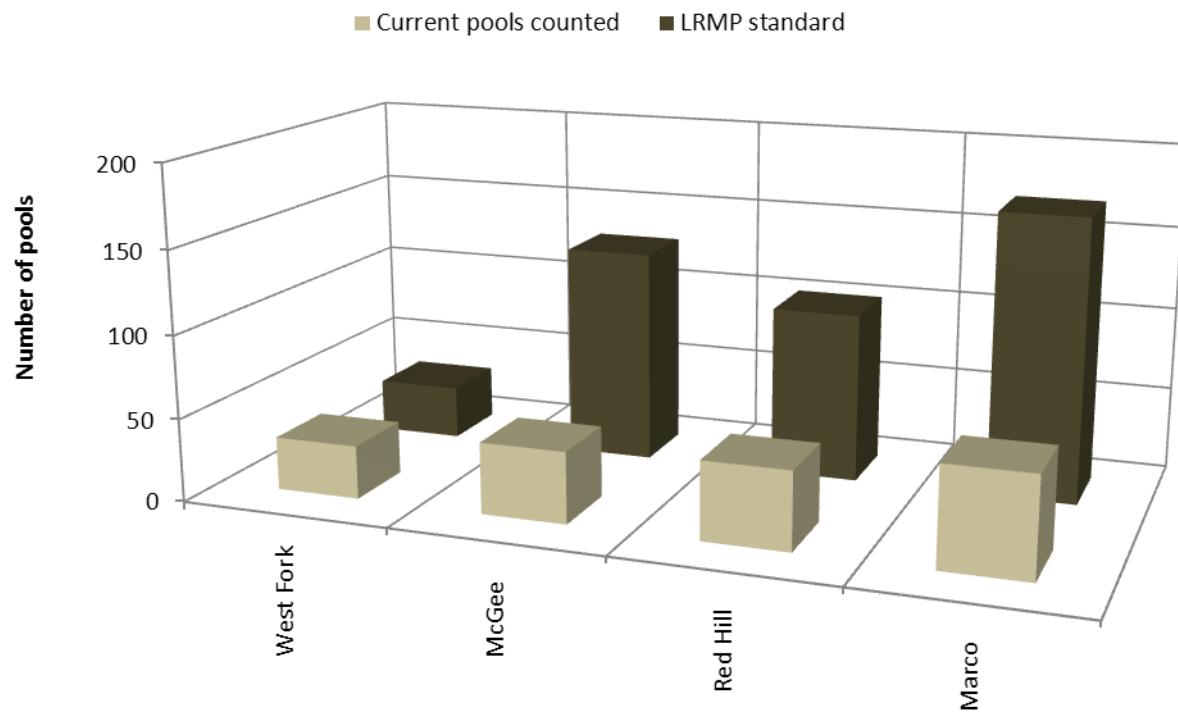
**Figure 7.** The existing number of pools in four streams within the Upper West Fork Hood River 6<sup>th</sup> field watershed compared with LRMP standards.

Pool habitat is a critical component of healthy stream habitat for salmonid populations. Pool frequency is often related to the occurrence of large wood or other channel obstructions (Montgomery et al. 1995). Pool frequency in streams within the Upper West Fork Hood River watershed is below LRMP standards although the West Fork Hood River approaches the standard (Figure 7) (USDA 2011b, 2011c, 2002, 1997, 1996a). In some streams and reaches the relative lack of pool habitat is a direct result of low levels of large wood, but in other streams the lack of pool habitat is more a function of geomorphology. In these areas it is likely that pool numbers would never meet LRMP standards.

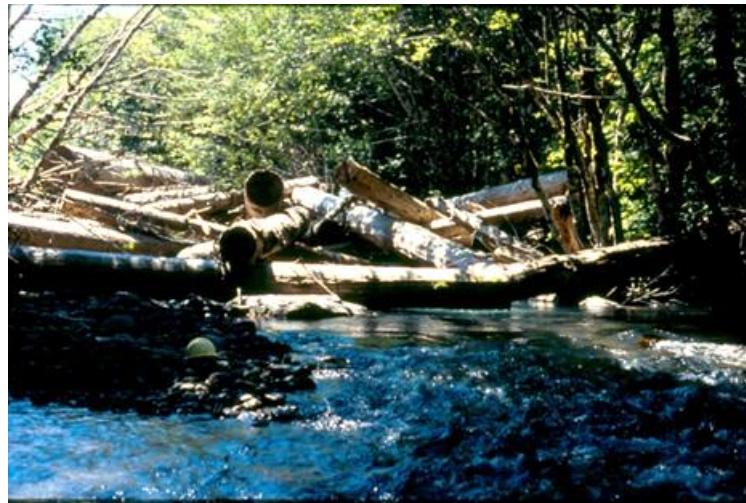
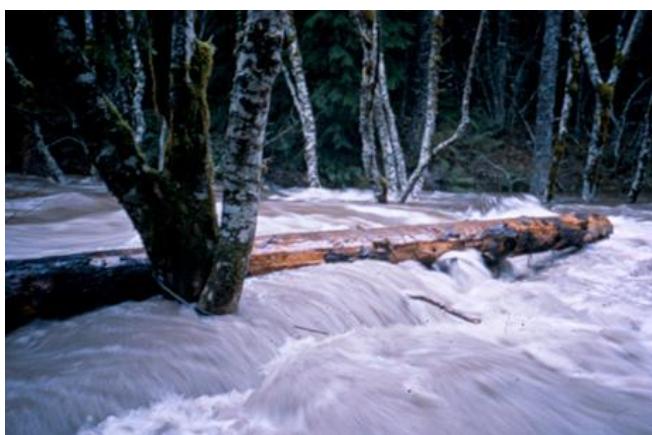
Numerous stream habitat restoration projects were implemented in the Upper West Fork Hood River watershed over the last 20 years. Project designs have evolved from single logs usually anchored to trees and/or boulders with cable to multiple log structures and finally logjams of various sizes along with large wood placed on the floodplain in anticipation of channel shifts. Streams treated with LWD in the watershed include West Fork Hood River, McGee

Creek, Elk Creek, Jones Creek, and Red Hill Creek. Multiple projects have occurred in the West Fork Hood River as it is the most important spawning and rearing area for anadromous salmonids. Stream response to habitat creation/maintenance has varied depending on the location; in most treated reaches the placed large wood has created excellent spawning and/or rearing habitat and often accumulated additional woody debris, aggraded the channel, and collected spawning gravel. However, in a few areas flood events have caused many of the wood structures to become mobilized and they now provide little habitat benefit. In these areas, many large pieces of wood are now parallel to the flow of the stream. Some project reaches have yet to experience significant high water that would lead to wood accumulation and habitat formation.

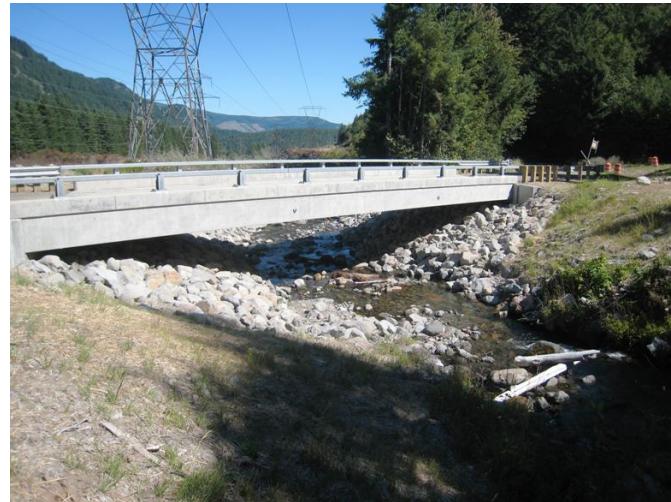
Compared to other watersheds, the Upper West Fork Hood River has relatively few anadromous fish passage barriers. One of these, Red Hill Creek at FSR 1800, was remediated in 2011 when a bridge was installed to replace the culvert barrier. The other, McGee Creek at FSR 1800, is currently in the design phase and it is included in this restoration plan as an essential project. Several resident fish/aquatic organism culvert barriers are present in the watershed and they are also included in this plan.

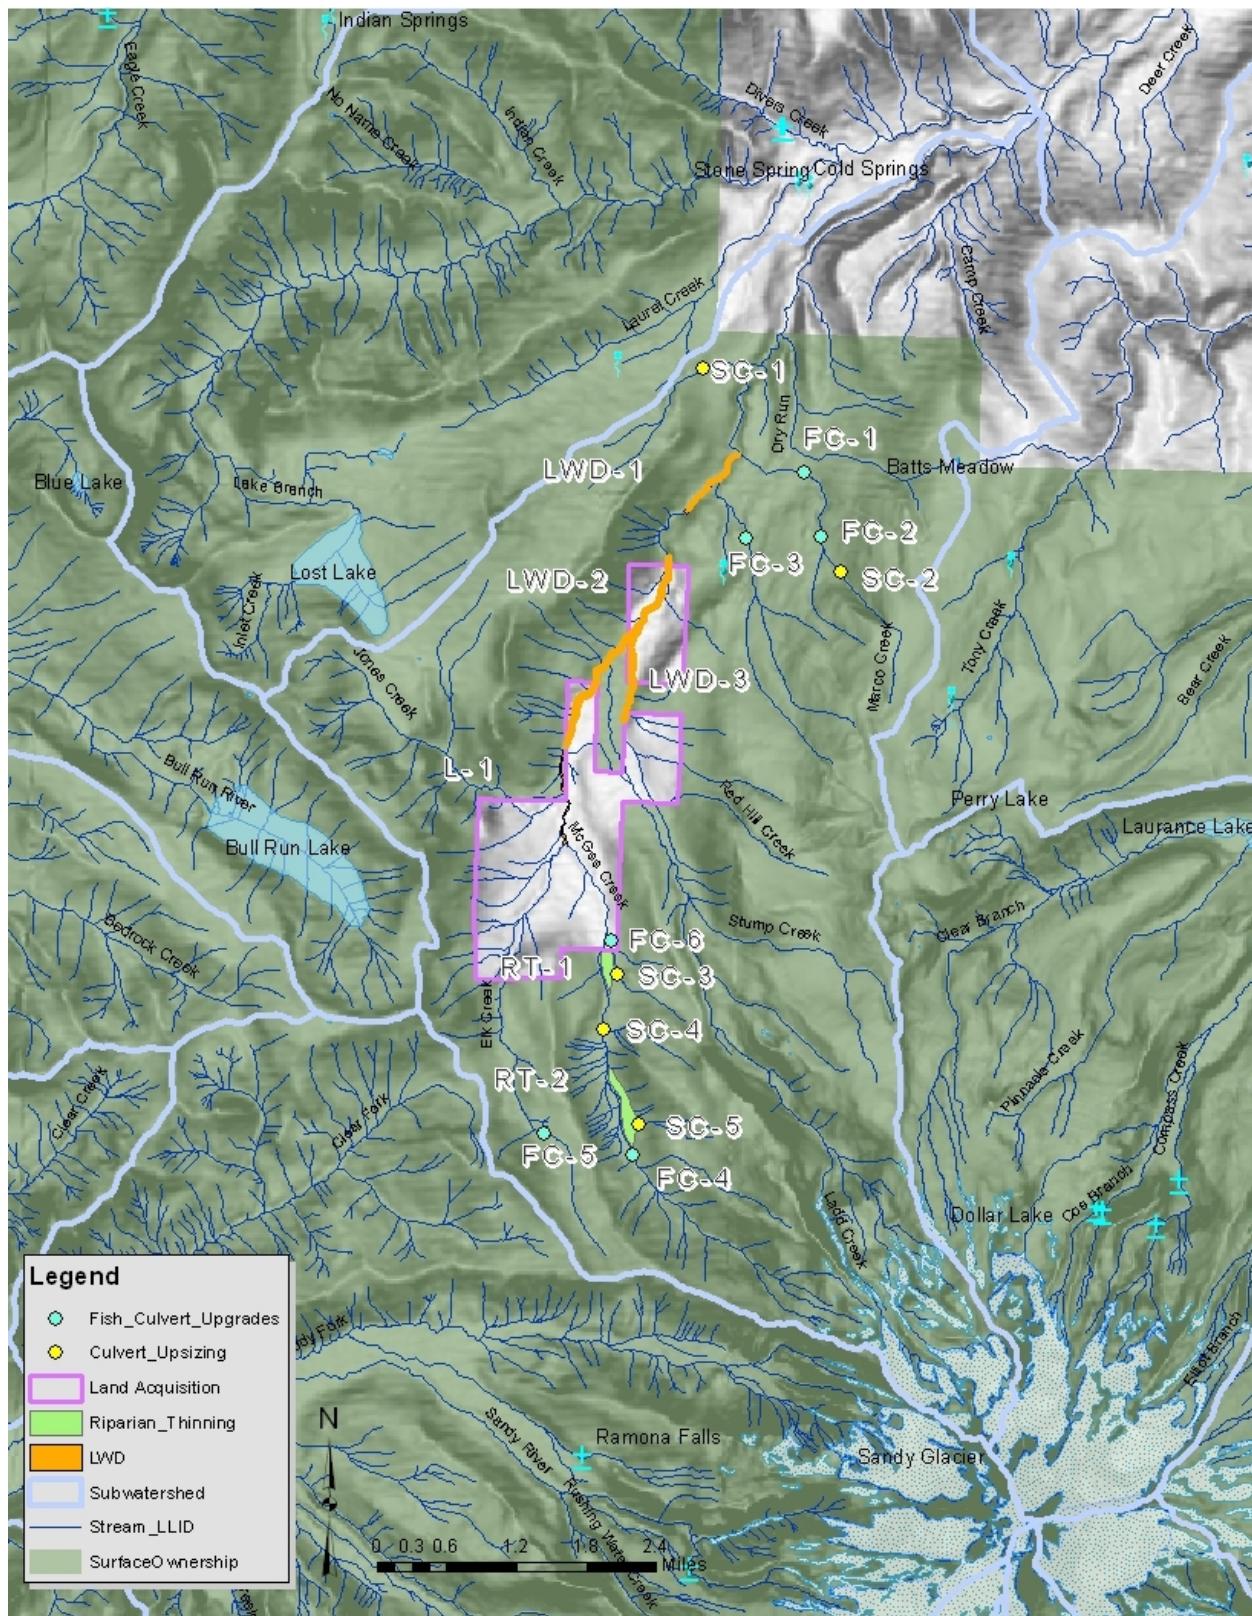
**Figure 8.** Essential project locations within the Upper West Fork Hood River 6<sup>th</sup> field watershed that do not involve road decommissioning/storm-proofing/closure. Invasive plant treatment is not displayed as infestations occur in many locations throughout the watershed.

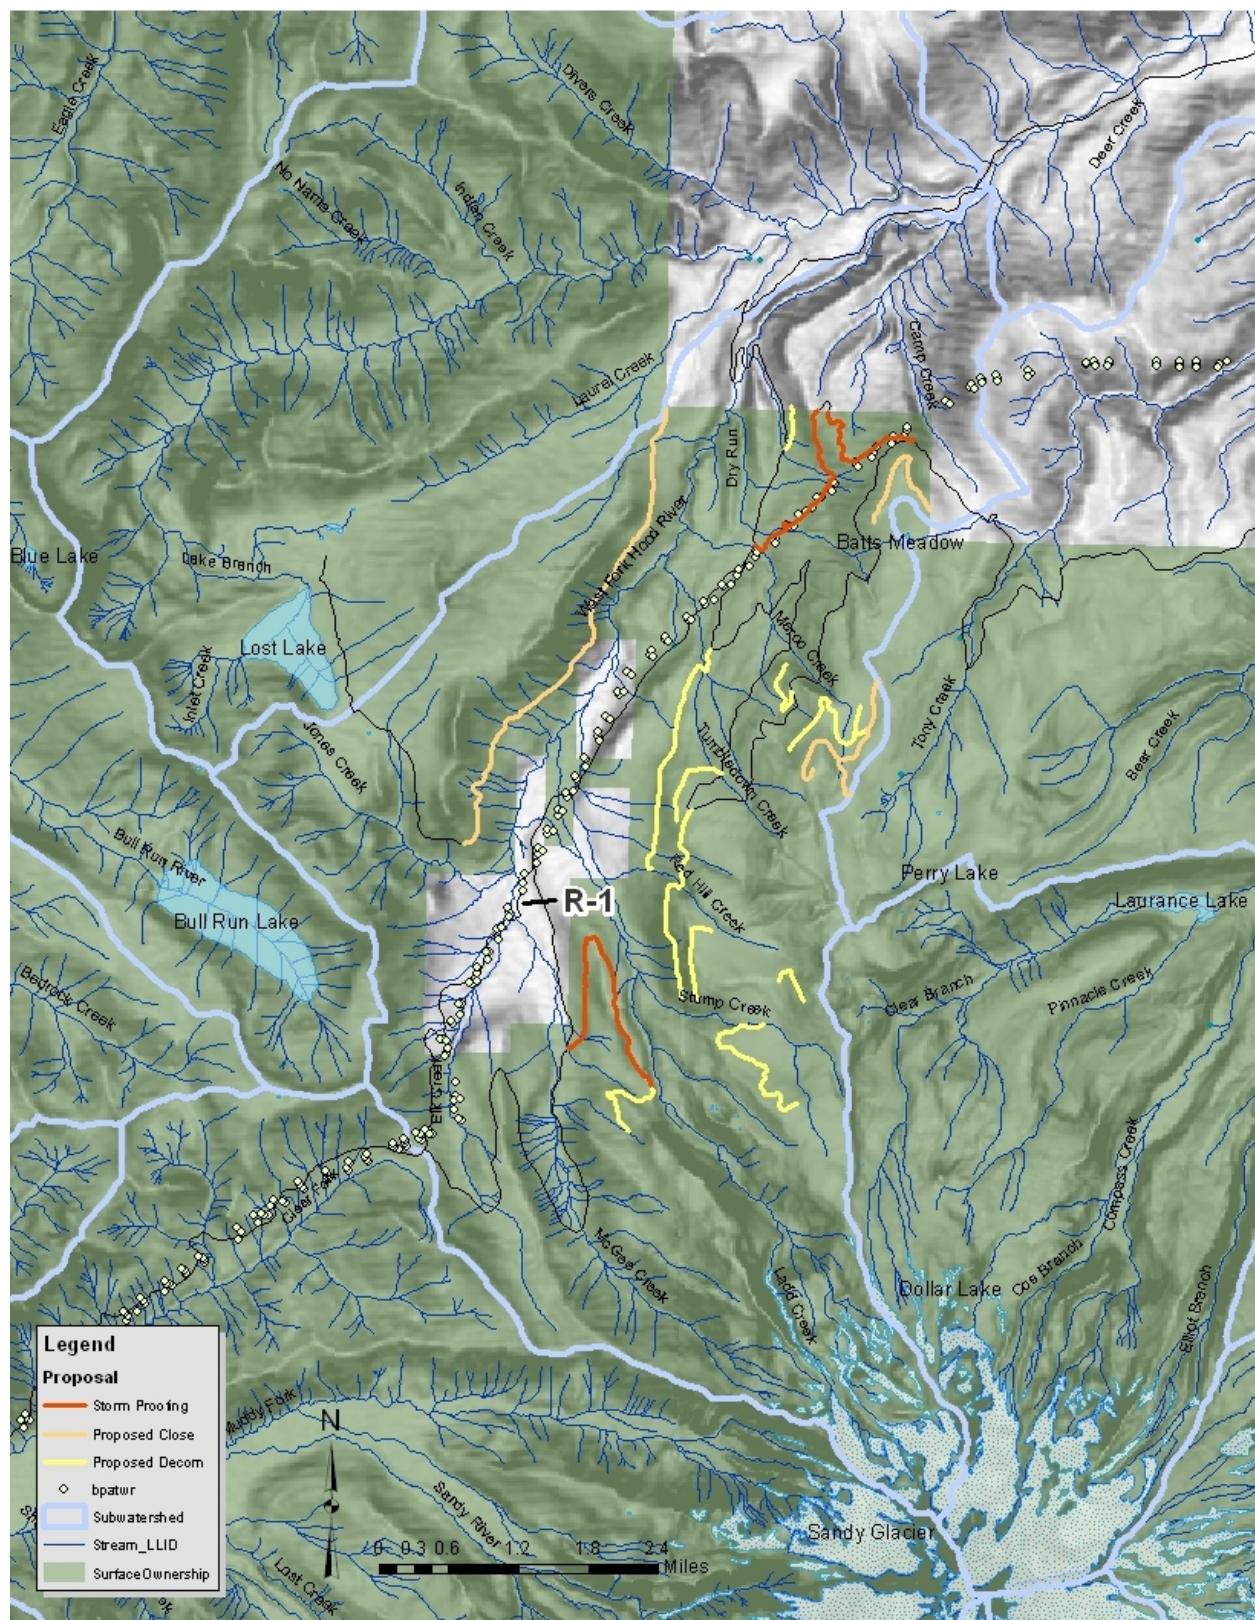
**Figure 9.** Road decommissioning, road storm-proofing, and road closure locations within the Upper West Fork Hood River 6<sup>th</sup> field watershed.
