US Forest Service  
March 2019

# Upper Sandy River Watershed Restoration Action Plan

Mt. Hood National Forest  
Zigzag Ranger District

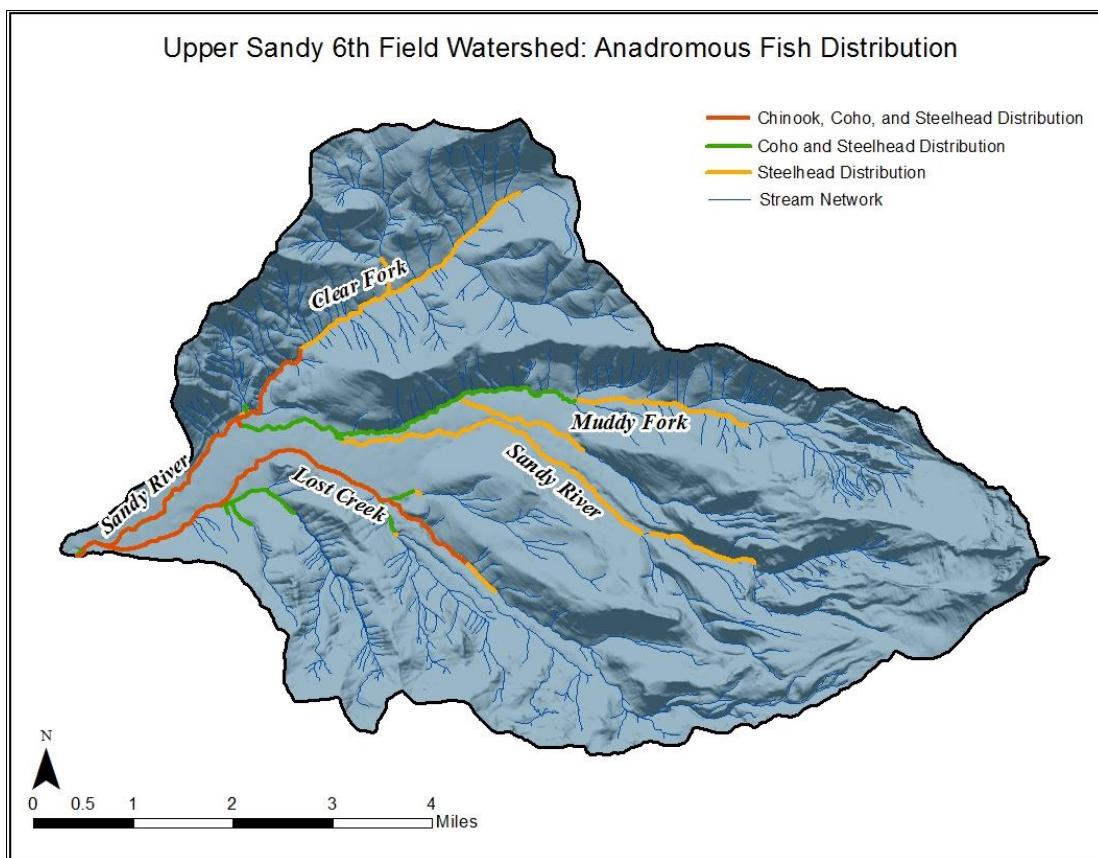
**Figure 4.** Distribution of Anadromous Fish in the Upper Sandy 6<sup>th</sup> Field Watershed. Update in coho distribution in the Clear Fork. Juvenile coho were identified immediately upstream of Gowan Creek in the Clear Fork (August 2018; Wanner, personal communication).

The removal of the Marmot Dam in 2007 by PGE, in collaboration with MHNF and multiple community partners, opened up historic fish habitat in the Upper Sandy watershed. Fish habitat conditions and changes to physical attributes of the stream channel are being monitored by the USFS, PGE, and other partners. The Zigzag Ranger District is involved in the monitoring of salmon smolt (pre and post dam removal) in the upper basin above the formal Marmot Dam site to gain an estimation of annual salmonid production in the upper basin (USDA 2017).

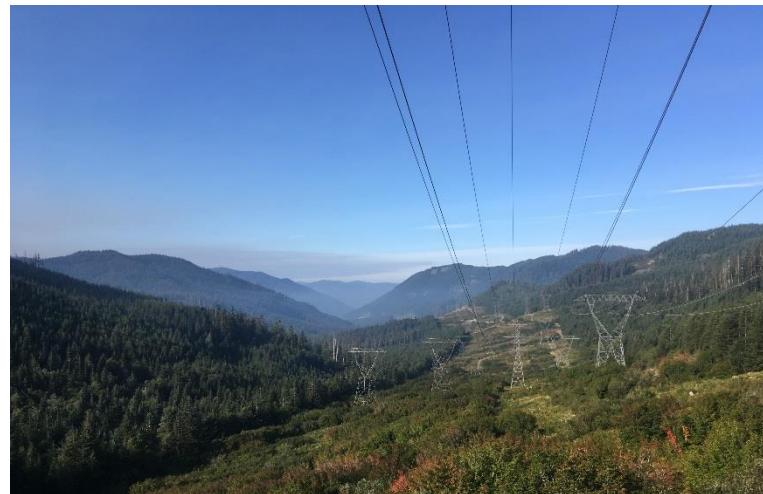
**Figure 5.** BPA right-of-way and powerlines in the Upper Sandy watershed.

The BPA right-of-way crosses through the northwest section of the Upper Sandy watershed and has numerous undocumented access roads (Figure 5). Road densities reported above do not take into account these undocumented access roads. Although the right-of-way is less than 1 percent of the watershed, poorly maintained access roads increase the road density and reduce water quality.

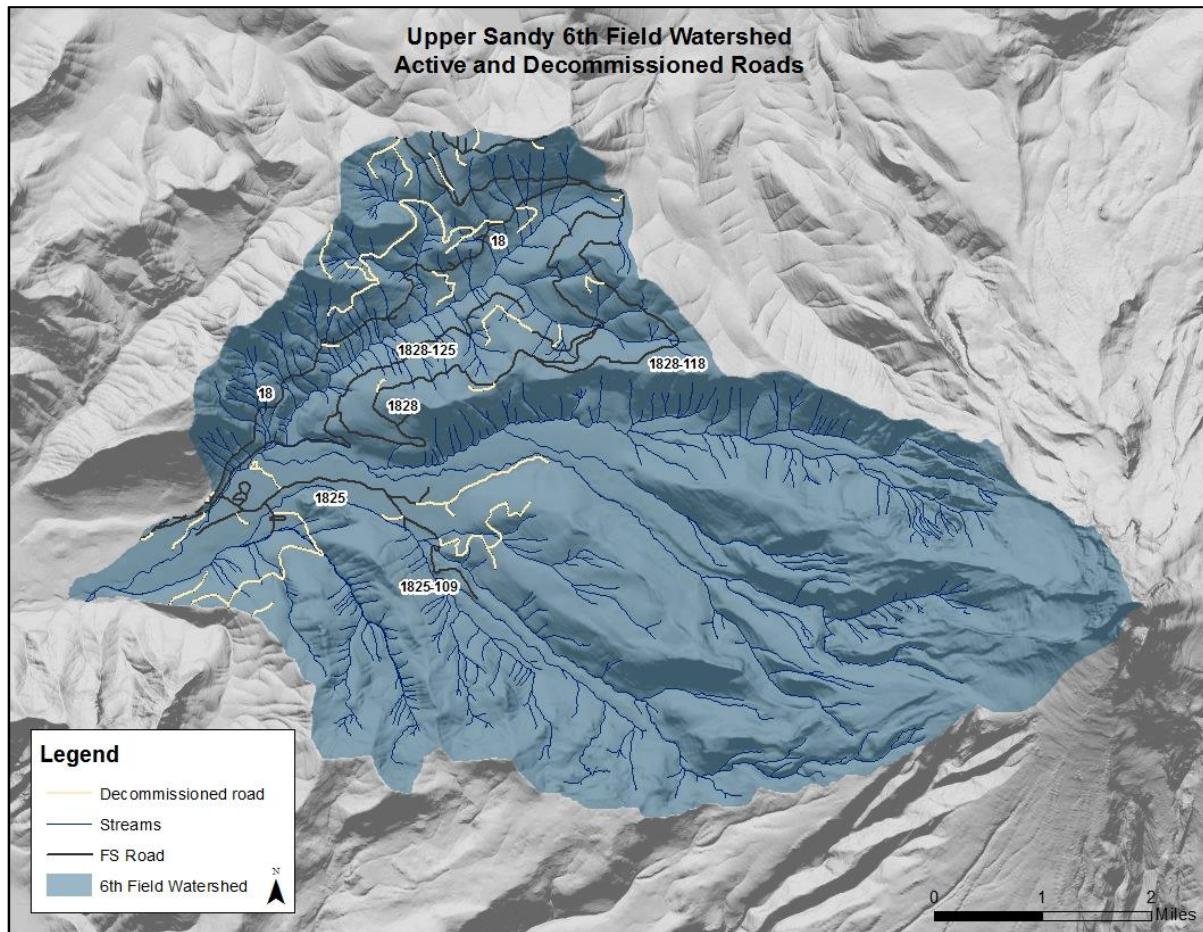
**Figure 6.** Active and decommissioned roads in the Upper Sandy 6<sup>th</sup> field watershed.

While road densities within the subwatershed are 1.4 miles/square mile (30 percent of which are decommissioned), 74 percent of the road network is within 300 feet of streams.

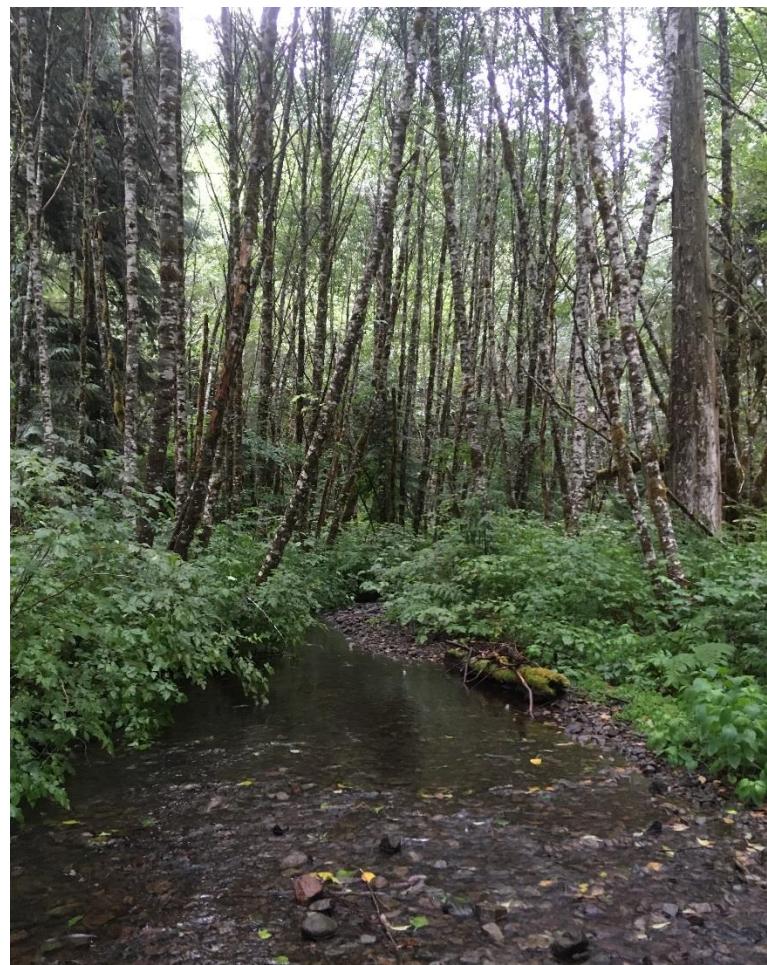
Figure 8. Lost Creek Trib2 hardwood dominant riparian area.

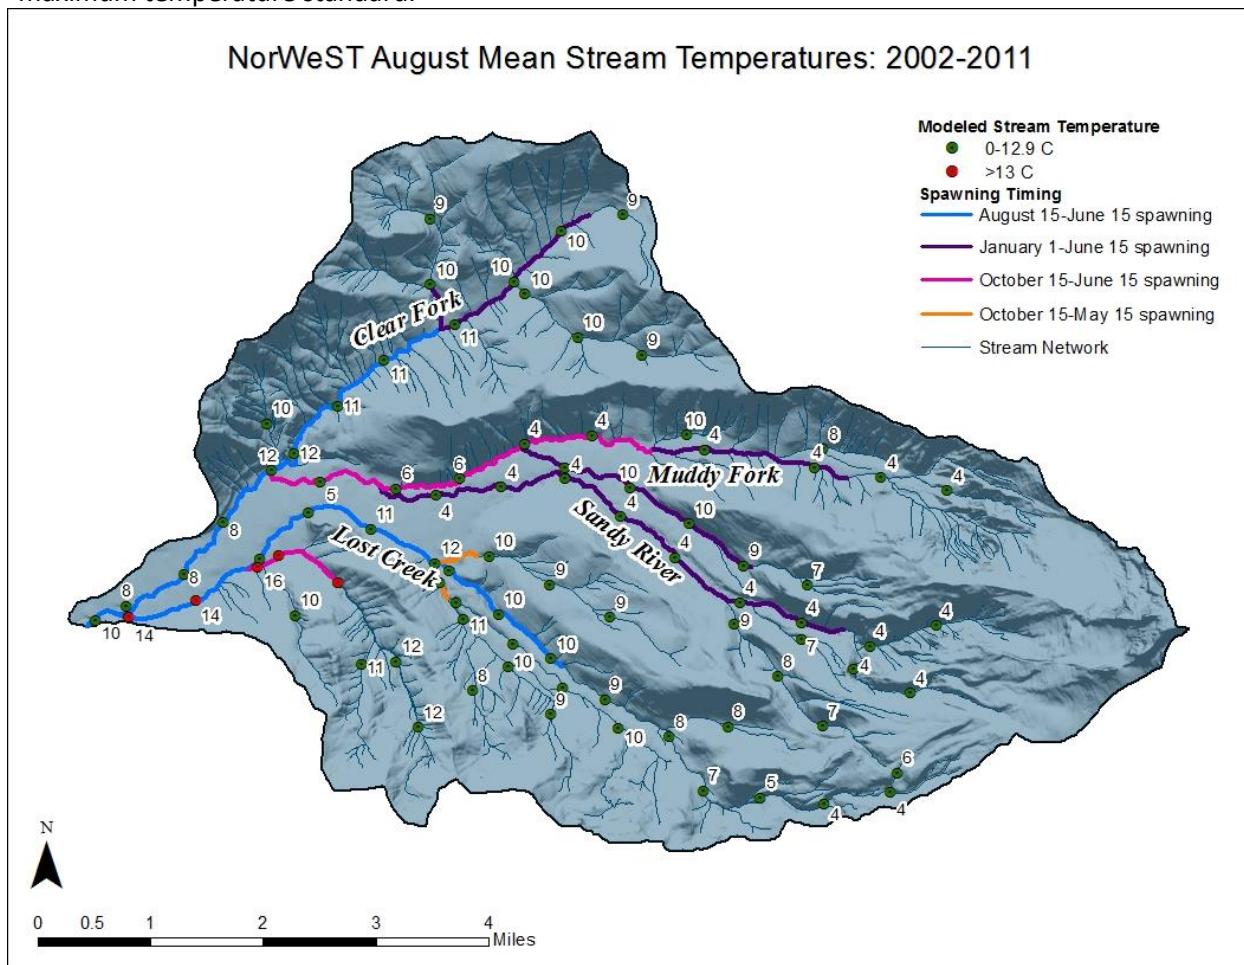
**Figure 9.** The Upper Sandy 6<sup>th</sup> field watershed NorWeST stream temperature scenario for August 2002-2011, with ODEQ spawning use temperature standards.

The composite scenario used for assessment on the Upper Sandy 6<sup>th</sup> field watershed represented the 10 year average August mean stream temperatures from 2002-2011. Oregon Department of Environmental Quality (ODEQ) temperature criteria for fish use in the Upper Sandy basin was used as the threshold of concern (ODEQ, 2003). ODEQ identified the seven-day- average maximum temperature of a stream identified as having salmon and steelhead spawning use at various times of the year. In the Upper Sandy watershed, stream temperature is a concern only during the August 15-June 15 spawning season. The maximum temperature standard is  $13^{\circ}\text{C}$  during these months. As shown in Figure 8, temperatures above  $13^{\circ}\text{C}$  are limited to the lower reaches of Lost Creek and Cast Creek, placing them above the maximum temperature standard.

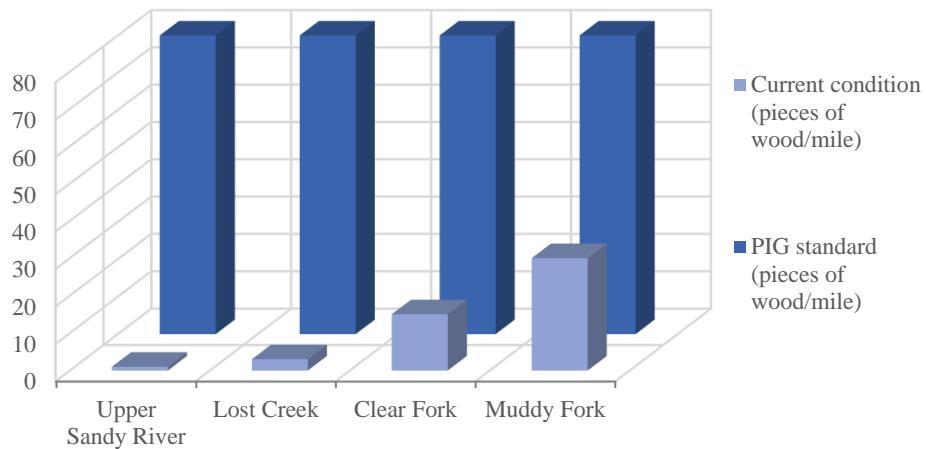
**Figure 10.** Current condition of Upper Sandy watershed streams compared to the PIG standard.

Large woody debris (LWD) provides pool structure, sediment storage, substrate, channel roughness, and velocity refuge for biota. The Upper Sandy River and tributaries have a history of large wood removal and channel straightening and thus is well below the 80 pieces per mile (large sized) PIG standard, as depicted in Figure 9 (USDA 1996).

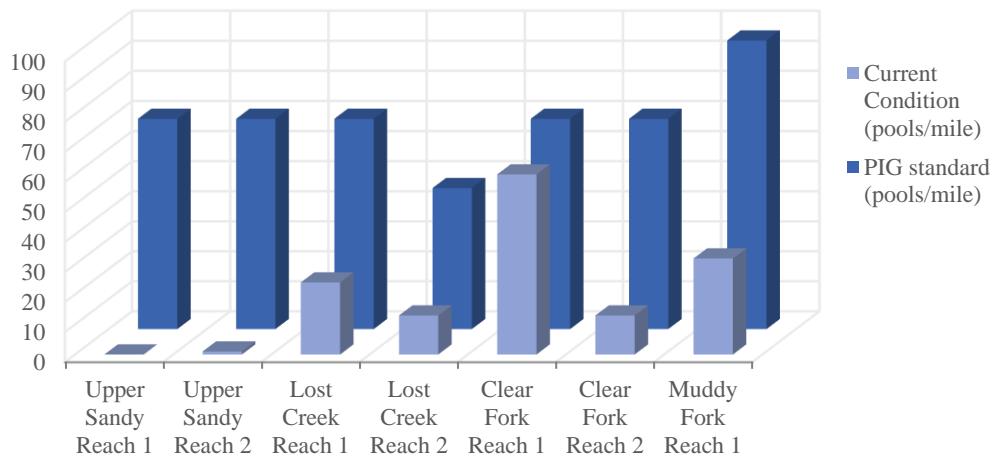
**Figure 11.** Existing pools per mile for the Upper Sandy River, Lost Creek, Clear Fork, and Muddy Fork compared to the PIG standard based on stream size.

Frequency of pools for most reaches of the Upper Sandy and its tributaries are well below the range or natural variation and LRMP standards (USDA 1996). The number of pools per mile compared with the Columbia River Basin Project Implementation Guide (PIG) standards is depicted in Figure 10.
