United States
Department of
Agriculture

Still Creek Watershed Restoration Action Plan

**Mt. Hood National Forest
Zigzag Ranger District**

September 2011

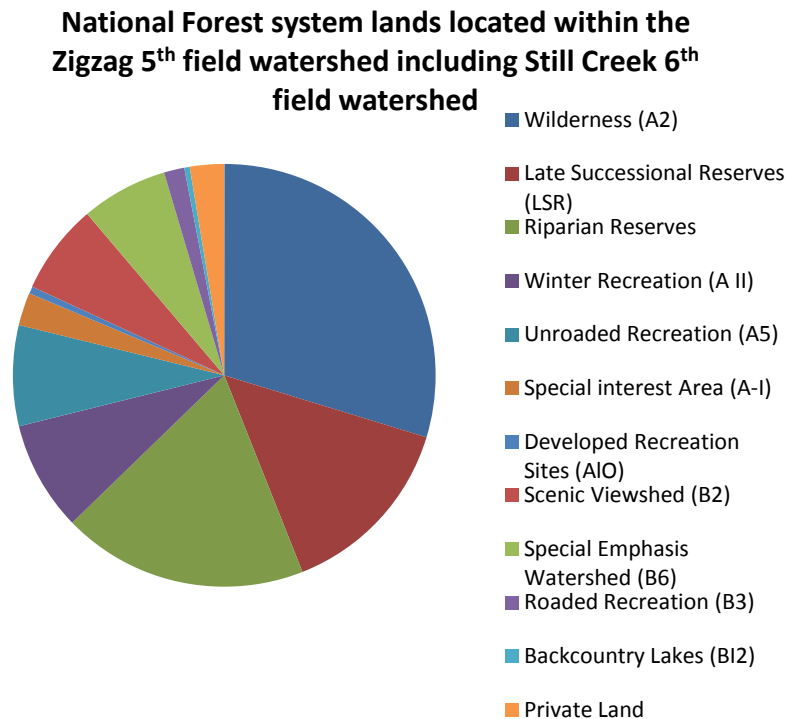
Figure 3. Mt. Hood National Forest LRMP Land Allocations within the Zigzag River 5th field watershed including Still Creek 6th field watershed.

Land Allocations	Acres in Allocation
Wilderness (A2)	11,216
Late Successional Reserves (LSR)	5,375
Riparian Reserves	7,082
Winter Recreation (A II)	3,165
Unroaded Recreation (A5)	2,901
Special interest Area (A-I)	951
Developed Recreation Sites (AIO)	205
Scenic Viewshed (B2)	2,612
Special Emphasis Watershed (B6)	2,491
Roaded Recreation (B3)	588
Backcountry Lakes (BI2)	156
Private Land	988
Total acres	37,730

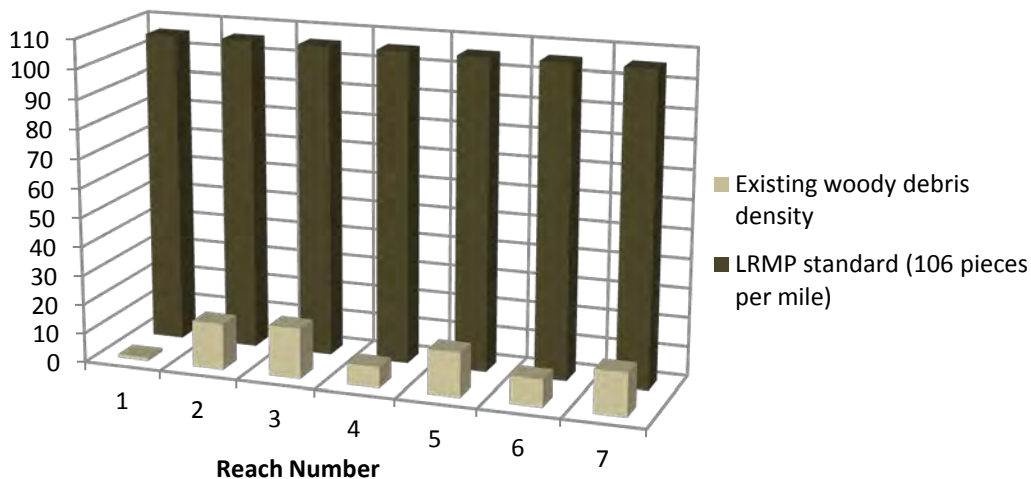
Figure 4. Comparison of existing large wood density with LRMP standards.

Large wood density within Still Creek is below the Mt. Hood National Forest Land and Resource Management Plan (LRMP) (USDA 1990) standards of 106 medium and large pieces per mile. See Figure 4.
