Willamette, Mt. Hood, and Deschutes National Forests Burned Area Emergency Response Summary – Lionshead Fire

October 21, 2020

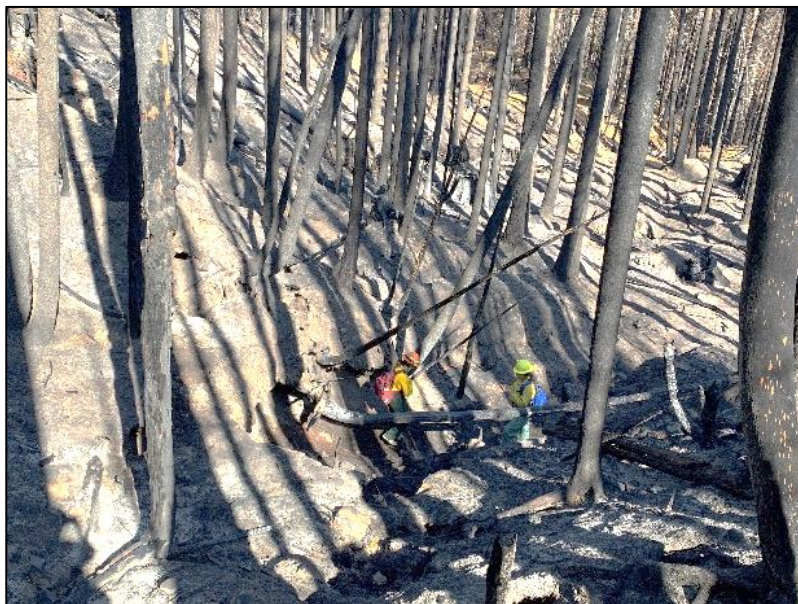
Figure 1 - High soil burn severity surrounding intermittent channel and culvert on Forest Road 1003

treatments include modifying 34 culverts, installing 3 armored dips, strengthening drainage on 21 miles of road for storm proofing, and performing inspections on roads after storms. We also recommend sites for 24 road hazard signs, and on 12 additional roads that had unsafe, limited or no access, road closure is the recommended treatment. The Hwy 46 corridor (Breitenbush River corridor) also had approximately 7,000 feet of guardrail that was either damaged or destroyed and that will need to be replaced.

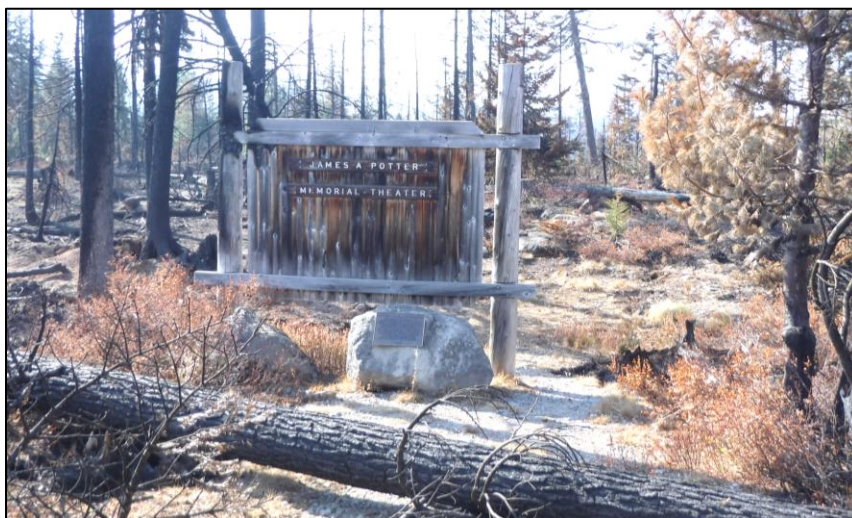
Figure 2 - Burned recreation site, the James Potter Memorial Theater

For the area within the fire perimeter we are suggesting restricting public access until the proper hazard tree mitigation has been completed. Areas that the public will be able to access outside of road closures will be posted with warning signs and hazard trees removed. Every location with restrictions in road access will be closed for the winter and will be reassessed in the spring.

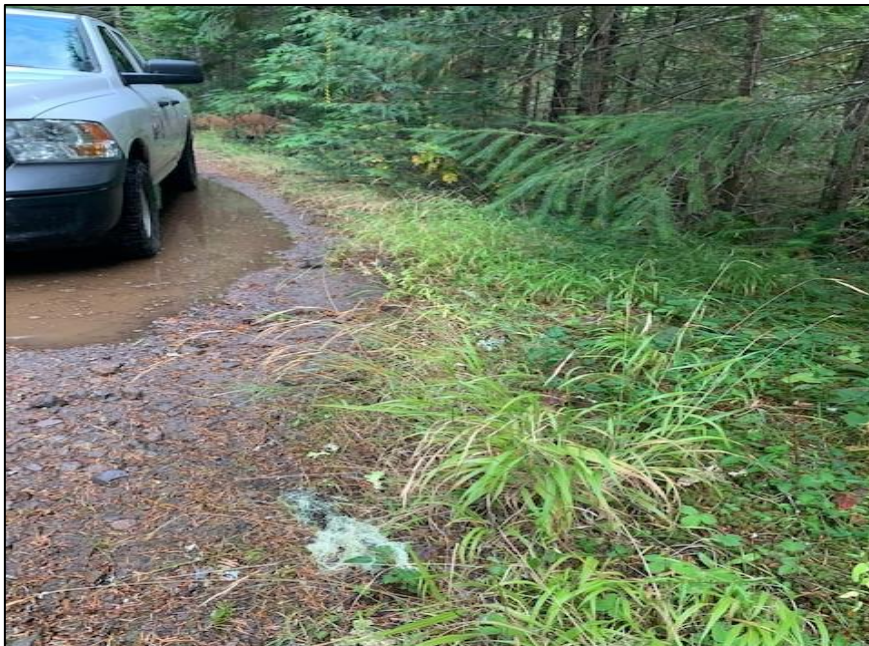
Figure 3 - False Brome along Forest Service Road 2234

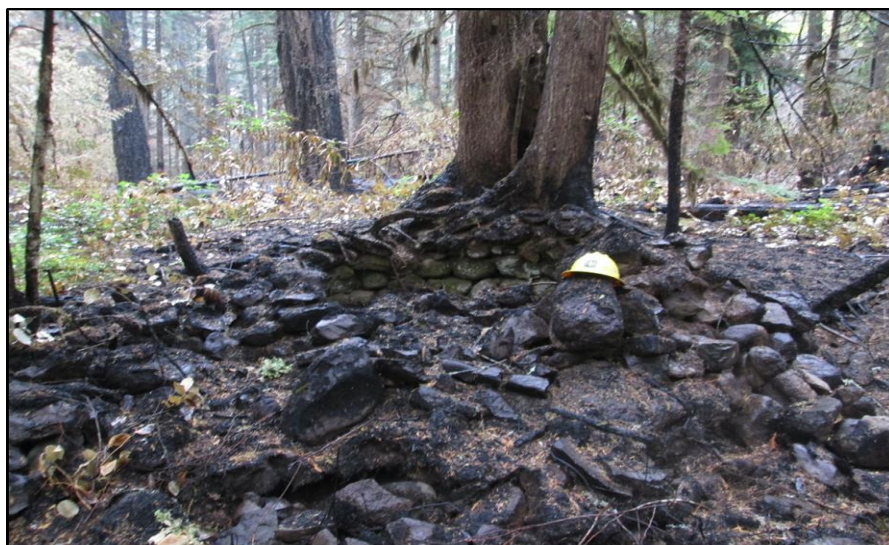
Figure 4 - Remains of an oven feature from a 19th century railroad camp
