# In-Stream Restoration

Prince of Wales Ranger District

Ellyn Rickels, Hydrologist  
POWLLA Public Workshop (virtual)  
November 13, 2021

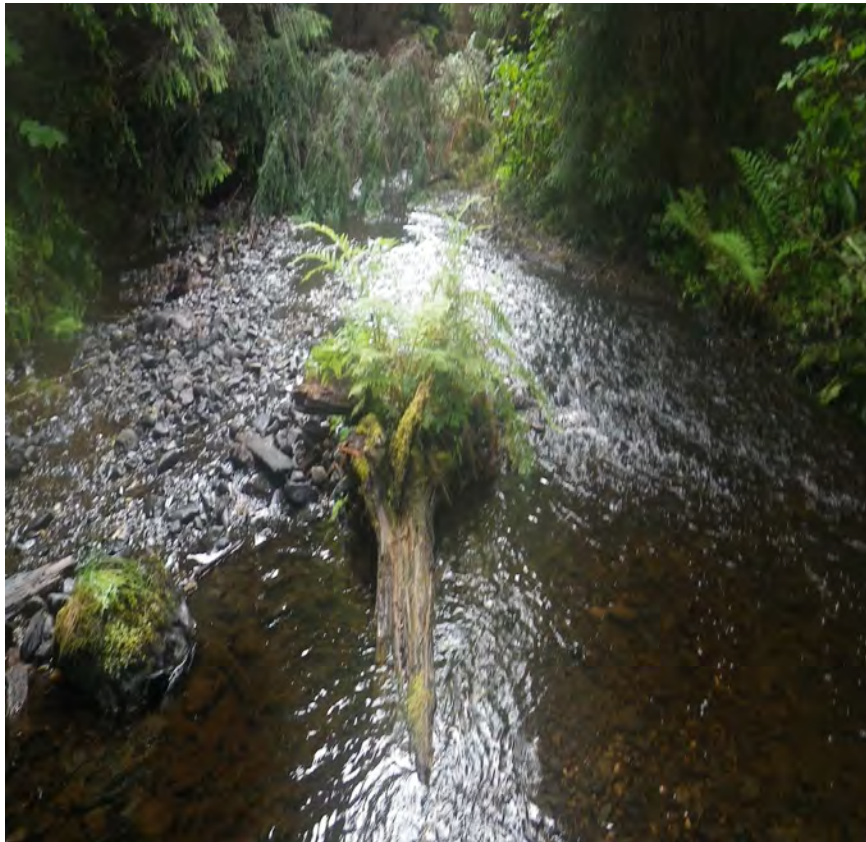
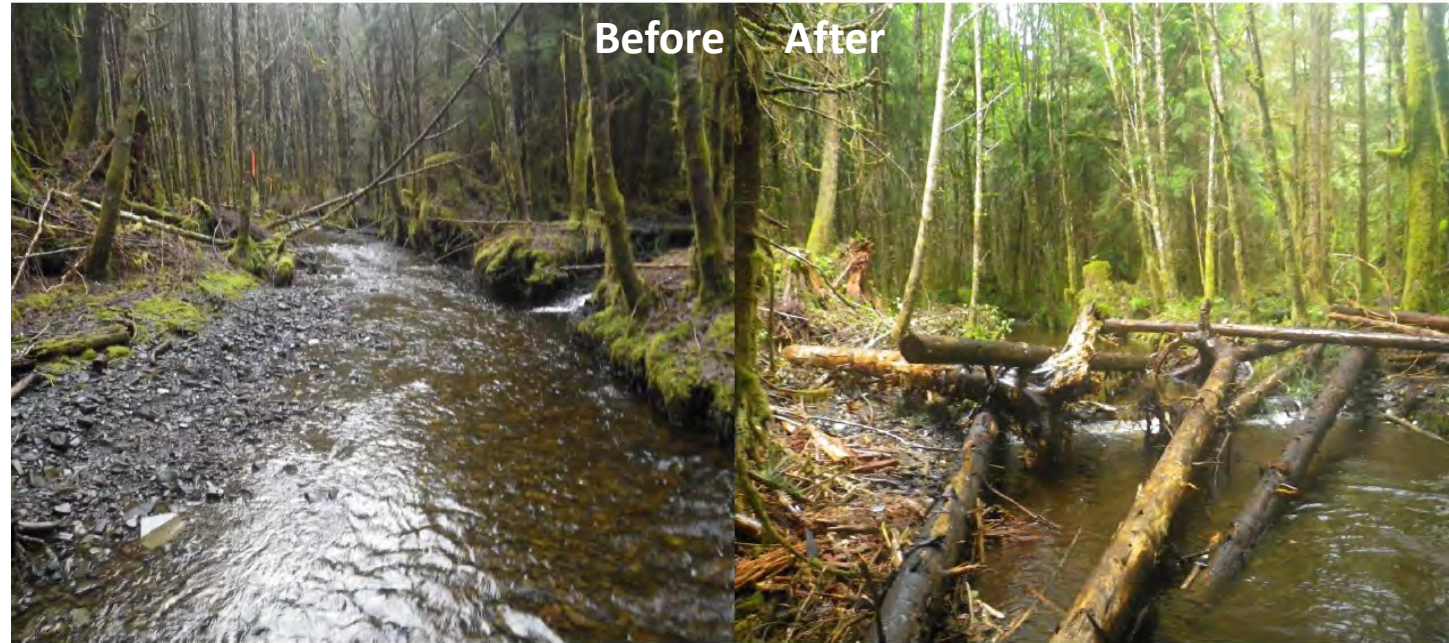
What is the function of large wood in streams?

- Stabilizes banks
- Creates complex channel structure and habitat
- Stores sediment
- Provides cover and deep pool habitat
- Dissipates energy during floods
- Traps and holds nutrients

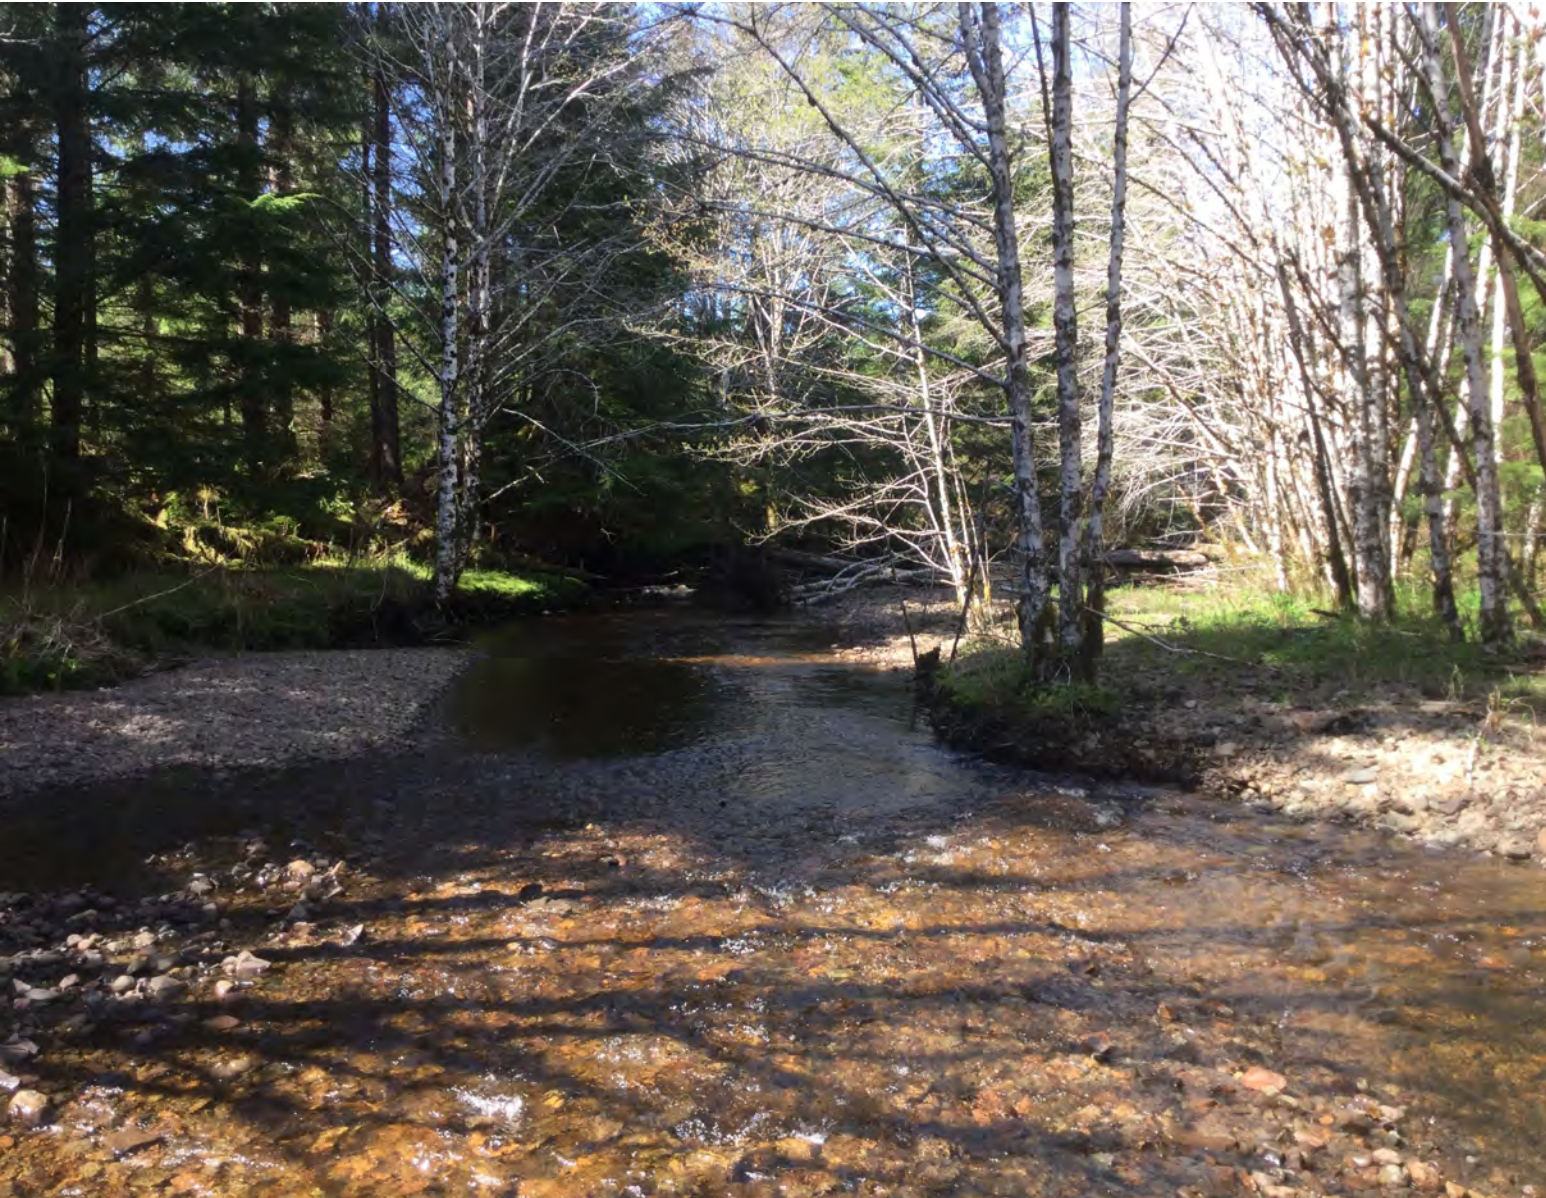
What happens to the channel when wood is removed?

- Less complex morphology
  - Reduced depth, width, sediment variability, and pool area
  - Increases in water velocity
  - Decreased sinuosity
  - Decreased pool depth
- Simpler, less diverse channels

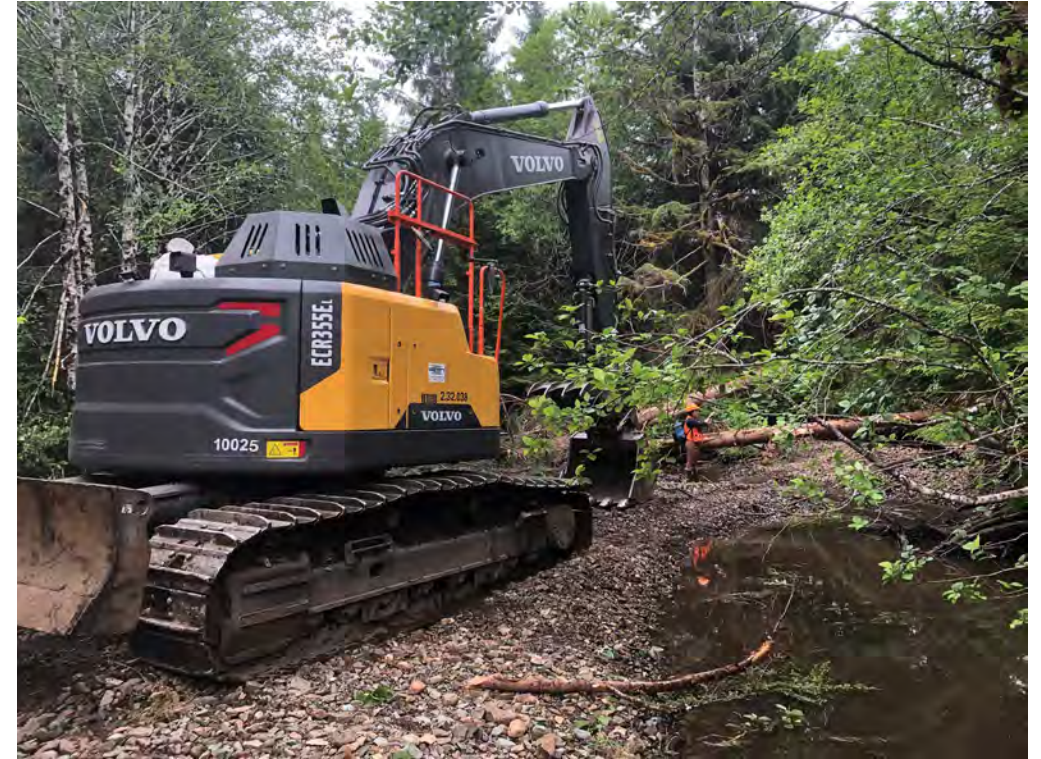
# Nahania Creek

Implementation Summer 2021

0.32 stream miles

100 root wad trees

7 logjam sites

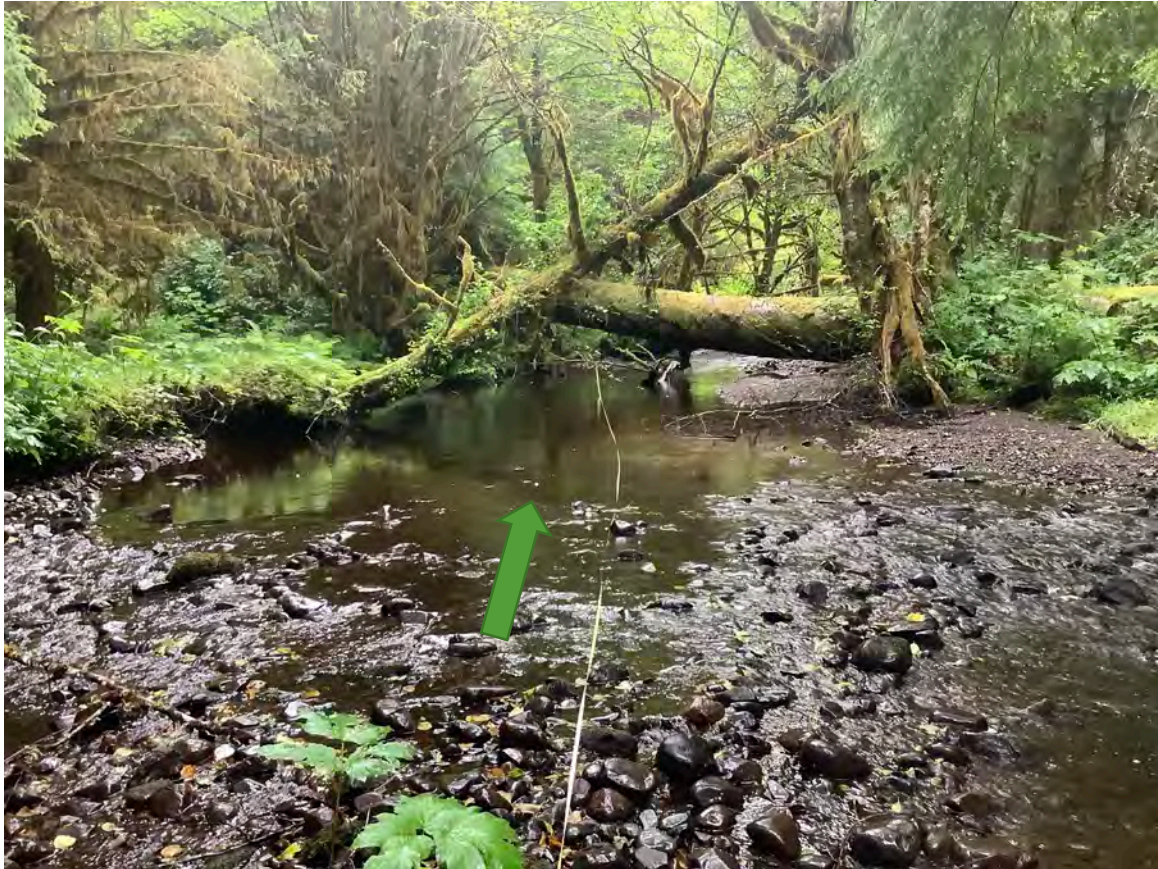
# Shaheen Reach SF2

Site 2: Place 5 rootwad trees as channel-spanning porous jam. Lock trees around twin alders on left bank and existing wood on right bank, with some tips extending across left bank floodplain. Place 1 rootwad tree parallel to left bank with root fan hooked onto existing stump.
