# Draft Watershed Condition and Water Resource Assessment

## Tongass National Forest Plan Revision

December 2024

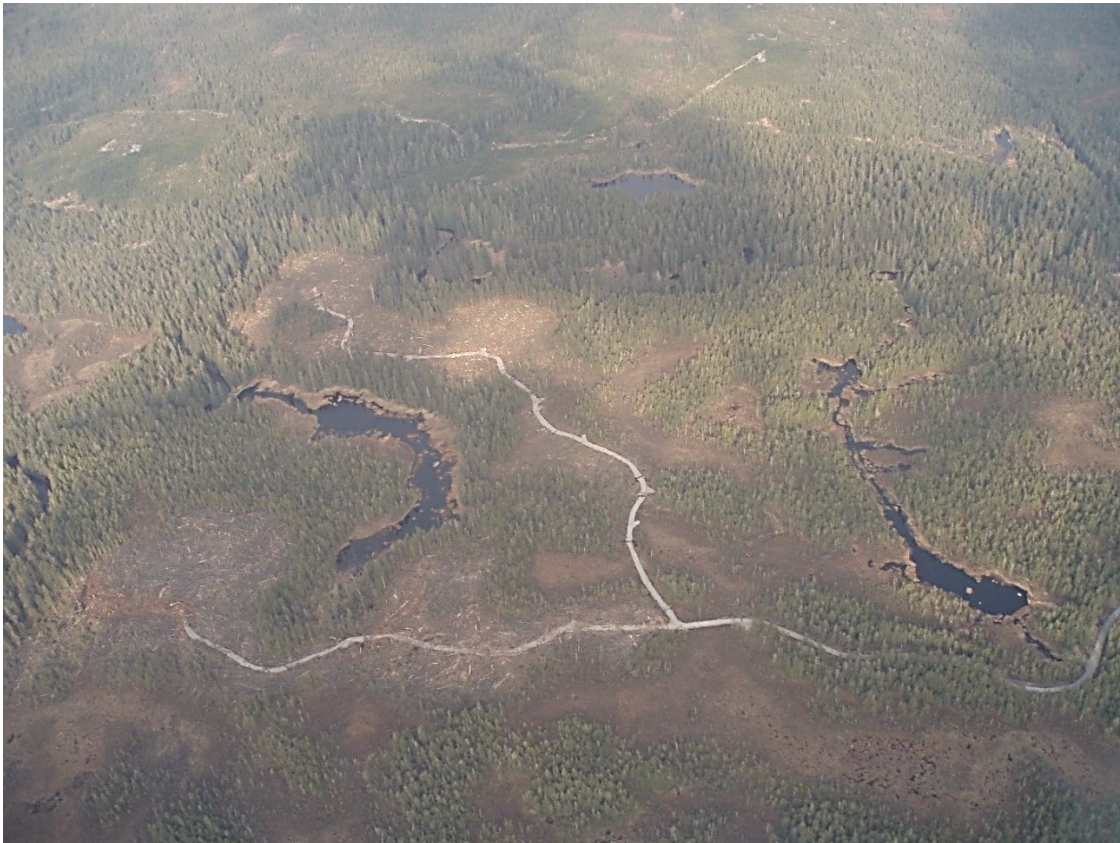
Figure 1. Example of Tongass Timber Reform Act buffers applied to a timber sale. The greener, treed areas around the lakes and stream channels show where the trees were not harvested, in order to provide the required buffers. The lighter brown areas show where trees were harvested. Photo credit to Emil Tucker.

The Tongass Timber Reform Act (16 U.S.C. 539d) prohibits commercial harvest within one hundred feet on each side of all Class I streams, and Class II streams that flow directly into a Class I stream (see Figure 1 for an illustration).

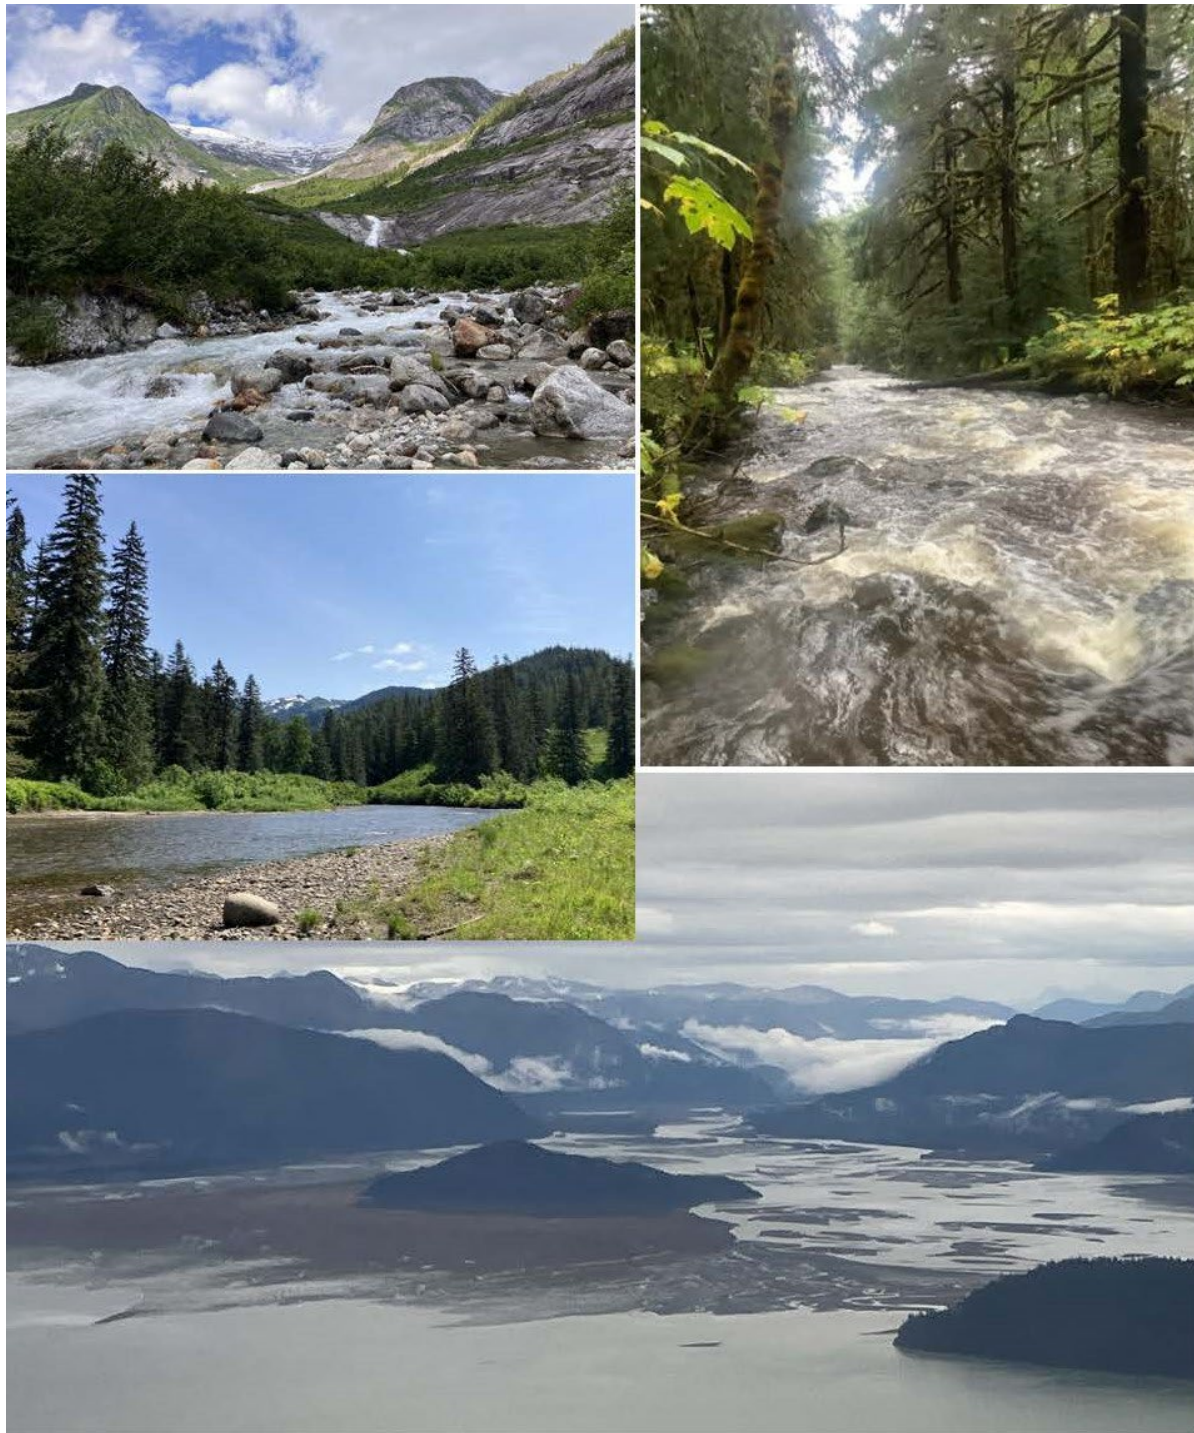
Figure 3. Photo collage of a selection of process groups. Upper left - high gradient contained process group. Upper right - moderate gradient mixed control process group. Middle left - floodplain process group. Lower - estuarine process group. Photo credit to Emil Tucker.

Existing riparian management area standards and guidelines use channel types and process groups to guide land management activities and predict the effects of those activities along streams and rivers. Fifty channel types are grouped into nine stream process groups. Over 60 percent of the mapped stream miles are within the high gradient contained process group (USDA 2016b). Figure 2 shows the typical distribution of process groups. Photos of select process groups are shown in Figure 3.

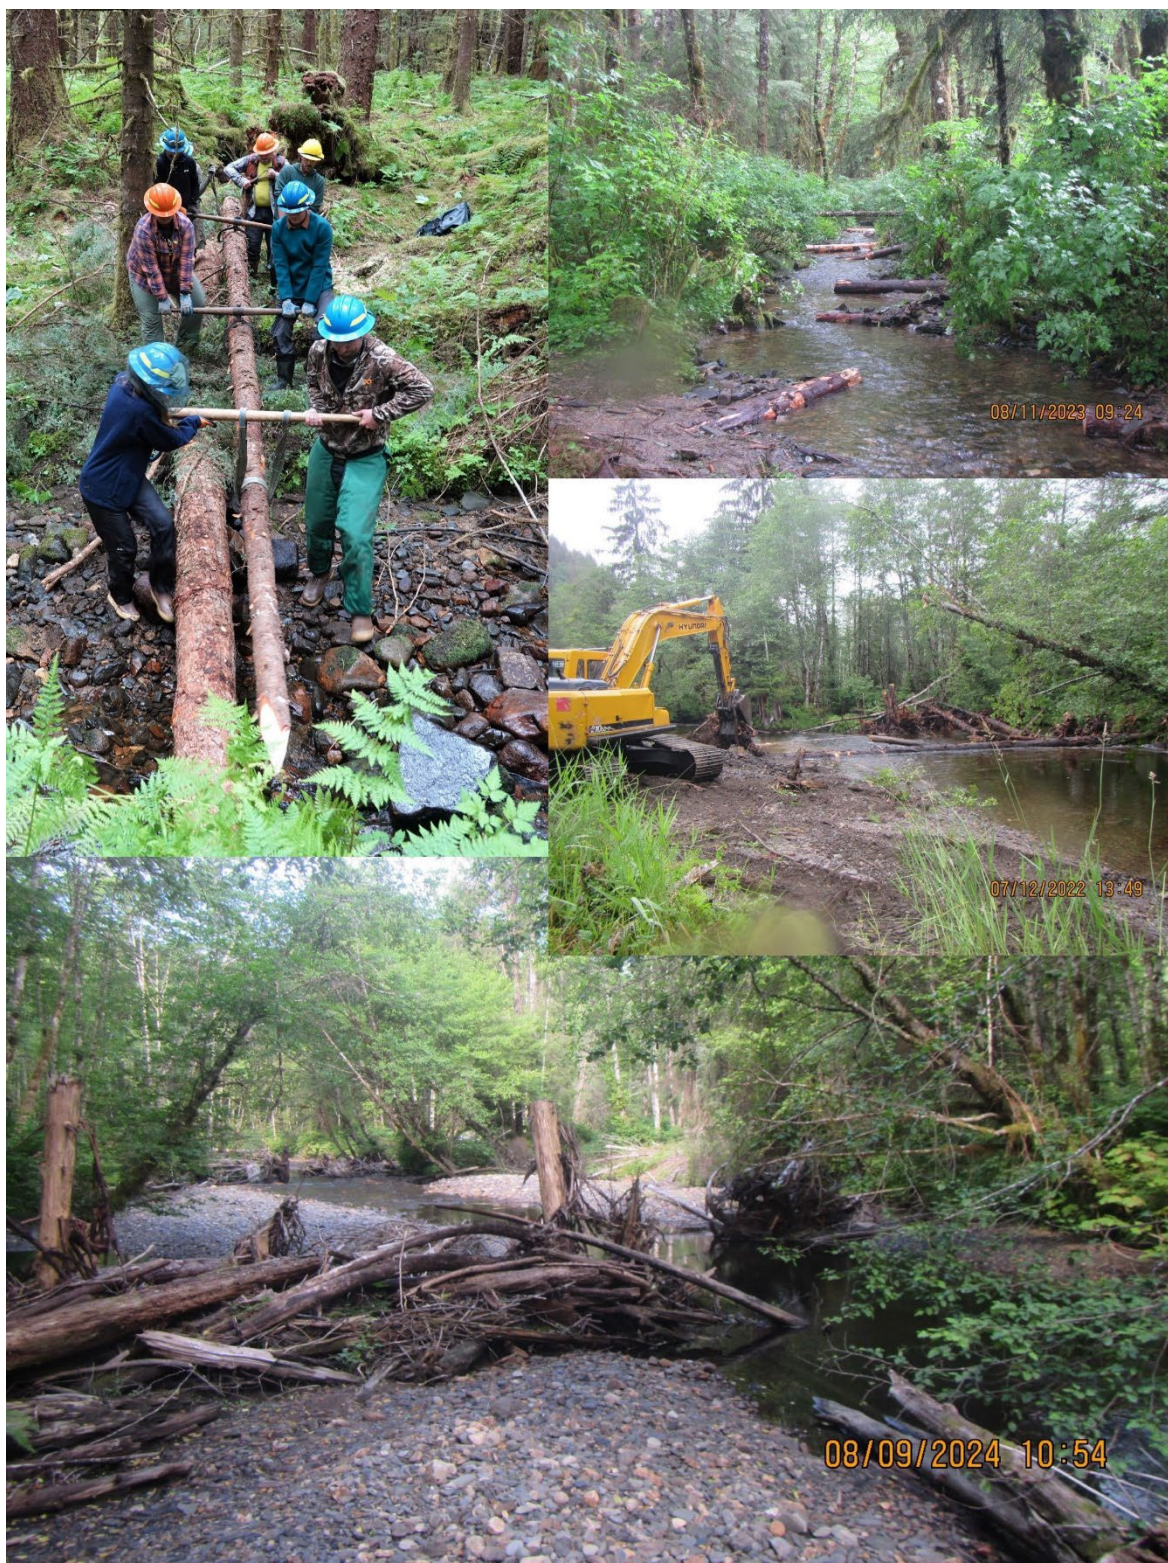
Figure 12. Photo collage of aquatic habitat improvement projects. Upper left: hand crew working on stream restoration in Sprout Creek of the Margaret Creek priority watershed. Upper right: completed hand crew stream restoration in Last Chance Creek. Middle right: excavator working on stream restoration in the Margaret Creek priority watershed. Bottom: completed stream restoration work in the Margaret Creek priority watershed. Photo credit Jonathan Hyde.

The Watershed Improvement Tracking (WIT) database includes aquatic, riparian, and road improvement projects both within and outside of priority watersheds. Nearly 80 miles of stream restoration has occurred on the Tongass National Forest since 1999 at an average of 3 miles per year (Figure 11). Since 2017, the annual average has declined to 1.5 miles. This decline is due to completing the highest priority projects initially resulting in fewer miles completed in recent years. Most aquatic restoration projects focused on increasing large wood in the channel (73 percent), with the remainder focused on stream channel reconnection, modification, reconstruction, and stabilization projects. Figure 12 is a photo collage of aquatic habitat improvement projects.
