# Wind River

## Watershed Analysis (Second Iteration)

*Mt. Adams Ranger District  
December 2001*

# Wind River Watershed Analysis— Second Iteration

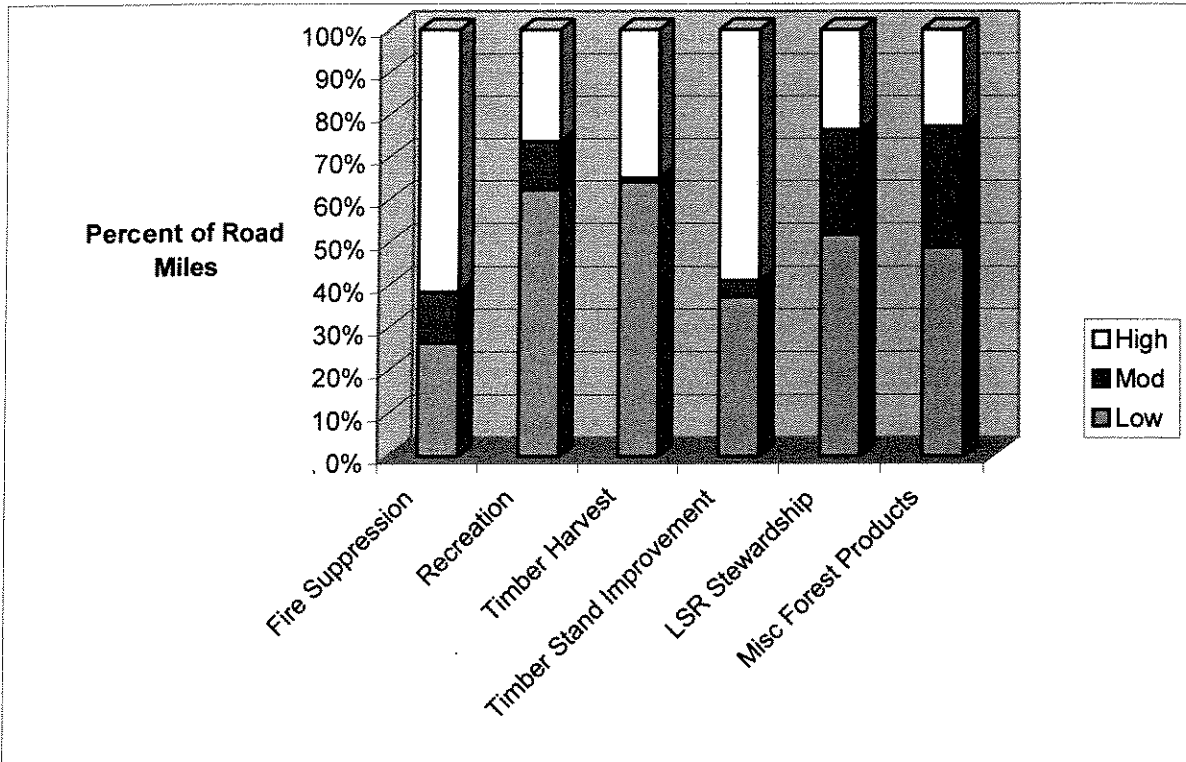
Figure RA-1 summarizes the results of the evaluations done for road uses.

Figure RA-1. Summary of road evaluations conducted for six major road use categories.

- With respect to timber stand improvement, over one half of the roads (59%) were found to be essential for providing access to forest stands needing some form of improvement work.

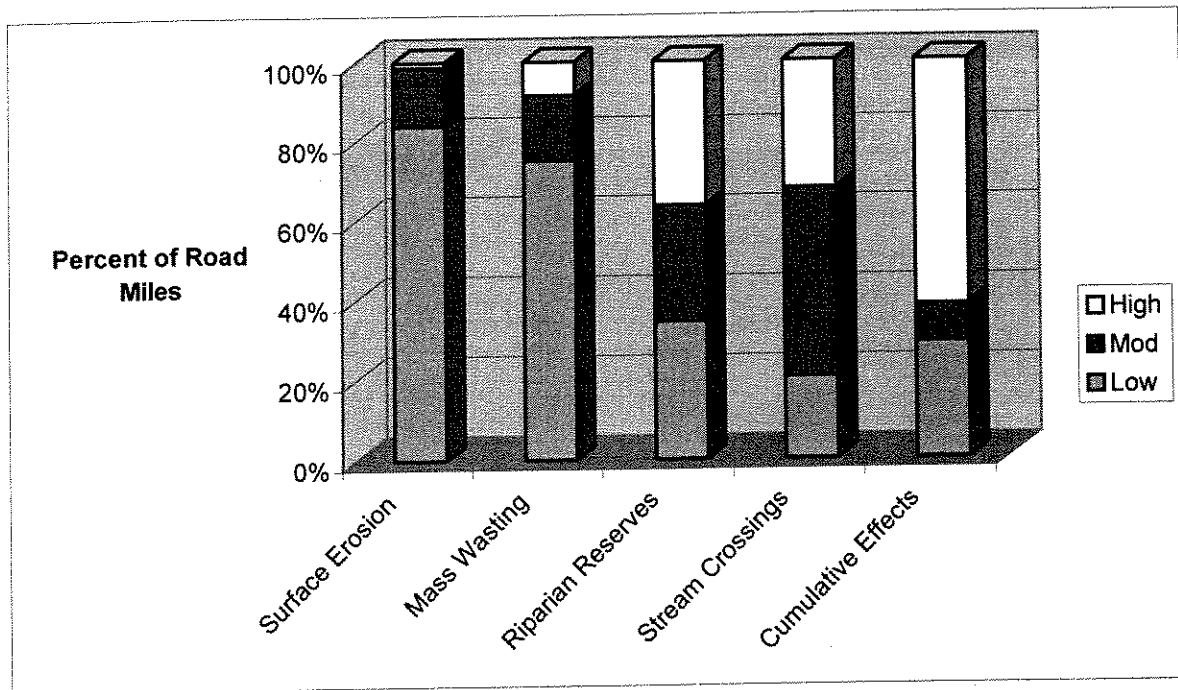
Figure RA-4. Summary of road segment evaluations by issue: **Aquatic Impacts and Risk**

- A relatively small share of the roads (8%) are identified as having a high risk of failure due to slope stability in this watershed. This reflects the relatively stable landforms found in the watershed.

- Evaluation of riparian areas found that 35% of the roads had a relatively low impact to Riparian Reserves, 29% were moderate, and 36% had a high impact.

- Evaluations for stream crossings found 20% of the roads had a relatively low impact, 47% were moderate, and 33% were rated high.
- Nearly two thirds of the roads in the watershed (64%) are in subwatersheds where there is a relatively high potential for cumulative effects from the combination of high road densities and past timber harvest. In contrast, only 30% of the subwatersheds in the Wind River are rated as having a high risk of cumulative effect impacts to streamflows. This indicates that nearly two thirds of the roads in the watershed lie in under one third of the watershed area.

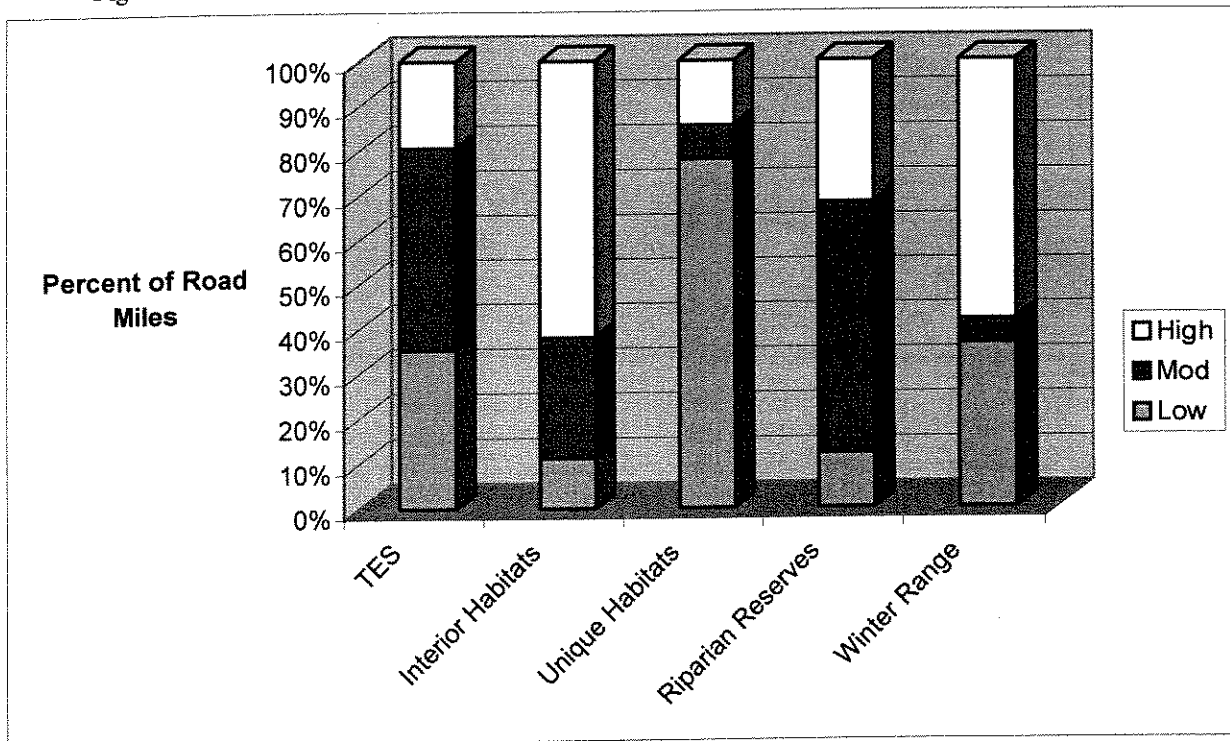
- Figure RA-5 summarizes the results of evaluations done to assess terrestrial habitat impacts.

Figure RA-5. Summary of road segment evaluations by issue: **Terrestrial Habitats**

- Nearly one fifth, or 19% of the roads pose a high risk to Threatened and Endangered Species
- The greatest share of road impacts to terrestrial habitats occur in interior habitats and winter range:
  - 63% of the roads were found to have a high impact to interior habitats;
  - 60% were rated as having a high impact to winter range.
- Approximately one third (32%) of the roads have a high impact to Riparian Reserves.
- Just 14% of the roads have a high impact to unique habitats, possibly reflecting the limited numbers of these habitats in the watershed

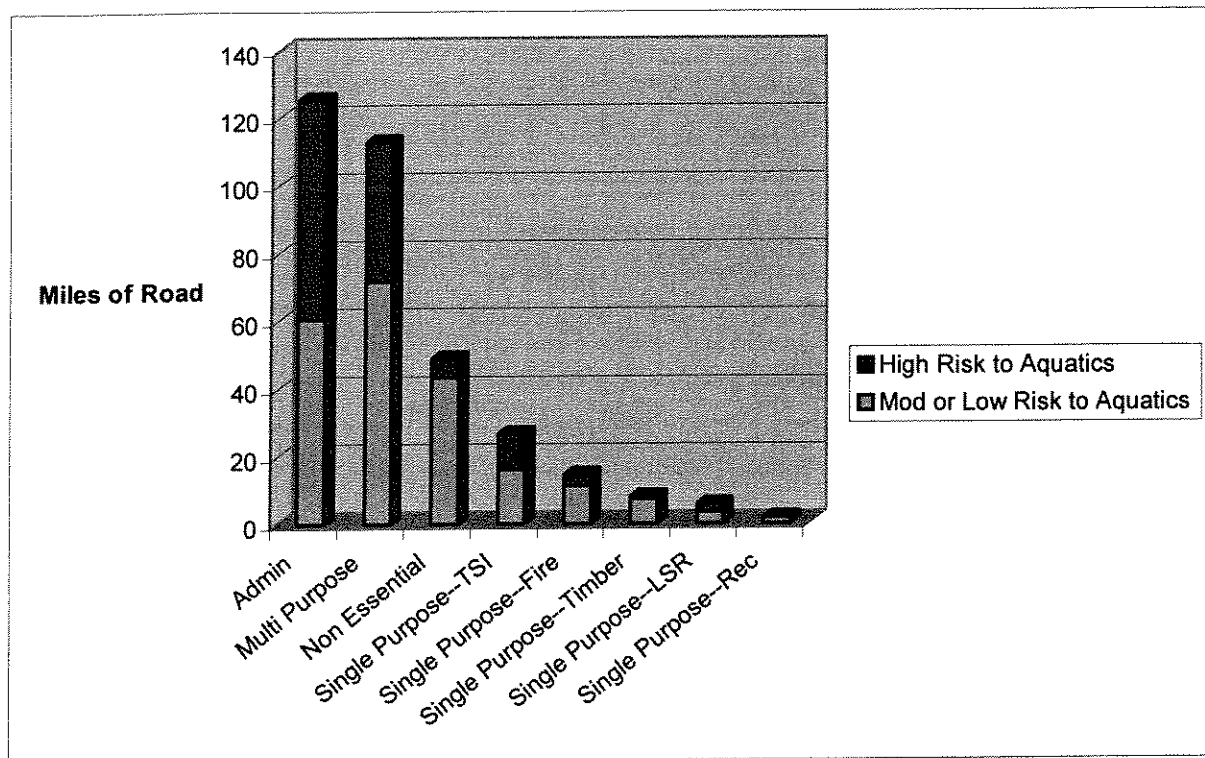
- Combining the road use class and the aquatic impact scores across all road segments yields the data summarized in Figures RA-5 and RA-6.

Figure RA-5. Miles of road in road use classes, with high impact aquatic roads highlighted.

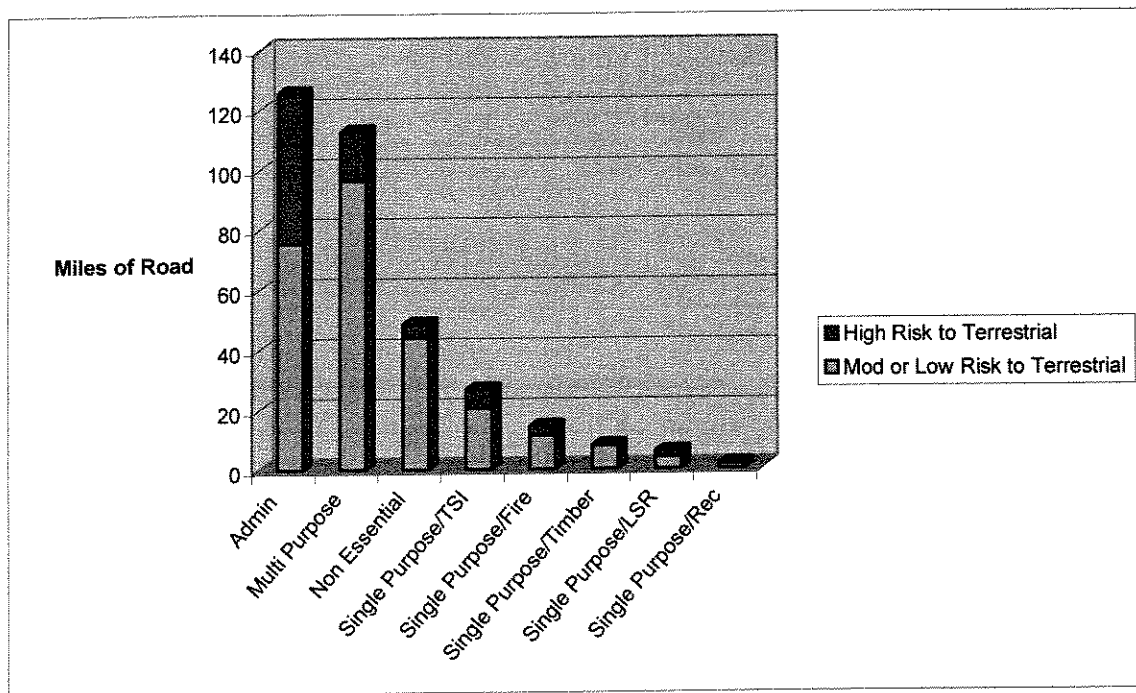
- Single purpose roads that are to be maintained on the system indefinitely could be either upgraded, stormproofed, and/or closed to traffic to reduce the aquatic impacts. If the single purpose of a road is to allow one functional area to accomplish work, then that functional area could be held responsible for covering the costs of maintaining the road.
- Single purpose roads needed for just one entry should be used in the near future if possible, and then decommissioned. The scheduling of the use of these roads should be used as a prioritization criteria for project work wherever feasible, so that these roads should be treated as soon as possible.
- Results from the terrestrial analysis are similar to those described for aquatic impacts in that a majority of the high risk roads (80%) are in the Administrative Use and Multi Purpose road use categories (Figure RA-7).

RA-7. Miles of road in road use classes, with high impact terrestrial roads highlighted.

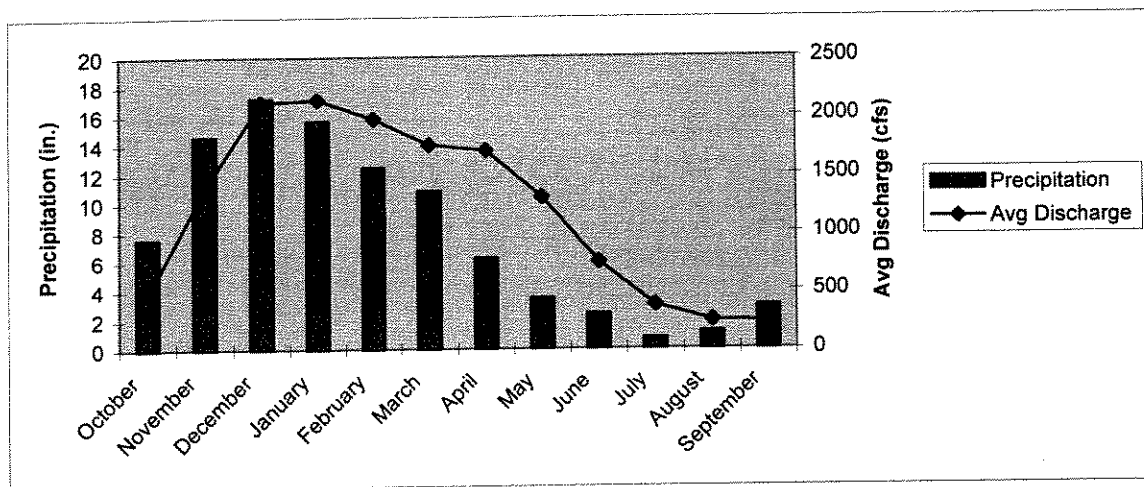
The average annual hydrograph for the Wind River and precipitation hyetograph from data collected at the Carson National Fish Hatchery summarize the general timing and amount of precipitation and runoff in the Wind River watershed (Figure H-1).

Figure H-1. Average monthly precipitation (from Carson National Fish Hatchery) and discharge on the Wind River near Carson.

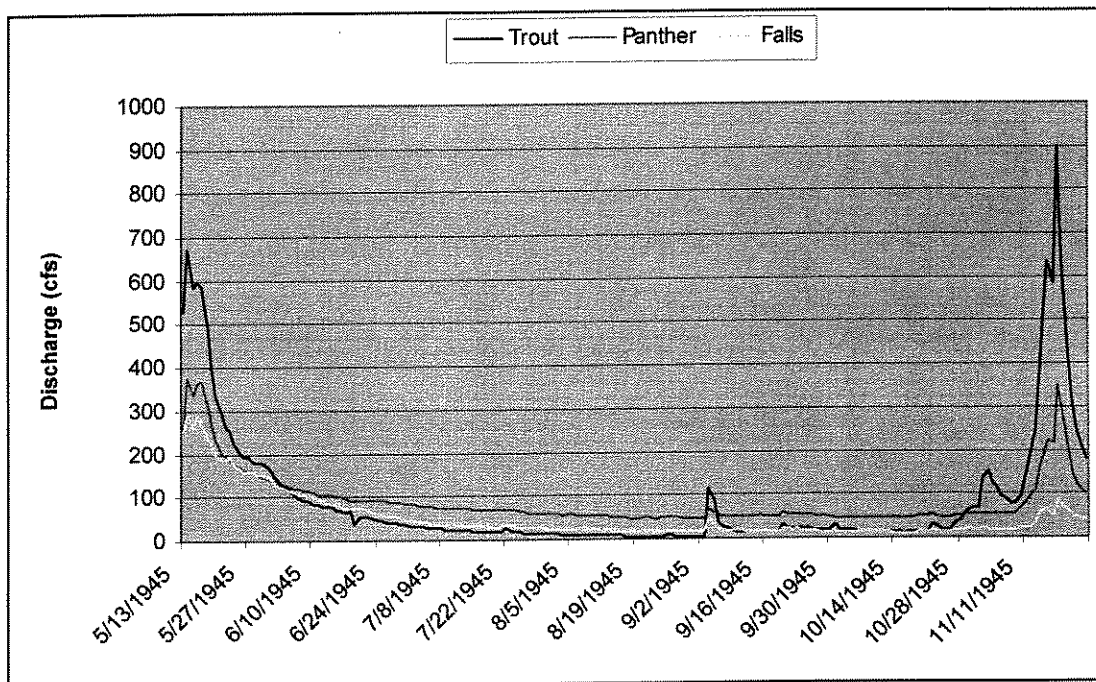
Discharge levels during summer months are important to aquatic life, both because higher flows provide more habitat, and because lower flows can be more easily heated above the range preferred by fish and other aquatic organisms. One of the significant results of the spring snowmelt that occurs in Falls Creek is the increased discharge levels that occur in Falls Creek and (subsequently) in the Upper Wind River as a result. Throughout the summer months, Falls Creek and Panther Creek both retain higher discharge levels than does Trout Creek. Figure H-4 compares summer discharge levels among the three streams for a six-month period in 1945. The chart spans a period including the last runoff-producing event in the spring through the first significant freshet of fall.

Figure H-4. Summer discharge on Trout, Panther, and Falls Creek, 1945.

The importance of the sustained summer low flows in Panther and Falls Creeks becomes apparent when analyzing water temperature maximums across the watershed. With relatively high summer flow levels, Panther Creek also has some of the lowest water temperature maximums of any stream in the Wind River watershed. Similarly, Falls Creek has relatively high summer discharge, and maintains relatively low maximum water temperatures throughout the year. In fact, Falls Creek and Panther Creek have the lowest maximum water temperatures found in any stream of similar drainage area size in the Wind River watershed. The Trout Creek system in contrast, has relatively low summer discharge, and has the highest recorded water temperatures in the Wind River watershed (see Water Temperature section of this report). Clearly there are numerous variables affecting water temperatures in these streams, but discharge is an important factor. The amount of heat required to raise the temperature of water is inversely related to the volume of water in the channel. By sustaining relatively high late summer flow levels, both Falls Creek and Panther Creek remain cool throughout the year, and play important roles in maintaining or reducing water temperatures in the Wind River.

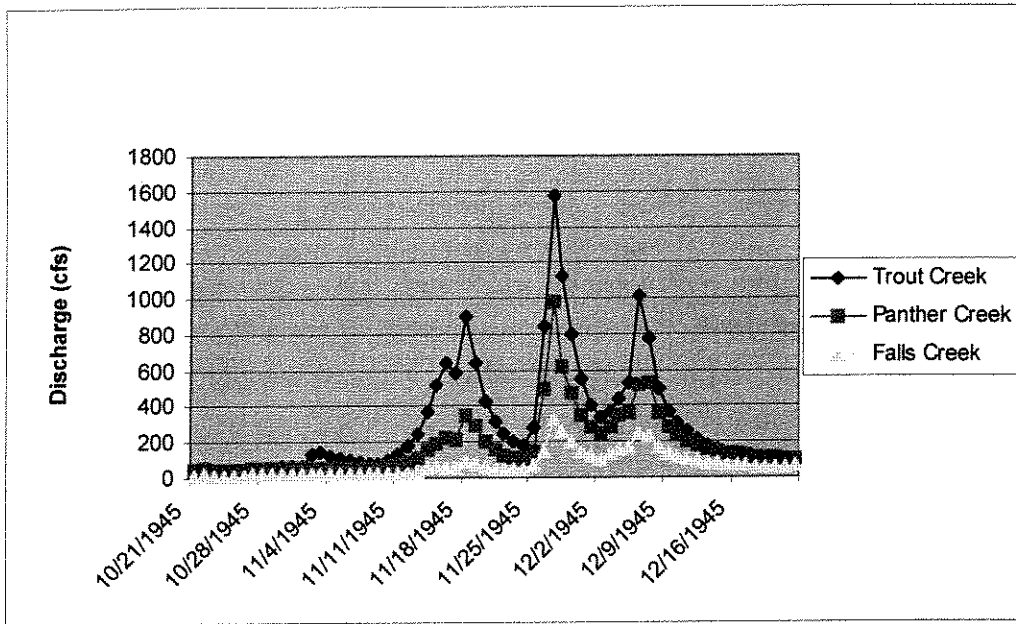
Using the same set of streamflow data for Trout Creek, Panther Creek, and Falls Creek, Figure H-5 shows the stormflow response in these streams to a series of precipitation events that occurred in November and December of 1945. Concurrent records of air temperature and precipitation are presented in Figure H-6 to help characterize the weather surrounding these events. Air temperature and precipitation data were taken at the Wind River Nursery, located at approximately 1,100 feet elevation in the Trout Creek subwatershed. A reconstruction of the meteorologic events provides an avenue for understanding the patterns of discharge seen on the three tributaries.

Figure H-5. Comparison of streamflows in Trout Creek, Panther Creek, and Falls Creek in response to a series of precipitation events occurring in November and December, 1945.

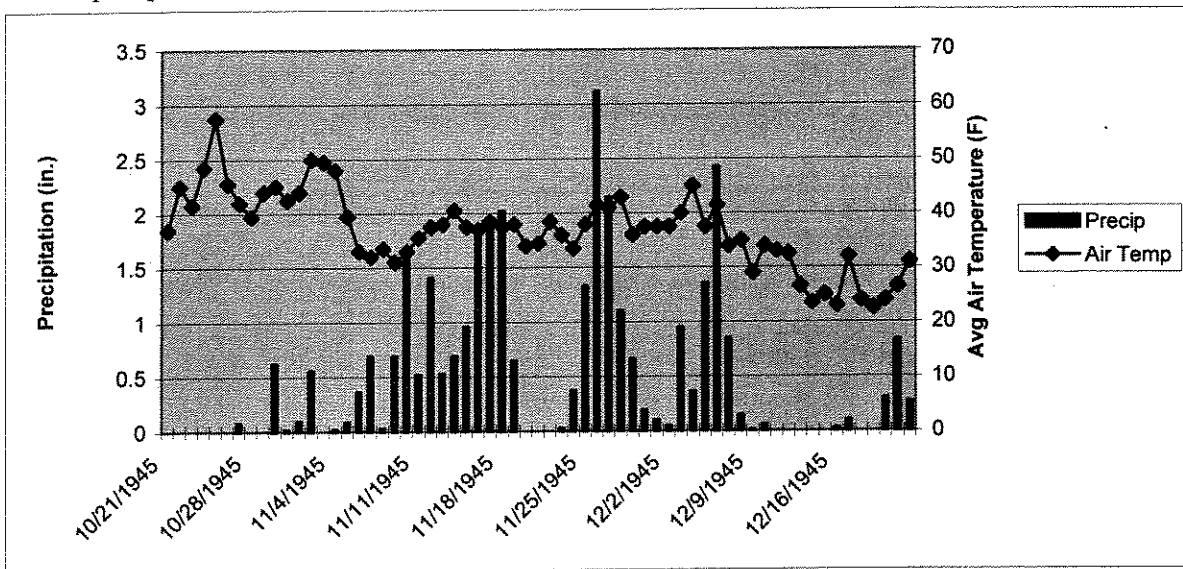
Figure H-6. Air temperature and precipitation at the Wind River nursery during the late fall and winter of 1945.

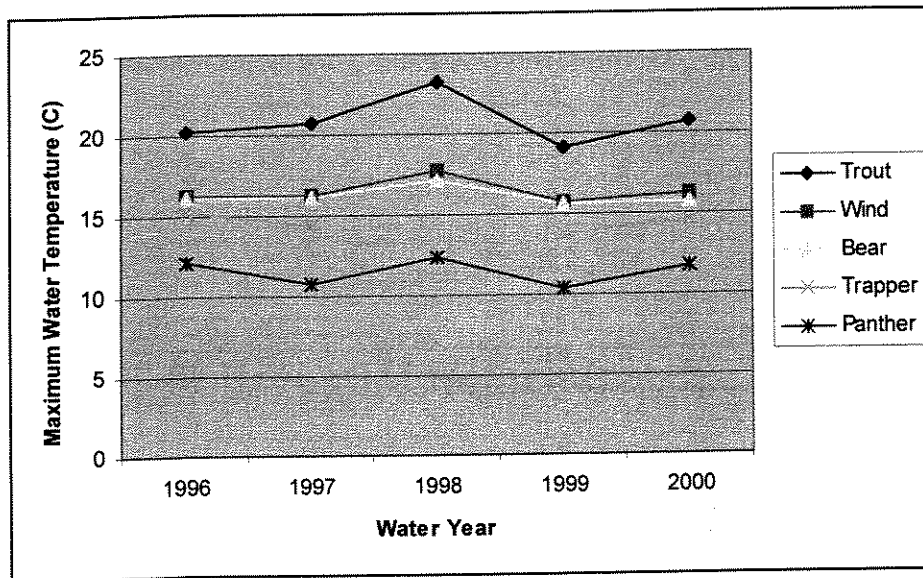
Over the past five years, three of five baseline monitoring stations exceeded the state standard for water temperature. Trout Creek exceeded the standard in each of the five years, reaching a maximum temperature of 23.2°C in 1998 (Figure WT-2). The Wind River and Bear Creek also exceeded the standard in 1998, reaching 17.8°C and 17.1°C respectively. Although Trapper Creek showed no exceedances over the four years of monitoring there, no data was collected at the Trapper Creek baseline station in 1998 (the warmest of the five years) due to instrument malfunction. Based on its temperature relationship with the other stations in other years, it appears that Trapper Creek would have been very near, if not over the standard in 1998. Panther Creek remained below the standard throughout this five-year period, reaching a maximum of 12.4°C in 1998.

Figure WT-2. Maximum water temperatures at Forest Service baseline monitoring stations in the Wind River, 1996-2000.

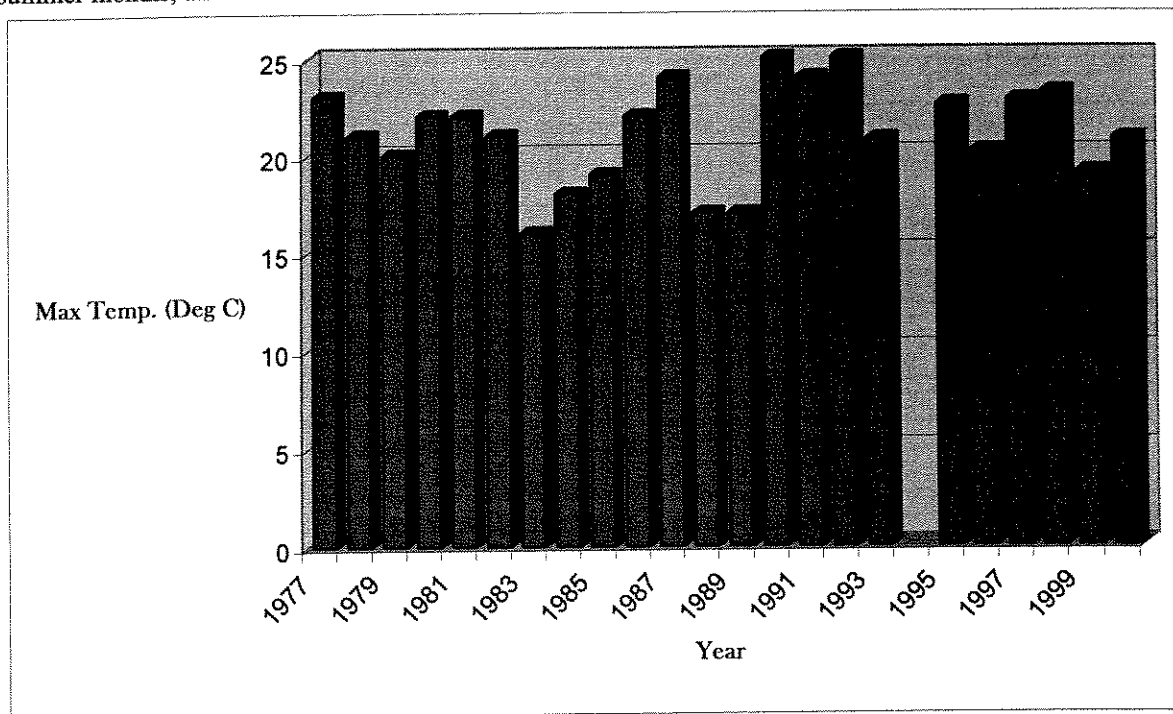
The highest measured water temperatures in the Wind River watershed occur in the Trout Creek system. In water temperature monitoring conducted since 1977 at the Trout Creek baseline station above Hemlock Lake, water temperatures have exceeded the state standard for temperature (16°C) in 22 of 23 years (Figure WT-3). Maximum water temperatures at that station have been recorded as high as 25°C (77°F) in late summer months, and have remained above state standards for as many as 75 days in a single summer.

Figure WT-3. Maximum water temperatures in Trout Creek at the baseline station located upstream of Hemlock Lake (1977-2000).

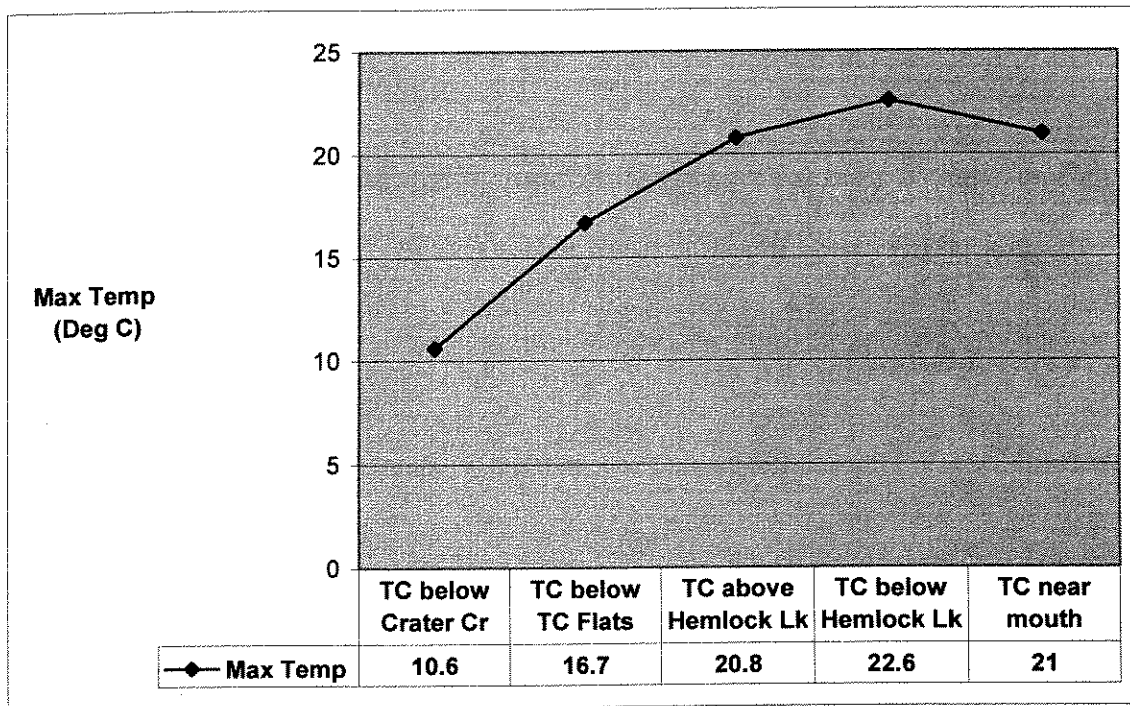
Figure WT-4. Maximum water temperatures at five locations on Trout Creek (TC). Data points are organized in a downstream direction from left to right. (Data from year 2000.)

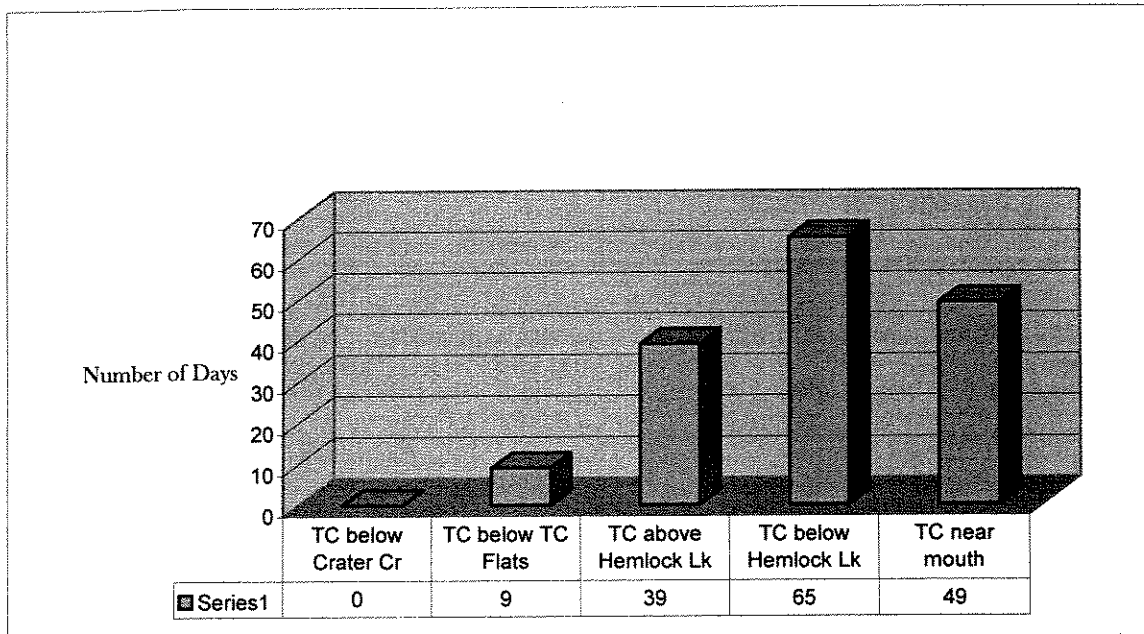
Figure WT-5. Number of days water temperature exceeded 16°C at five locations on Trout Creek (TC). Data are organized in a downstream direction going from left to right. (Data is from year 2000 monitoring.)

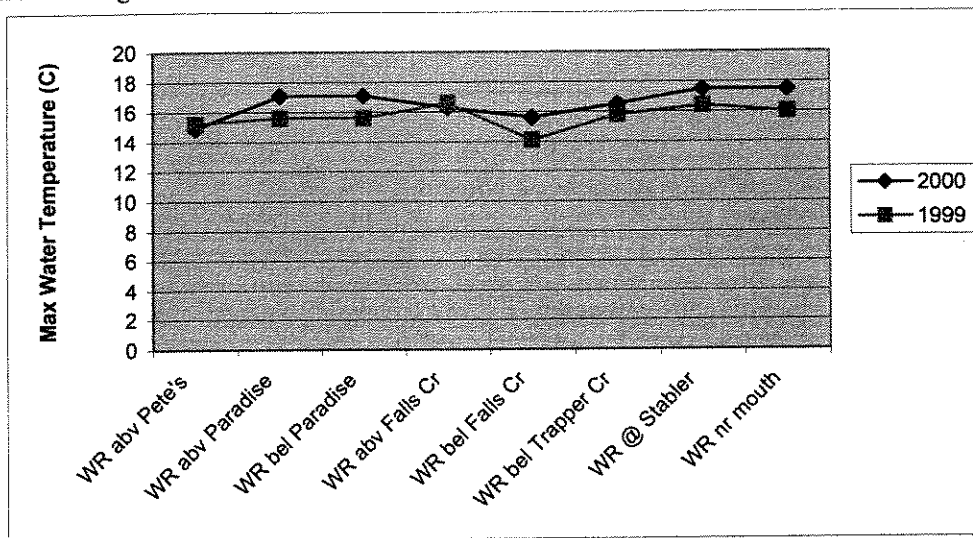
Figure WT-6. Maximum water temperatures at monitoring stations along the Wind River (WR), years 1999 and 2000. Data are arranged in a downstream direction from left to right.

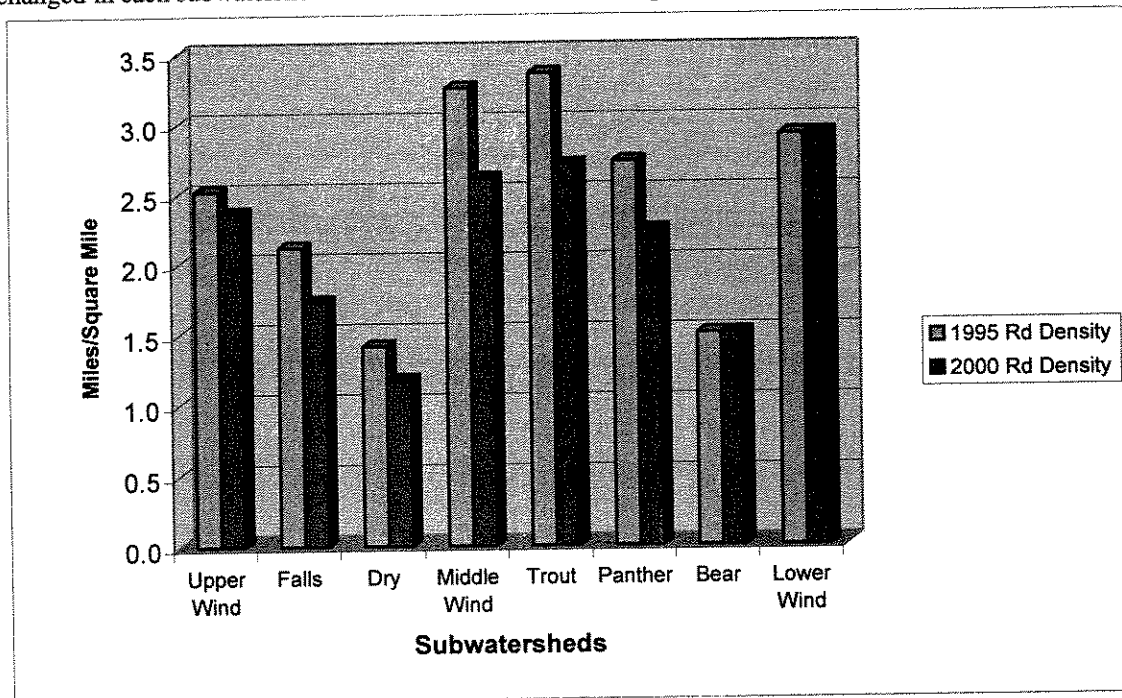
Figure WR-3. Road density reductions in the Wind River watershed (1995-2000).

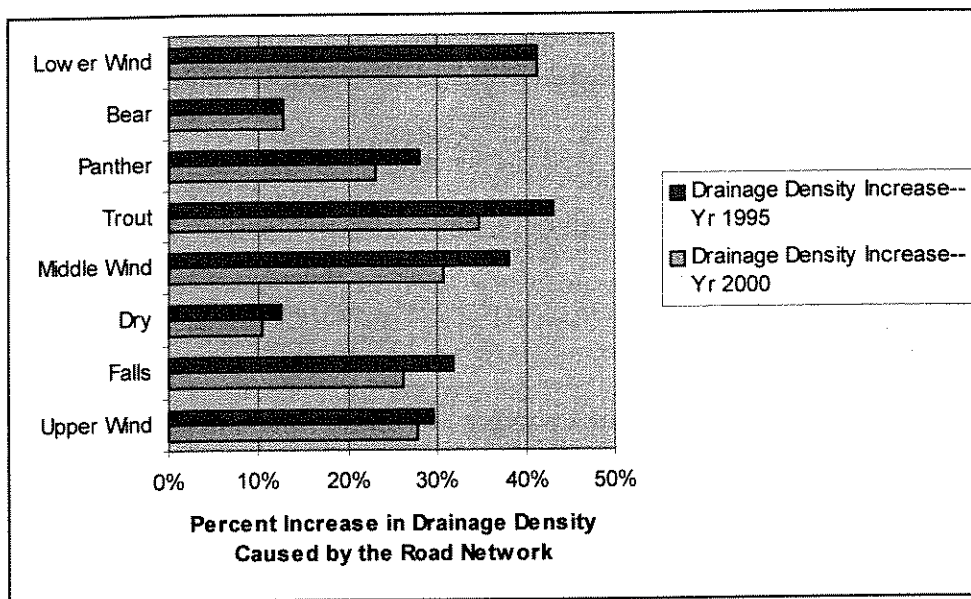
Figure WR-4. Estimated increase in natural drainage density caused by roads, and how the increased drainage density has changed from 1995 to 2000.

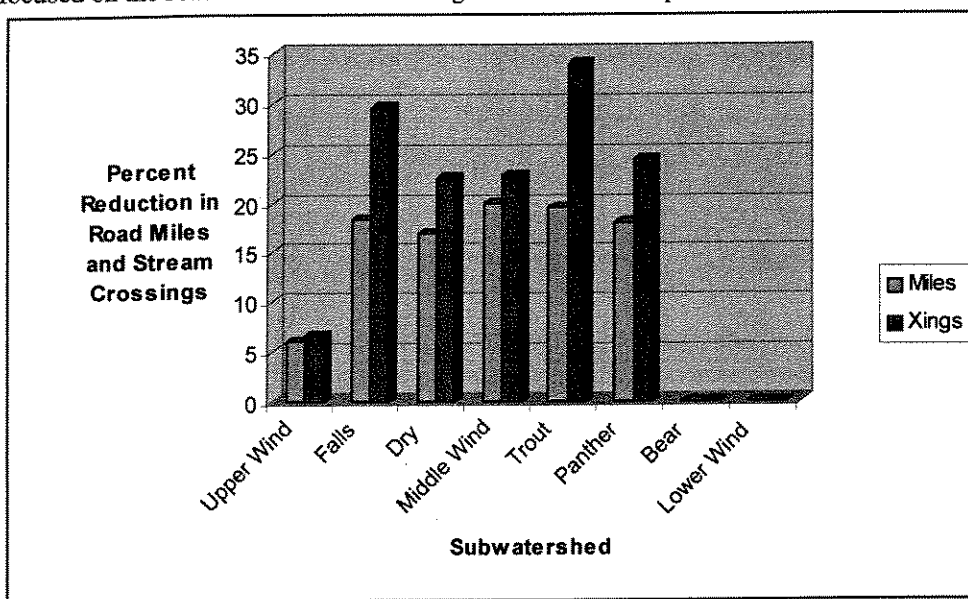
Figure WR-5. Comparison of the percent reduction in road miles vs. the percent reduction in stream crossings that have resulted from the past five years of road decommissions in the Wind River watershed.

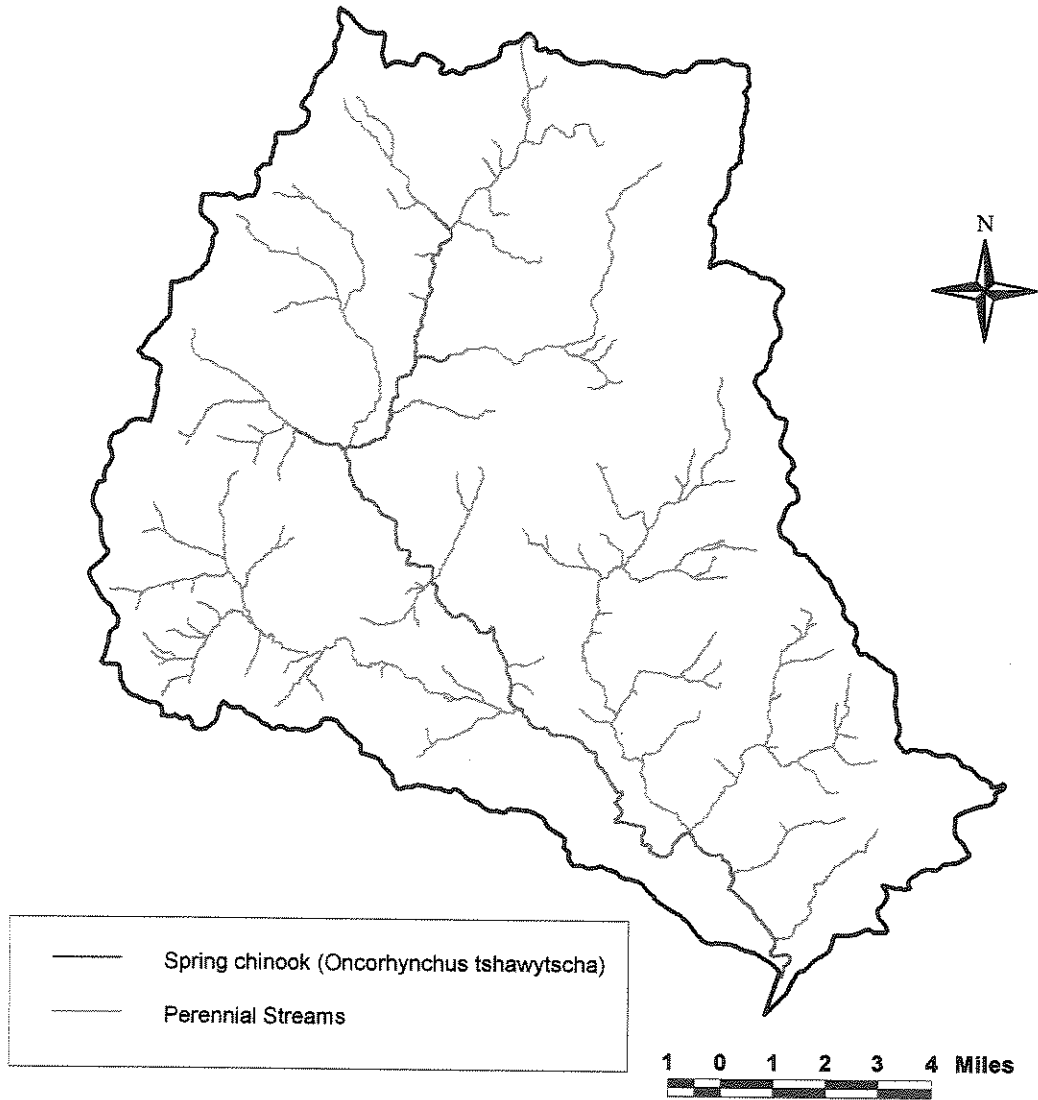
Figure F-4. Distribution of spring chinook in the Wind River system.

Natural spawning of spring chinook in the upper Wind River did not occur until passage facilities were built at Shipherd Falls in 1956. After passage was provided, a spring chinook run was established at the Carson National Fish Hatchery (CNFH), and natural spawning began in habitats above and below the hatchery. Most juvenile chinook have been found in the main-stem Wind River above the hatchery but occasionally in tributaries including Compass, Crater, Planting, Trout, and Trapper creeks. In two years of smolt trapping below one of primary spawning areas (above the CNFH) only four unclipped chinook smolts have been observed, which equates to approximately 16 naturally produced smolts. WDFW believes the majority of naturally spawning fish are hatchery strays, and that this population is not a self-sustaining. Currently, spring chinook salmon in the Wind River are managed for hatchery production.

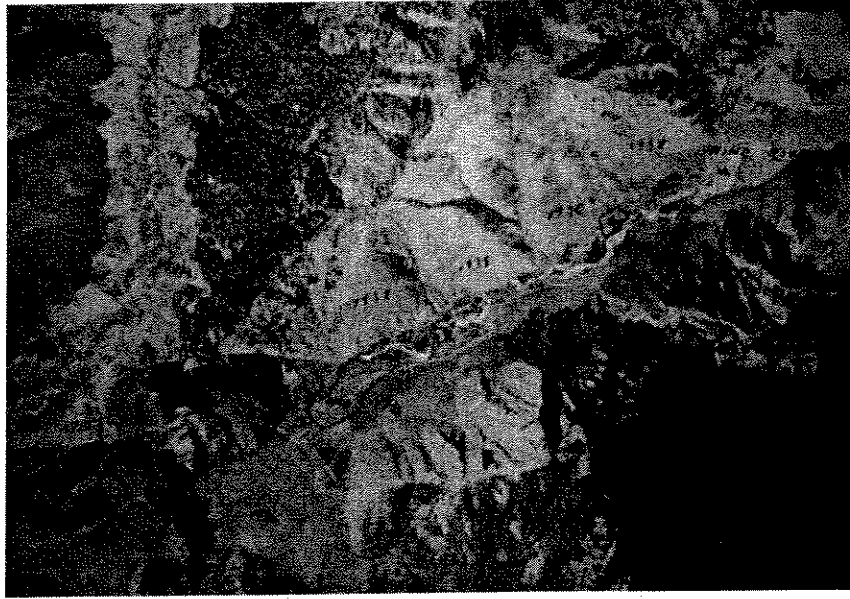
Figure F-9. 1944 aerial photo of Dry Creek and the upper Wind River (river mile 20-25), Skamania County, WA. Logging in the early part of the century focused on the main stem Wind River and major tributaries due to historic logging methods (splash dams and railroad logging) and the old growth timber along the streams.

The predominant land management activity within the Wind River watershed has been timber harvest. Timber harvest within the basin began in the late 1800's. "Splash dams" were constructed on the main stem Wind River and tributaries to stockpile and transport logs down stream to the mills along the Columbia River. Riparian areas were targeted due to the large quantities of old growth timber and access to the stream.

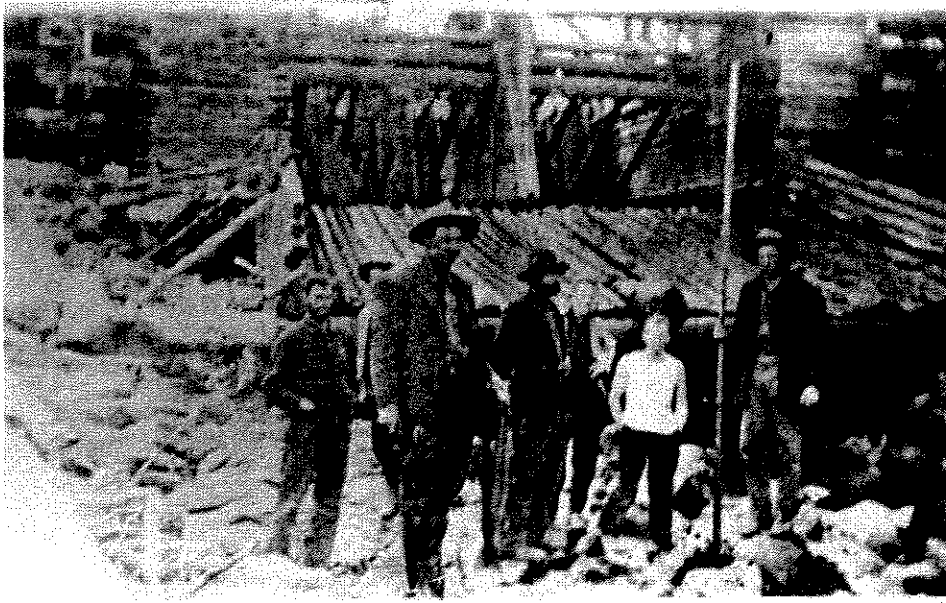
Figure F-10. 1902 Photo of the Trout Creek splash dam under construction, Skamania County, Washington. The man in foreground is holding a large fish presumably a steelhead caught at the base of the dam.

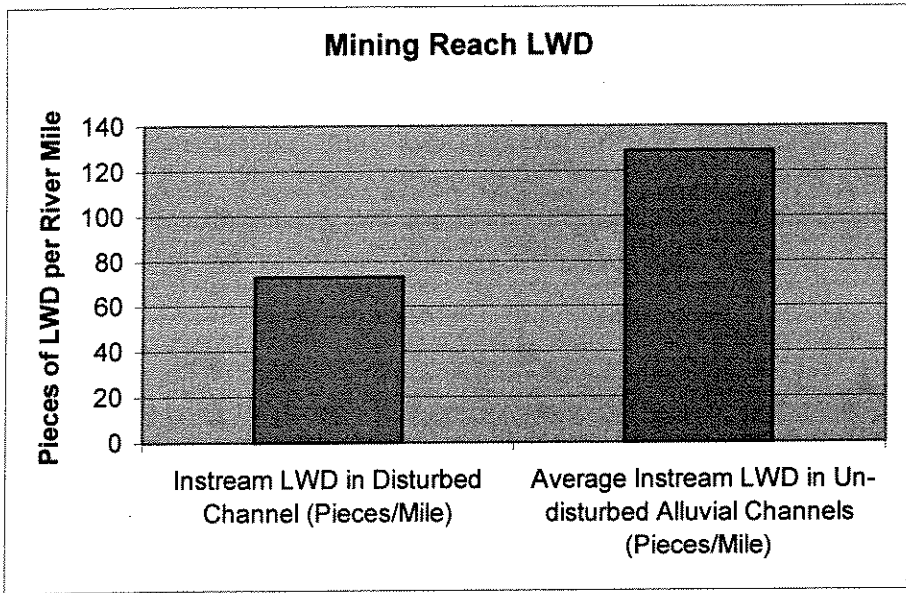
Figure F-13. Comparison of existing LWD observed in the Mining Reach and average LWD per river mile observed in 13 alluvial reaches of stream within Wind River, Skamania County Washington. LWD is defined as pieces >12" in diameter and >50' in length.

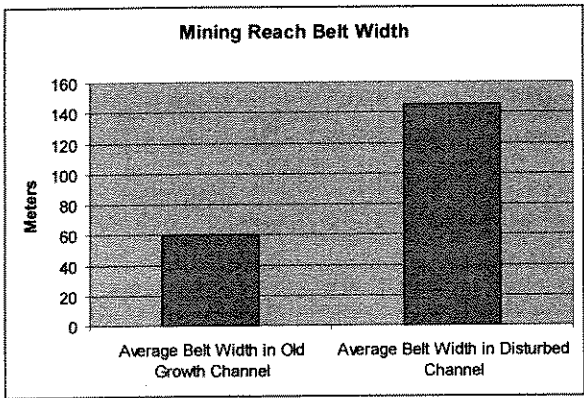
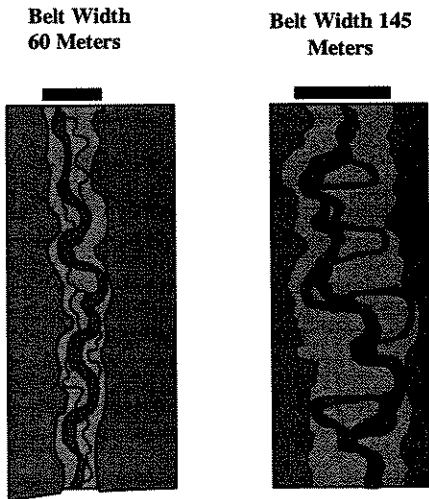
Figure F-14. Comparison of belt widths in old growth and disturbed channels for the Mining Reach of the Wind River, Skamania County WA.

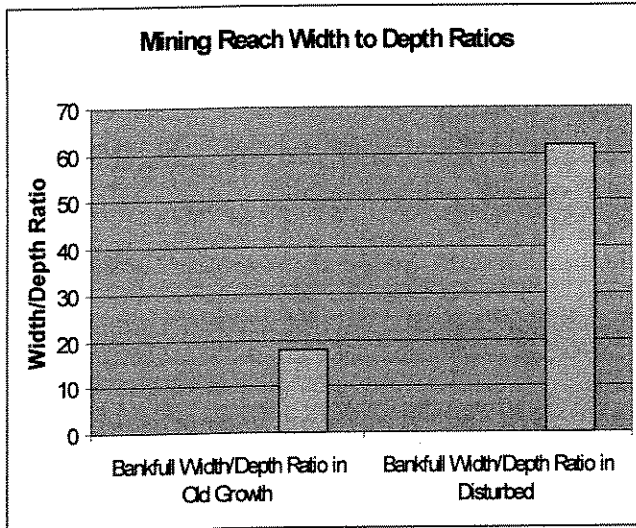
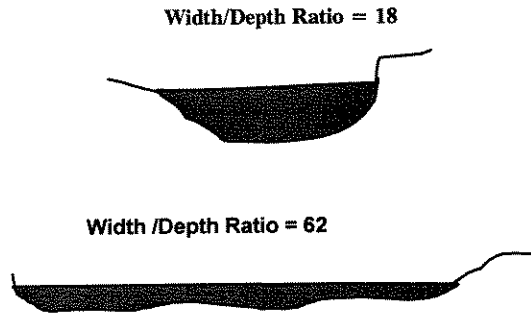
Figure F-15. Comparison of the average width to depth ratios in old growth and disturbed channels for the Mining Reach of the Wind River, Skamania County WA.

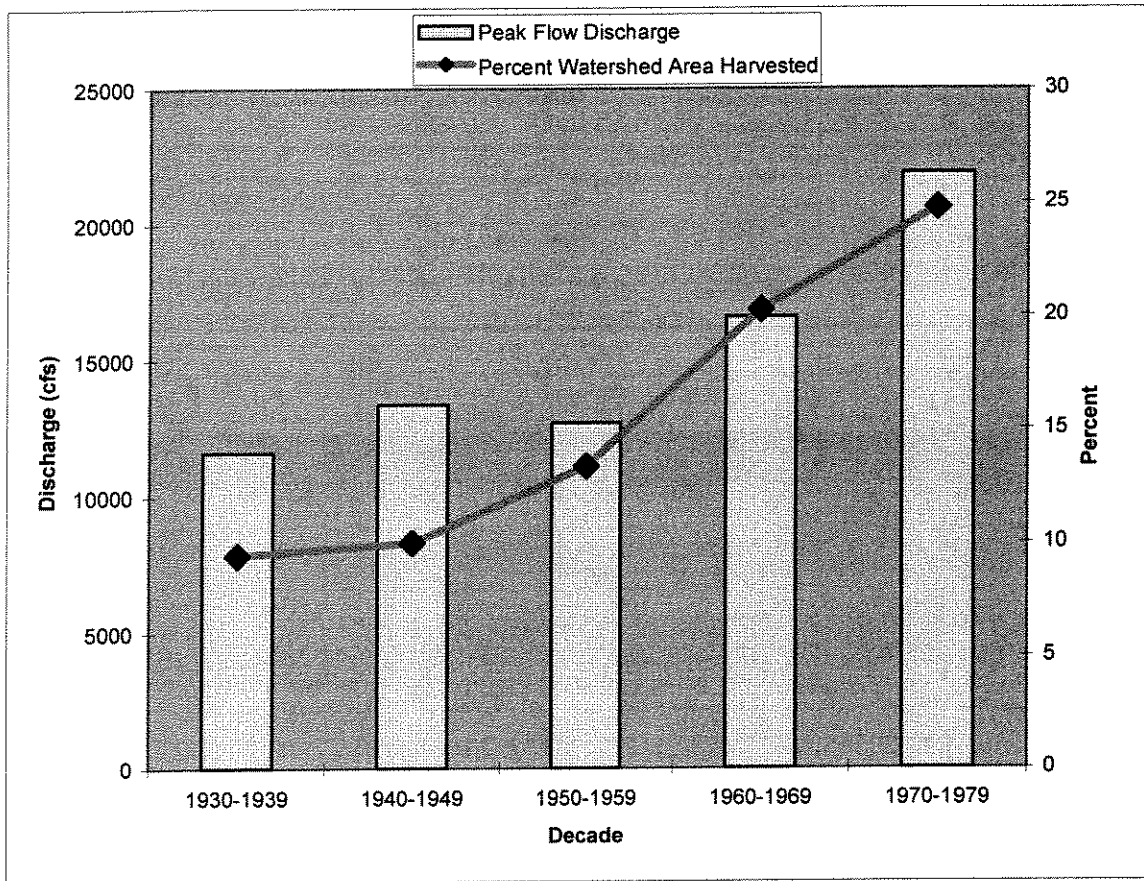
Figure F-16. Average peak flow discharge vs. the percentage of watershed area harvested by decade for the Wind River Watershed, Skamania County Washington.

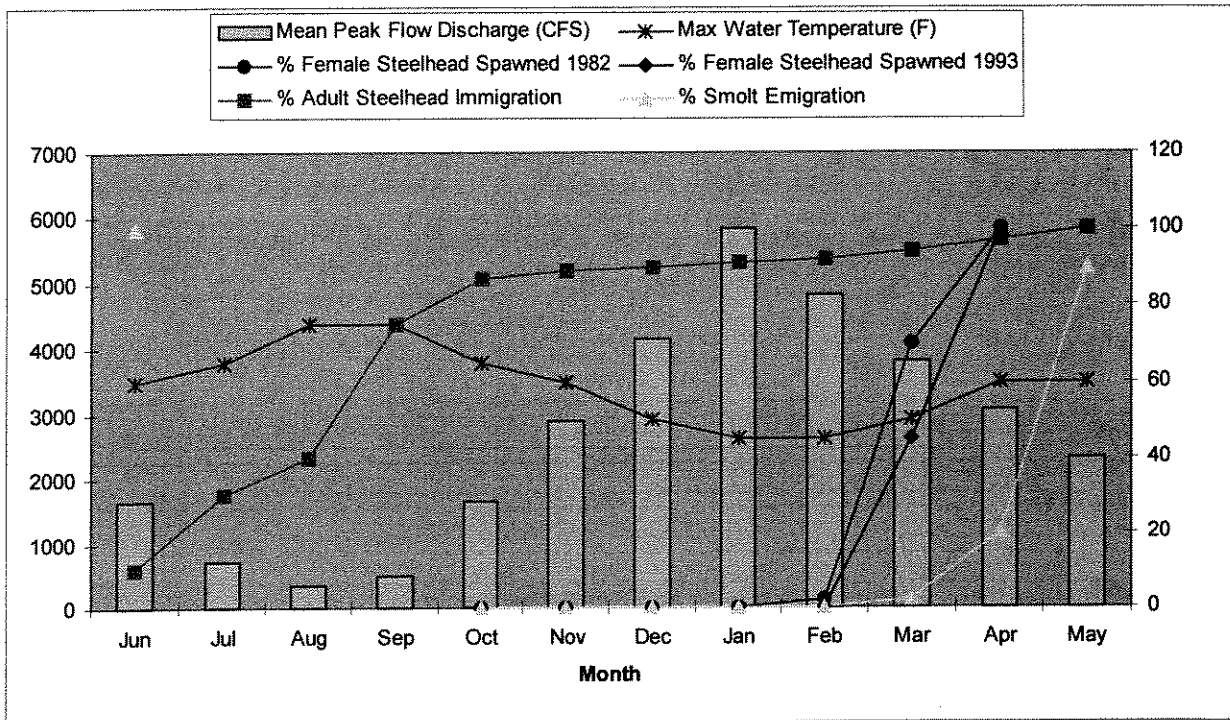
Figure F-17. Mean peak flow discharge (CFS), maximum water temperature, percentage of wild female steelhead spawned (1982 & 1993), percentage of adult wild steelhead immigration and percentage of smolt emigration by month for the Wind River, Skamania County, Washington.

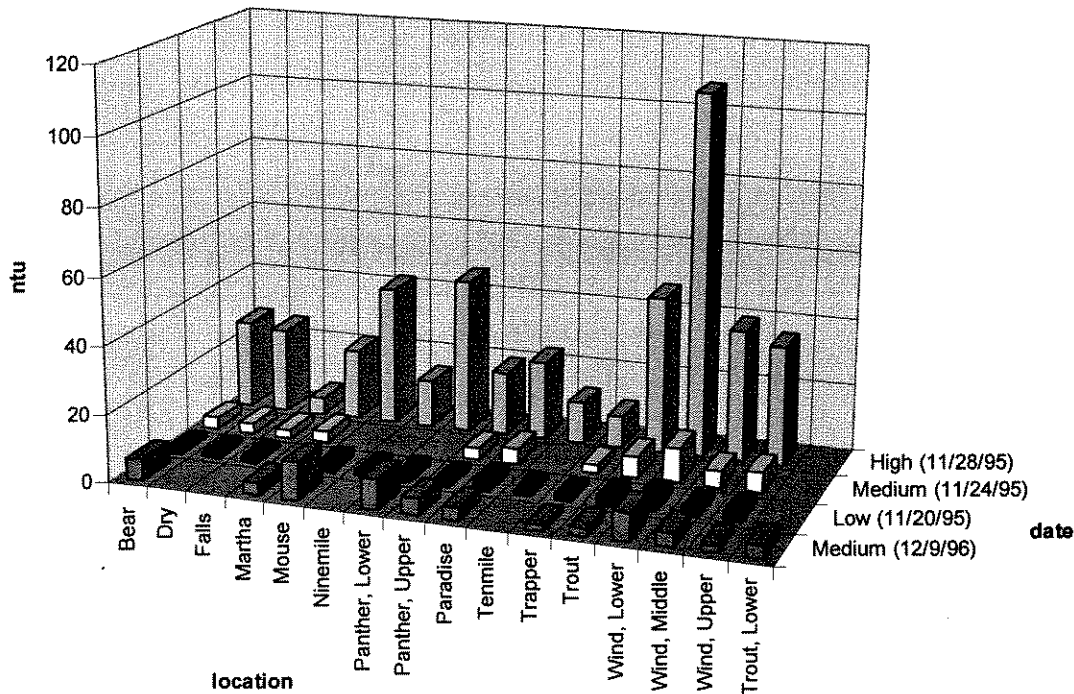
Figure AA-1. Turbidity (NTU's) for the Wind River and tributaries during low, medium and high flows [ 11/28/95, 11/20/95 and 12/9/96], Skamania County, Washington.

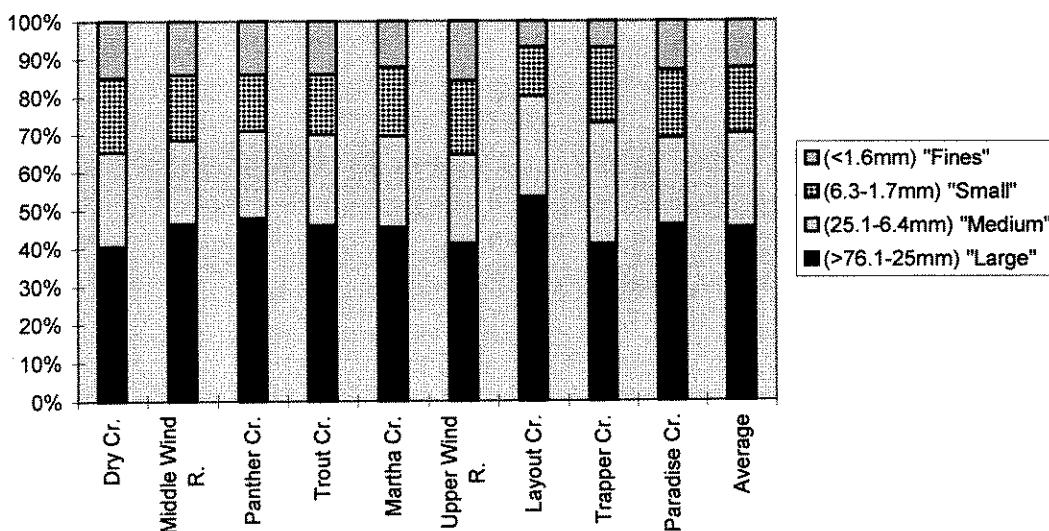
**Figure AA-2. 1998 spawning substrate composition for the Wind River and tributaries, Skamania County Washington.**
