# Wind River

## Watershed Analysis (Second Iteration)

*Mt. Adams Ranger District  
December 2001*

# Wind River Watershed Analysis— Second Iteration

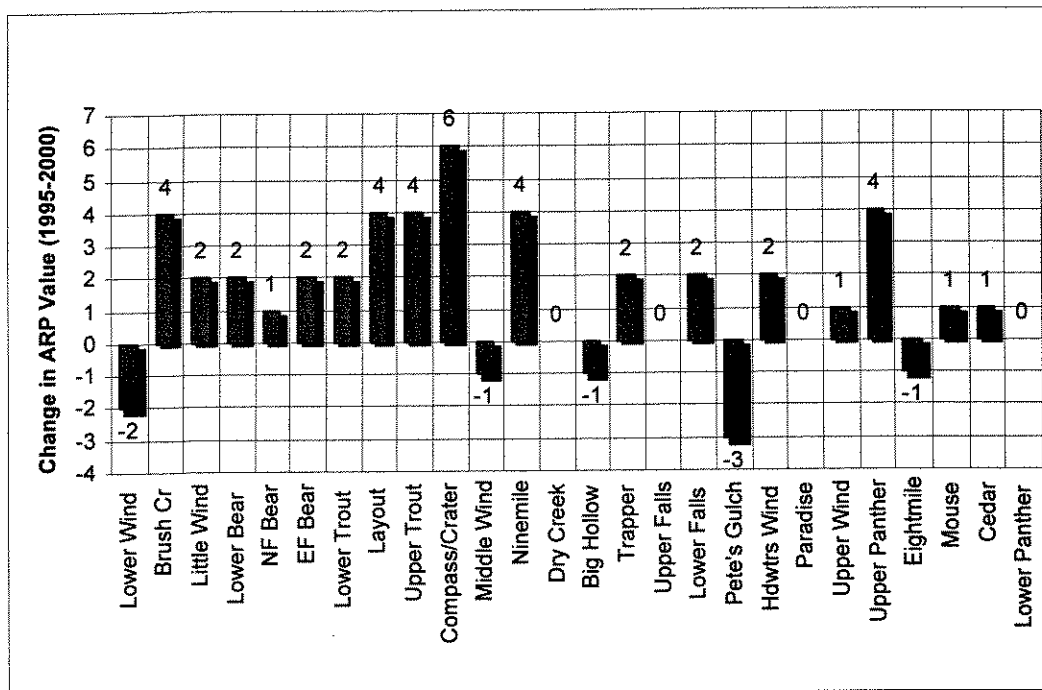
Figure AB-1. Five-year changes in ARP values by 7<sup>th</sup> field subwatershed (1995-2000).
