Lower Cispus Watershed Analysis

**Gifford Pinchot National Forest
Cowlitz Valley Ranger District
April 2003**

LOWER CISPUS WATERSHED ANALYSIS

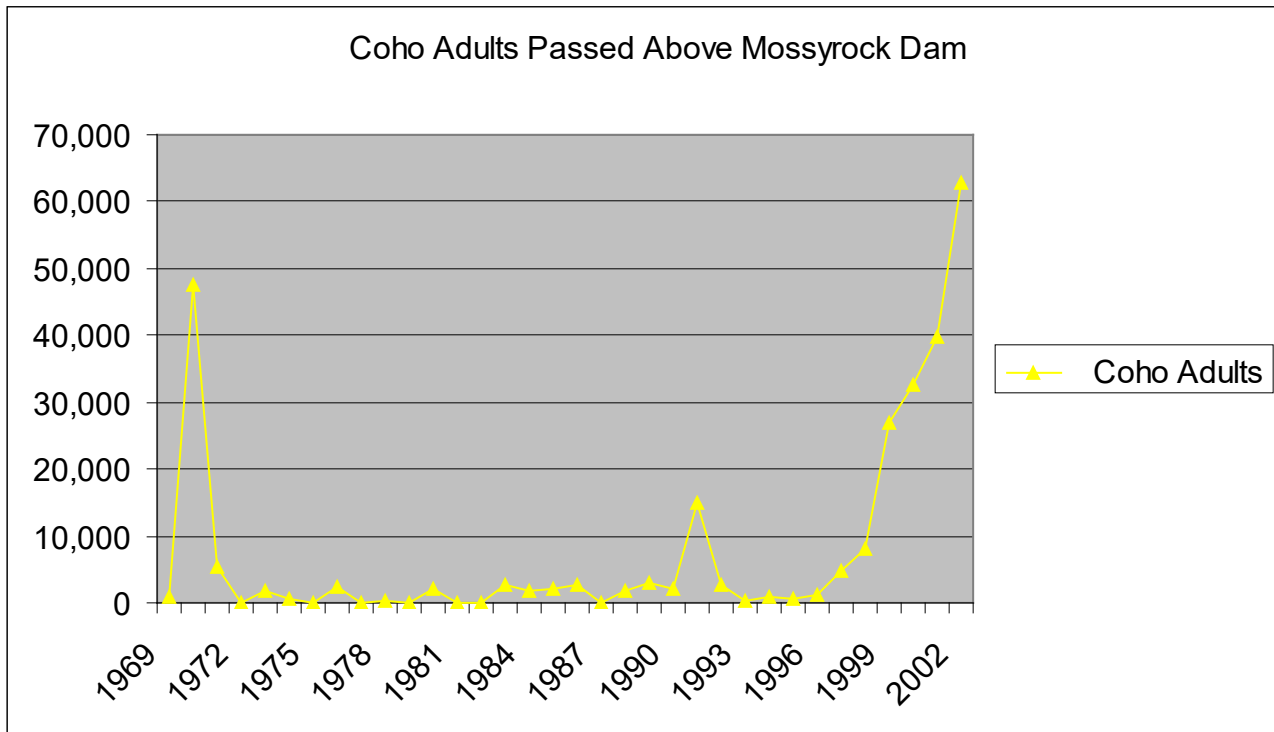
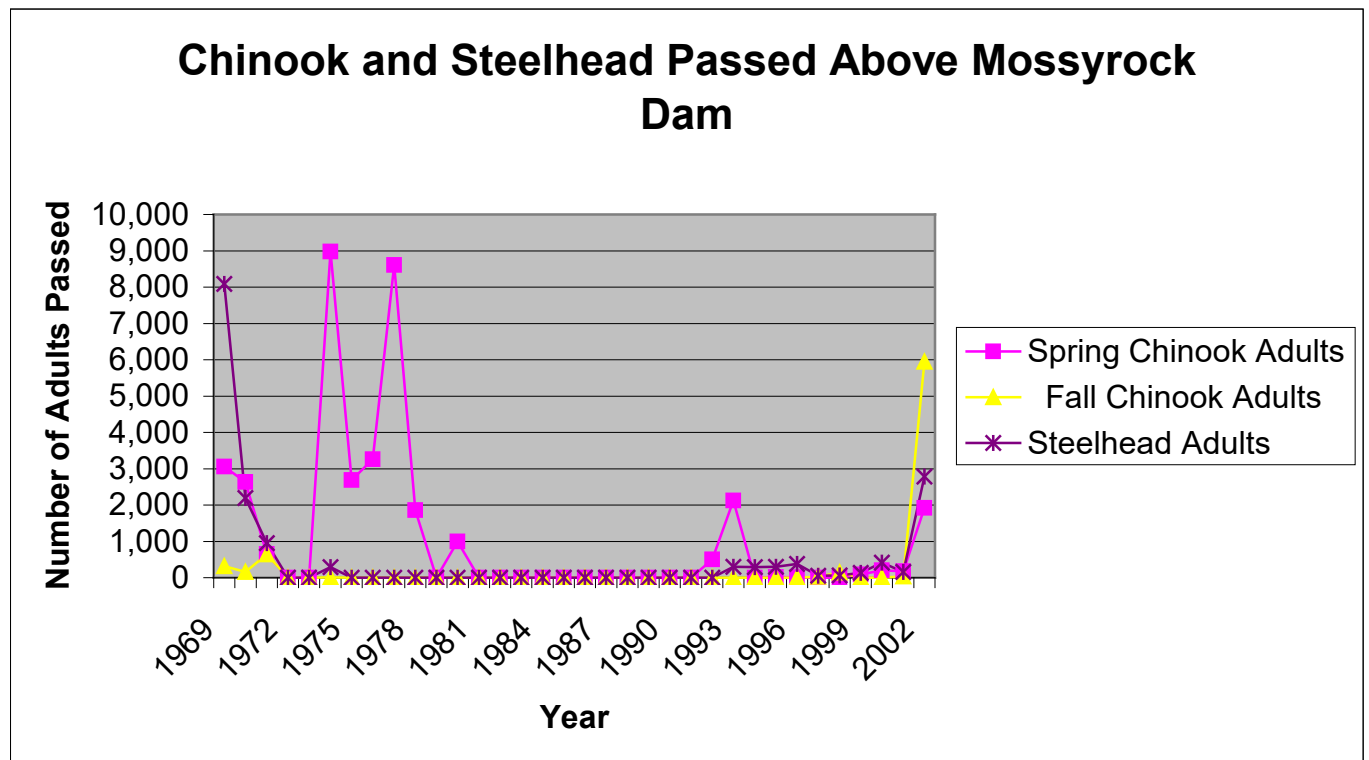
Figures 4.4 and 4.5- Graphs displaying the number of fish passing above Mossyrock Dam, 1969-2002.

The anadromous populations are dependent upon the reintroduction program for transport around the dams on the Cowlitz River. Figures 4.1 and 4.2 show the number of transported coho and Chinook salmon, and steelhead passing above Mossyrock Dam since 1969 (these numbers include fish using the all five of upper Cowlitz River watersheds, some unknown fraction use the Lower Cispus Watershed).

The number of coho in 2002 was large (62,960) and exceeds the peak of 47,423 in the early 1970s. The number of chinook (7,871) and steelhead (2,787) are still below peak numbers (8,981 and 8,088 respectively) after the dam construction, the the goals for these population have not been reached. In addition, much of the fish habitat is in an “At Unacceptable Risk” condition.

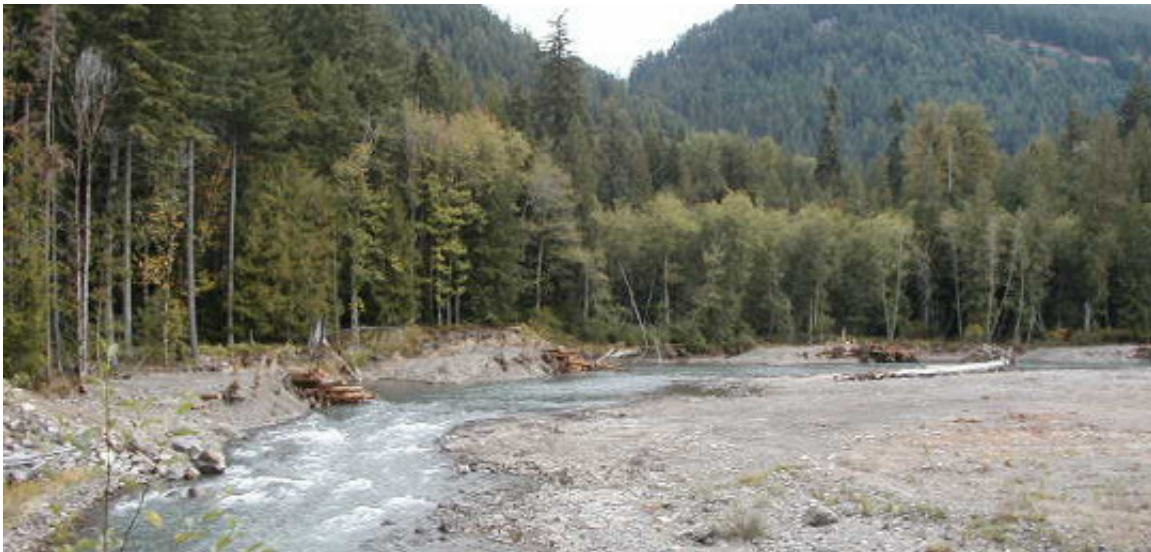
Figure 1- Engineered log jams along the mainstem Cispus River just upstream of Road 28 bridge (Tom Music Bridge) completed in Fall, 2001.
