# Lower Lewis River Watershed Analysis

Gifford Pinchot National Forest

Mount St. Helens National Volcanic Monument  
Gifford Pinchot National Forest  
Pacific Northwest Region  
USDA, Forest Service

July, 1996

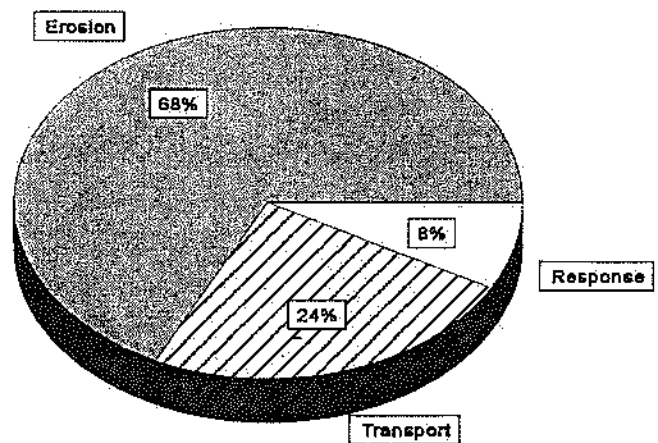
## Erosion-Transport-Response Reaches

Figure 27 - Percent of reaches that were classified as either erosion, transport, or response.
