*Middle Cowlitz Watershed Analysis*

February 1997

Gifford Pinchot National Forest  
North Skills Center

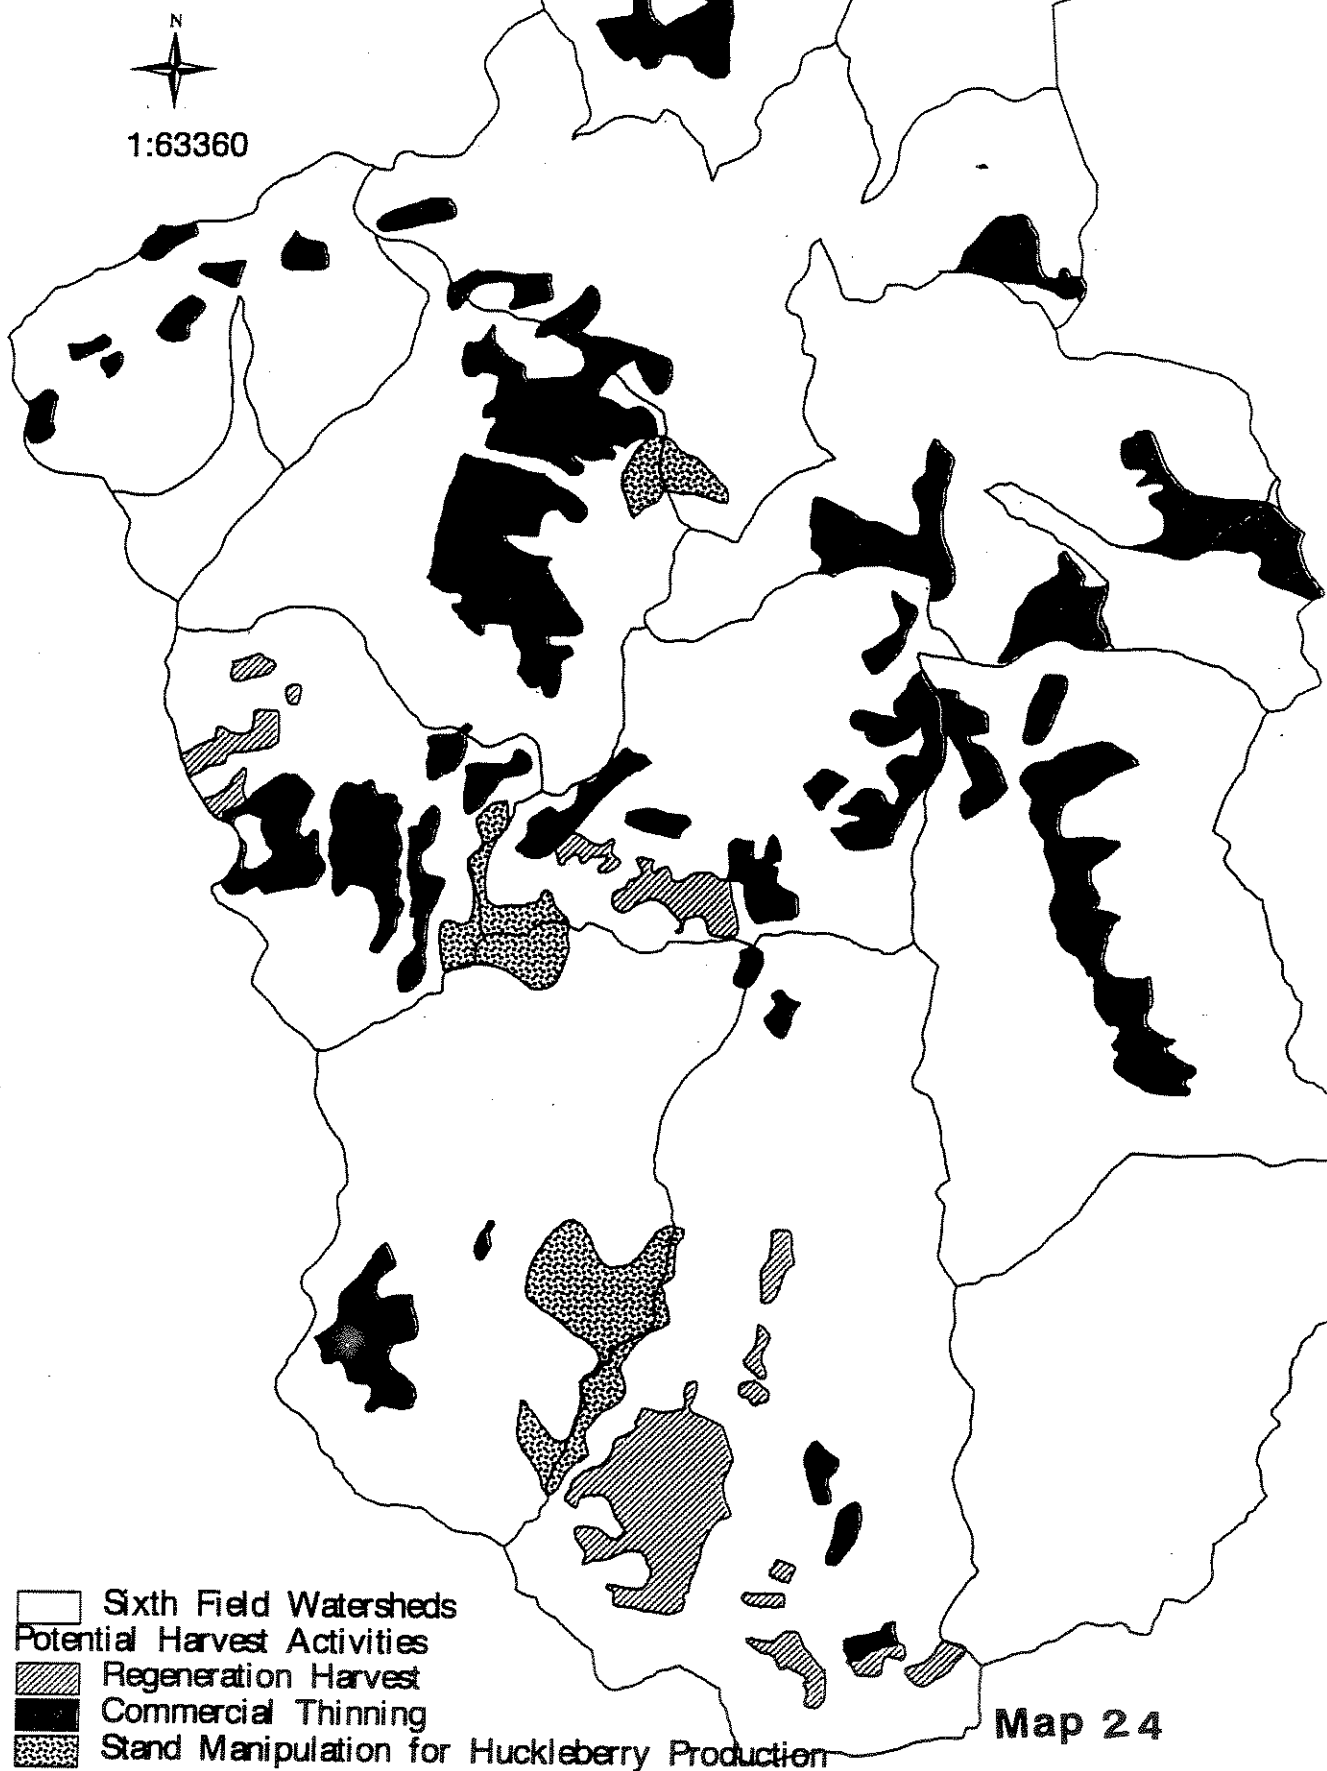
## Potential Timber Harvest Areas

**FOOTNOTE TO HARVEST MAP:** This map portrays some suggested areas where timber harvest may be possible, based on the recommendations in Chapter 7. These potential harvest areas have not been field verified, nor does the map portray every possible harvest area. It is intended to be used as a general starting point for further analysis.
