Lower Cispus West Watershed Analysis

**Randle Ranger District
Gifford Pinchot National Forest**

March, 1996

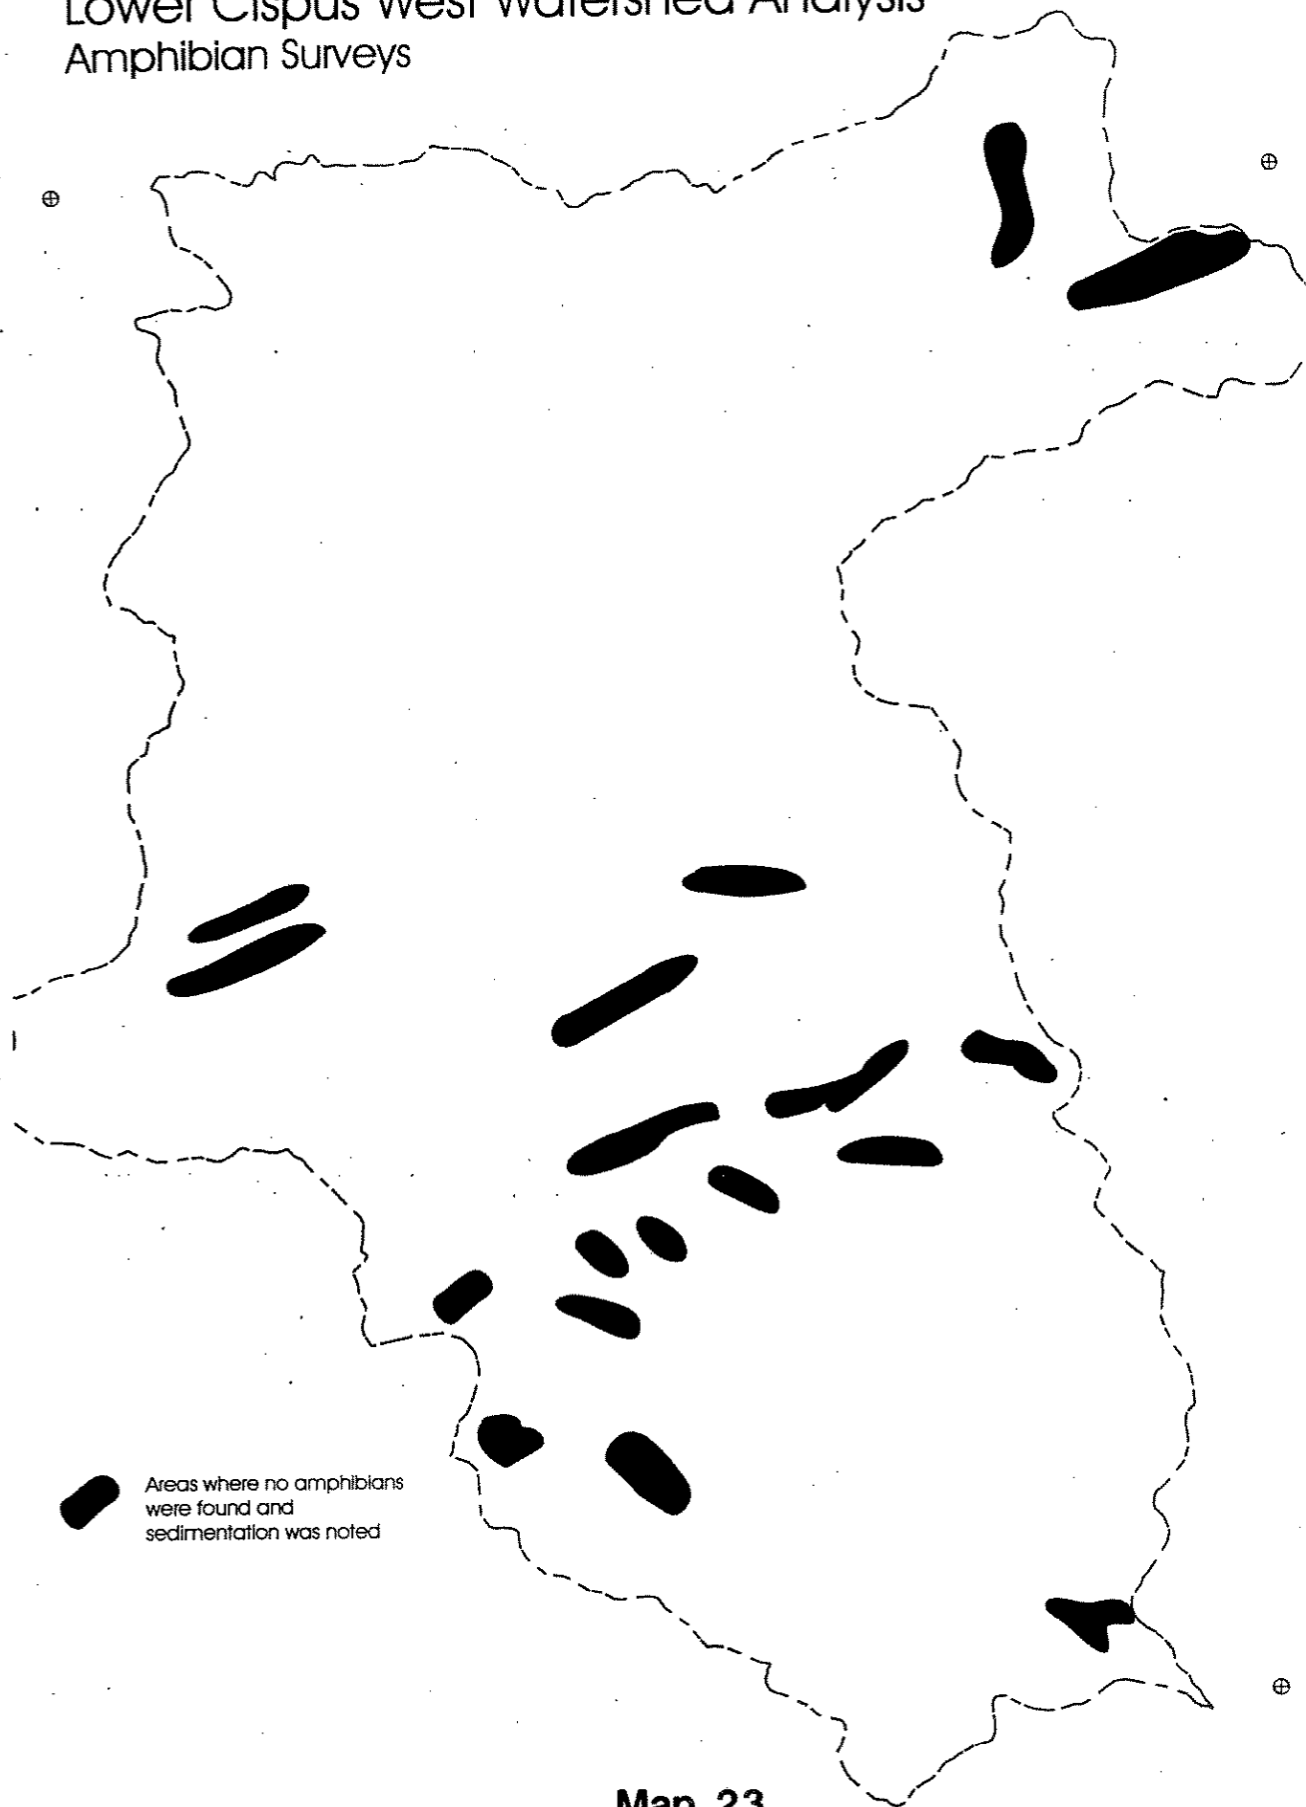
Map 23

Lower Cispus West Watershed Analysis
Amphibian Surveys

Areas where no amphibians
were found and
sedimentation was noted
