# Muddy River Watershed Analysis

Gifford Pinchot National Forest

**Mount St. Helens National Volcanic Monument  
Gifford Pinchot National Forest  
Pacific Northwest Region  
USDA, Forest Service**

**May, 1997**

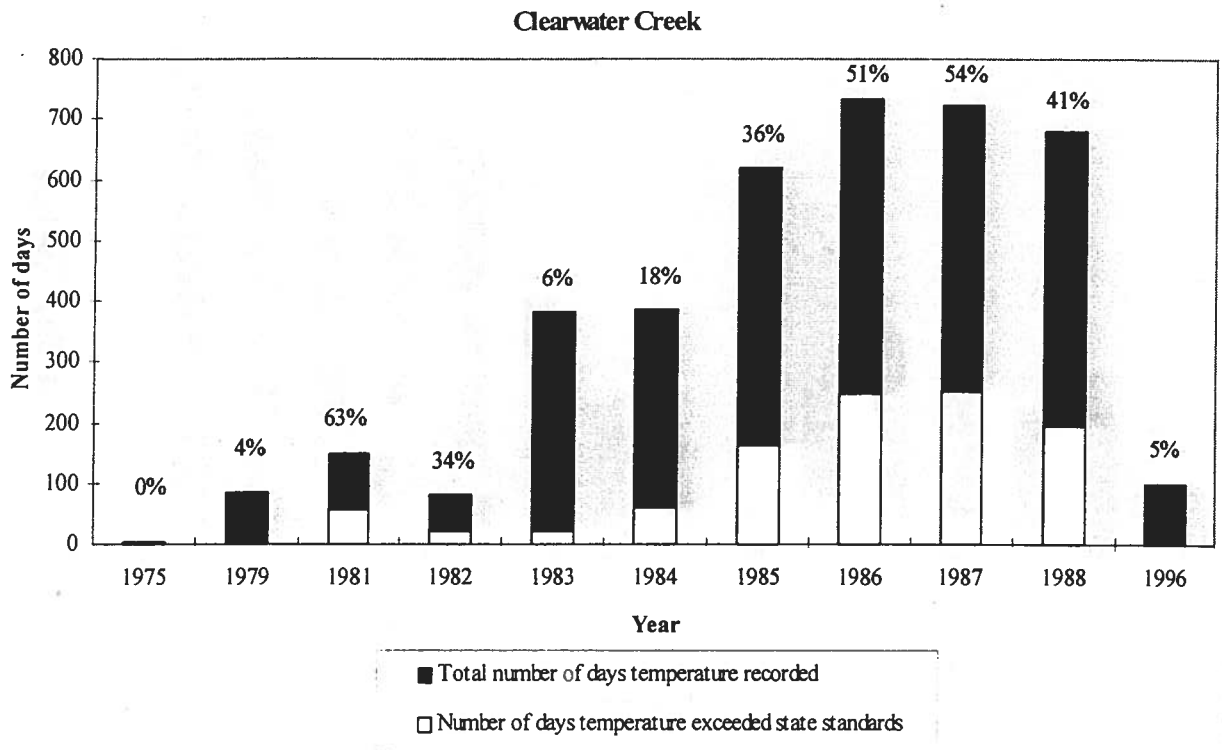
Loss of riparian vegetation from the 1980 eruption caused increased stream temperatures in Clearwater Creek. Maximum stream temperatures are decreasing and recovery is continuing as canopy begins to close back in over smaller and intermediate sized tributaries to Clearwater Creek (personal communication Charlie Crisafulli).

Figure 26A. Stream temperature monitoring data for all stations on Clearwater Creek. The percentage values shown above each bar are the percent of the total readings that exceeded the State Water Quality Standard of 16 degrees Celsius.

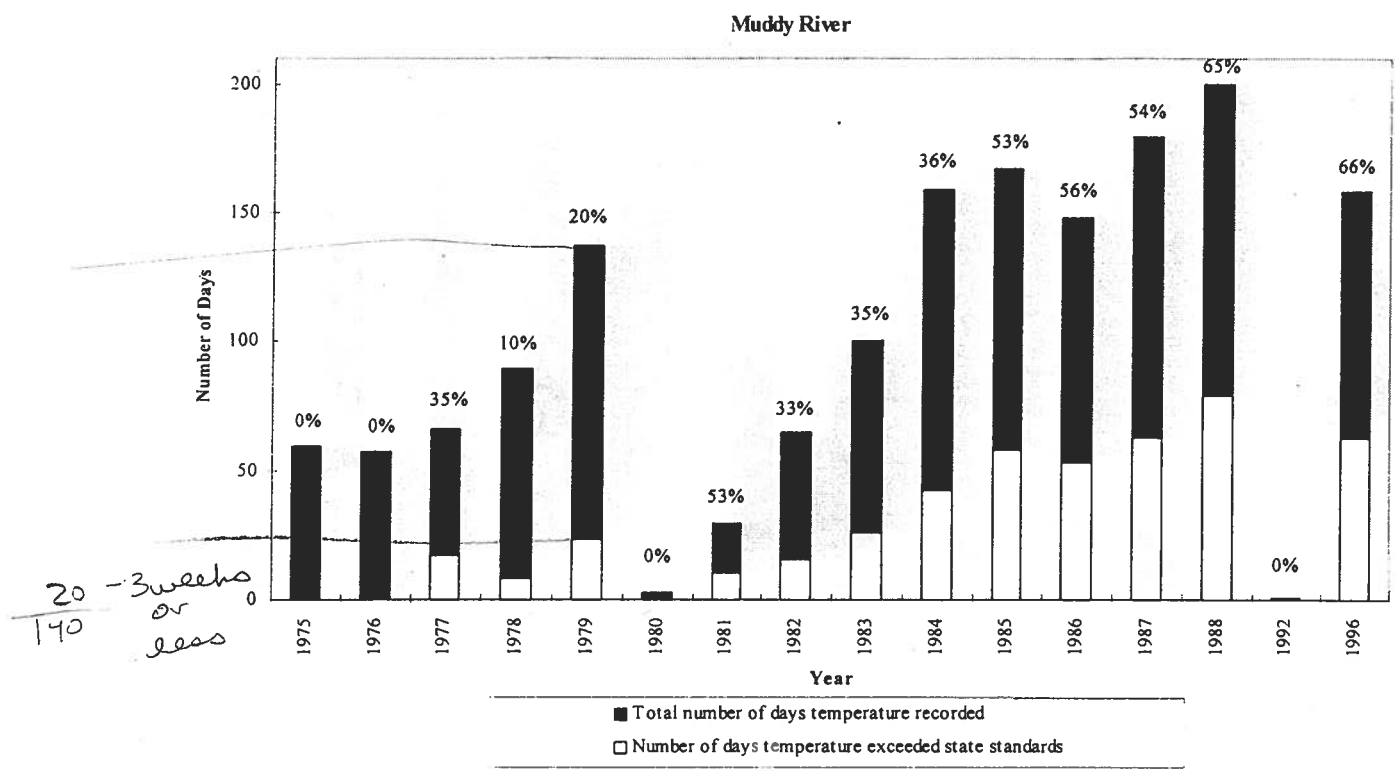
Several factors associated with the 1980 eruption probably have contributed to increased stream temperatures in the Muddy River after 1980. These include loss of riparian vegetation in tributary streams, channel widening from the mudflow that traveled down the Muddy River, and channel widening from introduction of large amounts of tephra. As displayed in the figure below, this area has still not recovered to pre-eruptive conditions due to continued channel widening from upstream tephra introduction. Increased stream temperatures noted in 1977-1979 may be due to extensive mechanized channel work that occurred upstream from the baseline monitoring station during this time period. This channel work was an attempt to straighten the river channel and “repair” damage from the early 1970's floods. The work removed riparian vegetation along the river (personal communication Jim Chamberlin).

Figure 26b. Stream temperature monitoring data for all stations on the Muddy River. The percentage values shown above each bar are the percent of the total readings that exceeded the State Water Quality Standard of 16 degrees Celsius.

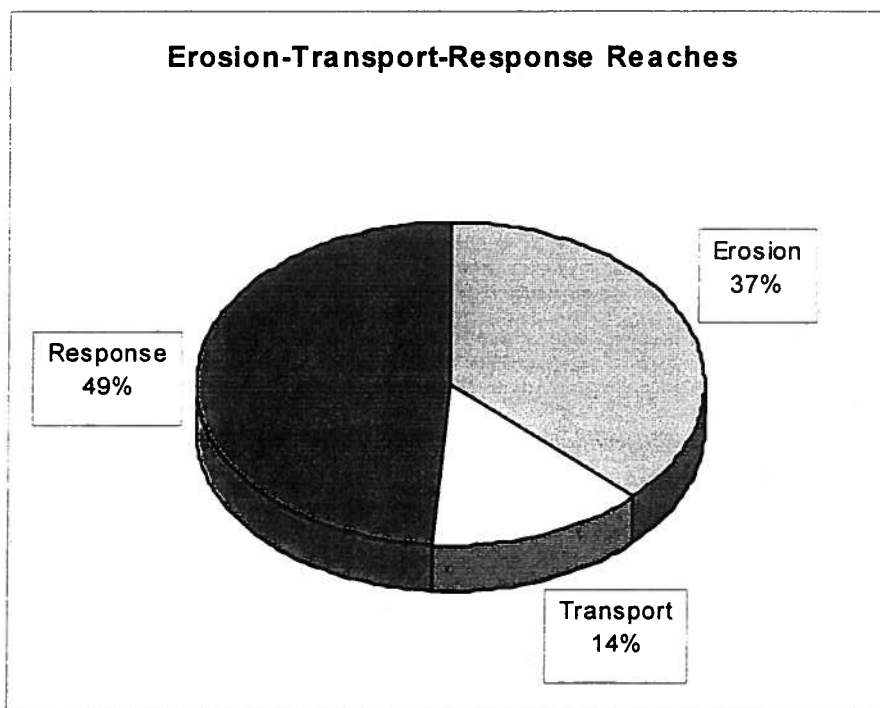
The rest of the length of named streams are characterized as "erosion" and "transport" reaches. Erosion-type channels usually have relatively steep gradients and are actively down cutting at various rates due to underlying geology and other physical characteristics. They are also travel paths for up slope mass wasting events (debris torrent areas). Some channels with more gentle gradients can be defined as erosional reaches if they have high rates of bank cutting. Transport reaches, on the other hand, have moderate gradients and are less confined than erosion-type channels. Both erosional and transport channels tend to move input variables such as wood, water, and sediment through relatively quickly.

Figure 30. Percent of reach mileage that was classified as either erosion, transport or response.

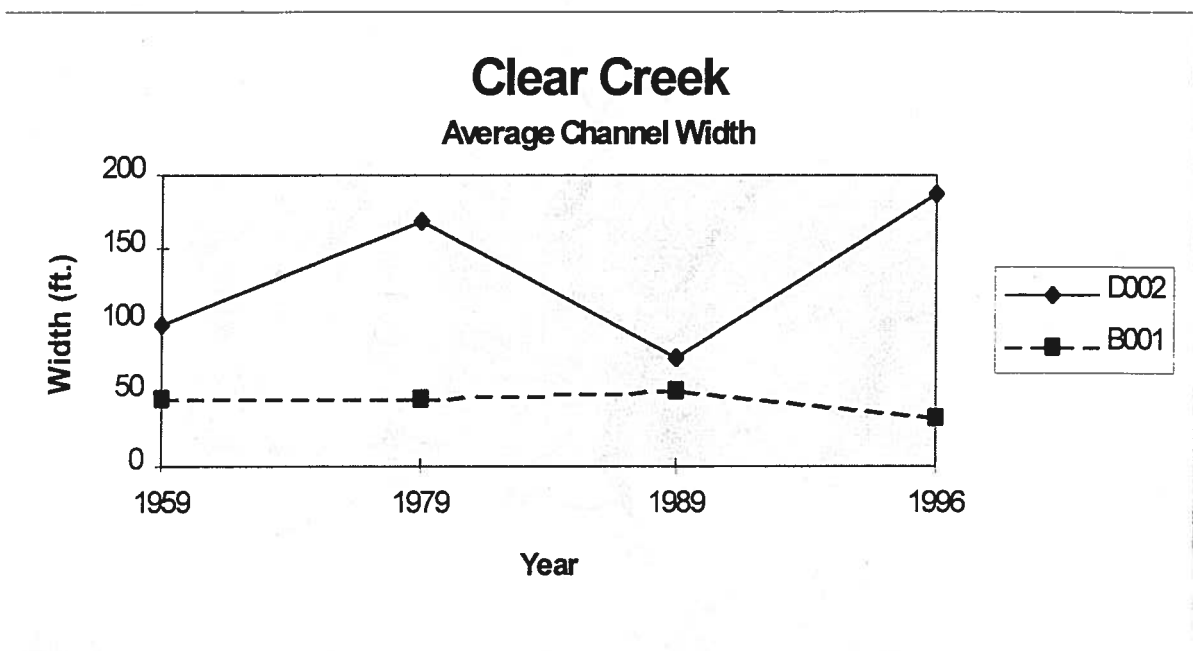
- Clear Creek was outside the blast zone and not subject to mudflows. Flood events in the 1970's changed reach # D002 from a meandering single "C" type channel to a braided "D" type channel and increased its width 81 percent during this period (see Figure 32 - Clear Creek average channel width). The reach readjusted to a meandering single "C" type channel and decreased in width 56 percent as the channel downcut and vegetation grew on the flood plain in the period 1978-1989. This reach reverted to a braided "D" type channel and increased in width 149 percent due to an influx of sediment and wood from the 1996 flood.

Figure 32 - Average channel width from two reaches on Clear Creek. Note the rapid rate that reach D002 widens and narrows, indicating this reach is very responsive to input of large woody debris and sediment.
