**Site Inspection
Granite Creek Mines
Wallowa-Whitman National Forest, Oregon**

U.S. Department of Agriculture–Forest Service
Wallowa-Whitman National Forest
Baker City, Oregon 97814

EA Engineering, Science, and Technology, Inc.
12011 Bellevue-Redmond Road, Suite 200
Bellevue, Washington 98005

January 2004
FINAL
Project No. 13890.13

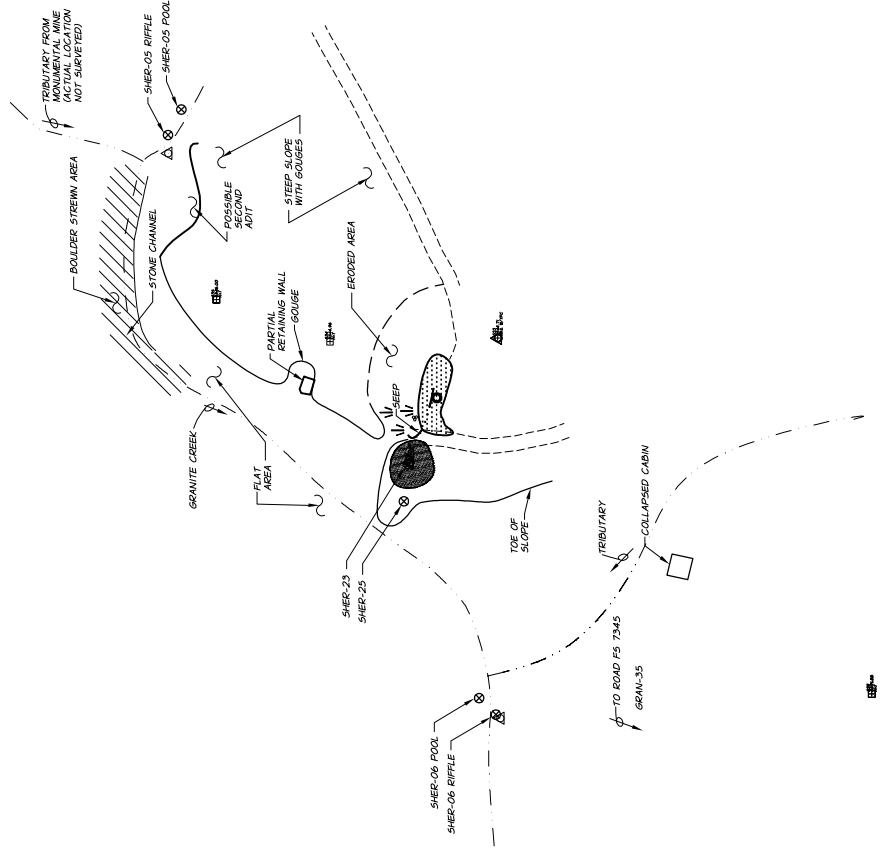
Figure 3. SHERIDAN MINE SITE

- **Sheridan Mine.** Granite Creek near the mine site has been significantly altered by placer mining, as evidenced by large boulder piles and stone channels (Figure 3). Two tributaries enter Granite Creek in the area of the mine: one which flows from Monumental Mine on the north side of the creek and the other from the south side of the creek. There is also a seep near the collapsed portal that forms a marshy area upgradient of the waste pile. No staining or mineralization was observed in this area.

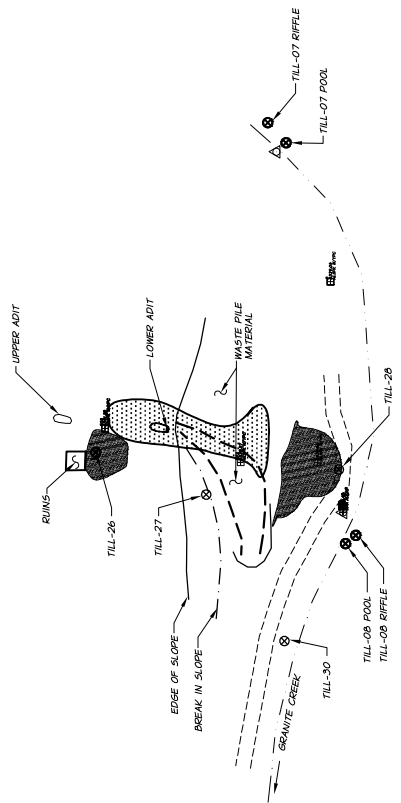
Figure 4. TILLCUM MINE SITE

- **Tillicum Mine.** No overland flow was observed at the mine site during the field investigation. Two erosion channels (dry during the field investigation) were observed coming from the collapsed adits and lower waste pile (Figure 4). No staining was observed along the channels. Water likely runs through these channels over the waste material during periods of high rainfall and snowmelt.

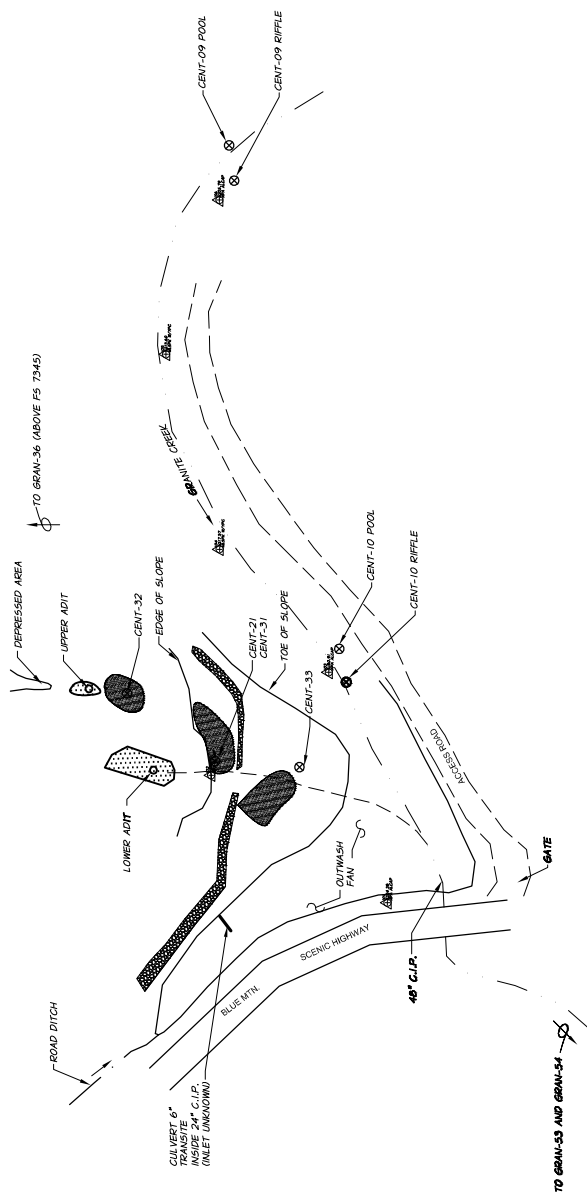
Figure 5. CENTRAL MINE SITE

- **Central Mine.** No overland flow was observed at the mine site during the field investigation. A runoff channel (dry during the field investigation) was observed coming from the waste pile near the lower adit (Figure 5). Water likely runs through this channel into Granite Creek during periods of high rainfall and snowmelt. A waste rock berm, the result of hydraulic mining activities, was observed along the slope above the creek. Immediately downstream of the mine, Granite Creek flows under the Scenic Highway through a large culvert.
-
