Chapter I Characterization

The Blue River Watershed is a fifth field watershed of 59,000 acres located entirely within the Blue River Ranger District of the Willamette National Forest. Most of the area is administered by the Forest Service; 3% of the watershed is within private ownership. The watershed is located north of the town of Blue River and extends from a ridge above Simmonds Creek to the west up to the Gold Hill area and then runs along the ridge up to Tidbits Mountain to Bear Pass and then to Squaw Mountain. From there the boundary turns south and continues to Carpenter Mountain down the ridge to Lookout Ridge where it turns west and back to below the Blue River dam and Simmonds Creek. The Blue River Watershed is located within the McKenzie River Subbasin and represents approximately 7% of the subbasin's total acreage.

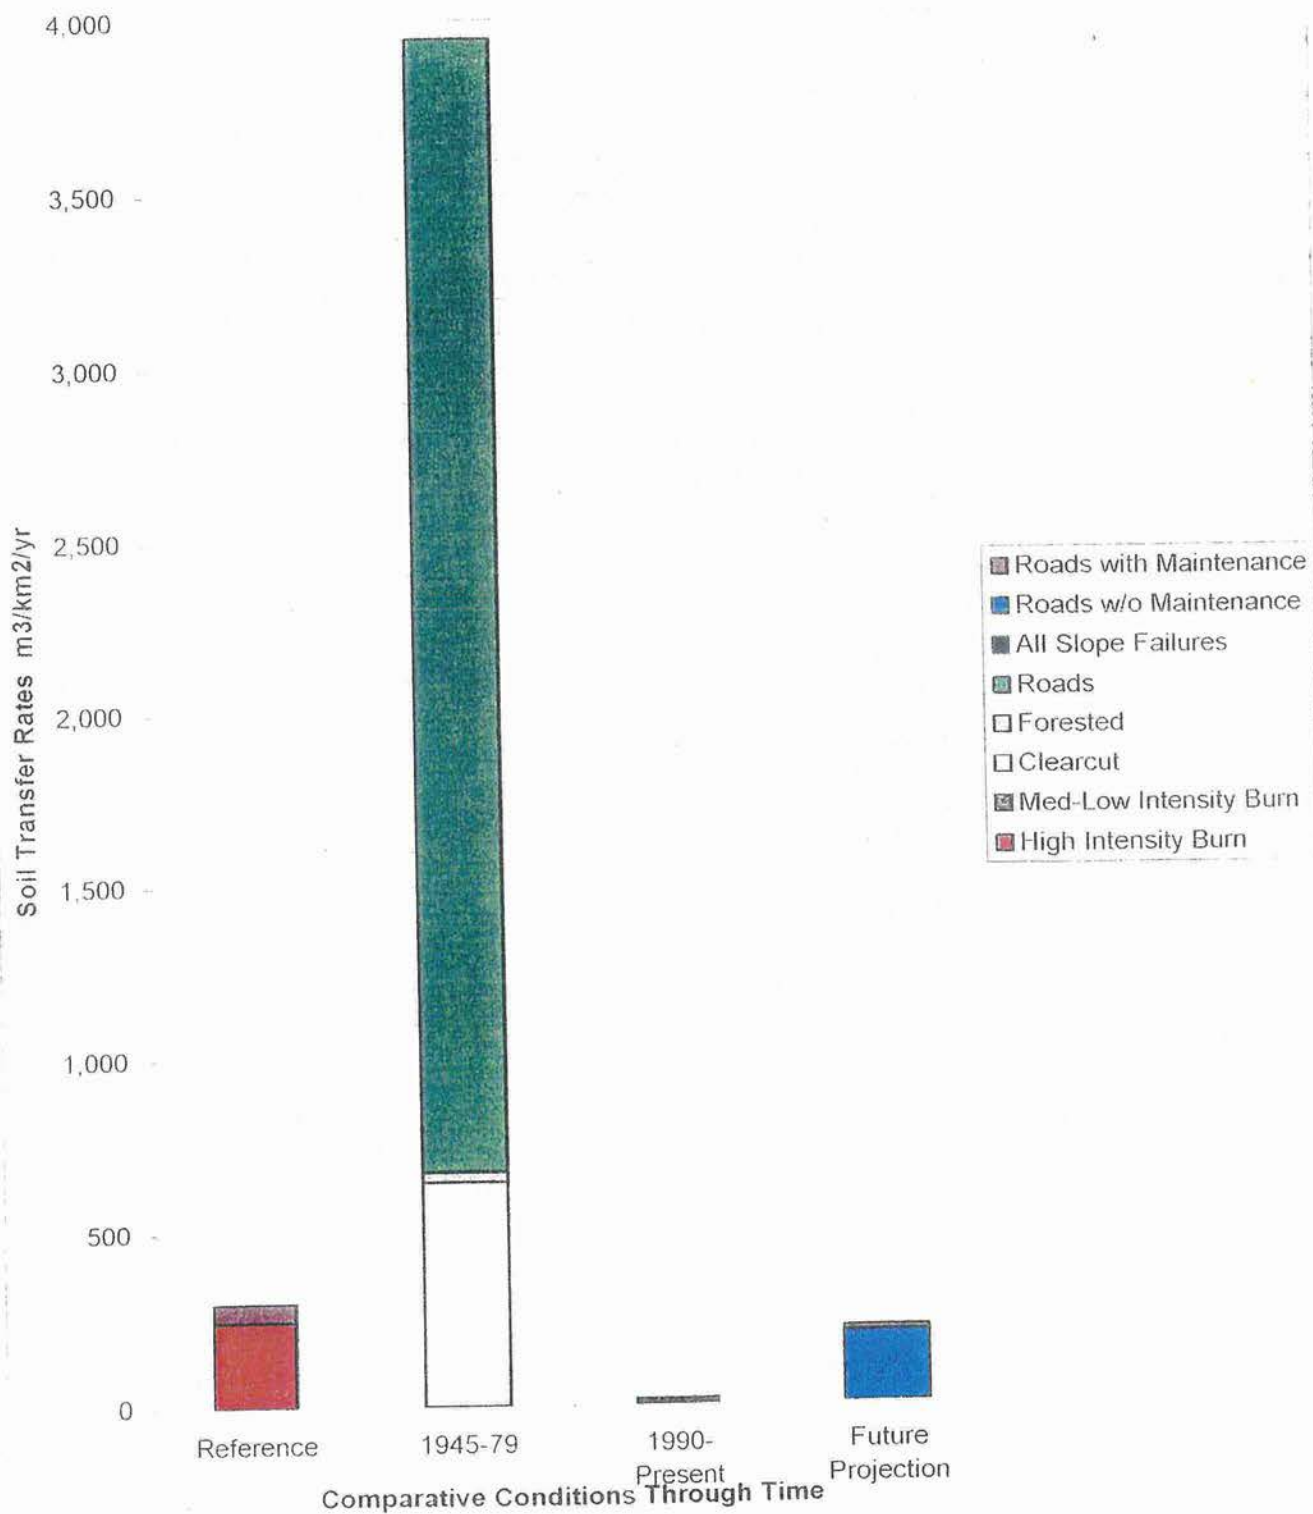
Figure 2: Soil Transfer Rate

SOIL TRANSFER RATES by Cumulative Area per unit Time

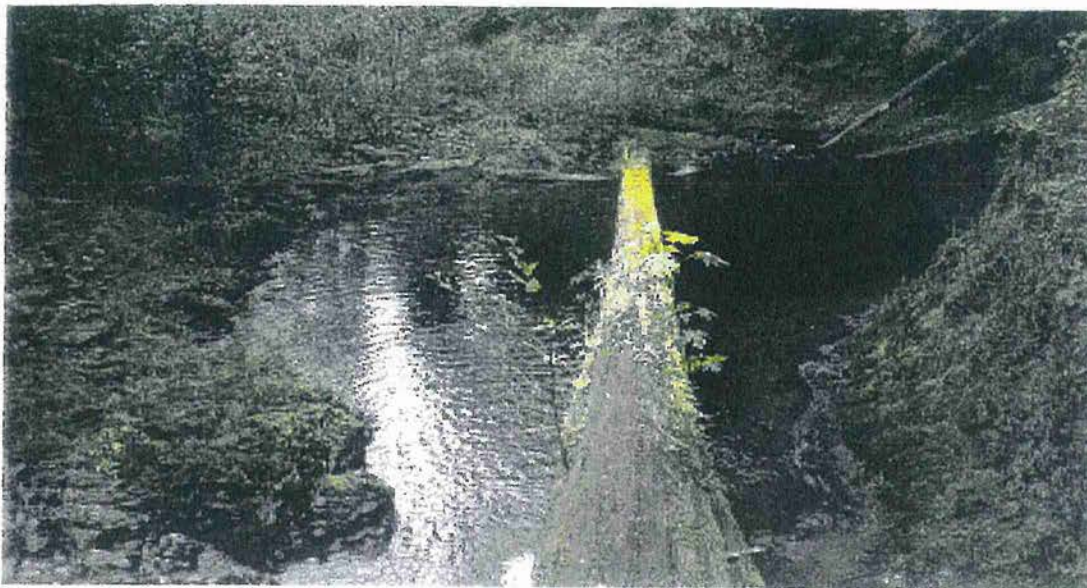
Blue River aquatic ecosystem restoration project photopoint monitoring. Photopoint 2 taken summer 1995. Notice recruitment of gravels on once bare bedrock.
