# TUMALO CREEK WATERSHED ANALYSIS

Deschutes National Forest  
Bend/Ft. Rock Ranger District  
2008

An Update to the 1998 Bend Watershed Analysis

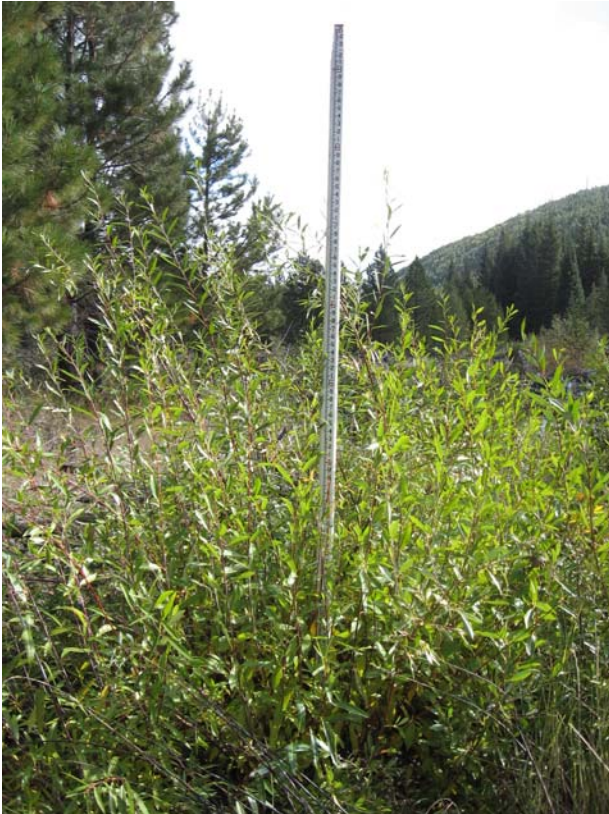
**Photograph 2. Phase I Plants**

The photographs below, taken in October 2008, depict the plants in all three restoration phases. Plants were not measured for height in 2008, but individuals were near 7, 8, and 3 feet height for Phases I, II, and III, respectively. The rod in the photographs is 9.5 feet tall.
