# Pinyon Plain Mine – 2025 Q2 Monitoring Summary

**April - June 2025  
Kaibab National Forest**

The purpose of this report is to provide a summary of the USDA Forest Service's administration and monitoring of the Pinyon Plain (formerly Canyon) uranium mine on the Tusayan Ranger District of the Kaibab National Forest.

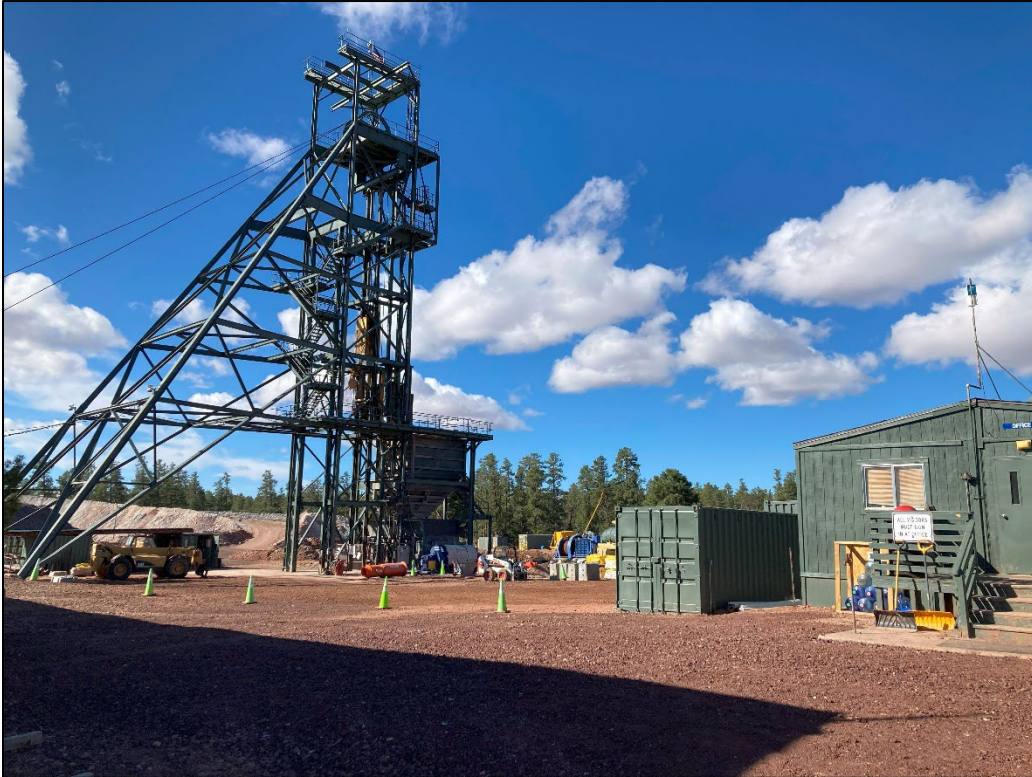
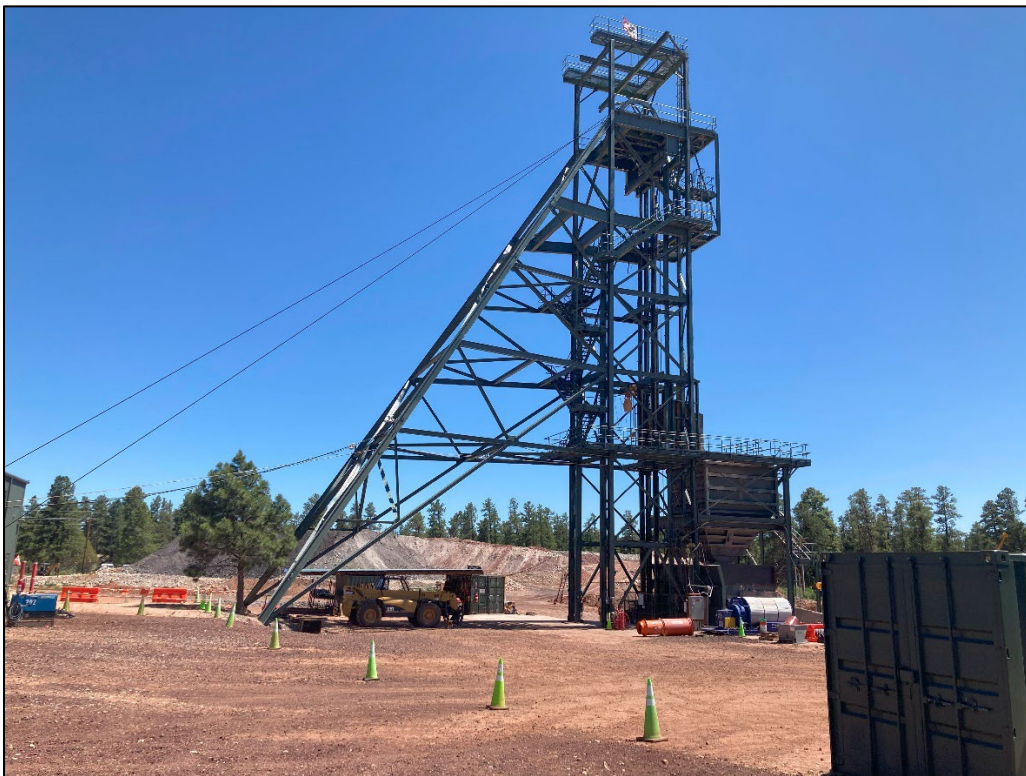
The office, parking area, and structures remain clean and well maintained. Staff on site have created safety areas using cones and other high-visibility barriers to block machinery as people travel on foot (Photos 1 – 3). Minimal snowfall and rain occurred in Q1 and Q2, allowing the operator to properly maintain the roadways used within the perimeter of the site (Photos 4 – 6).

Photo 1 – View of the headframe from office trailer, facing south. (Apr. 29)

Photo 2 – Additional view of the headframe from office trailer, facing south. (Jun. 23)

Photo 3 – Overlooking the office area, adjacent to staff parking. (Apr. 29)

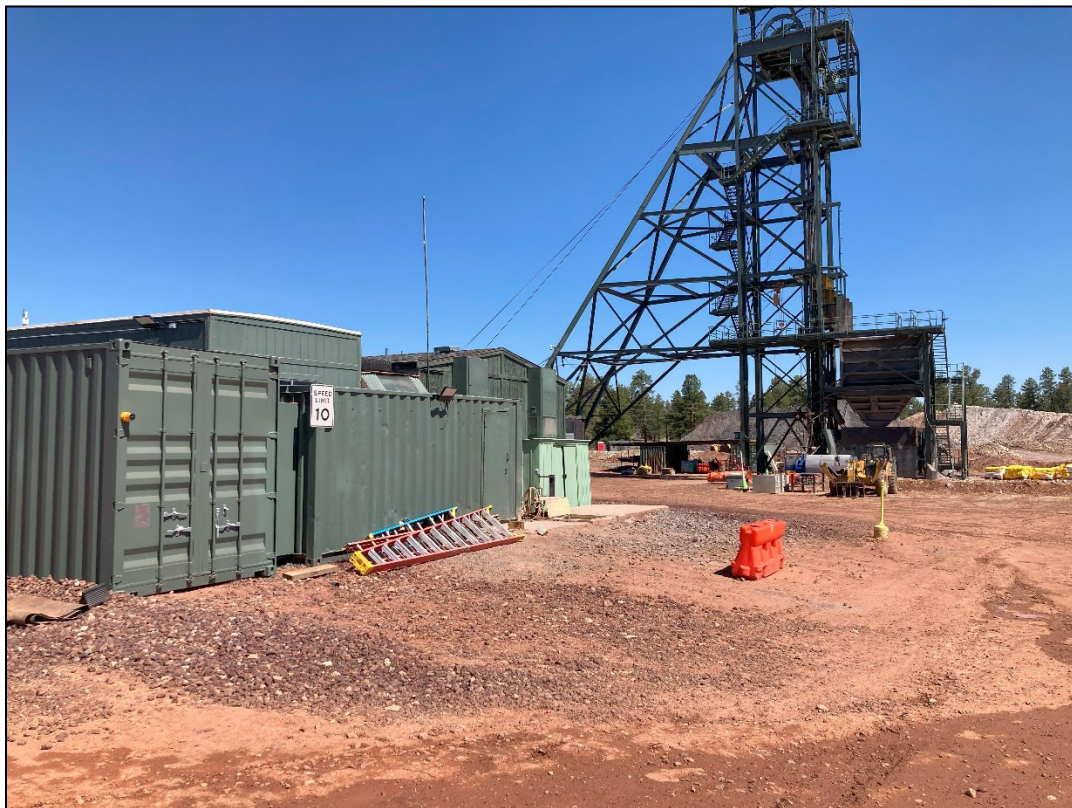
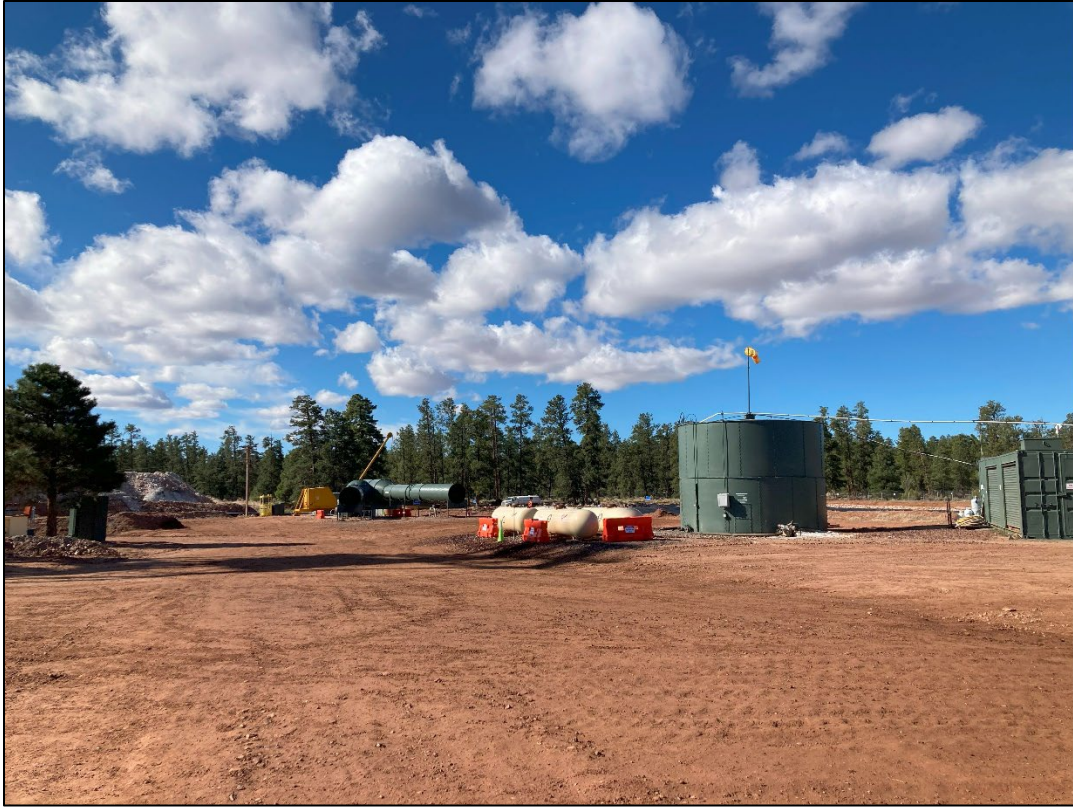
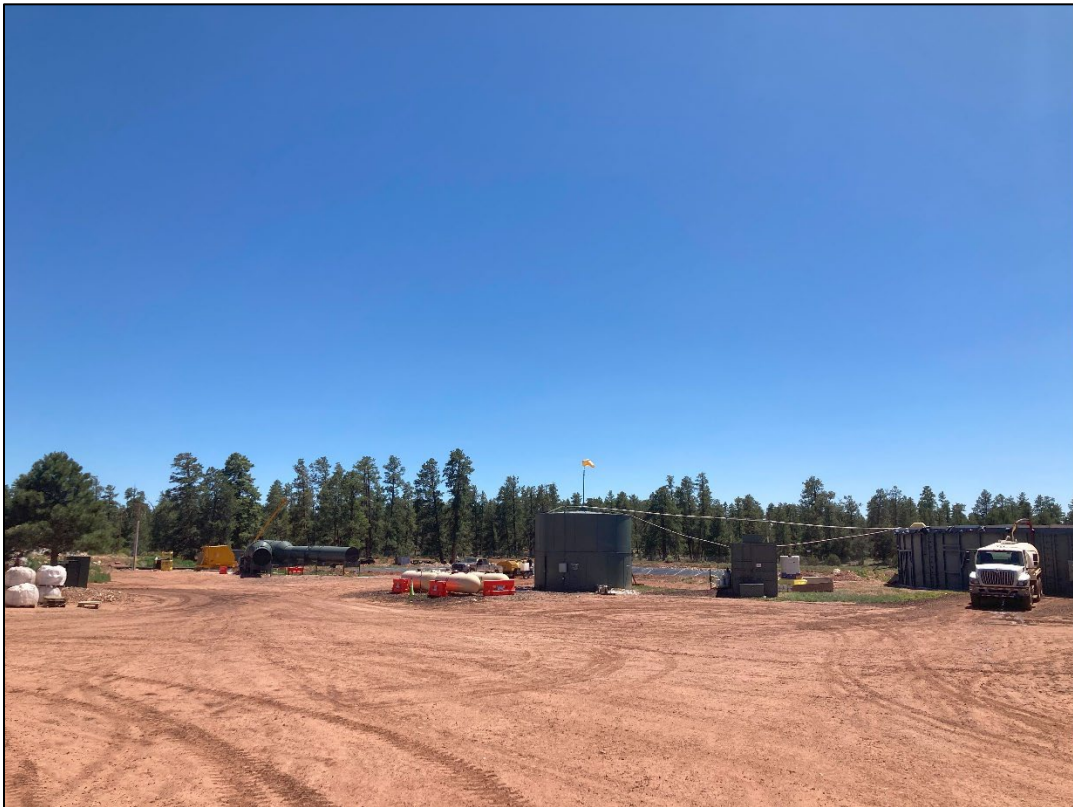
Photo 4 – Conex box storage for gear near the office building. (May 23)

Photo 5 – Overlooking propane tanks, ventilation shaft and water storage tanks. (Apr. 29)

Photo 6 – Additional view of the propane and water storage tanks. (Jun. 23)

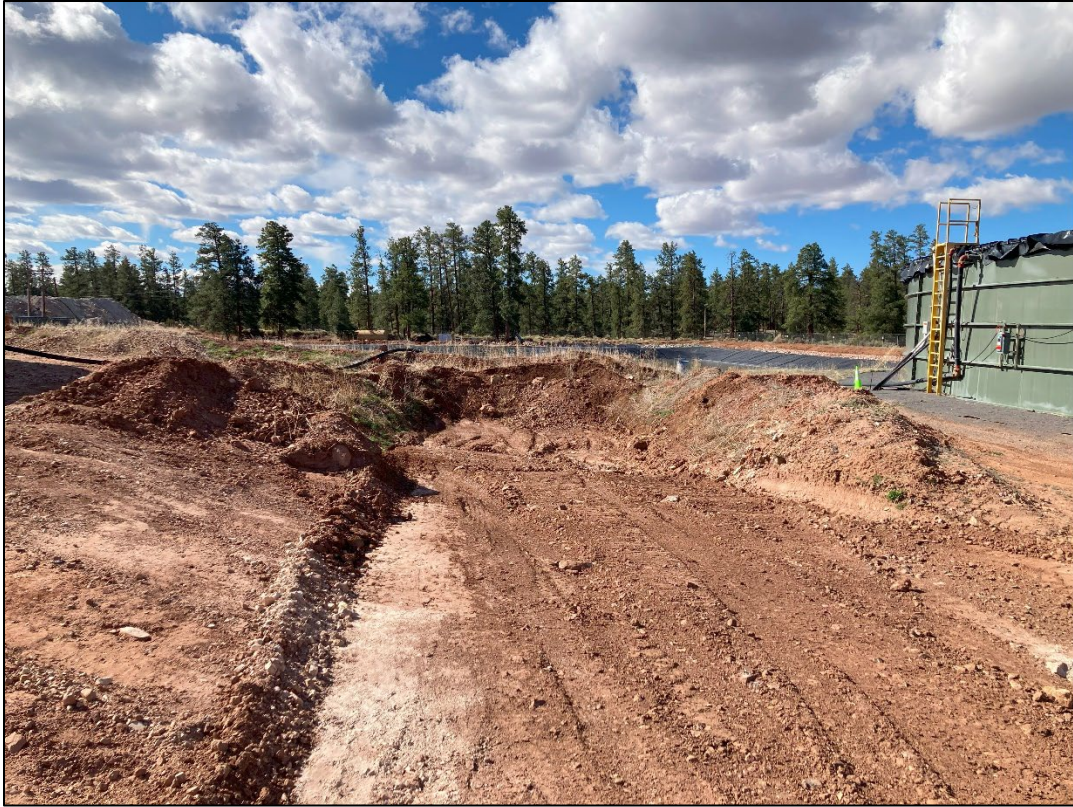
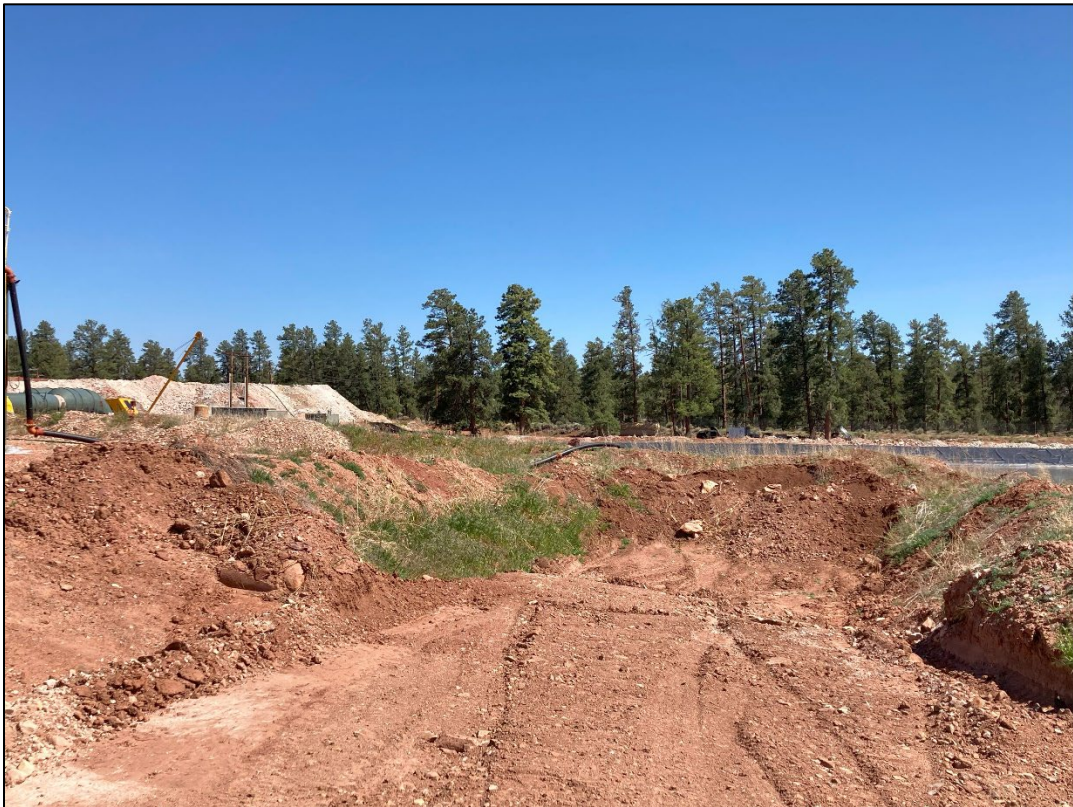
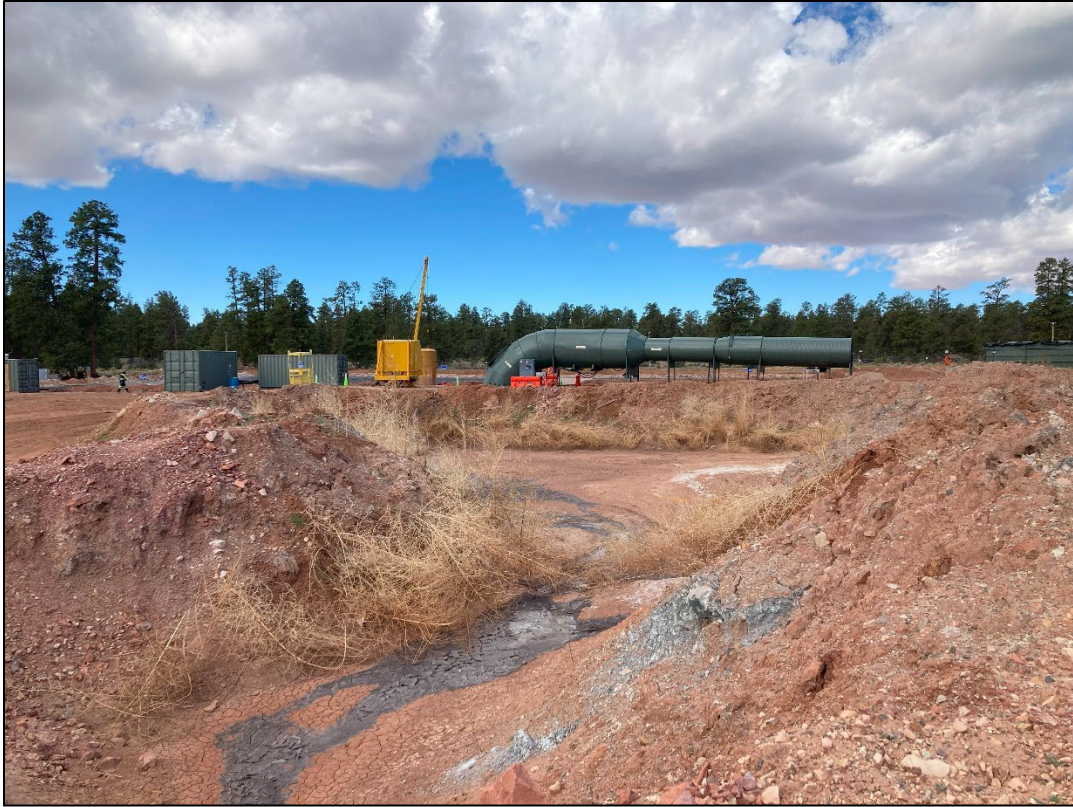
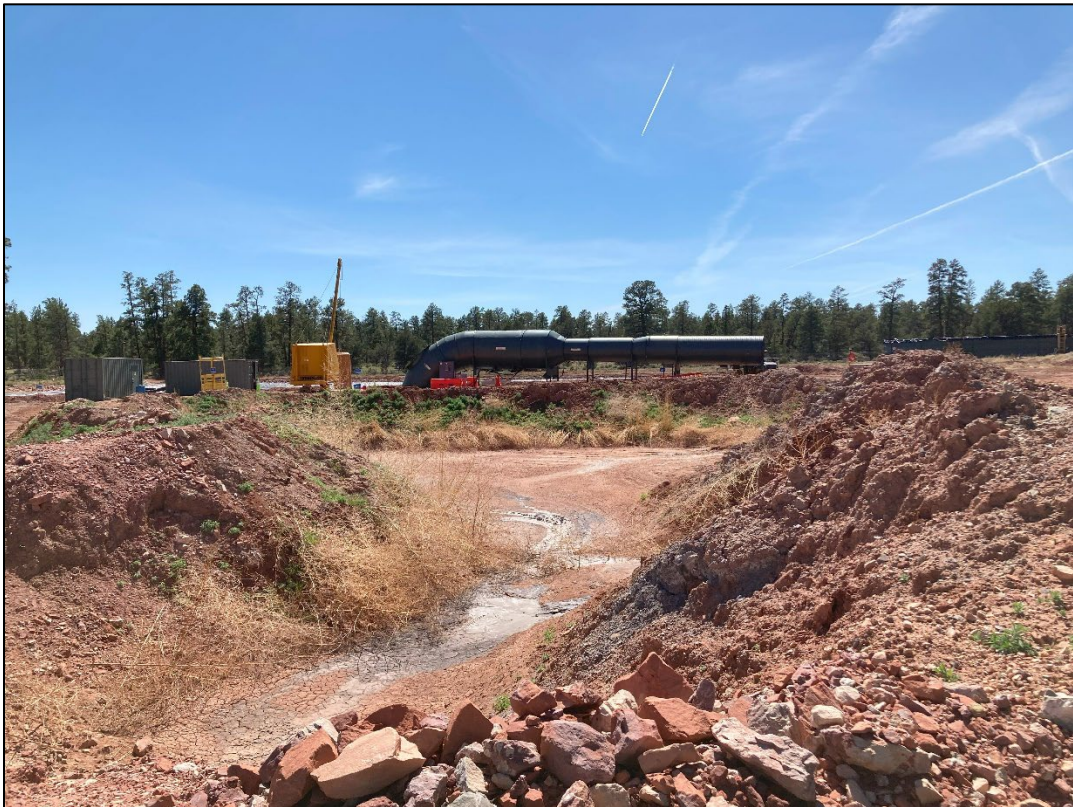
Both rainwater catchments remained dry during Q2 (Photos 7 – 10). During the June site visit, the non-stormwater impoundment was under maintenance (Photo 11). Mud was being removed from the impoundment and EFR stated this type of maintenance would become a routine operation, occurring once every other year. The mud is transported to the development rock stockpile, and at times added to the ore stockpile depending on the grade of the material. EFR previously removed mud from the non-stormwater impoundment in 2021. The evaporation system in the non-stormwater impoundment was offline during all three site visits in Q2 (Photos 12 – 14).

Photo 7 – Rainwater catchment (empty) between the two water tanks in NW perimeter. (Apr. 29)

Photo 8 – Additional look at rainwater catchment (empty) between the two water tanks in NW perimeter. (May 23)

Photo 9 – Overlooking the central rainwater catchment, facing southwest. (Apr. 29)

Photo 10 – Central rainwater catchment. (May 23)

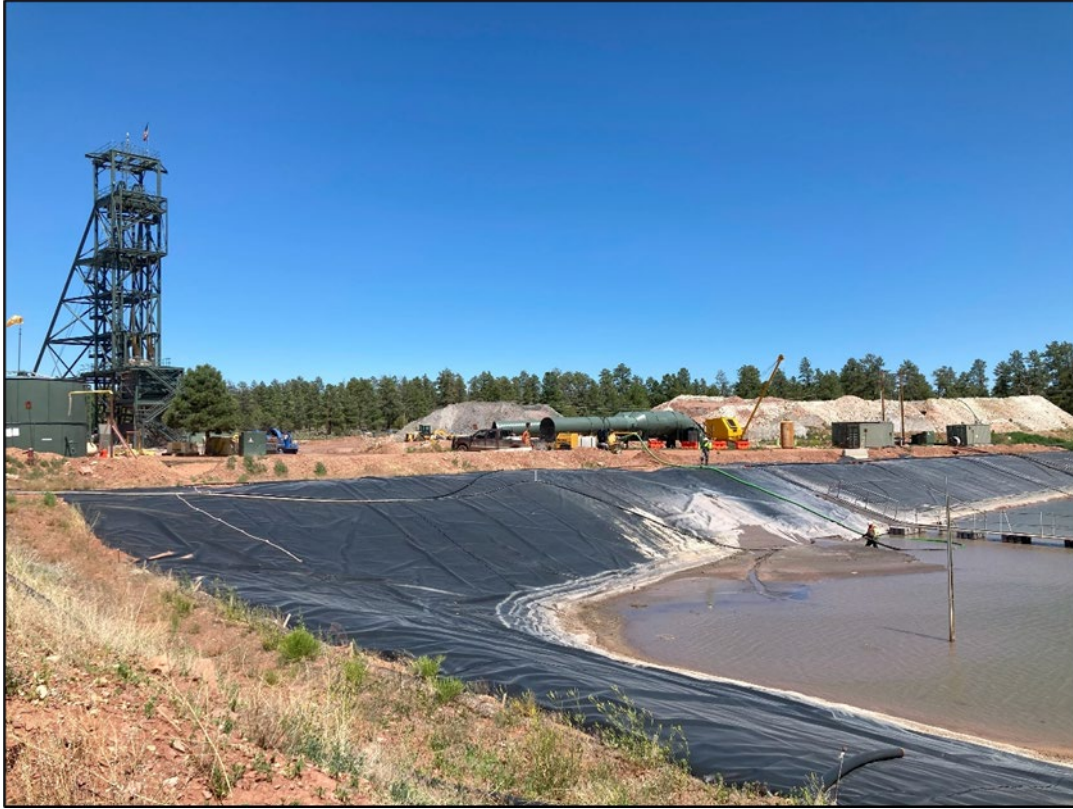
Photo 11 – Non-stormwater impoundment undergoing maintenance. (Jun. 23)

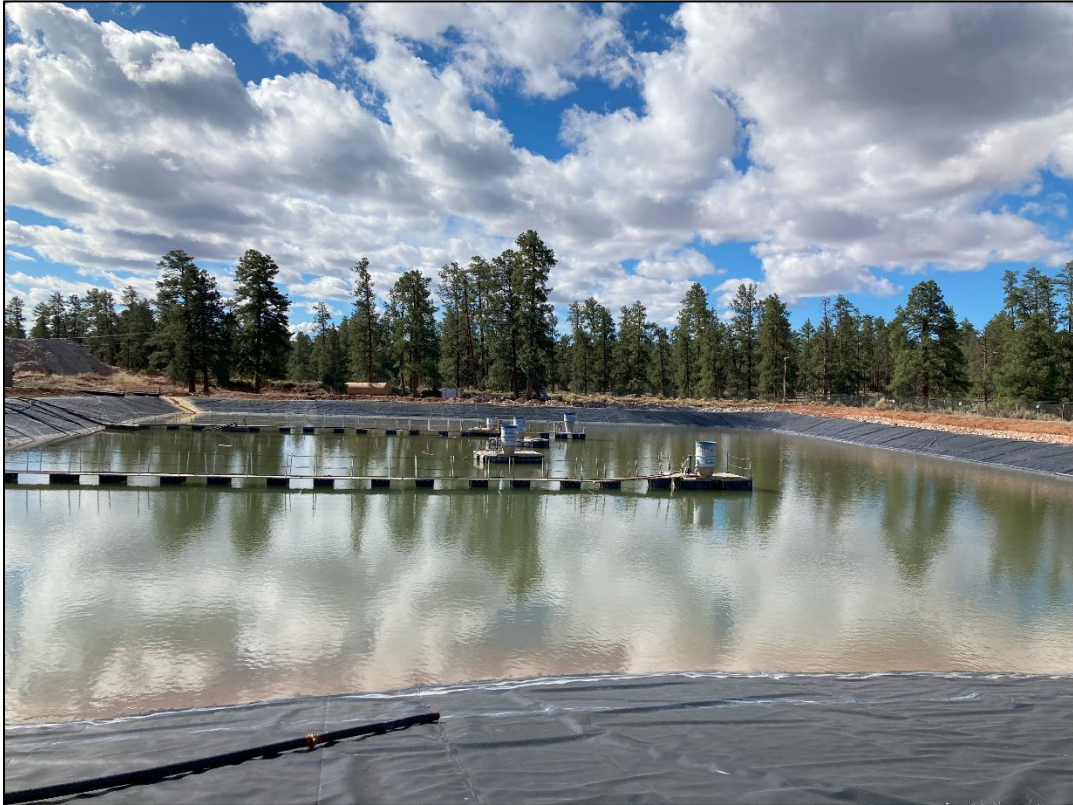
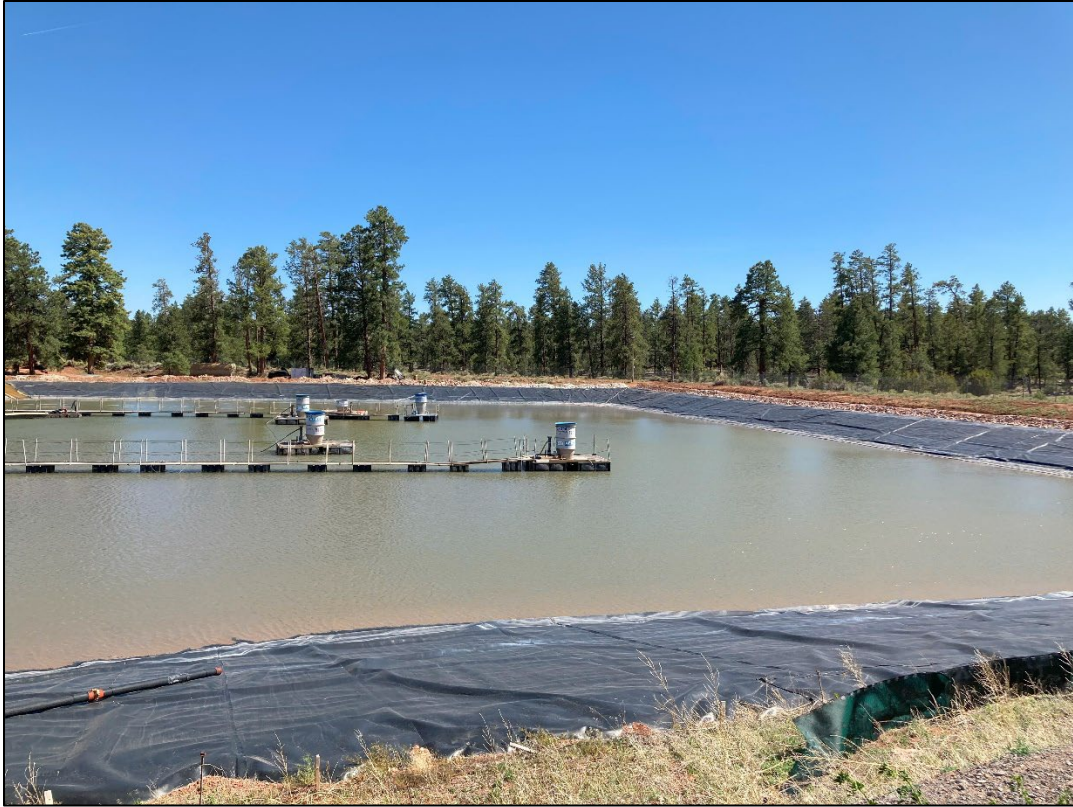
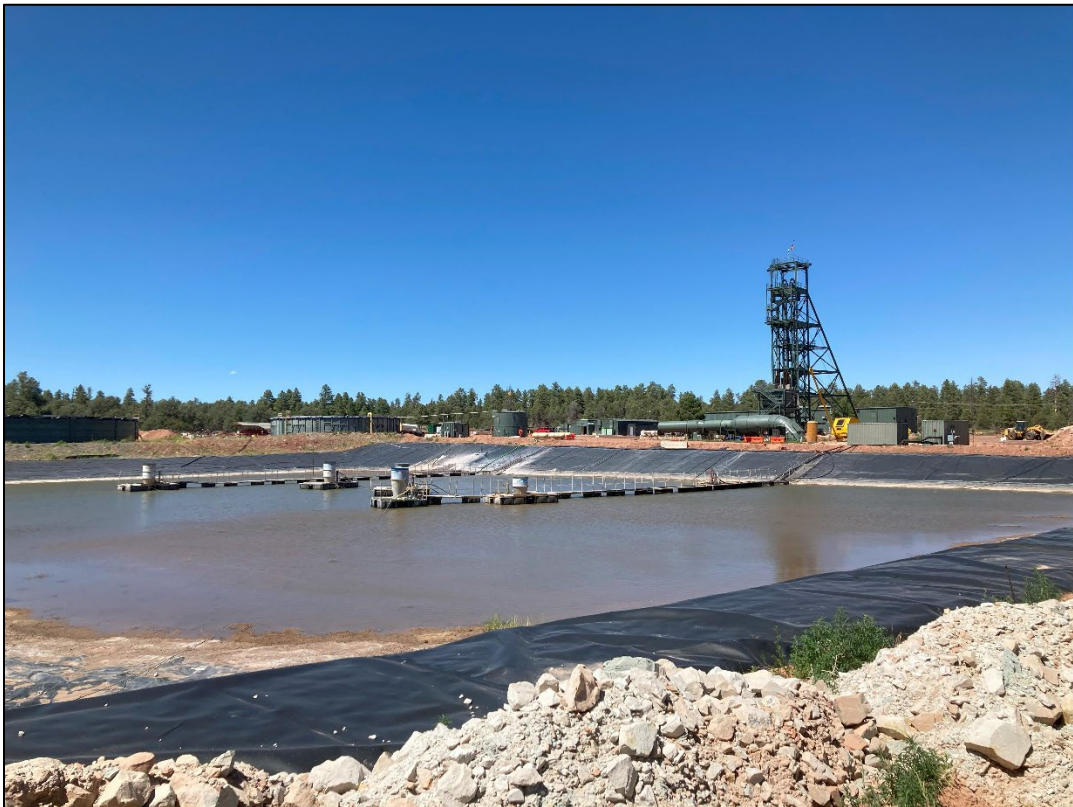
Photo 12 – Overlooking the non-stormwater impoundment. All evaporators were offline. (Apr. 29)

Photo 13 – Non-stormwater impoundment. All evaporators were offline. (May 23)

Photo 14 – Overlooking non-stormwater impoundment, facing NE. All evaporators were offline. (Jun. 23)

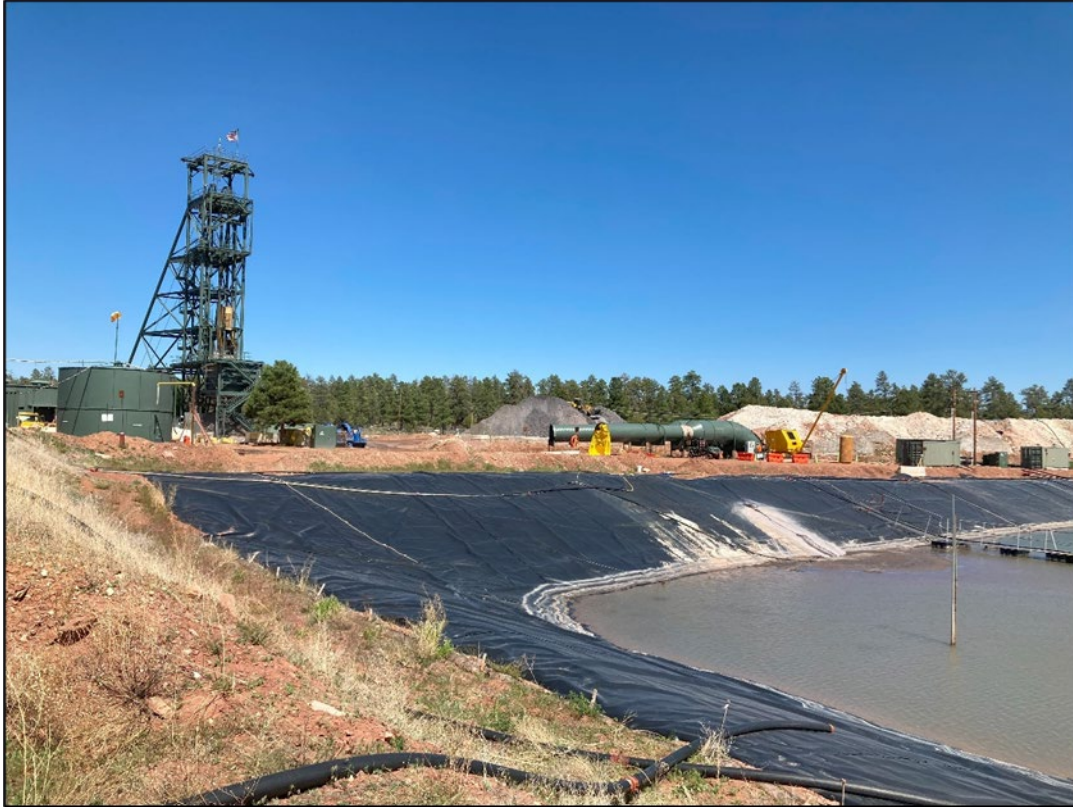
Ear protection was not necessary while walking near the perimeter of the fans and non-stormwater impoundment. The ventilation system currently runs at 50% of its capacity and underwent routine maintenance in May (Photo 15).

Photo 15 –Ventilation shaft undergoing maintenance. (May 23)

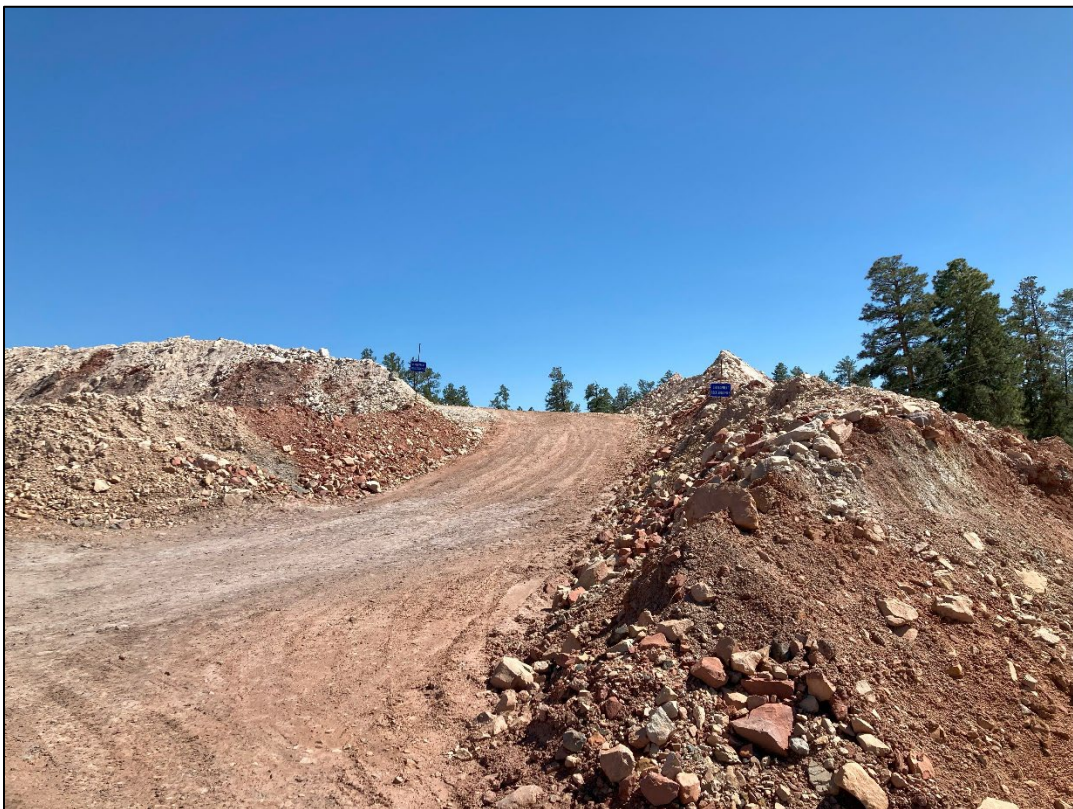
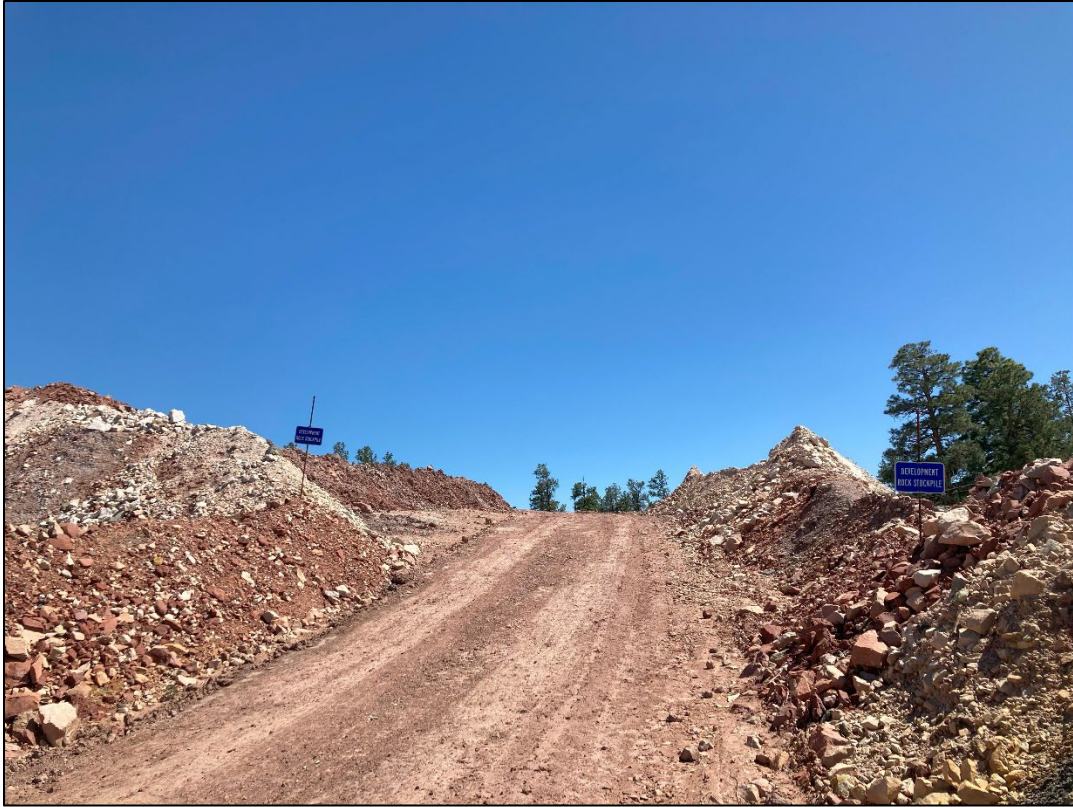
The volume of the development rock stockpile continues to increase (Photos 16 – 17). The hoses used to apply water for dust abatement were reinstalled in April for use during Q2 (Photos 18 – 19). These hoses are typically removed during the winter season to avoid freezing or damage from cold temperatures. The amount of ore on the ore pad also increased during Q2 (Photos 20 – 25). In May, the location of the pole used to determine the height of the ore pad was moved to a different spot within the ore pad. The lowest recorded amount of ore reported in Q2 was approx. 6,200 tons in April and highest approx. 12,800 tons in June.

Photo 16 – Entrance of development rock stockpile. (May 23)

Photo 17 – Entrance of development rock stockpile. (Jun. 23)

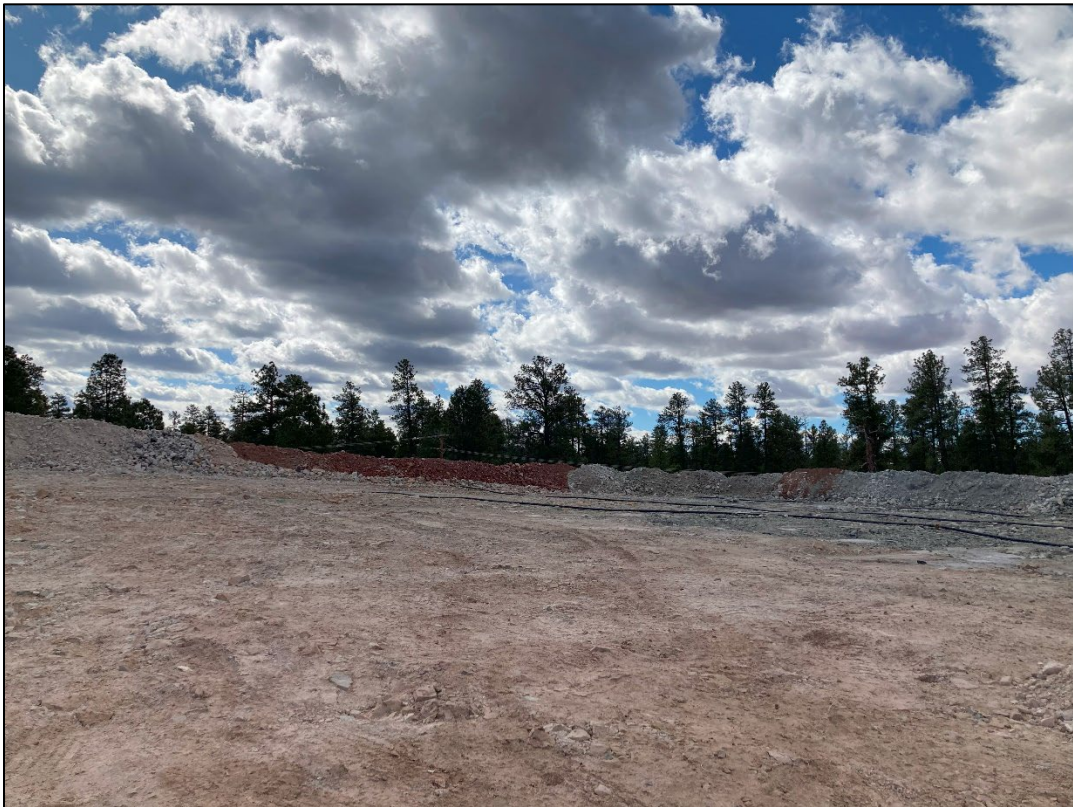
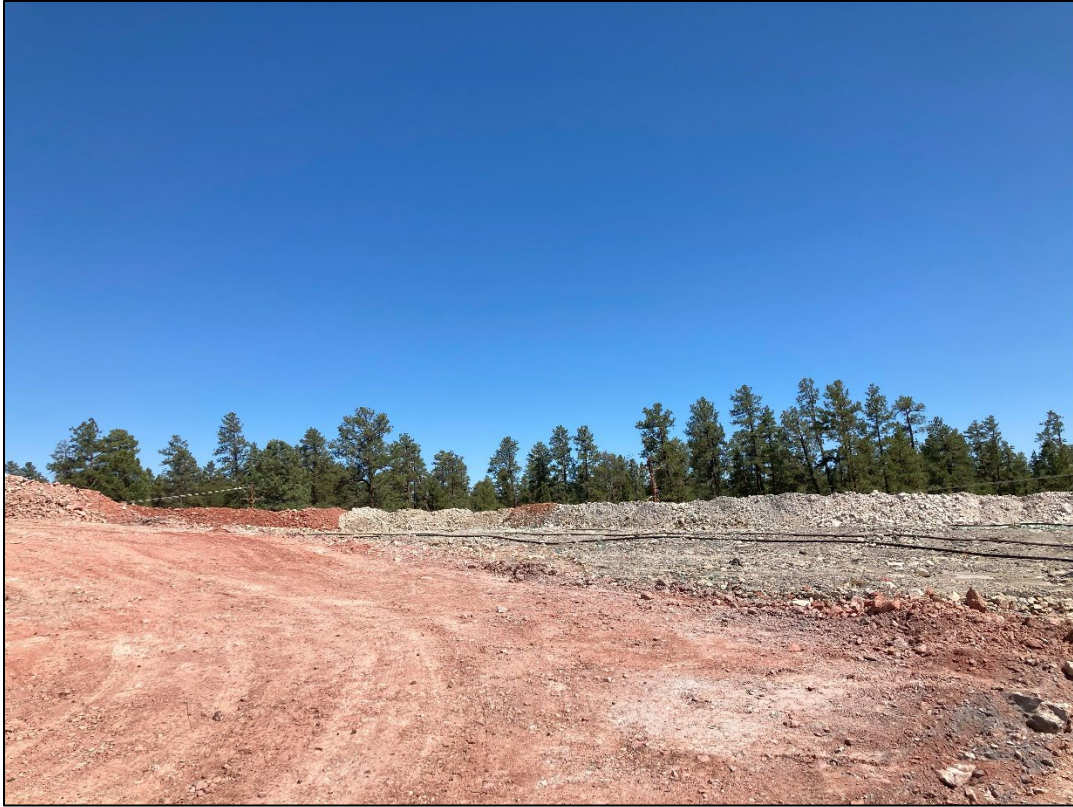
Photo 18 – Overlooking central area within development rock stockpile. (Apr. 29)

Photo 19 – Overlooking central area within development rock stockpile. (Jun. 23)

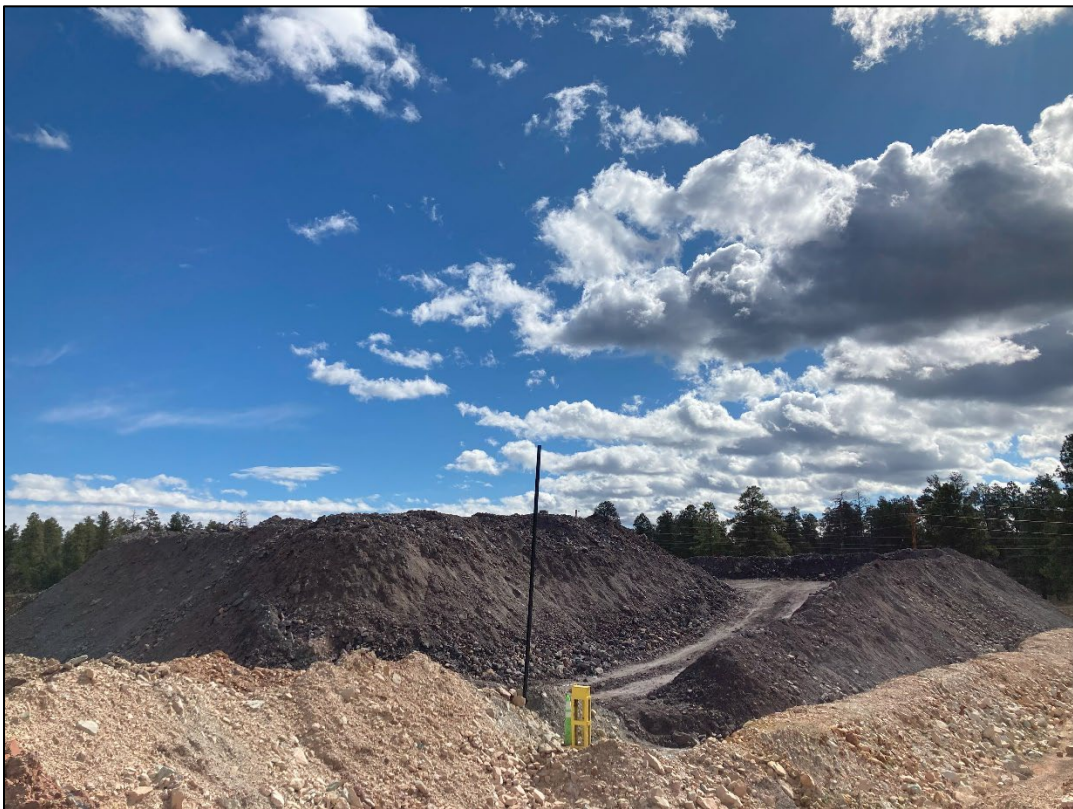
The 2025 Q1 report noted that the amount of ore on the ore pad fluctuated between 5,900 and 6,900 tons. During Q2 of 2025, EFR increased its production and by the end of the quarter, the ore pad contained approximately 12,800 tons. Ore stockpile heights, as reported by EFR, fluctuated between 16 and 20 feet, with a height of 19 – 20ft. reported on June 23, 2025. The amount of ore on the ore pad is limited to 13,100 tons and 20 ft in height by the air quality permit EFR has from the Arizona Department of Environmental Quality. All numbers EFR reported to the Forest Service during Q2 of 2025 were within these limits. In November 2024, EFR reported that a survey of the mine site was complete. The results from the survey, including calculations from estimated ore bucket weights, indicate that the conversion rate from a ton to a cubic yard of uranium ore is 1.68 tons per cubic yard.

Photo 20 – Overlooking the ore pad, facing NE. Pole is used to determine height of stockpile. (Apr. 29)

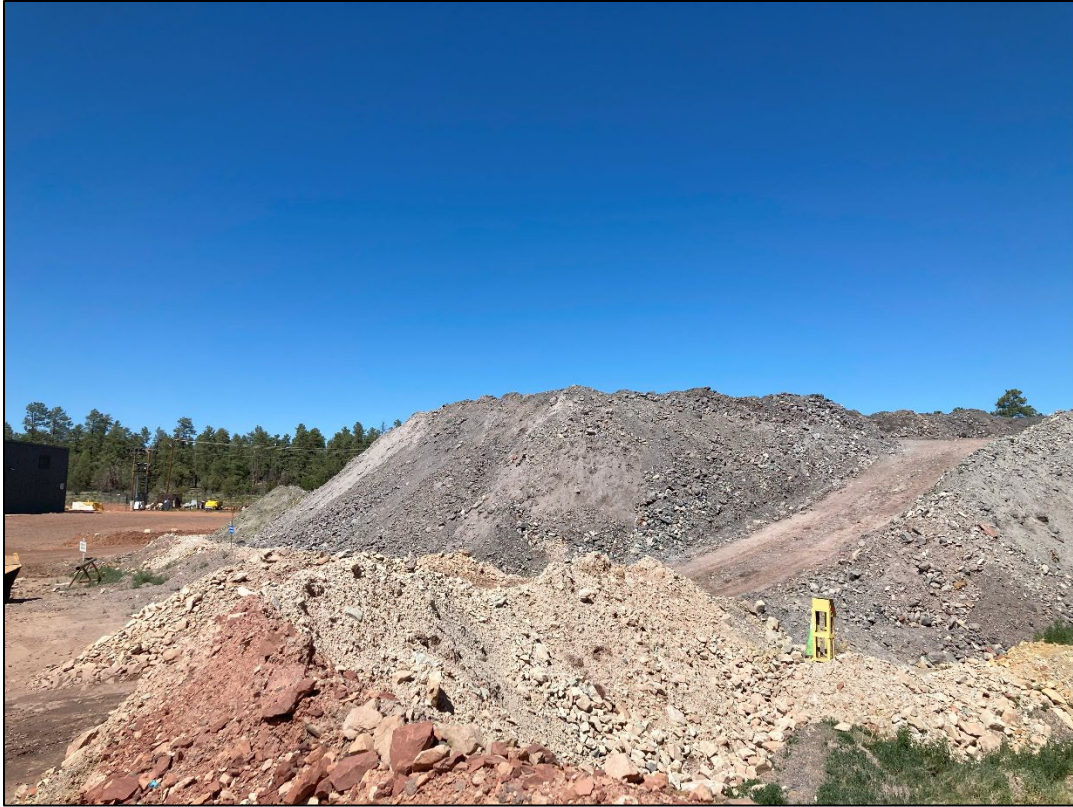
Photo 21 – Overlooking the ore pad from the entrance to the development rock stockpile, facing NE. (Jun. 23)

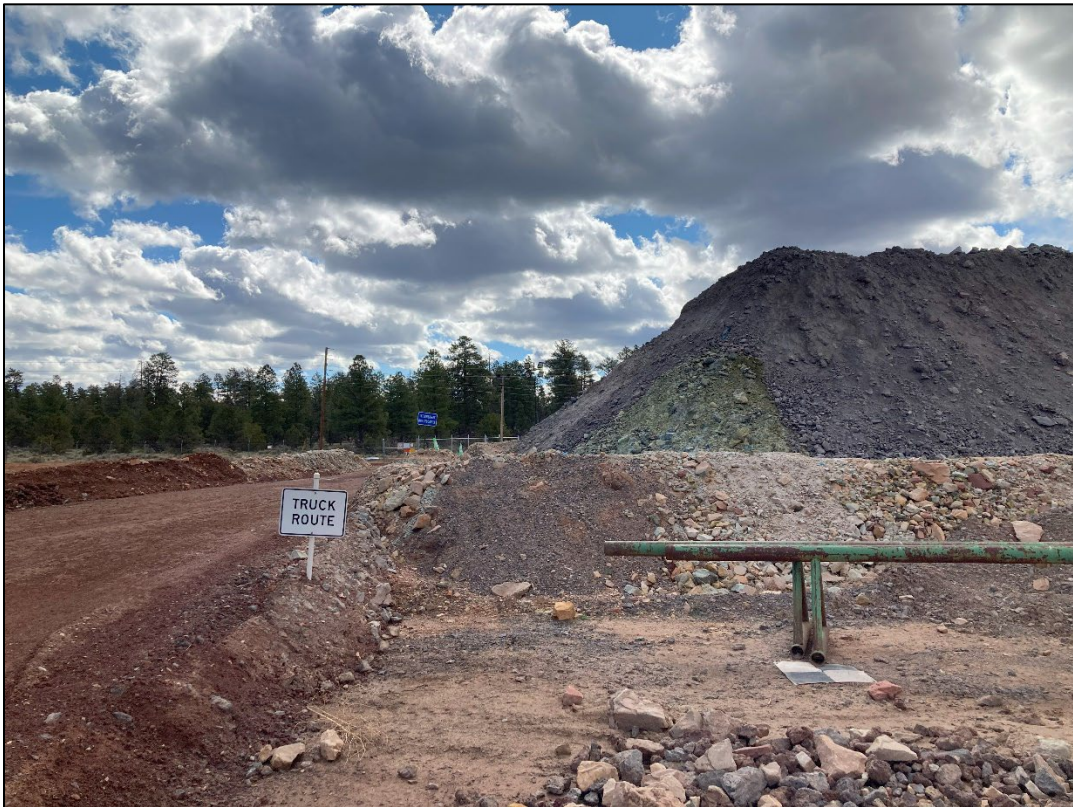
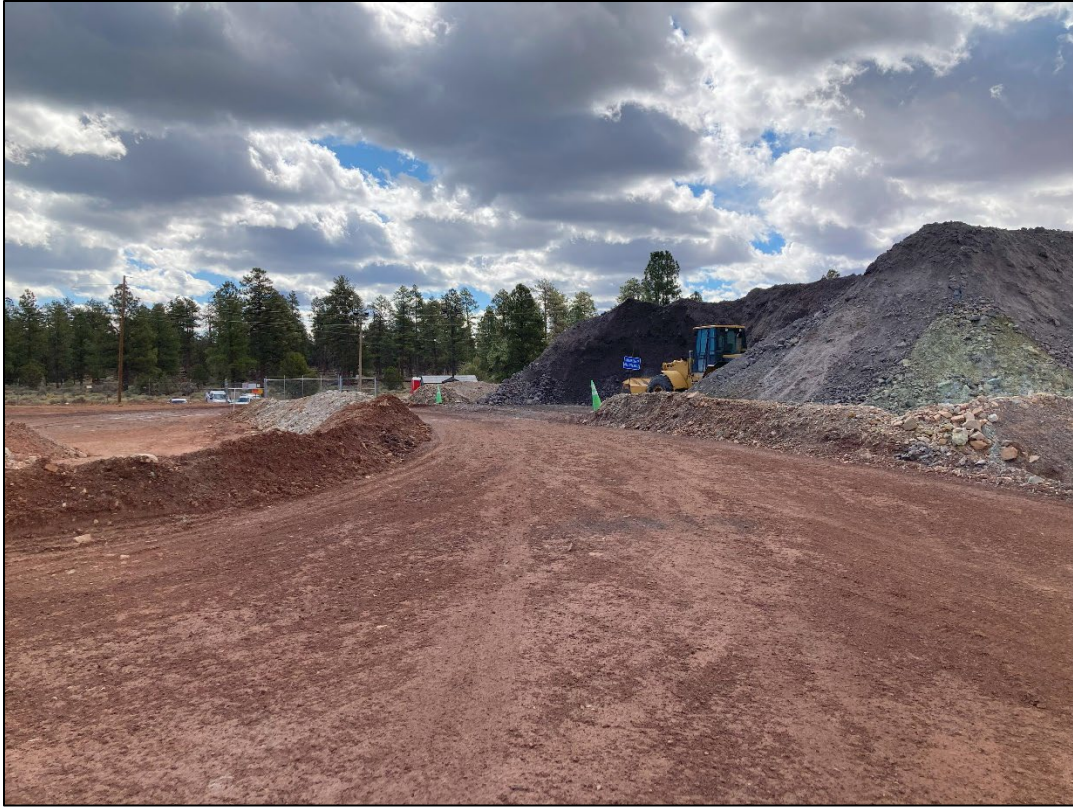
Photo 22 – Overlooking the ramp of the ore pad. (Apr. 29)

Photo 23 – Overlooking the ramp used by haul trucks to access the ore pad. (Apr. 29)

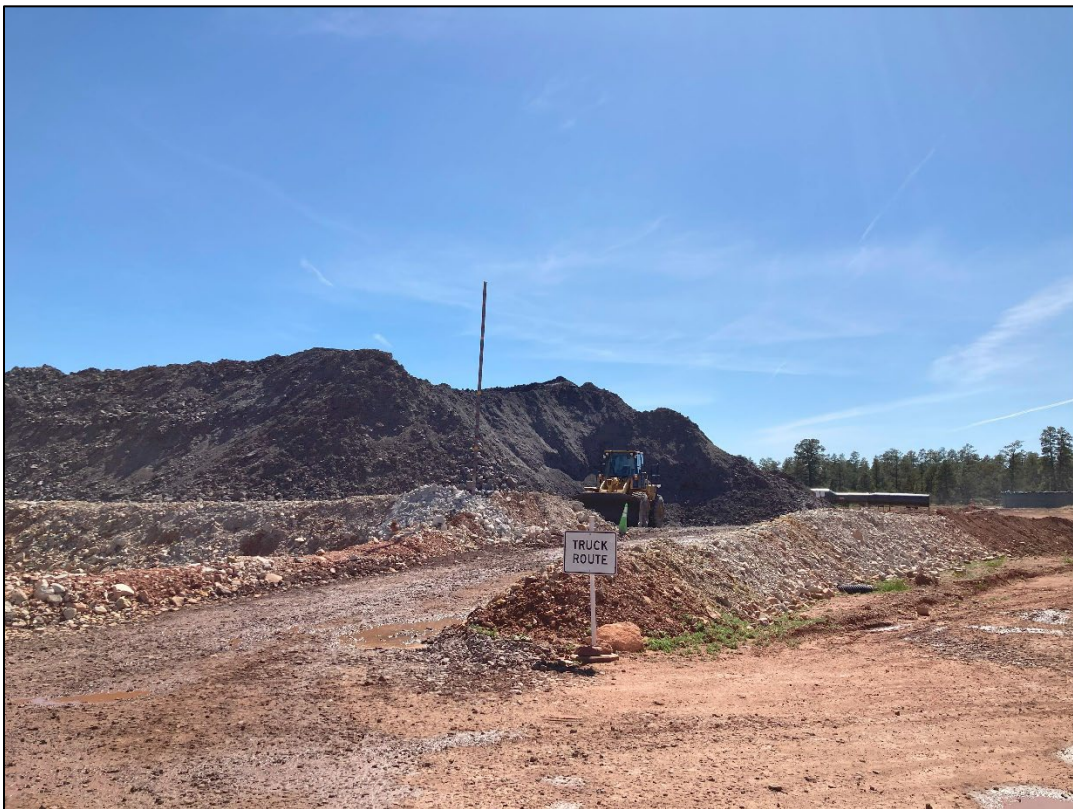
Photo 24 – Overlooking ore pad ramp. Note new location of pole use to determine height of ore stockpile. (May 23)

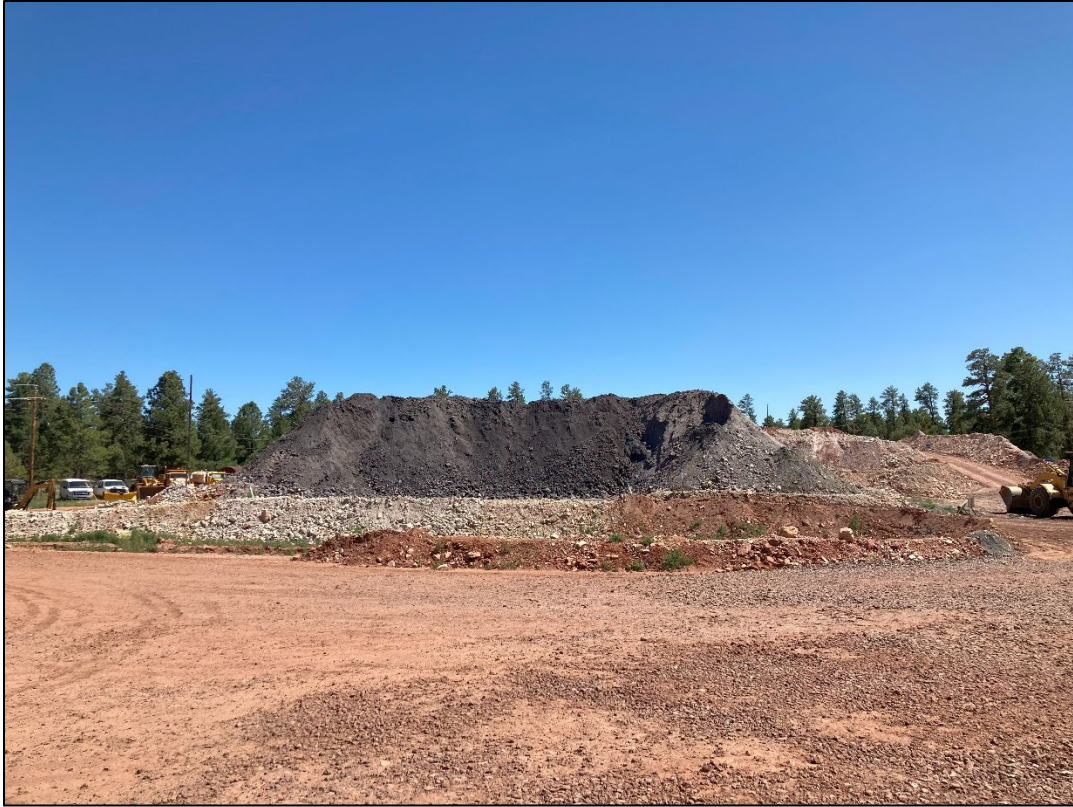
Photo 25 – Ore stockpile on ore pad. Ore is dark gray material. (Jun. 23)

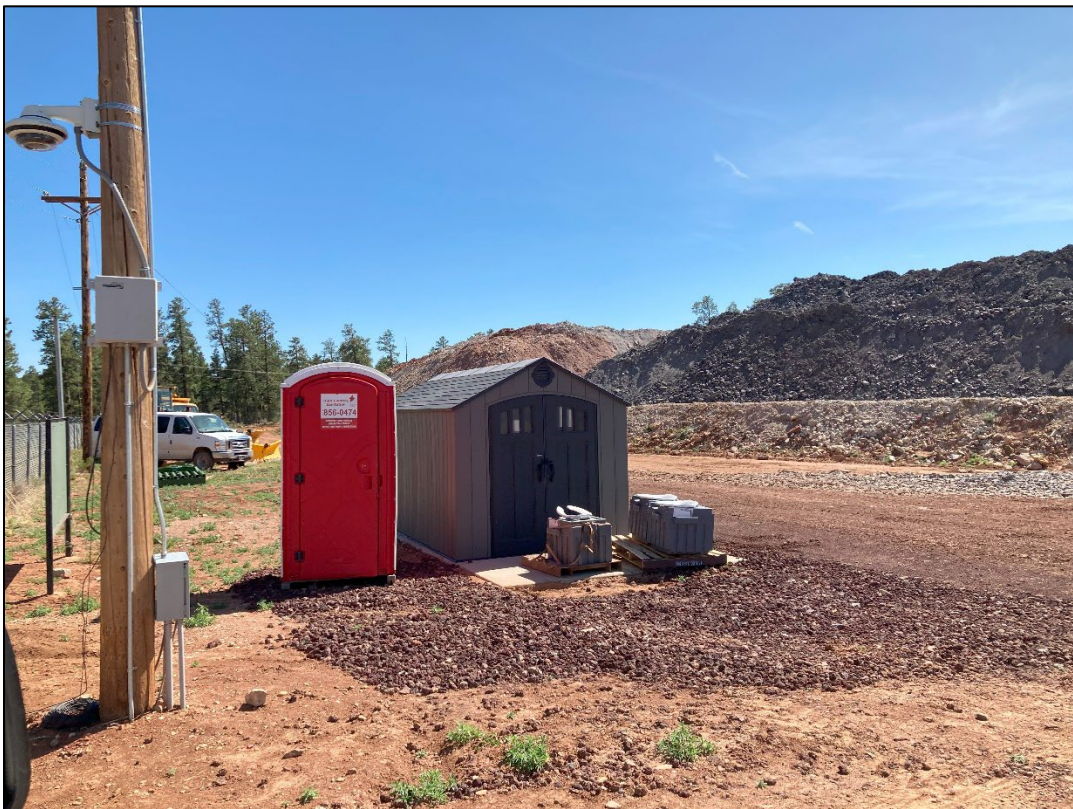
Photo 26 – Installed shed to be used by Navajo Nation. (May 23)
