# Pinyon Plain Mine – 2025 Q2 Monitoring Summary

**April - June 2025  
Kaibab National Forest**

The purpose of this report is to provide a summary of the USDA Forest Service's administration and monitoring of the Pinyon Plain (formerly Canyon) uranium mine on the Tusayan Ranger District of the Kaibab National Forest.

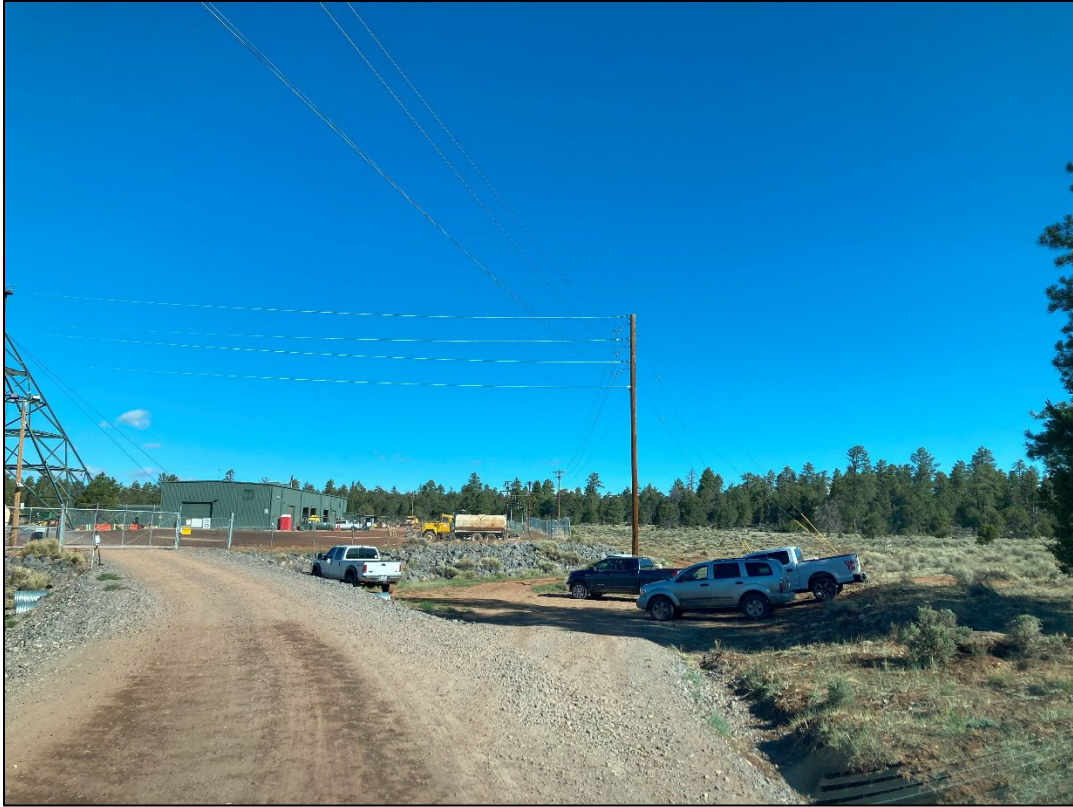
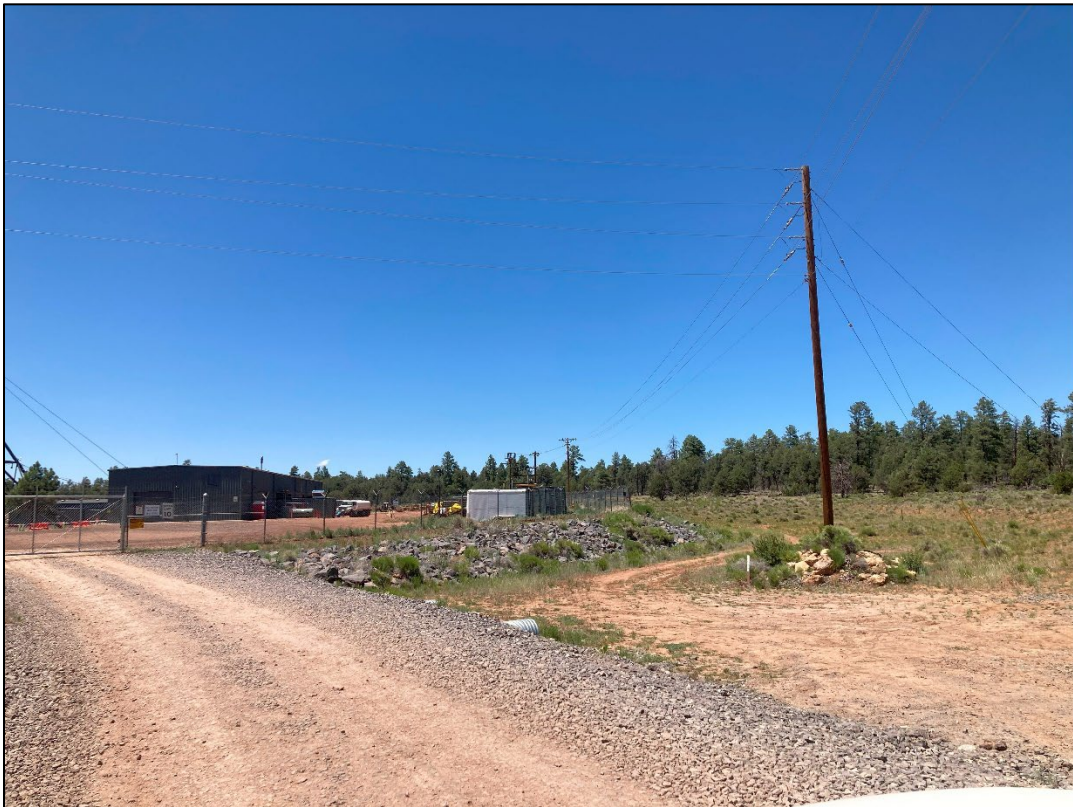
The access road continues to be maintained and no signs of rutting were present. Parking outside the perimeter was observed in April and corrected by June (Photos 27 – 28).

Photo 27 – Trucks parked outside the mine perimeter, near the entrance to the site. (Apr. 29)

Photo 28 – Overlooking area near entrance of the mine. (Jun. 23)
