Pinyon Plain Mine – 2025 Q3 Monitoring Summary

**July - September 2025
Kaibab National Forest**

Introduction

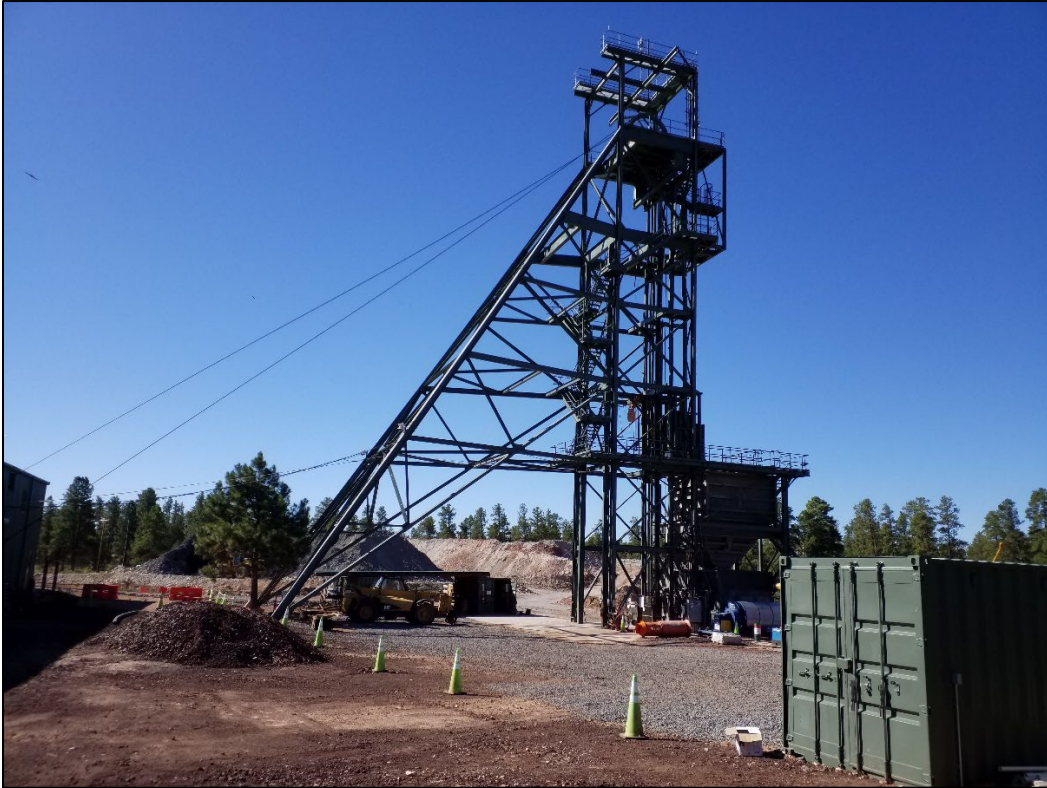
EFR continues to maintain the parking area and structures within the perimeter in an orderly manner. Staff on site have created safety areas using cones and other high-visibility barriers to block machinery to allow safe passage for foot traffic (Photos 1 – 3).

Photo 1 – View of the headframe from office trailer, facing south. (July 30)

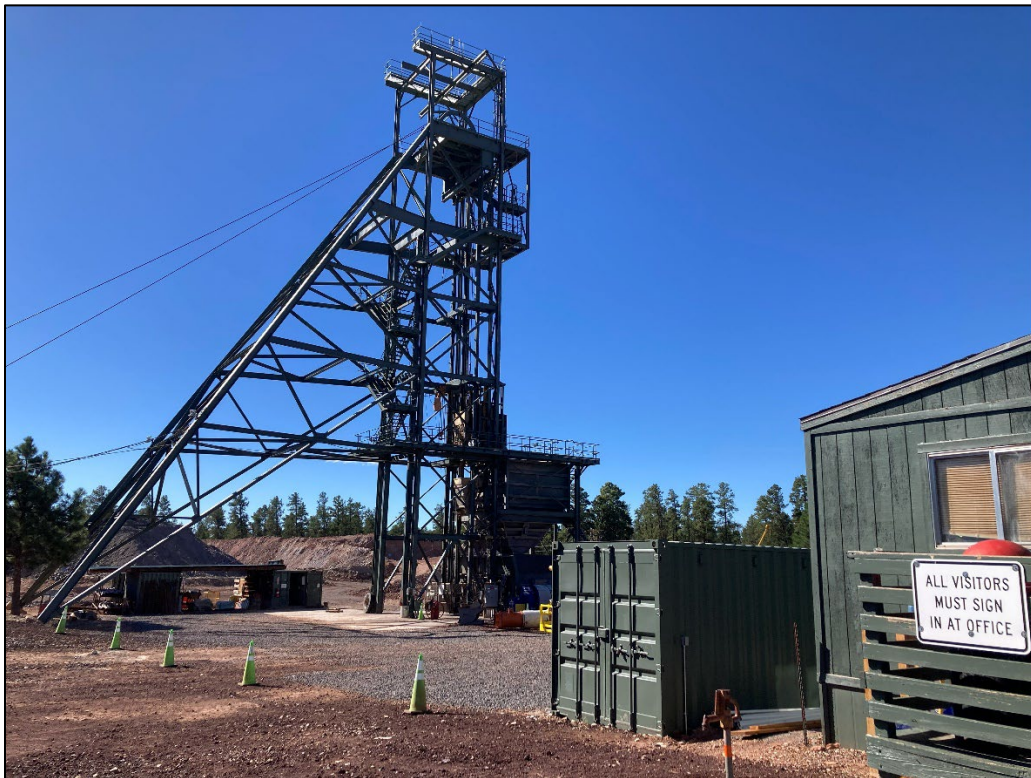
Photo 2 – Headframe from office trailer, facing south. (Aug. 22)

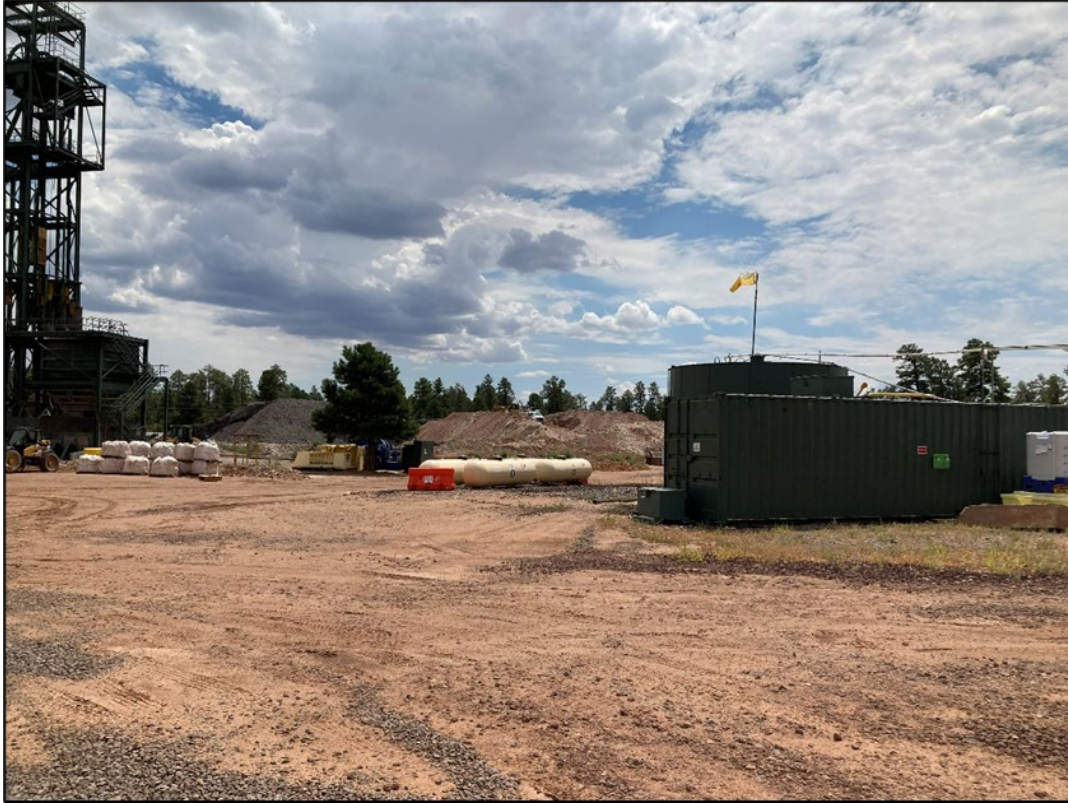
Photo 3 – Overlooking propane tanks near the center of the mine site. (Aug. 22)

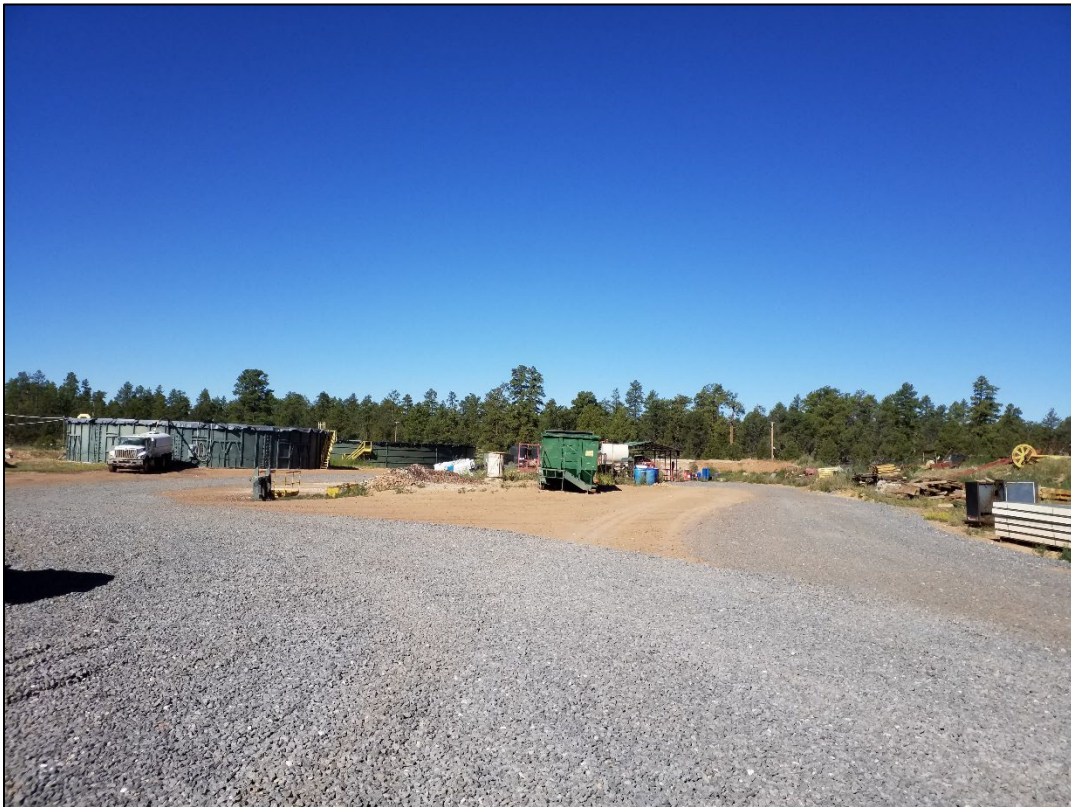
Two days prior to the July site visit, EFR reported they recently used locally sourced gravel to reinforce areas used by the haul trucks (Photos 4 – 5). This is partly due to the increase in number of trucks used per day. Similar gravel has been previously used to reinforce the loading area near the ore pad. During the September site visit, EFR reported using 12 – 15 haul trucks per day.

Photo 4 – Gravel recently used to reinforce heavily traveled areas. (July 30)

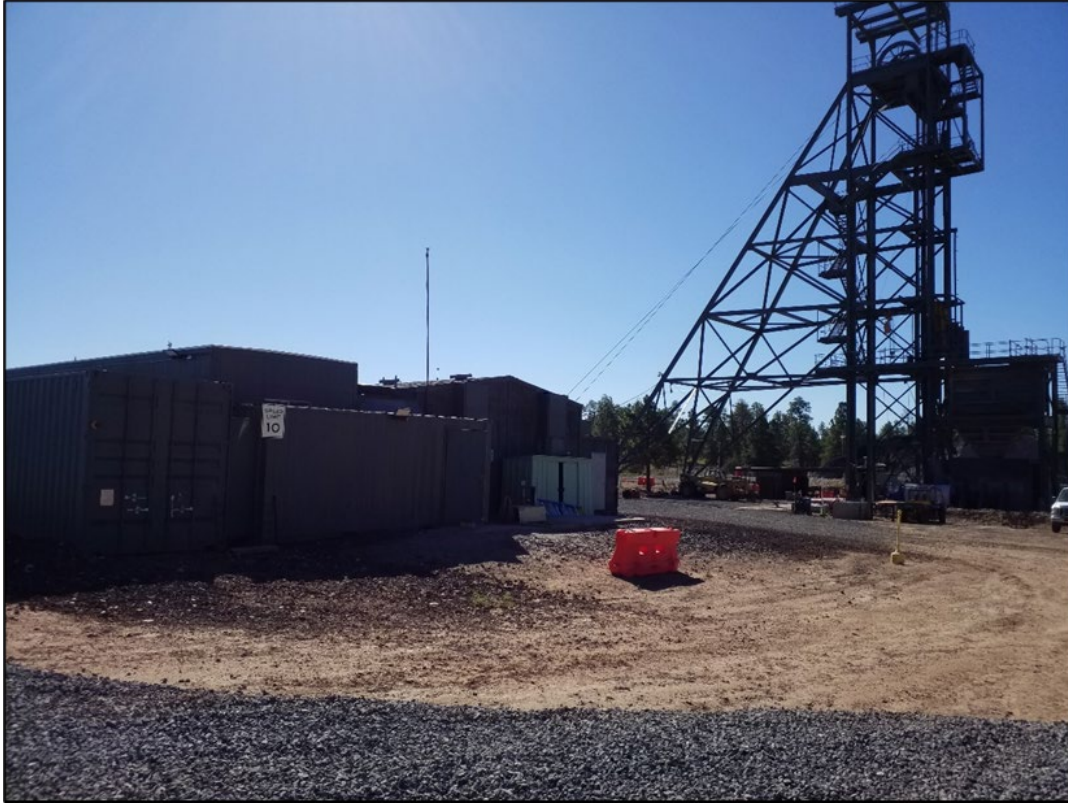
Photo 5 – Conex box storage for gear, adjacent to office buildings. (July 30)

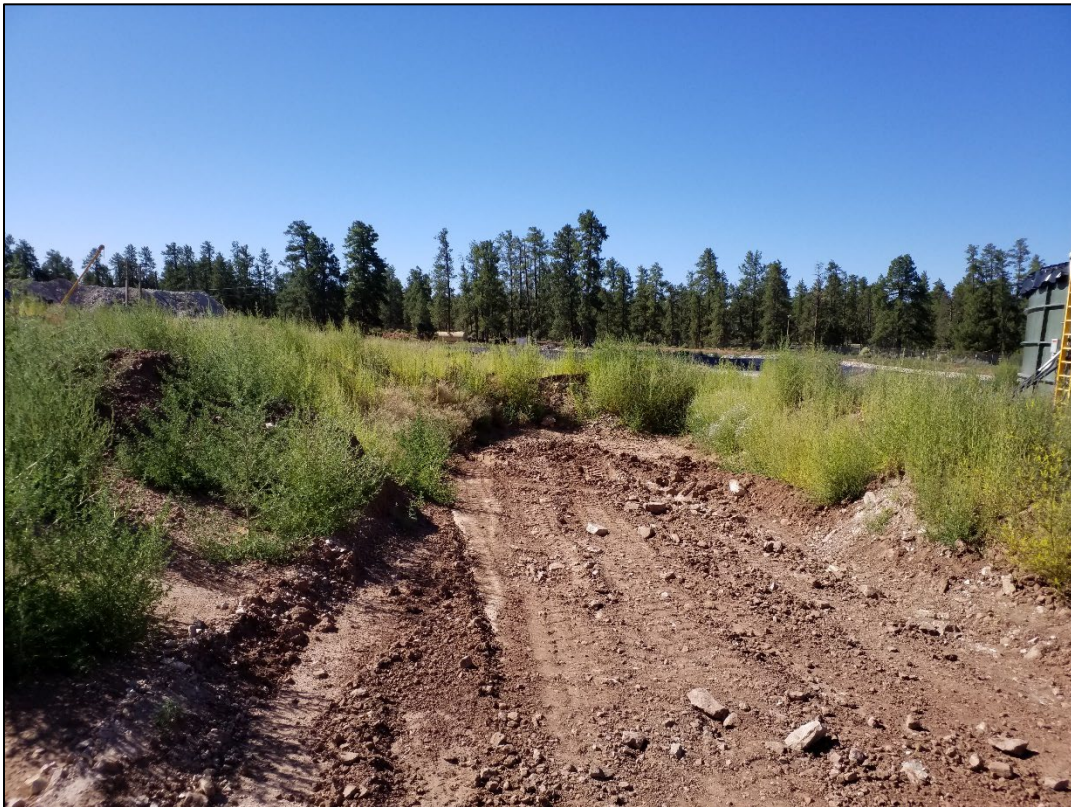
Both rainwater catchments were dry in July but contained moisture during the August site visit (Photos 6 – 7). By September, a contractor was hired to remove weeds on site that were generally located near the rainwater catchments (Photo 8). Additionally, EFR reported on September 4 that the central rainwater catchment was pumped out, filled in, and contoured to match the grade on site. EFR states the central catchment was not part of the original design of the mine (Photos 9 – 10).

Photo 6 – Rainwater catchment (empty) between the two water tanks in NW perimeter. (July 30)

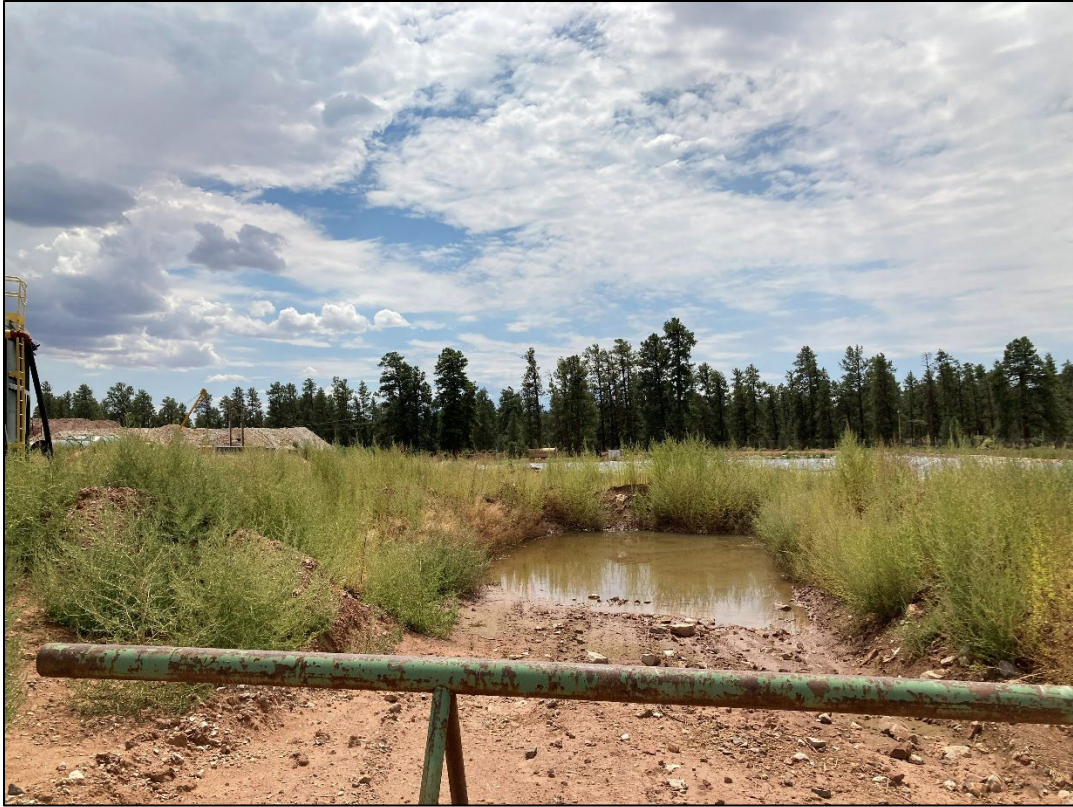
Photo 7 – Rainwater catchment from previous photo containing water. (Aug. 22)

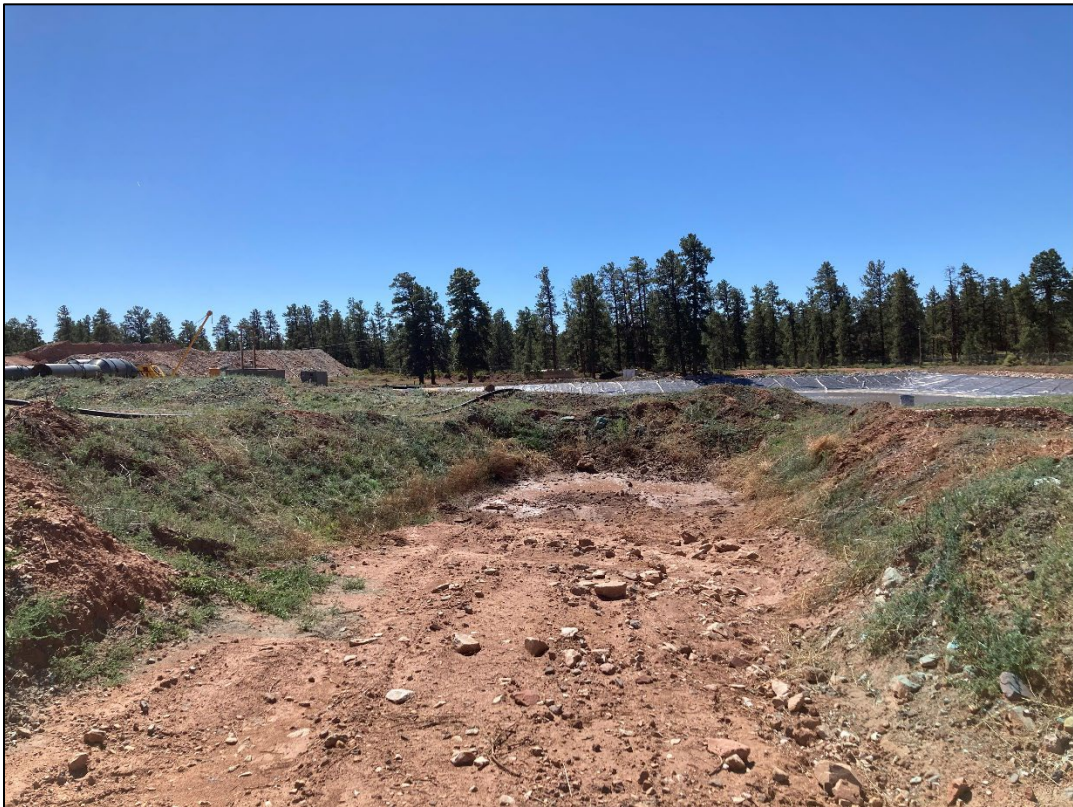
Photo 8 – Weeds near rainwater catchment removed, with minimal moisture within the catchment in September.

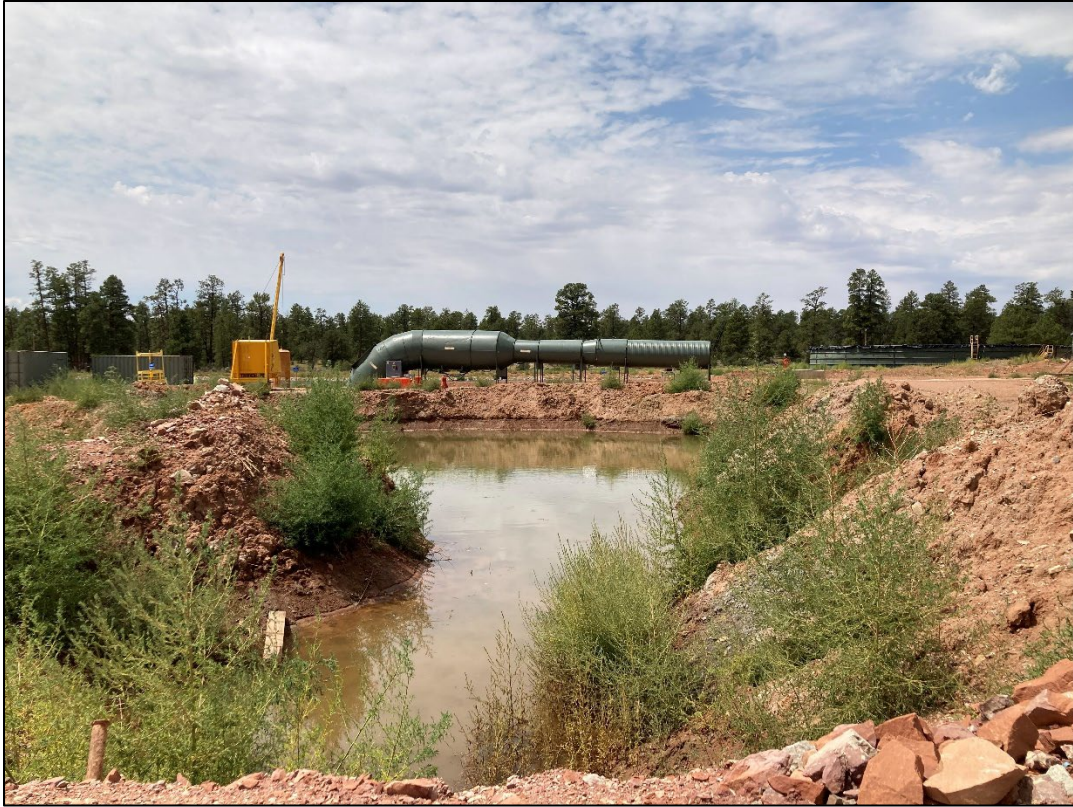
Photo 9 – Before earthwork, overlooking the central rainwater catchment, facing southwest. (Aug. 22)

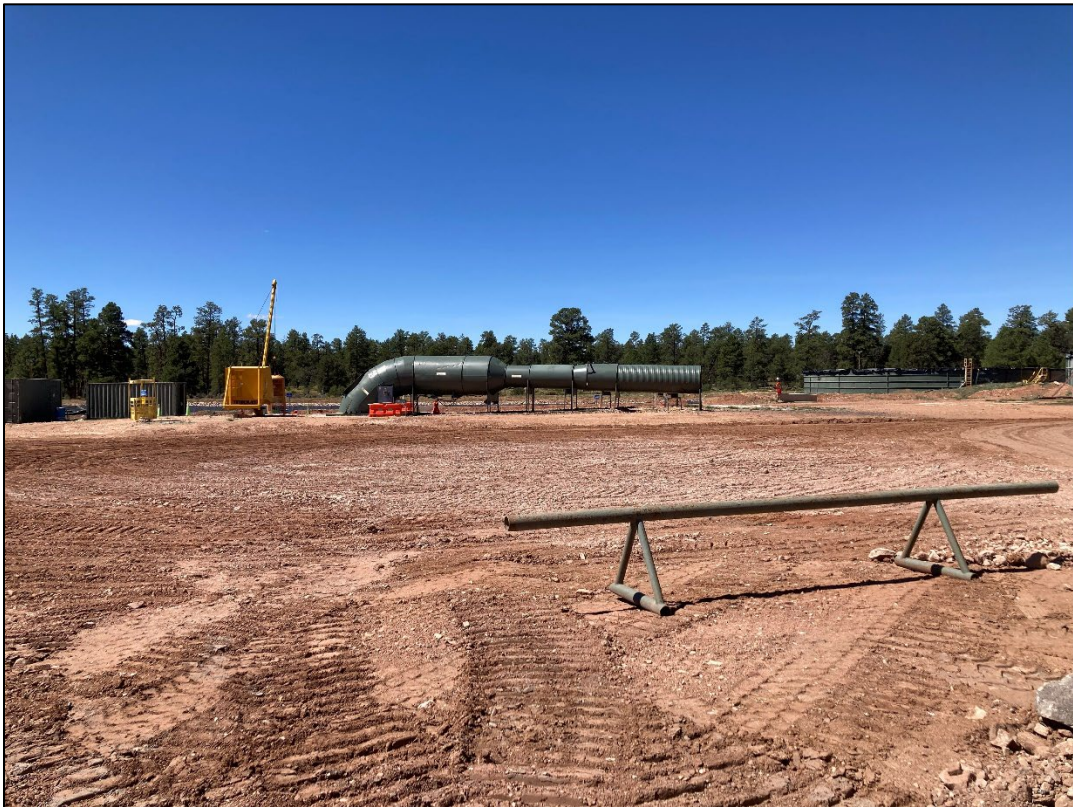
Ear protection was not necessary while walking near the perimeter of the fans and non-stormwater impoundment. The ventilation system currently runs at 50% of its capacity (Photos 10 – 11).

Photo 10 – After earthwork, overlooking the area where rainwater catchment previously existed. (Sept. 11)

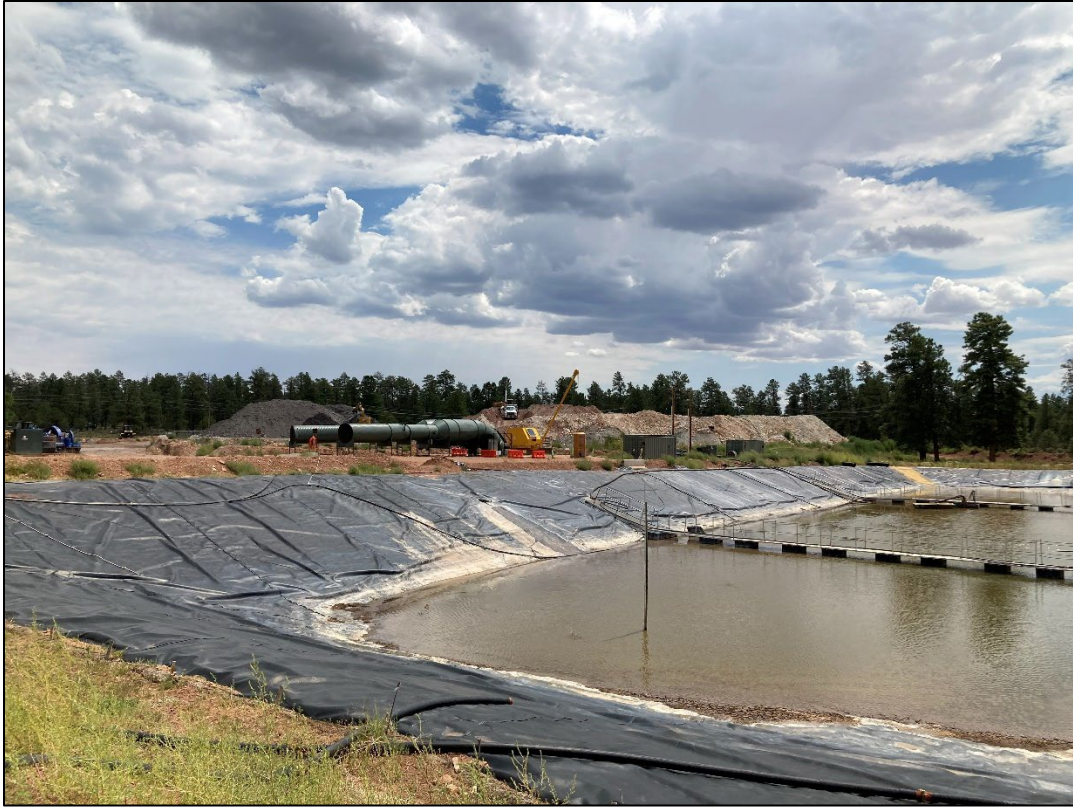
The evaporation system in the non-stormwater impoundment was offline during all three site visits in Q3 (Photos 11 – 15). Drier conditions during the summer allowed for evaporation to naturally occur without the assistance of the evaporator system.

Photo 11 – Non-stormwater impoundment with ventilation system in background. (Aug. 22)

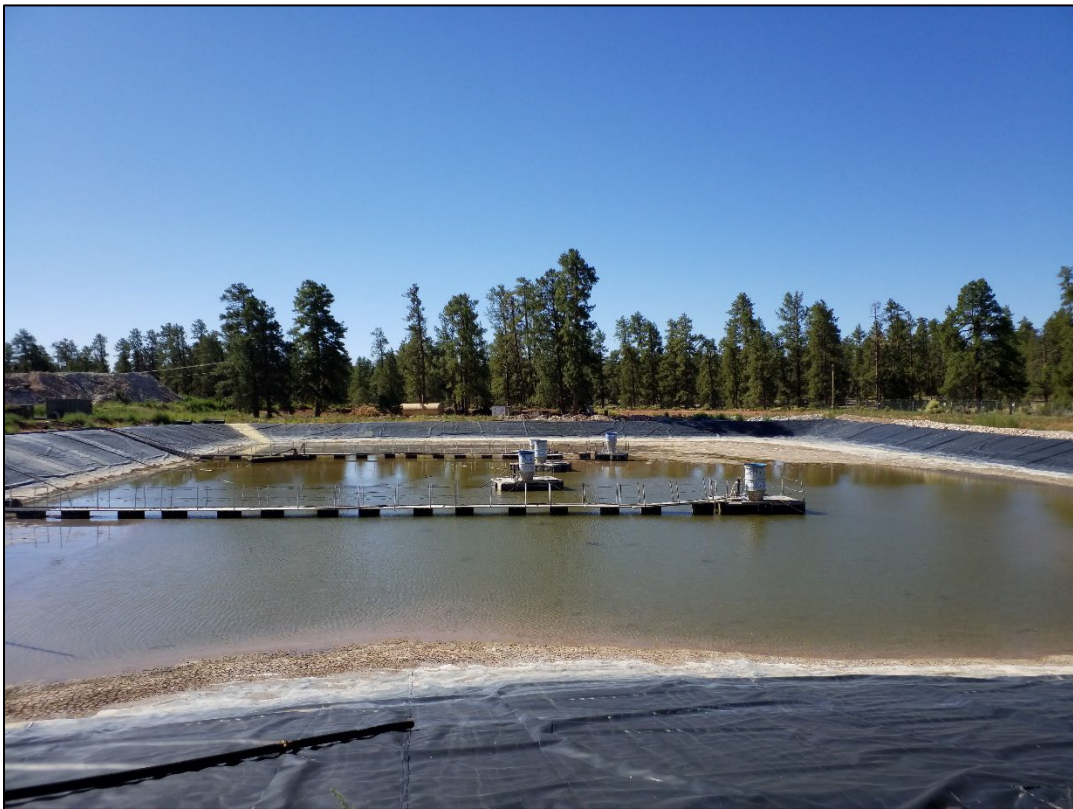
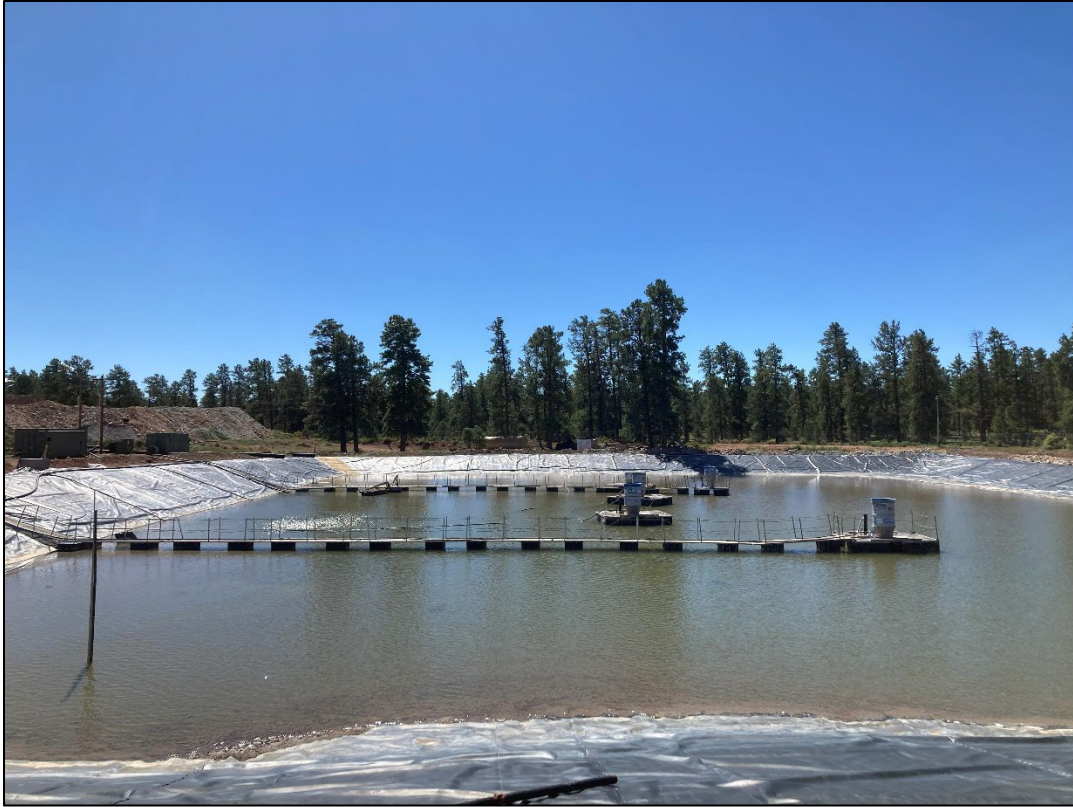
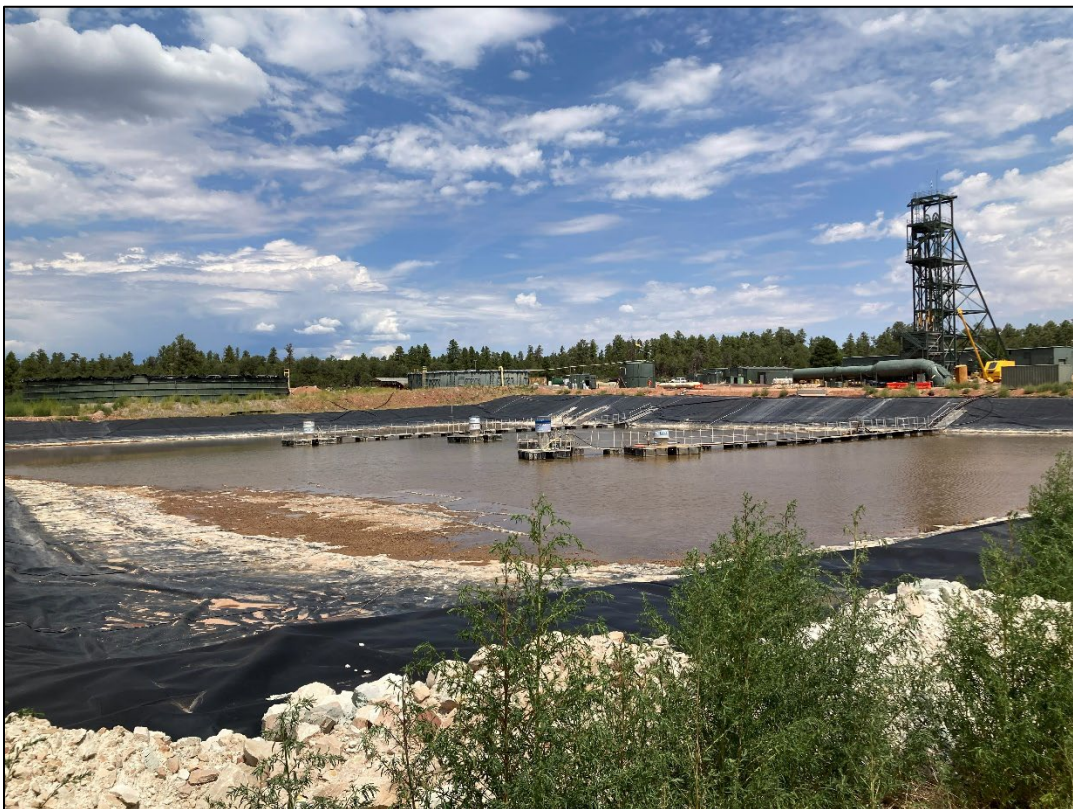
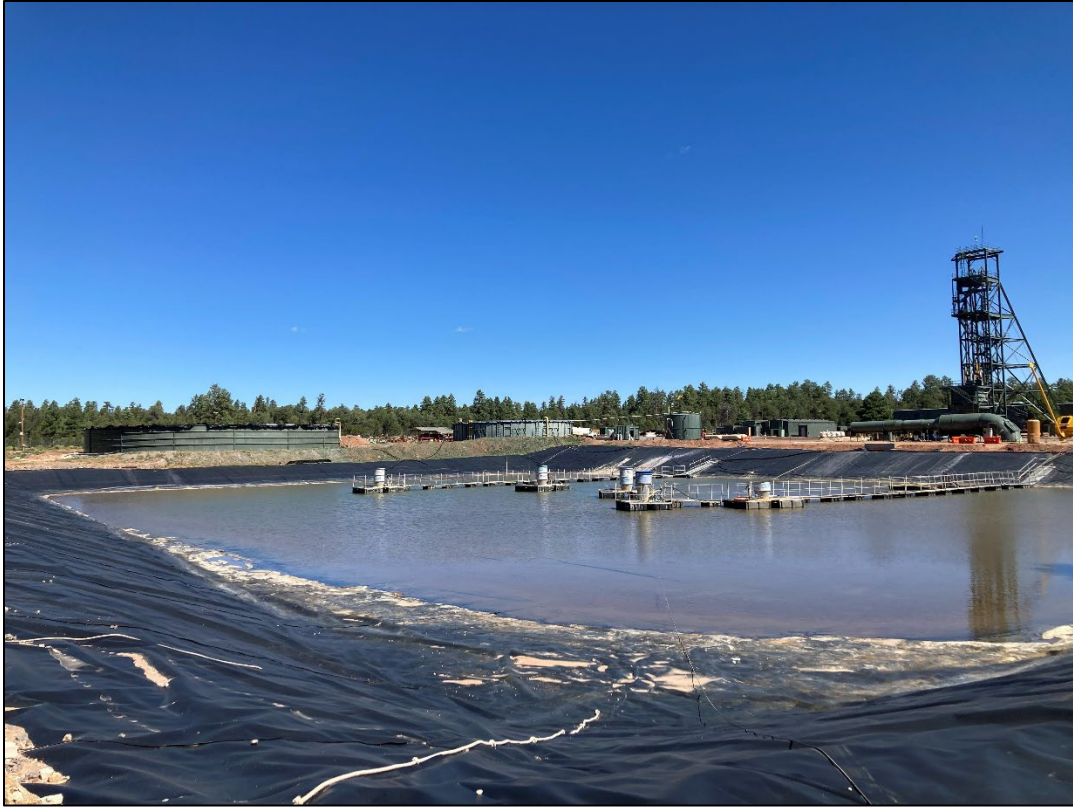
Photo 12 – Overlooking the non-stormwater impoundment. All evaporators were offline. (July 22)

Photo 13 – Non-stormwater impoundment. All evaporators were offline. (Sept. 11)

Photo 14 – Overlooking non-stormwater impoundment, facing NE. All evaporators were offline. (Aug. 22)

Photo 15 – Non-stormwater impoundment, facing NE. All evaporators were offline. (Sept. 11)

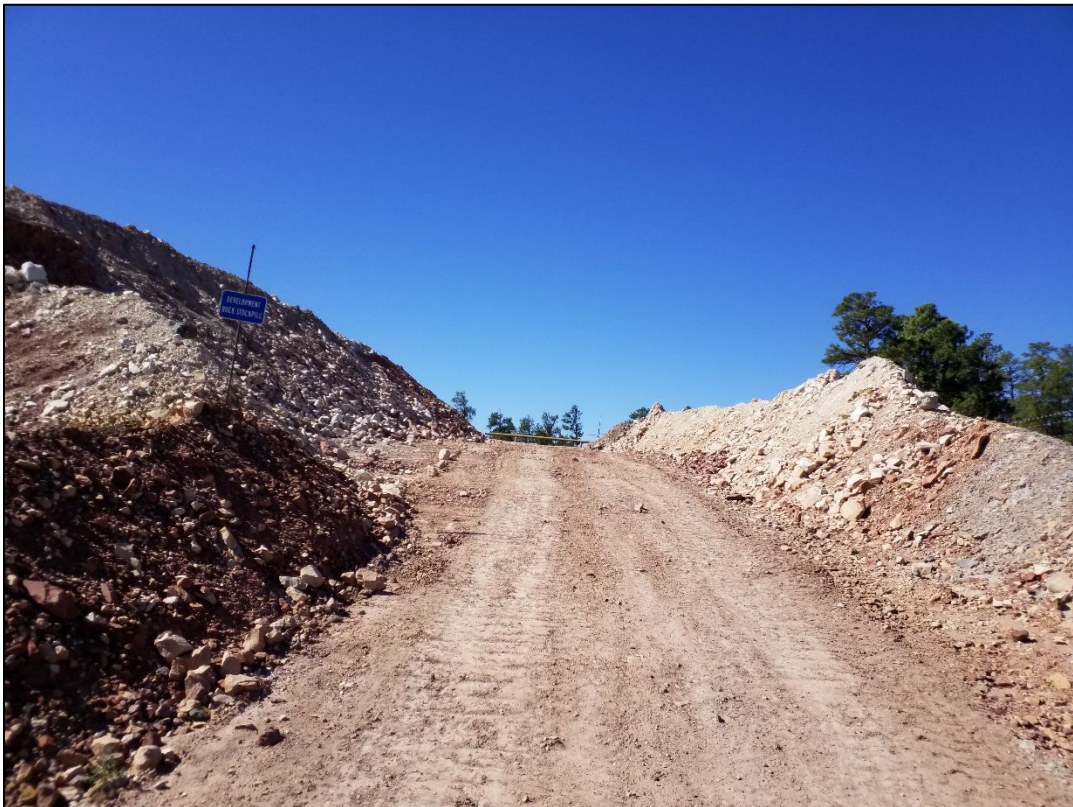
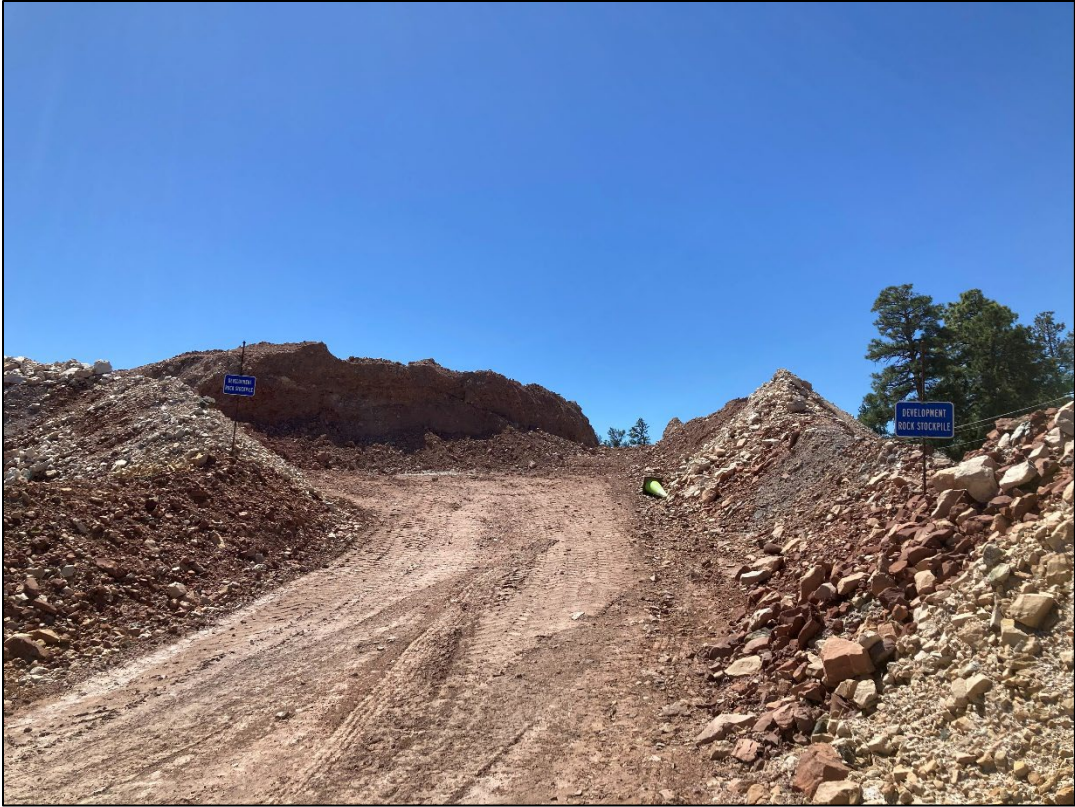
The volume of the development rock stockpile continues to increase (Photos 16 – 17). The amount of ore on the ore pad roughly remained in the same range throughout Q3. Reported estimates ranged between 12,000 – 12,950 tons during the quarter (Photos 18 – 23). The highest recorded amount of ore reported in Q3 was approximately 12,911 tons during a meeting on July 10.

Photo 16 – Entrance of development rock stockpile. (July 30)

Photo 17 – Entrance of development rock stockpile. (Sept. 11)

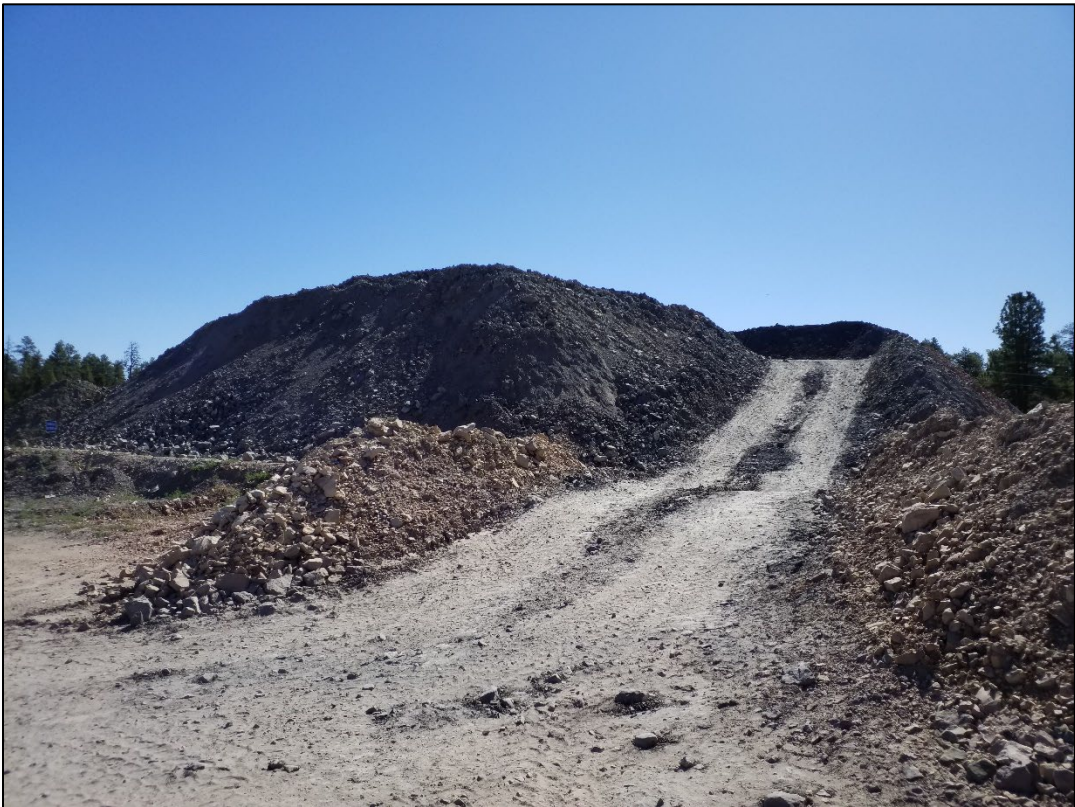
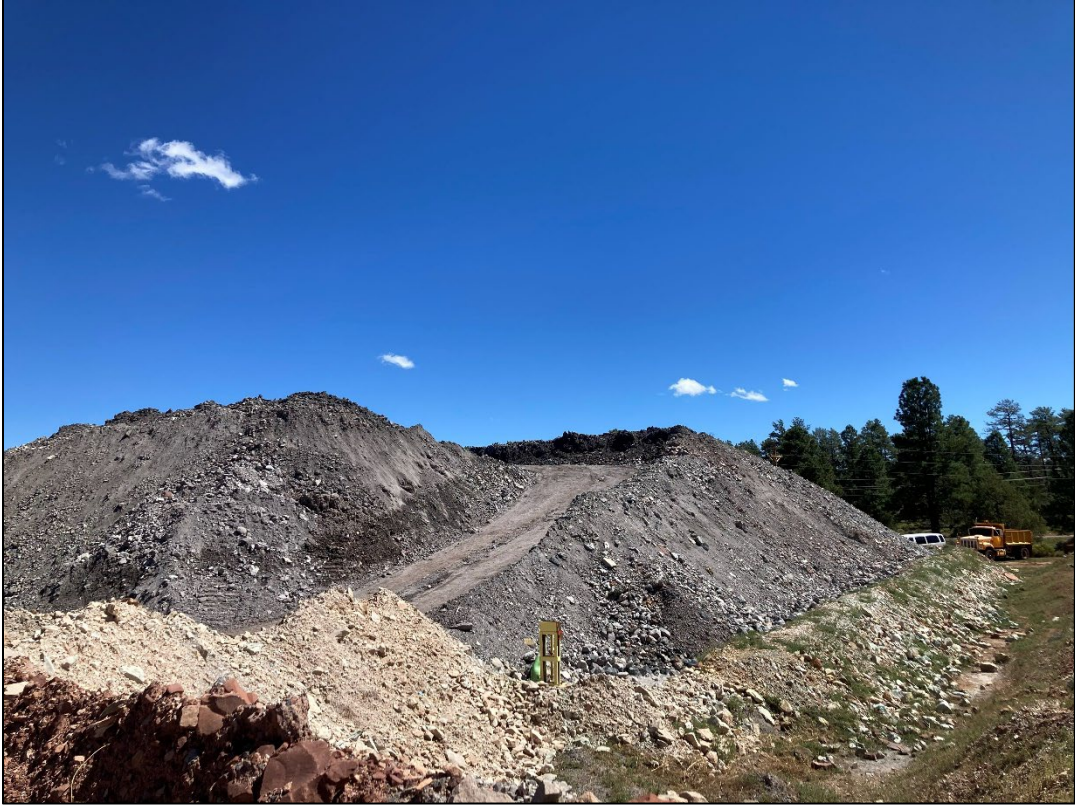
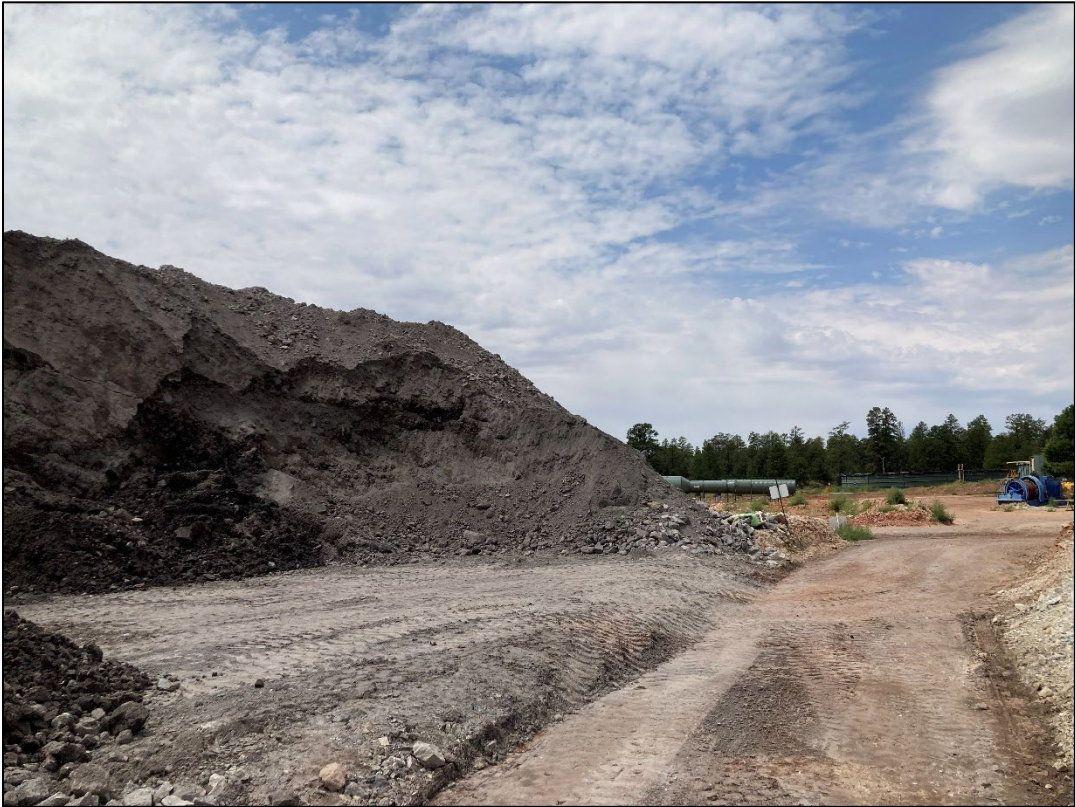
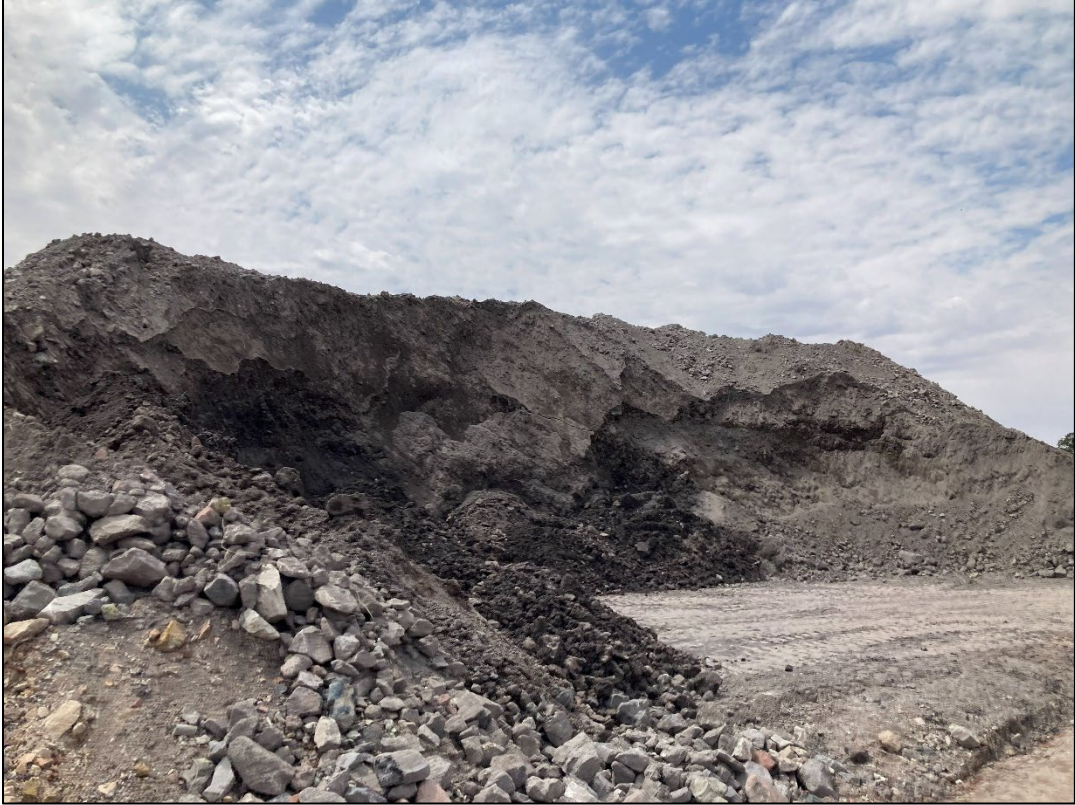
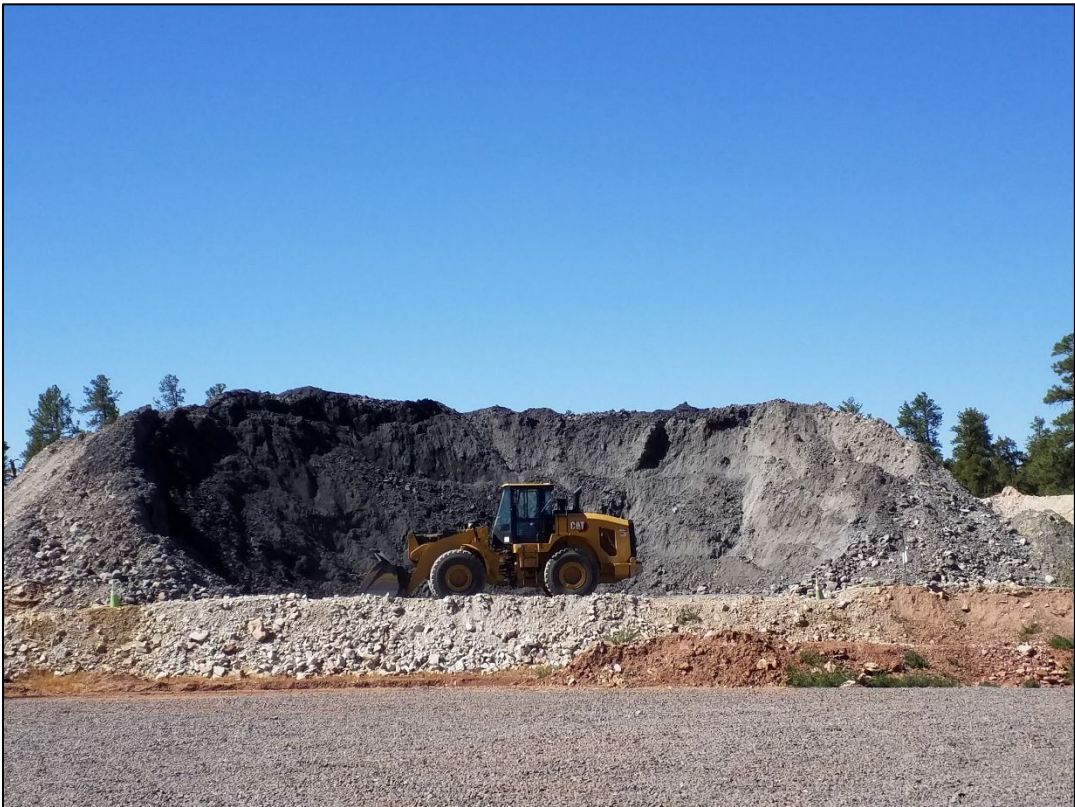
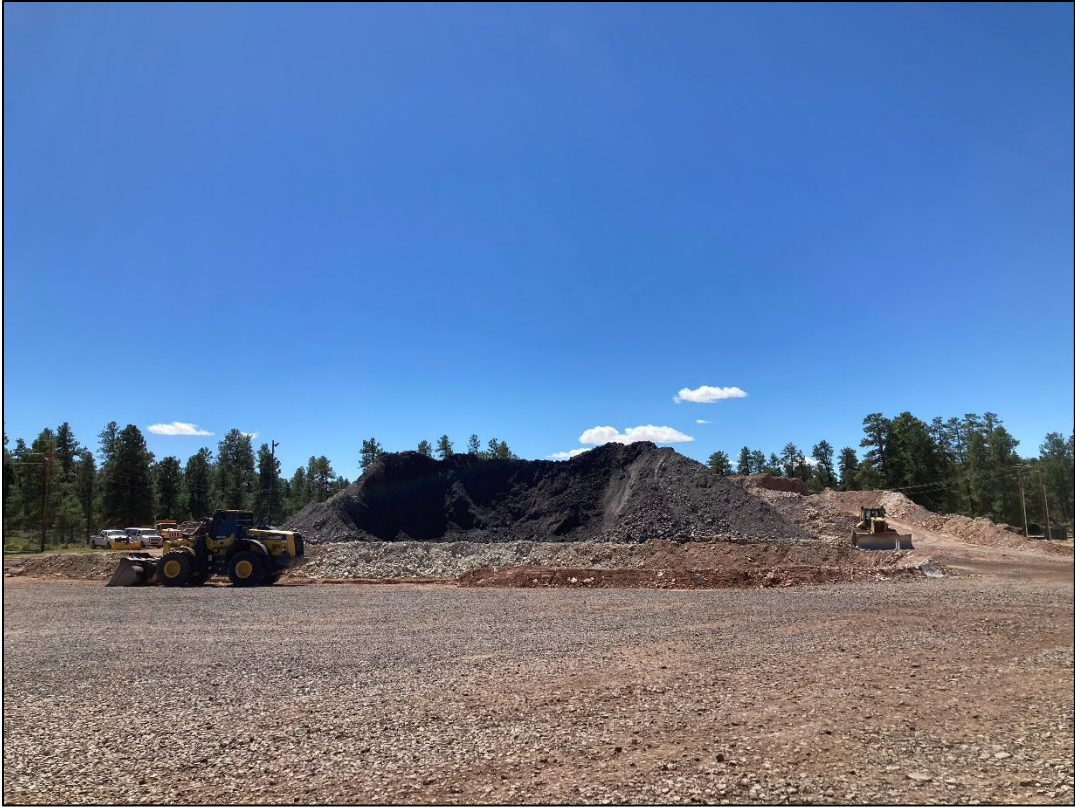
Photo 18 – Overlooking ore stockpile (gray material) facing east. (July 30)

Photo 19 – Overlooking the ore pad, facing NE. (Sept. 11)

Photo 20 – Ore stockpile and loading ramp. (Aug. 22)

Photo 21 – Ore stockpile and loading area. (Aug. 22)

Photo 22 – Ore stockpile and loading area. (July 30)

Photo 23 – Overlooking ore stock pile and loading ramp. (Sept. 11)

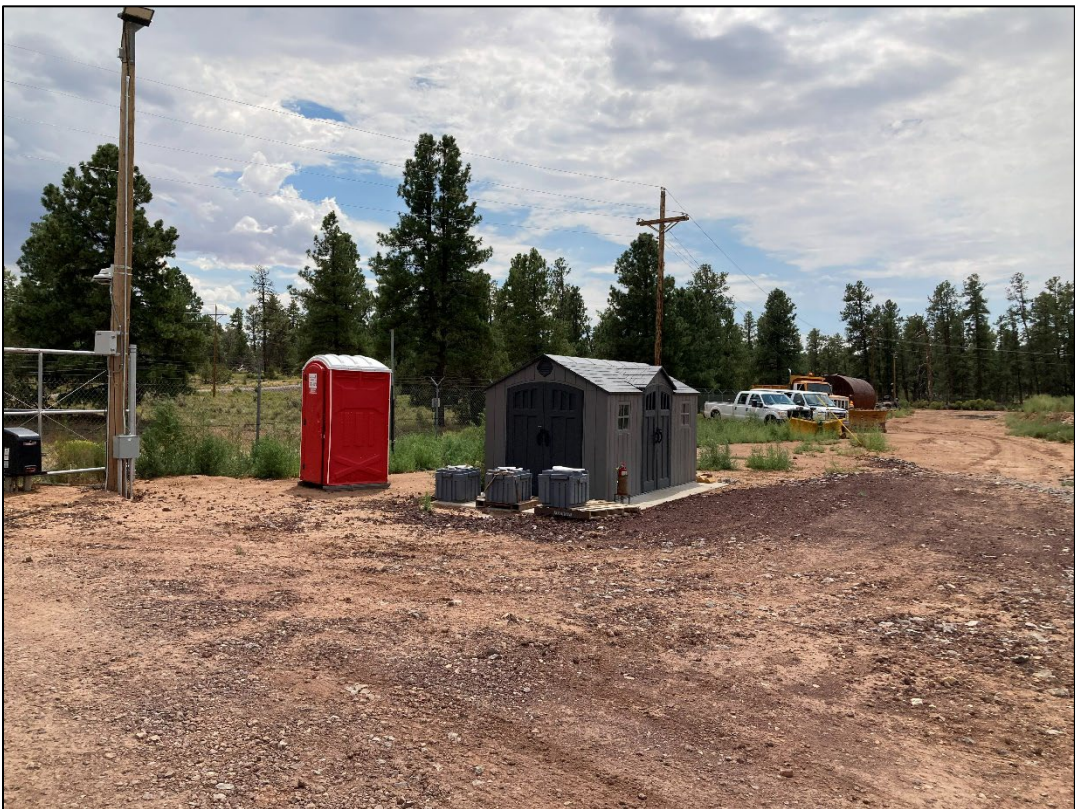
Photo 24 – Shed to be used by the Navajo Nation located near entrance of mine. (Aug. 22)
