Pinyon Plain Mine – 2025 Q3 Monitoring Summary

**July - September 2025
Kaibab National Forest**

Introduction

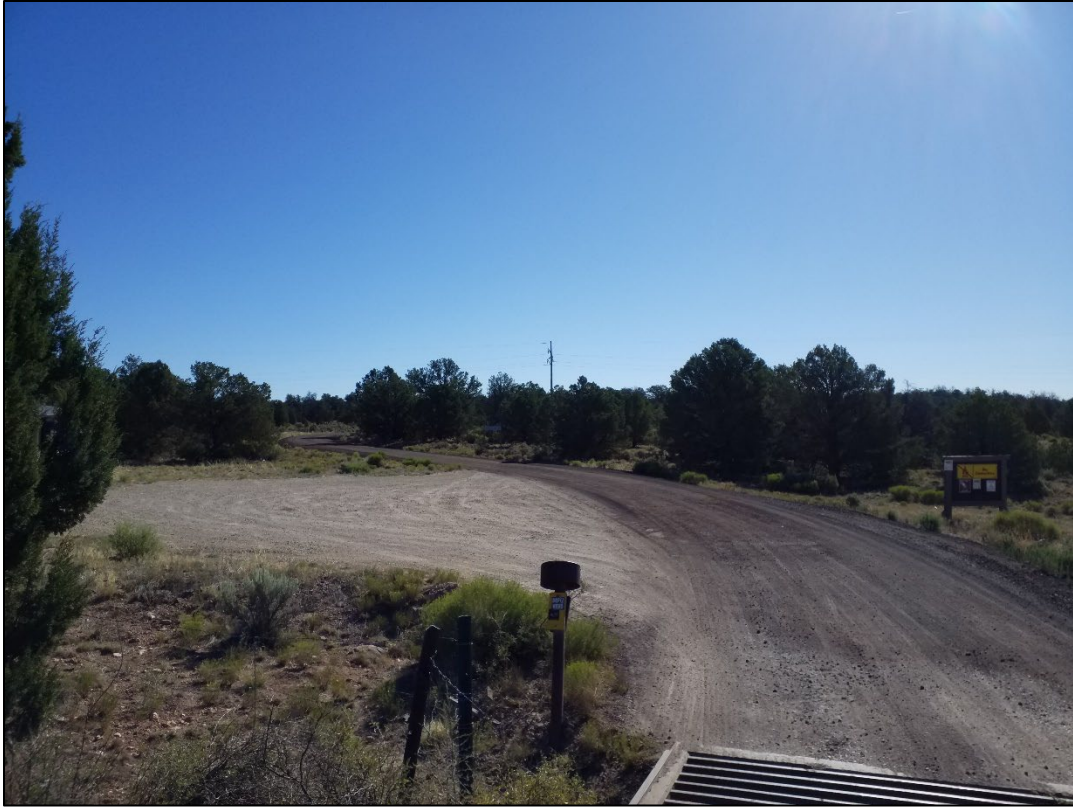
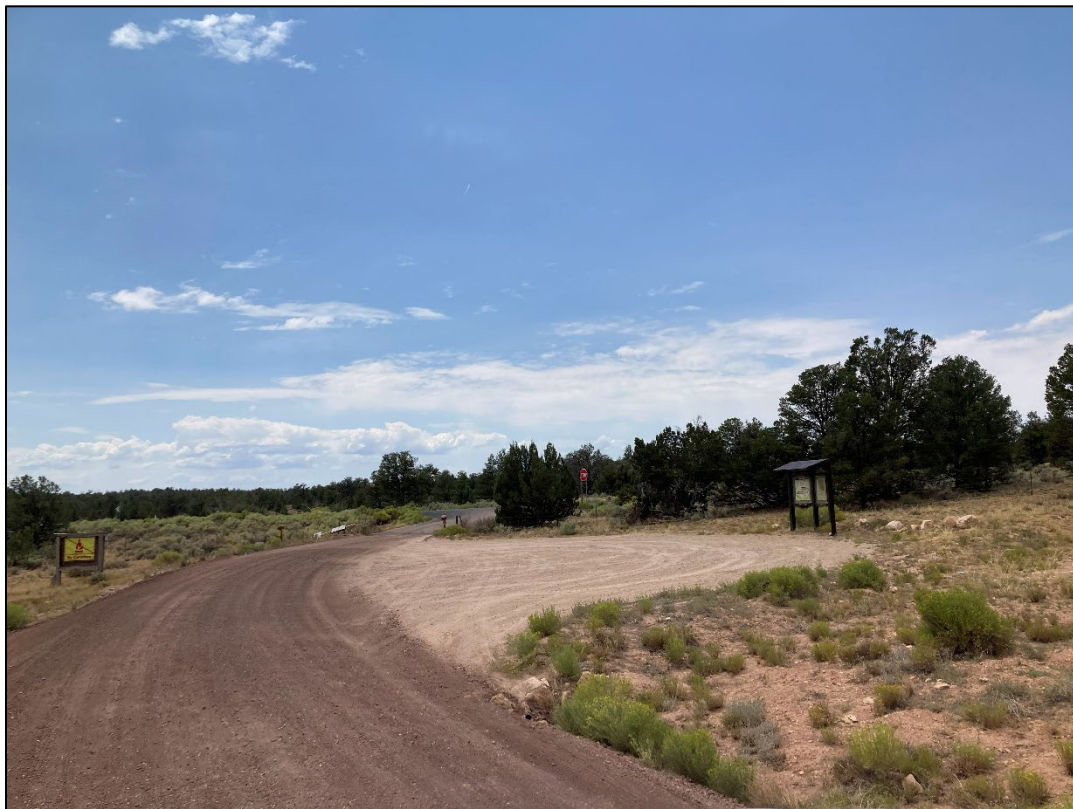
In an effort to raise awareness about the haul route and in response to a stakeholder request, the USFS installed orange carsonite signs affixed with “URANIUM HAUL ROUTE” and directional arrow stickers along Forest Service roads 305, 305A, and 305AB. Signs were initially placed at all intersections or at visible locations approximately 0.5 miles apart. Additional signs were installed in Q4 of 2024, based on comments made in a uranium working group meeting that the existing signage was hard to see.

Photo 25 – Overlooking FSR 305 from Hwy 67. (July 30)

Photo 26 – Overlooking the junction of FSR 305 and Hwy 67. (Aug. 22)
