# Lower Sugarloaf Fire Burned Area Summary

## Burned Area Report

## 2025 Lower Sugarloaf Fire, Okanogan-Wenatchee National Forest, Washington

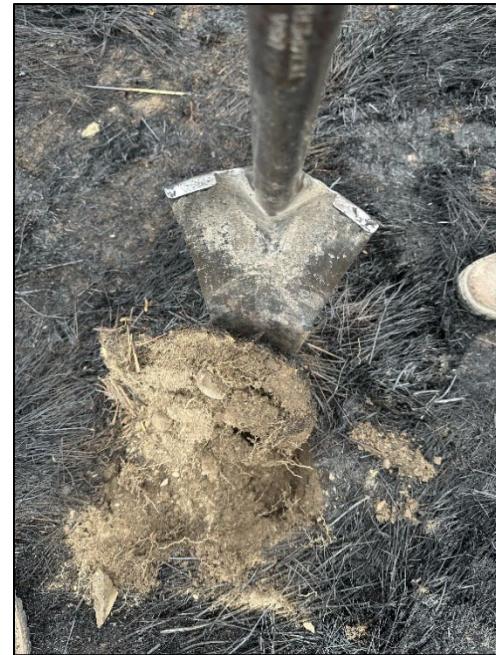
Figure 1: Example of Low SBS in ash cap soils within the fire.

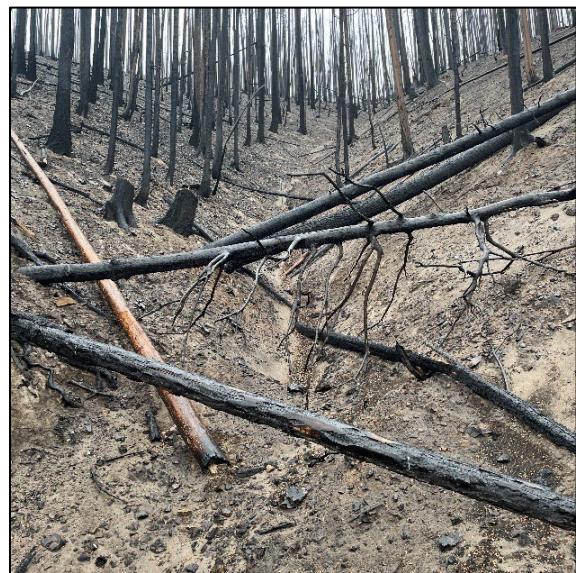
Figure 2: Burned drainage along NFSR 52 within the Lower Sugarloaf Fire.

A rapid hydrologic assessment suggests that there will be increased response particularly in small, steep drainages with a high percentage of high and moderate SBS, particularly in the headwaters of Tillicum Creek, Roaring Creek, and Beaver Creek.

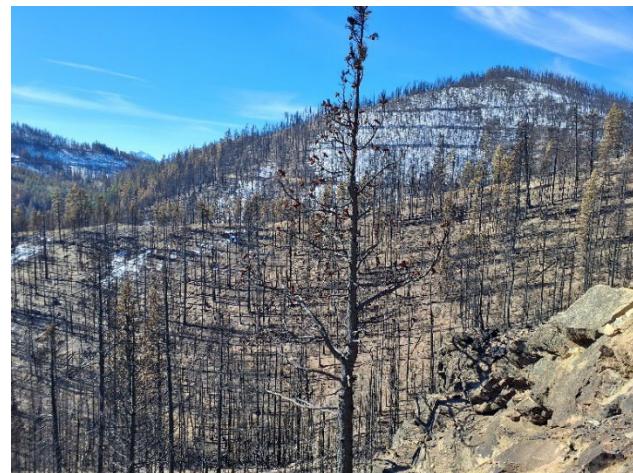
Figure 3: Looking west from NFSR 1808 at stacked road system.

Critical values addressed in the BAER report include Forest Service System Roads and related drainage features. Treatments for the protection of these roads include storm proofing, installation of drainage dips along the road and armored dips at stream crossings, drivable water bars, and storm inspection and response.

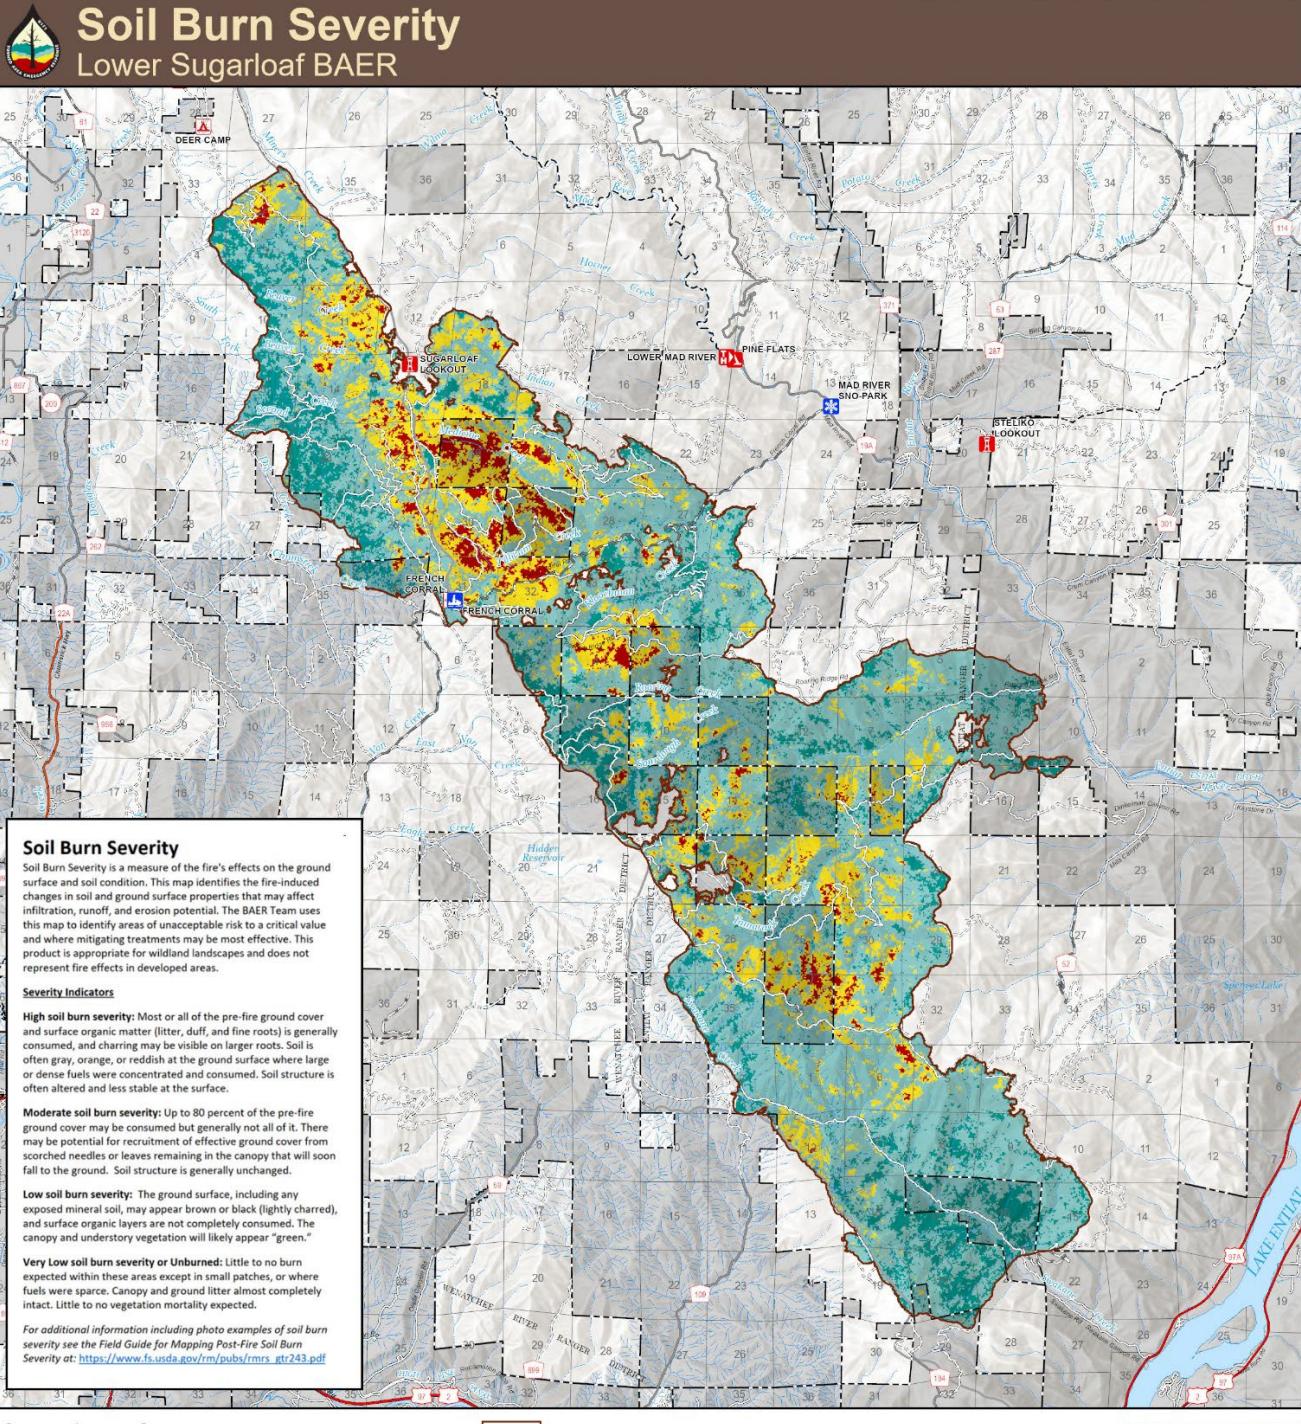
Mapped and validated SBS for the burned area is High (4%), Moderate (20%), Low (60%), and Very Low/Unburned (16%) (see map on Page 6). The more severe a fire's effects are on the soil, the more likely those soils will erode in subsequent rainstorms – especially in locations with steep slopes. Erosion after fires can cause tremendous damage to homes and other structures in the years after a fire.

Figure 4: Soil Burn Severity for Lower Sugarloaf Fire

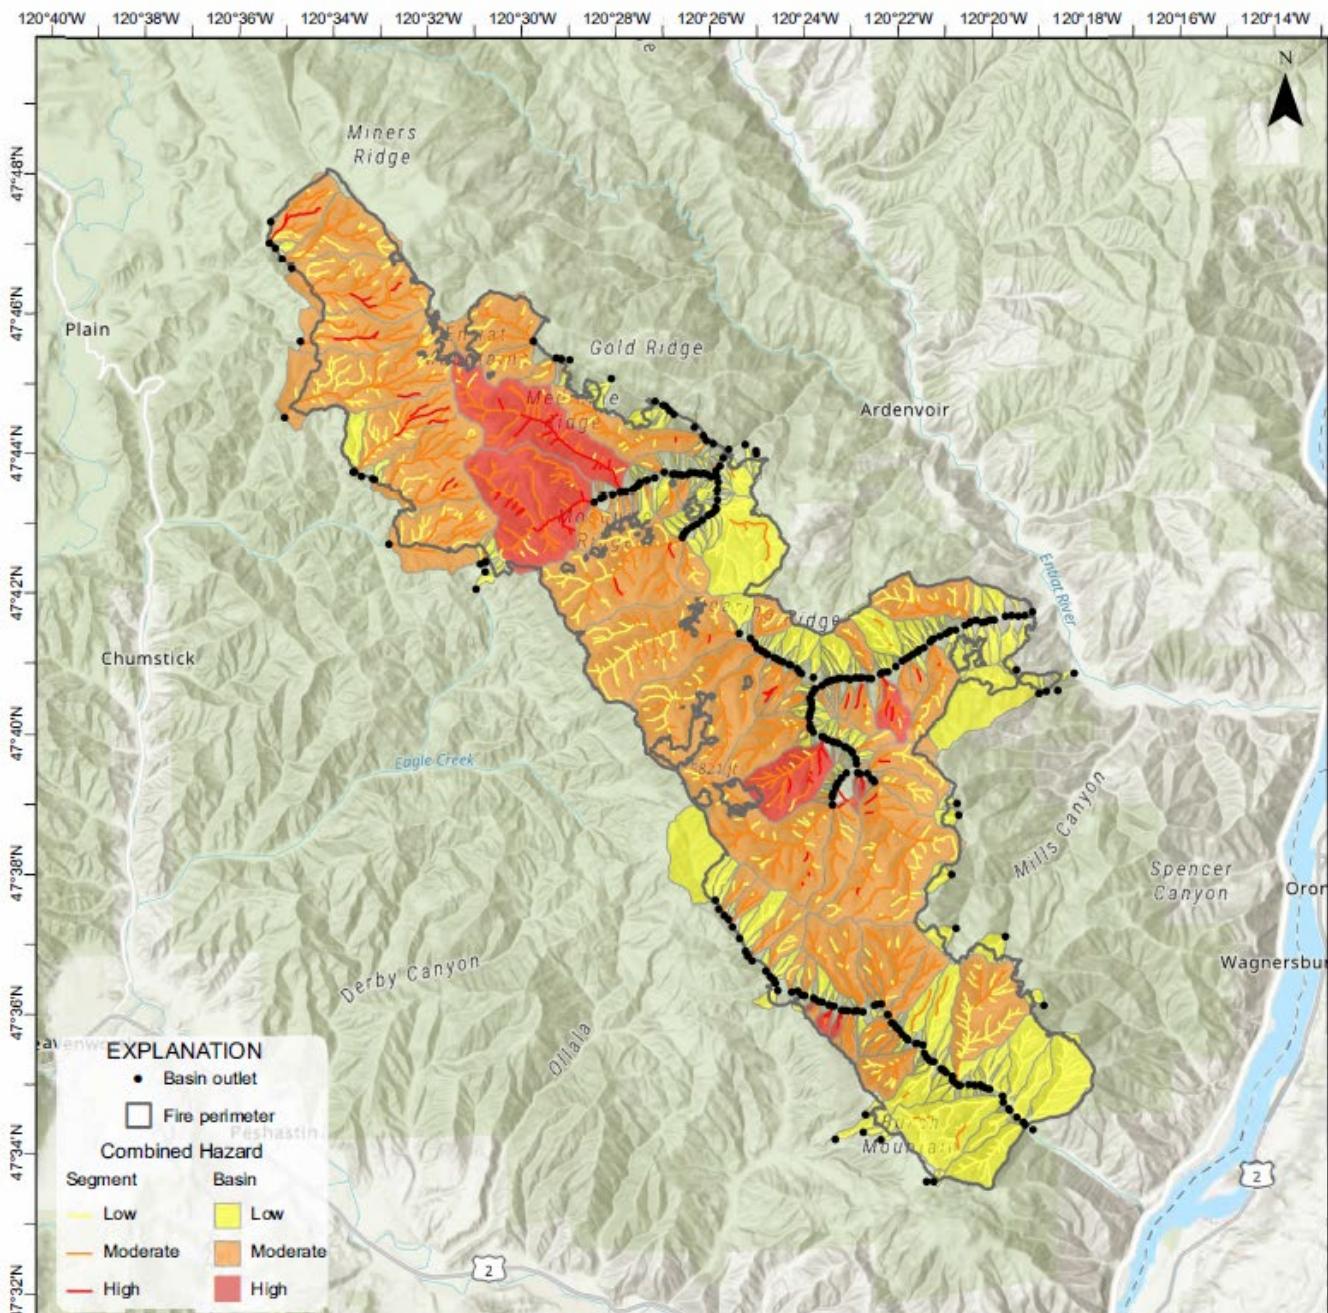
The team provided soil burn severity field data to the US Geological Survey Landslide Hazard Program to assist in forecasting the probability, potential volumes, and hazards of debris flows through their developed empirical models. The USGS Post-fire Debris Flow Hazard Model estimates a that short-duration, high-intensity rainstorms (a 15-minute rainfall intensity of 24mm/hour for this assessment) tend to trigger debris flows. The drainages at high combined hazard for mass movement are Tillicum Creek, Medicine Creek, and Tamarack Creek. Most

estimated basins within the fire have moderate combined hazard for debris flow (see maps on Pages 7 and 8).

### Combined Hazard

Design storm: Peak 15-minute rainfall intensity 24 mm/h

Figure 5: USGS combined debris flow hazard map for Lower Sugarloaf Fire.

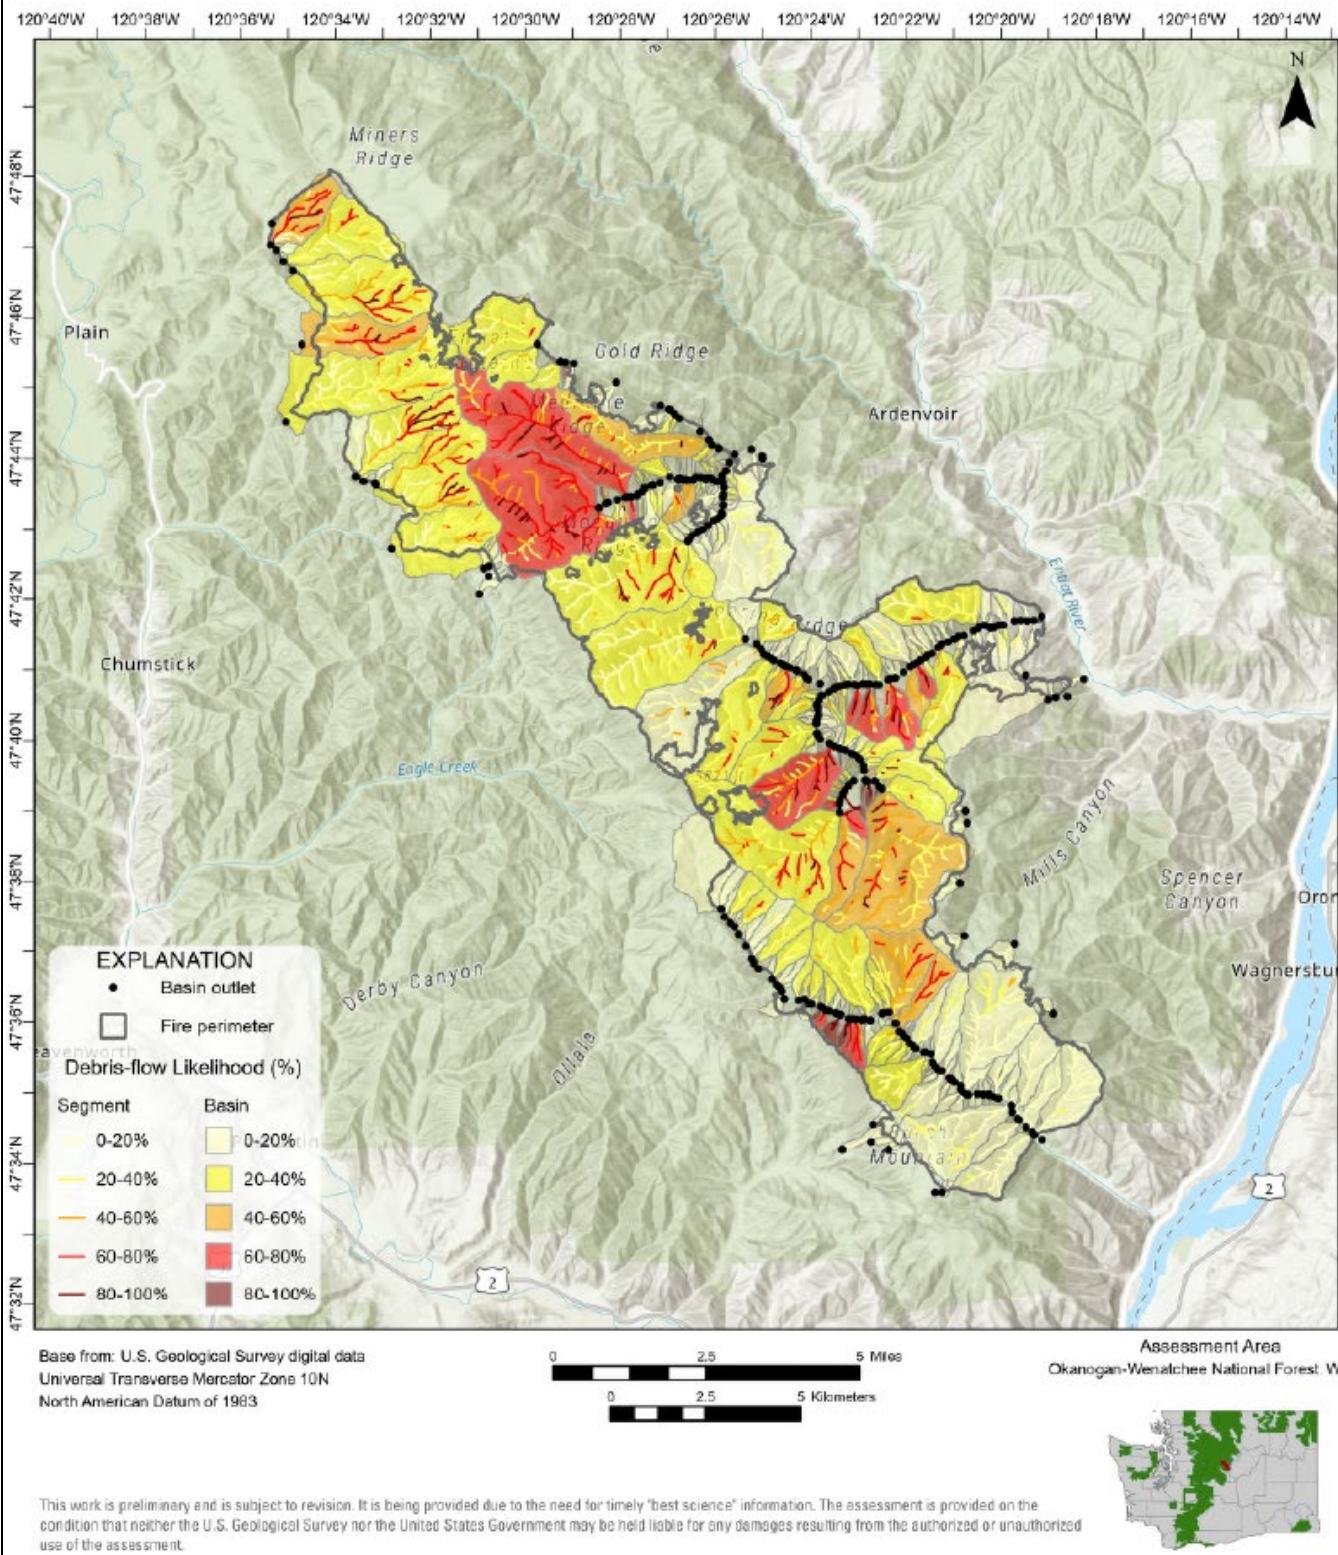
### Debris-flow Likelihood

Design storm: Peak 15-minute rainfall intensity 24 mm/h

Figure 6: USGS debris flow hazard map. Likelihood of a debris flow occurring by stream segment and basin.
