Labor Mountain Fire Burned Area Summary

Burned Area Report

Labor Mountain Fire started by lightning on Monday September 1, 2025, due to a dry lightning storm passing over Central Washington. The fire started in steep terrain between Standup and Stafford Creek drainages, 10 miles northeast of Cle Elum, Washington. The fire burned from west to east driven by high wind events over several days. As of October 24, 2025, the fire was approximately 42,967 acres and 92% containment.

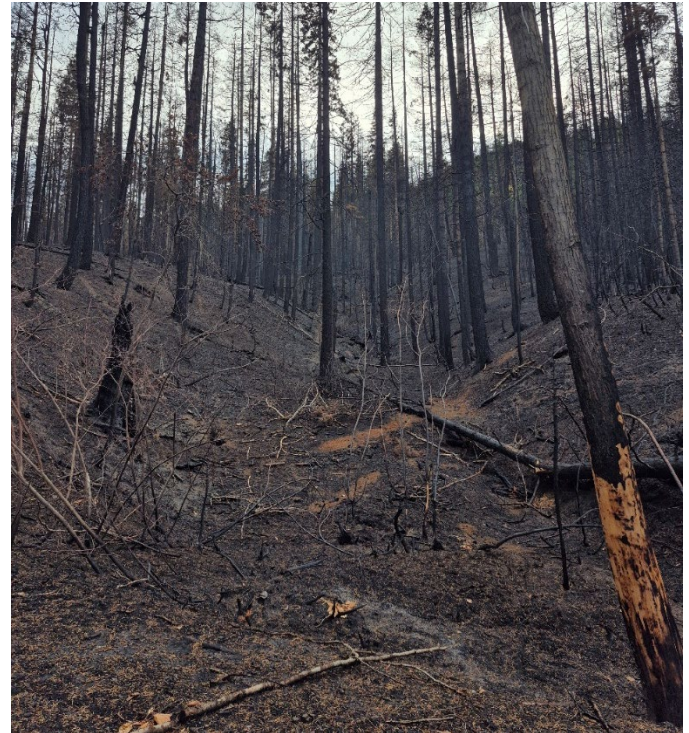
Figure 2: Burned drainage within Labor Mountain Fire.

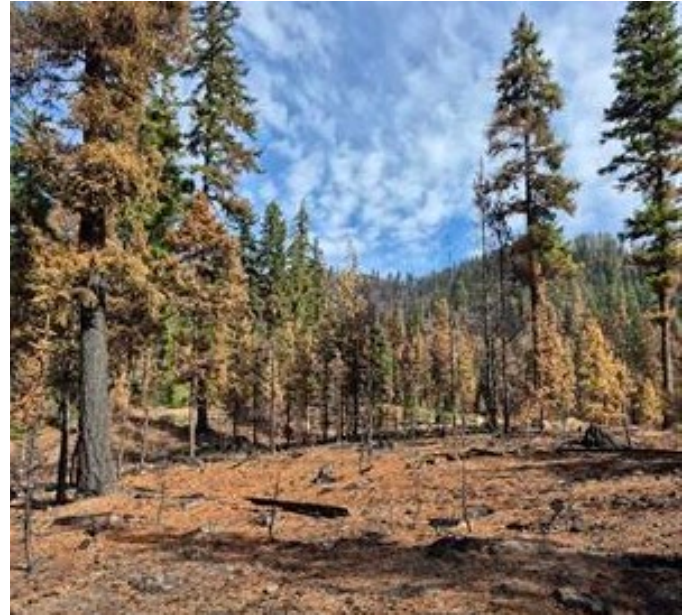
Figure 3: Area of low soil burn severity within Labor Mountain Fire

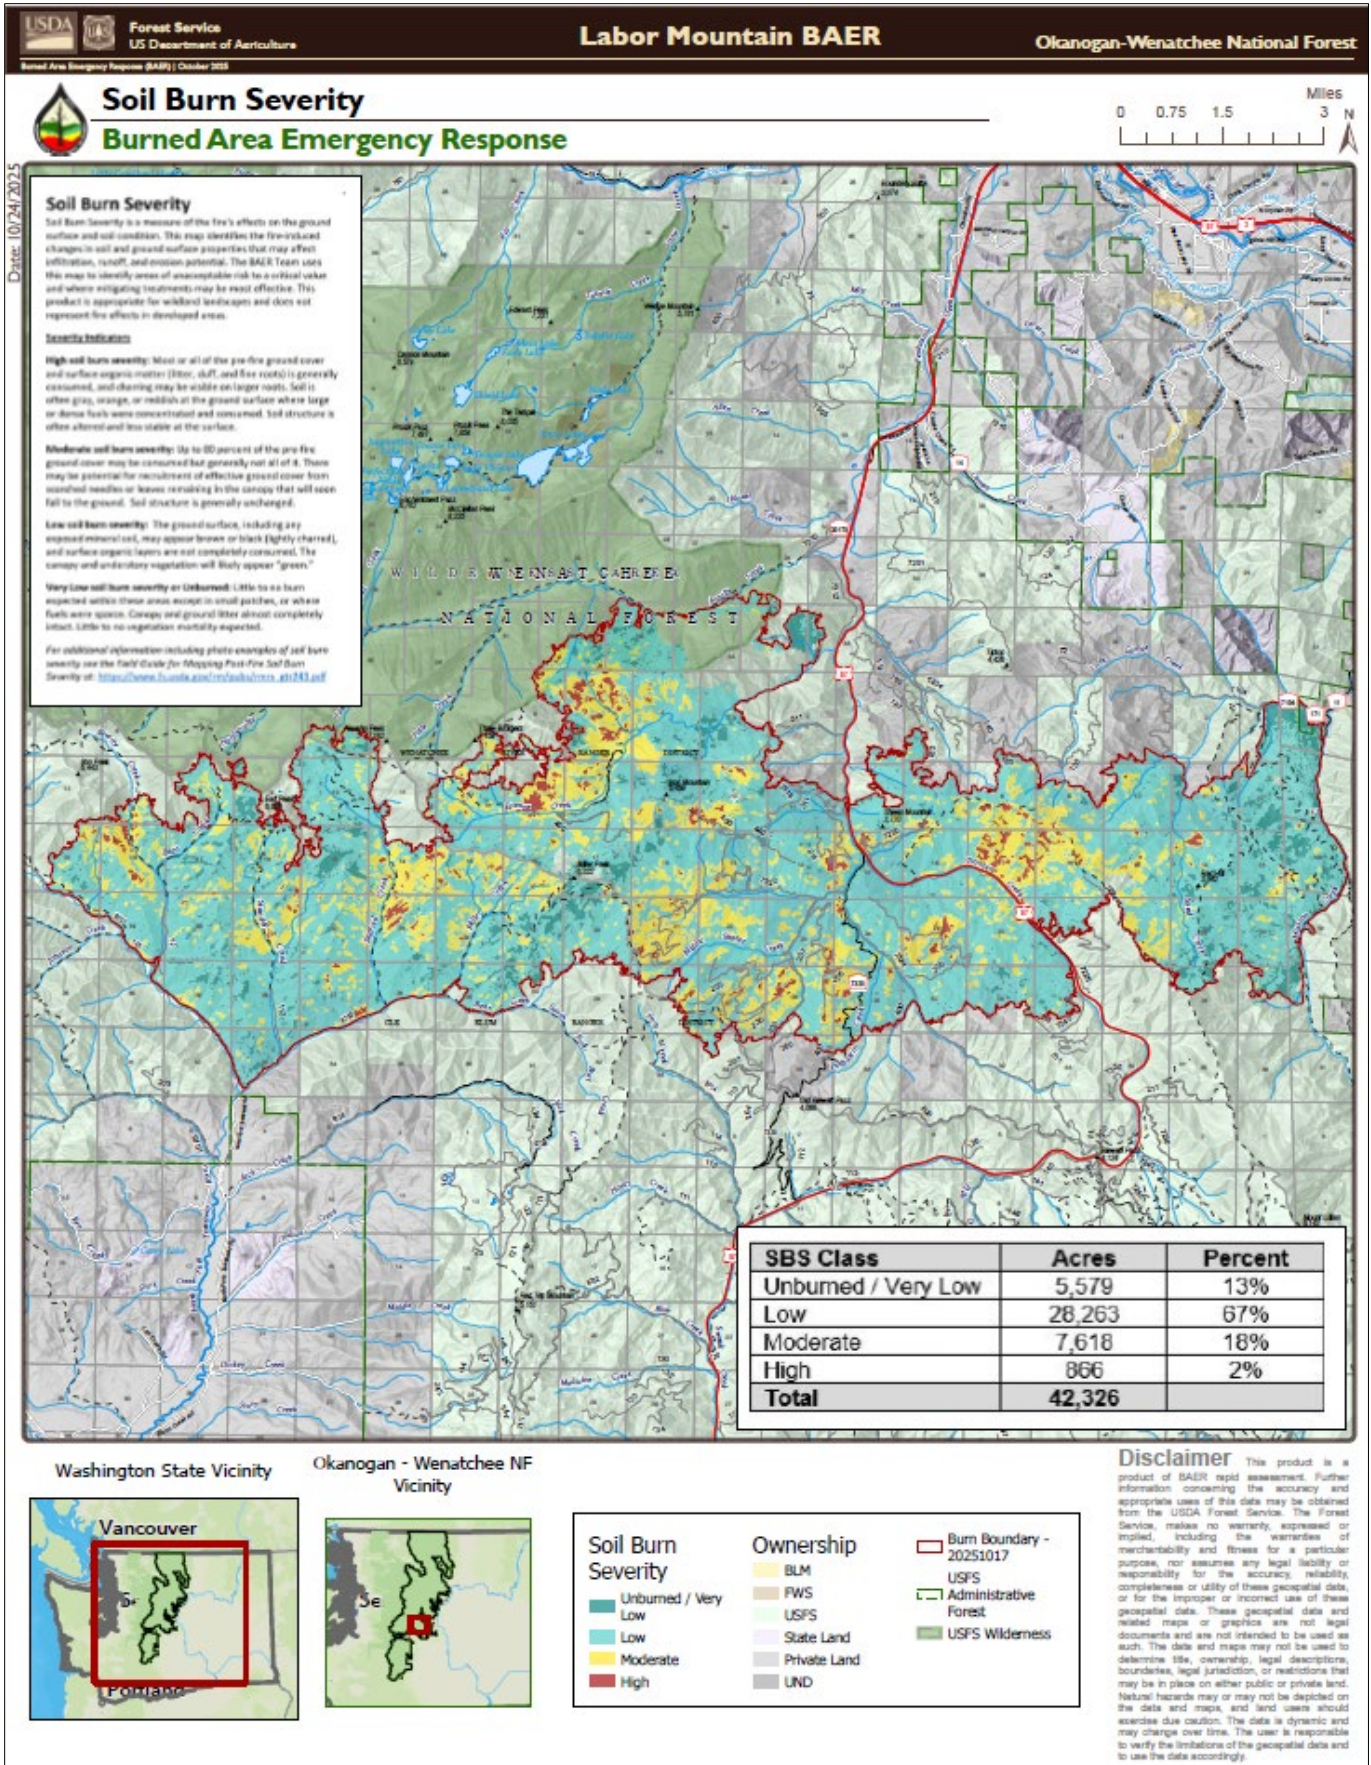
Figure 4: Soil Burn Severity for Lower Sugarloaf Fire

Mapped and validated SBS for the burned area is High (2%), Moderate (18%), Low (67%), and Very Low/Unburned (13%). (see map on page 7) The more severe a fire's effects are on the soil, the more likely those soils will erode in subsequent rainstorms – especially in locations with steep slopes. Erosion after fires can cause tremendous damage to homes and other structures in the years after a fire.

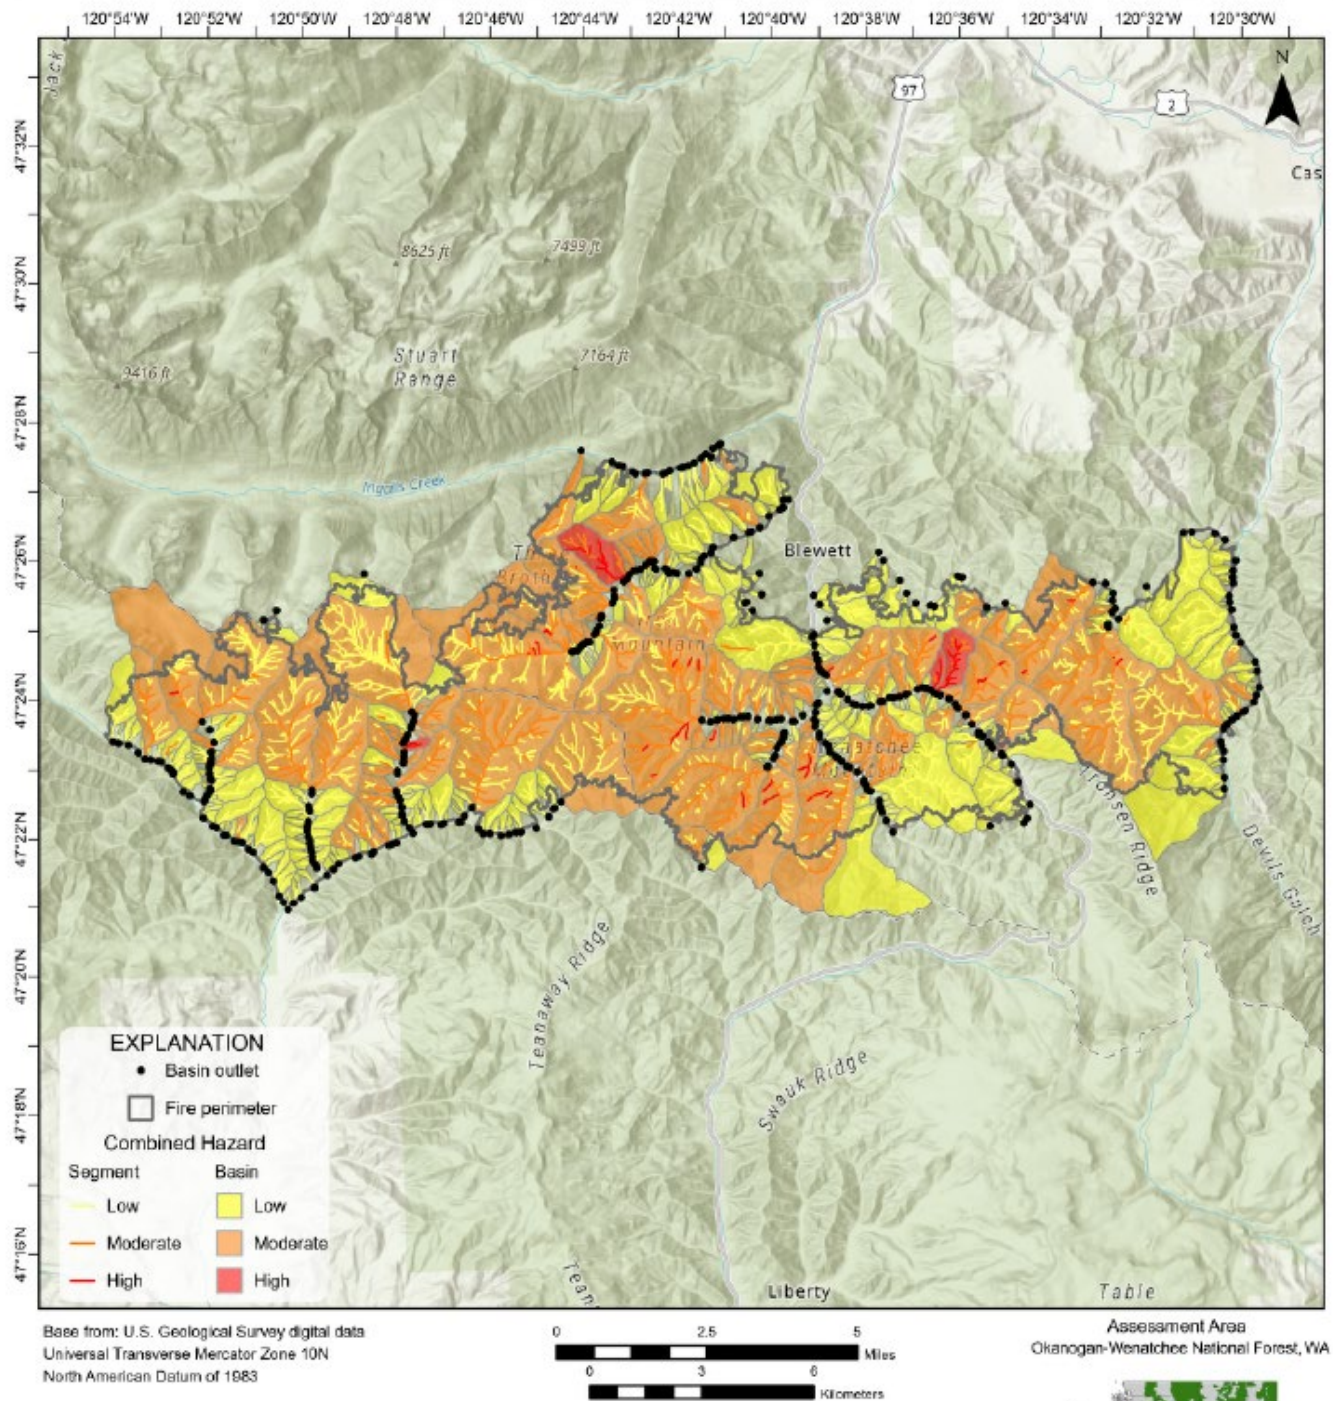
Combined Hazard

Design storm: Peak 15-minute rainfall intensity 24 mm/h

Figure 5: USGS combined debris flow hazard map for Lower Sugarloaf Fire.

potential volumes, and hazards of debris flows through their developed empirical models. The USGS Post-fire Debris Flow Hazard Model estimates that short-duration, high-intensity rainstorm (a 15-minute rainfall intensity of 24 mm/hour for this assessment) shows moderate to high likelihood of debris flows in the Etienne Creek tributaries to the North of Shaser Creek (see map on page 8 and 9).

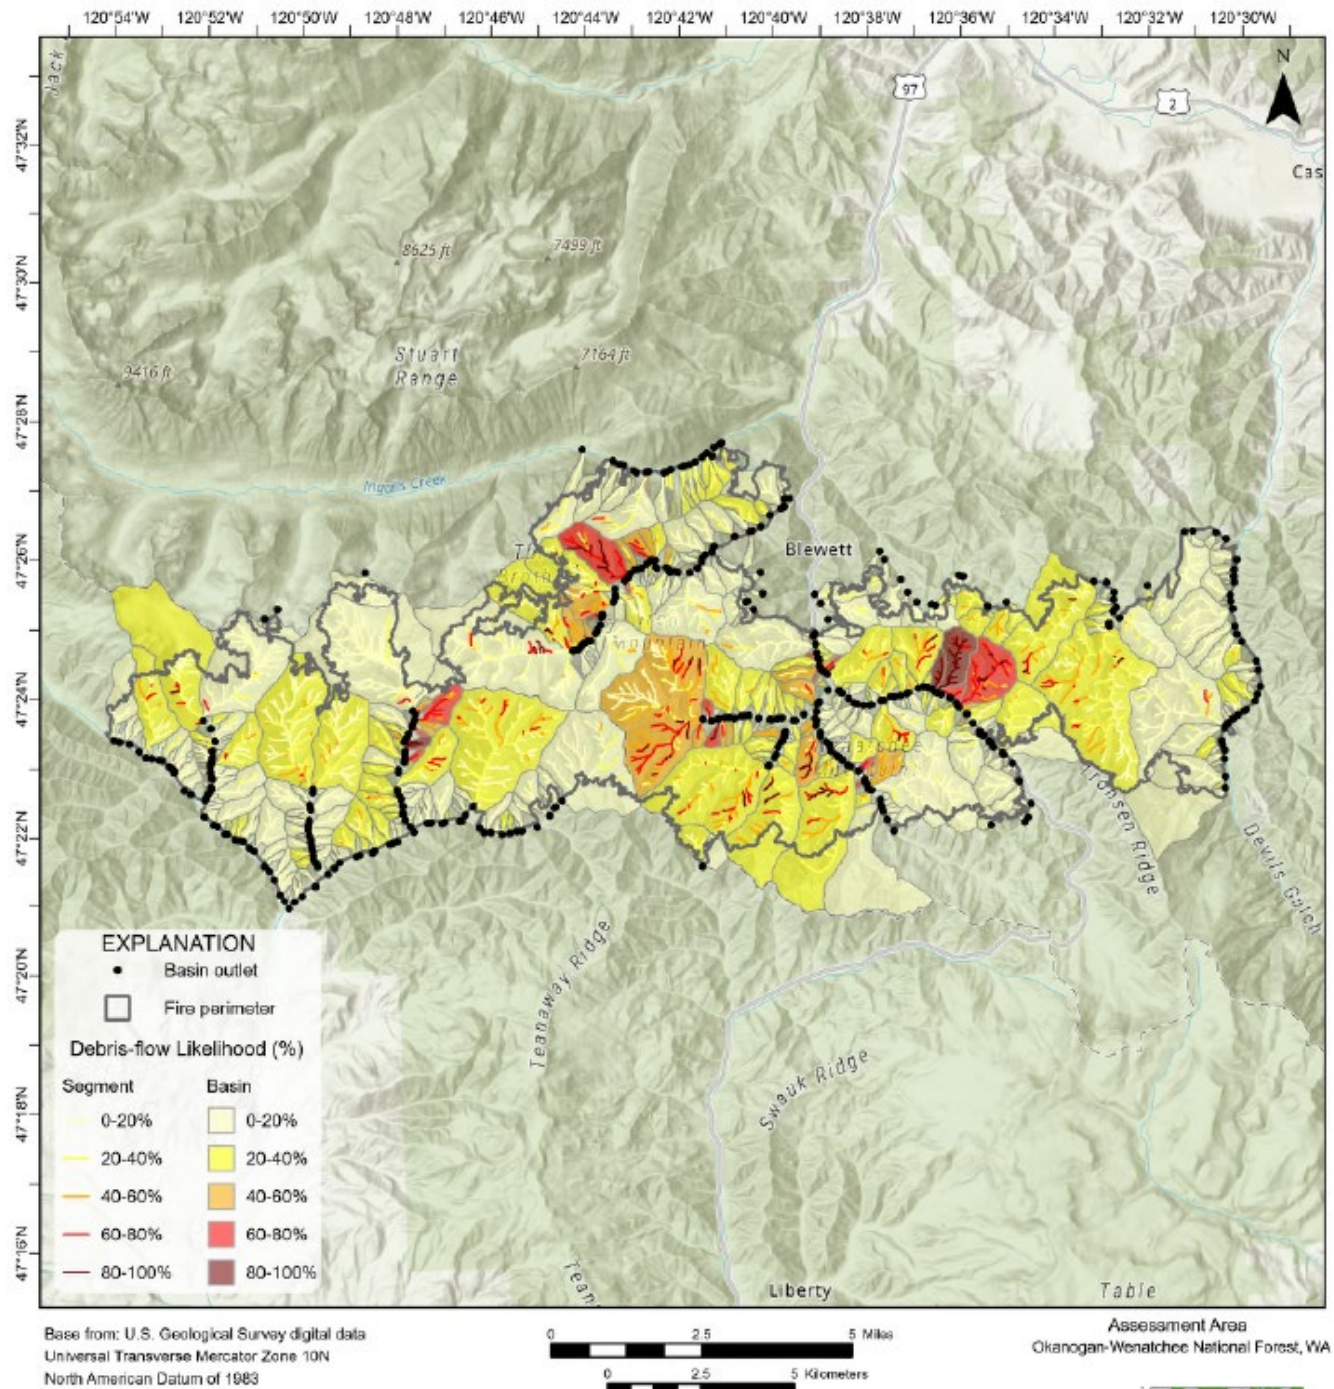
Debris-flow Likelihood

Design storm: Peak 15-minute rainfall intensity 24 mm/h

Figure 6: USGS debris flow hazard map. Likelihood of a debris flow occurring by stream segment and basin.
