# History of Forest Fire Lookouts on the Nez Perce National Forest

# Forest Fire Lookouts

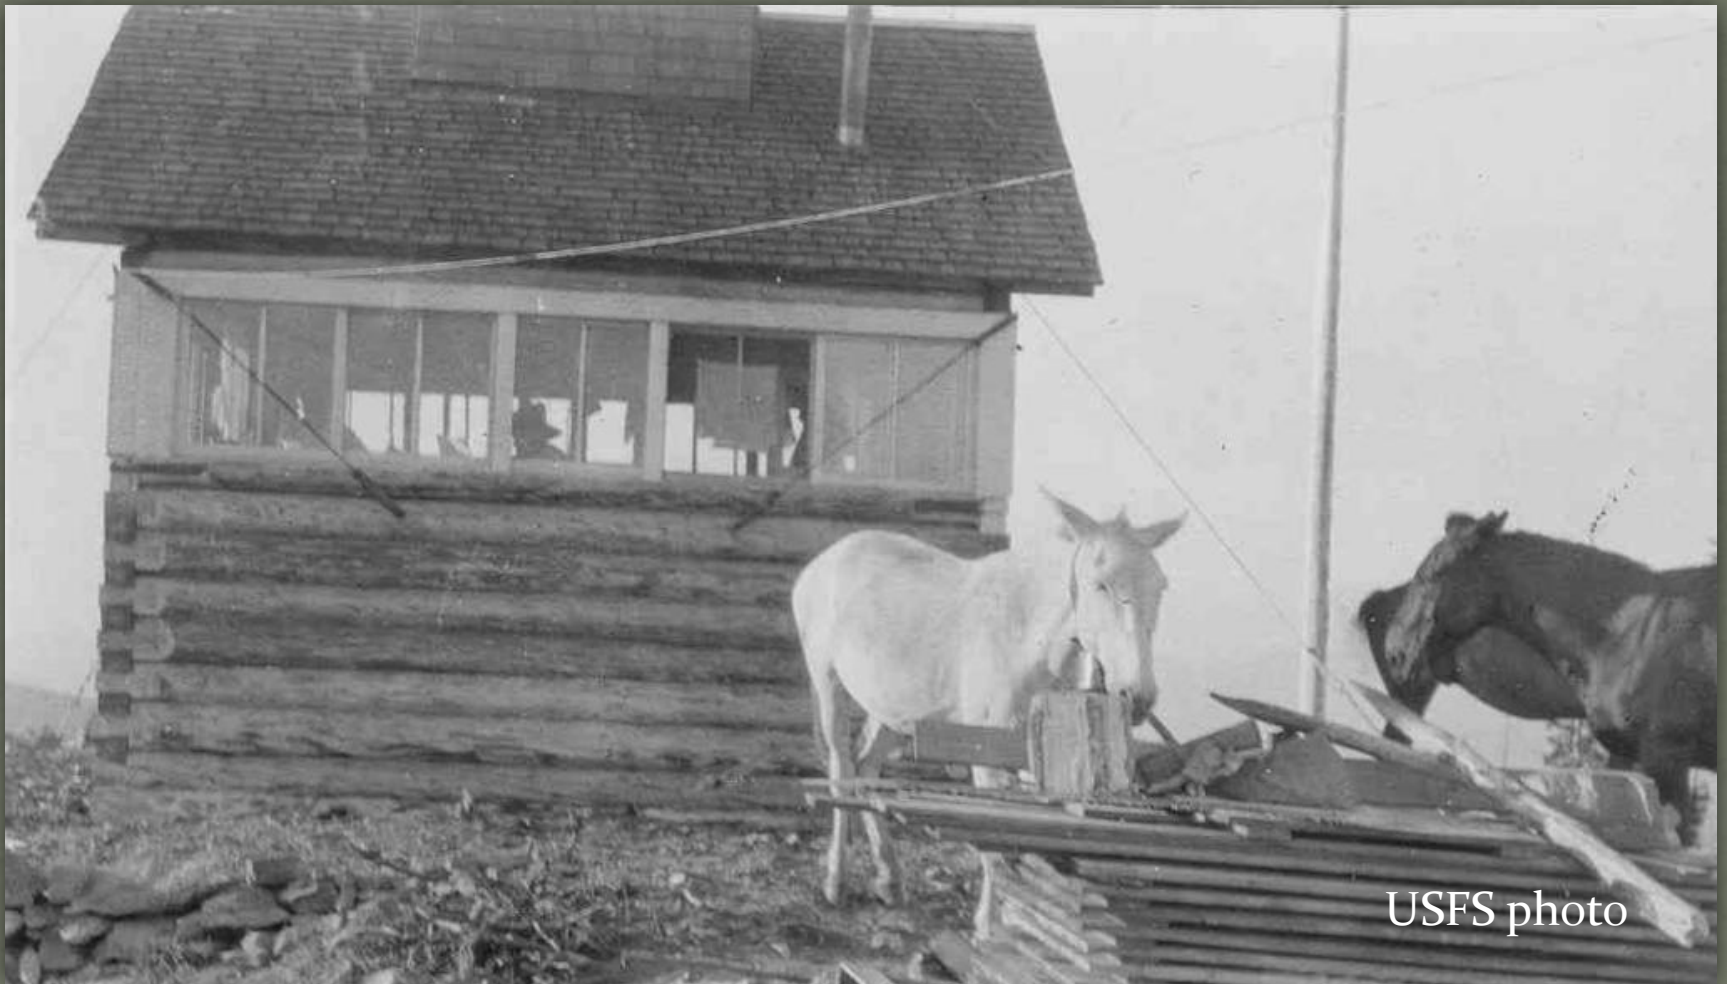
Wall logs were coped for a nearly perfect fit.

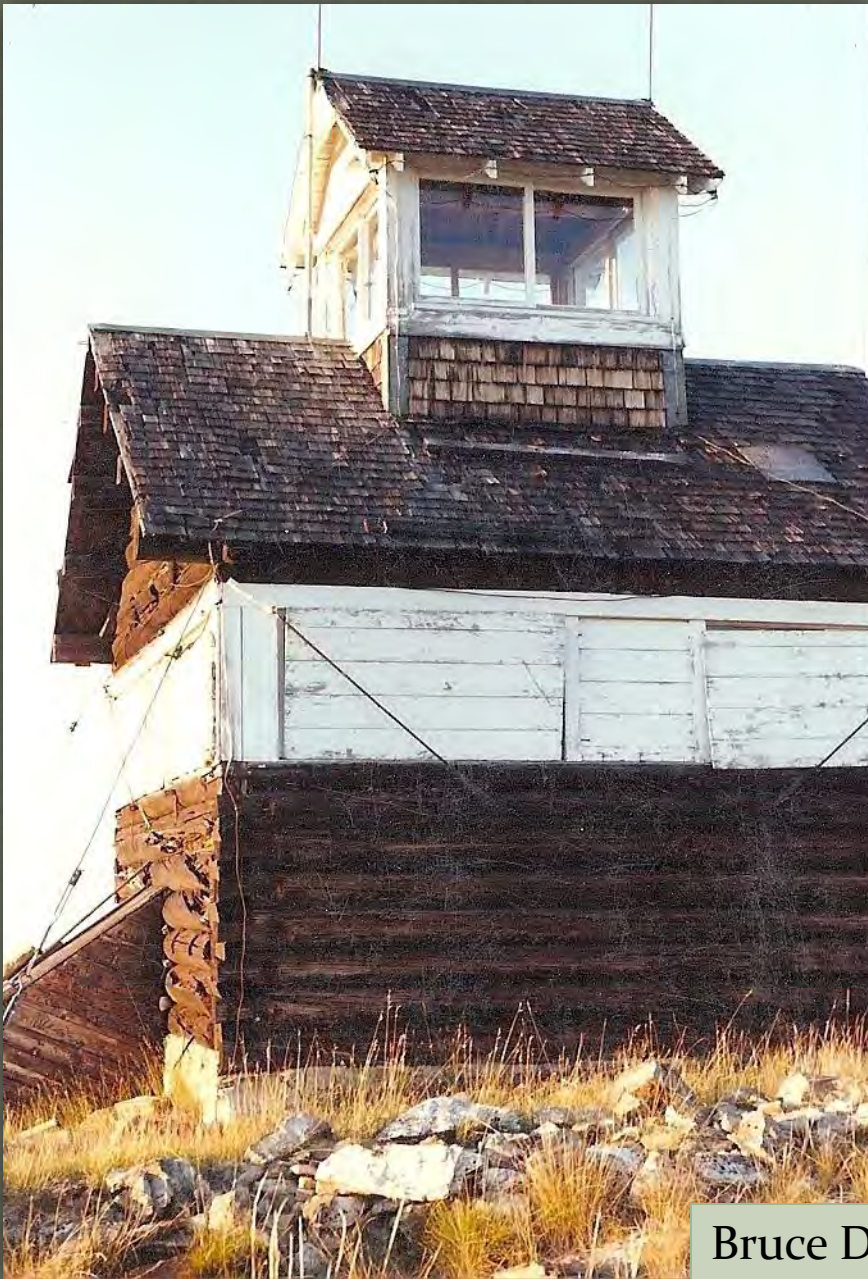
By the 1990s the lookout was badly in need of repair.

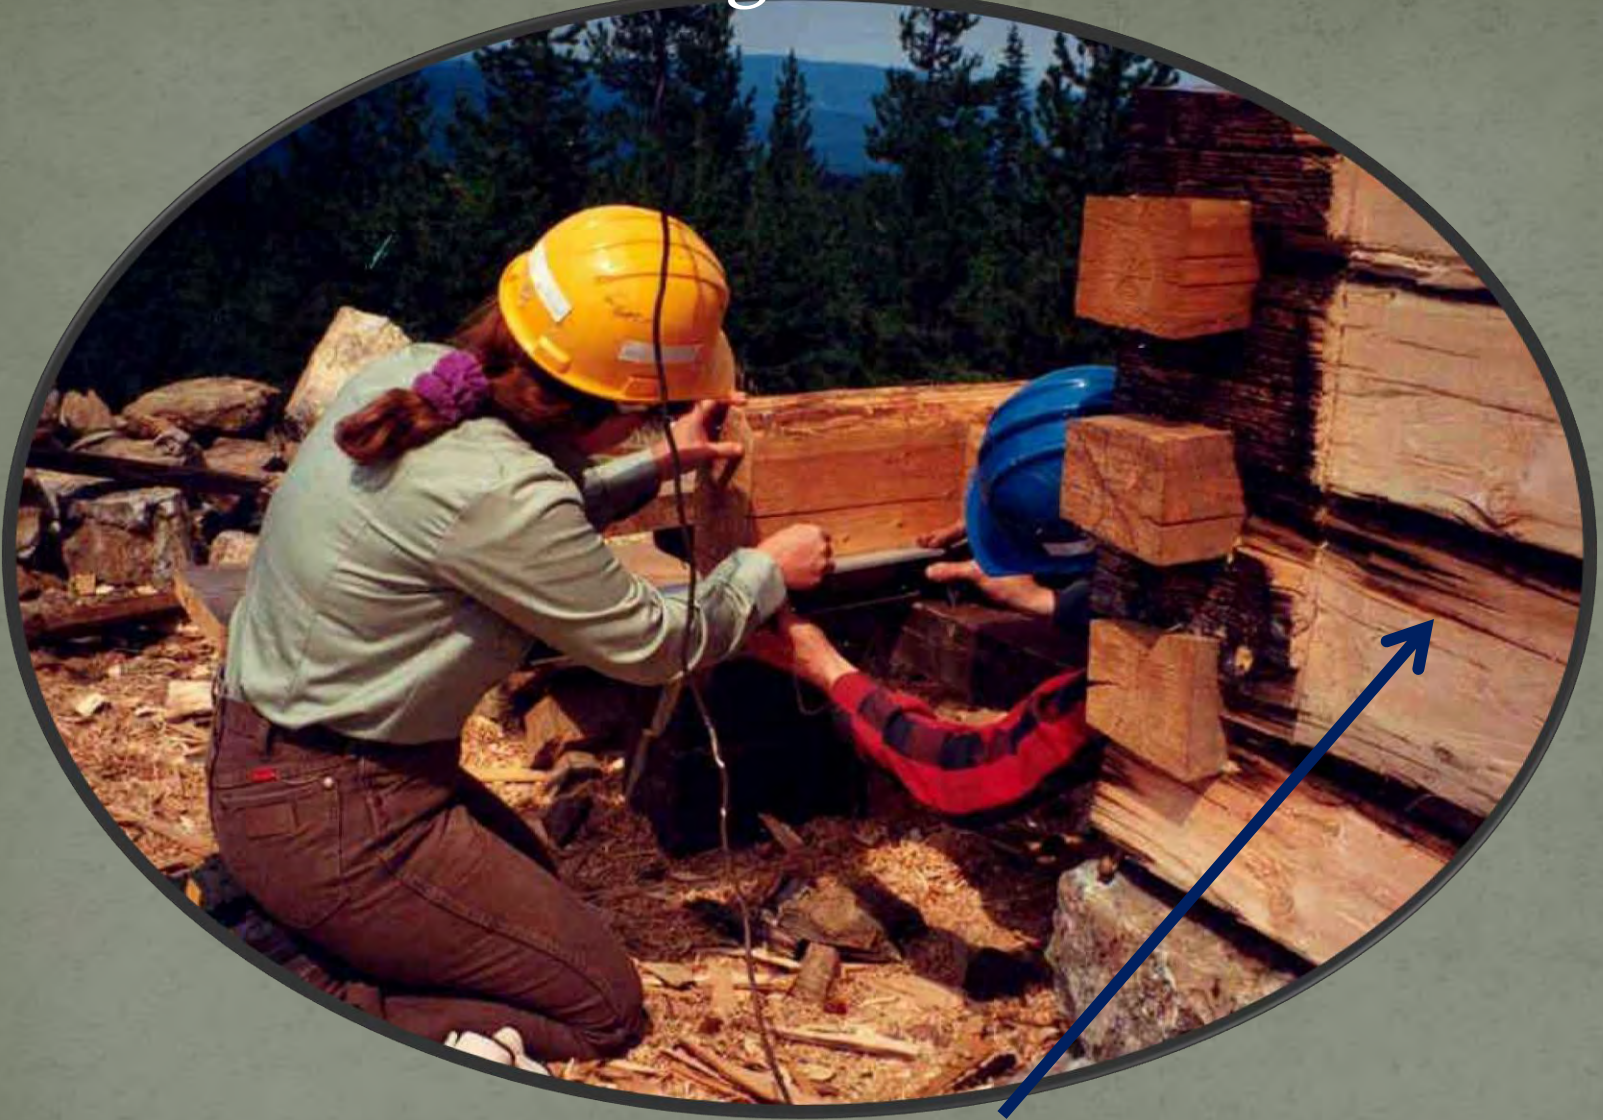
After removal of decayed surfaces of log.

New logs were cut to closely match the dimensions of the existing wall logs . The logs were then peeled.

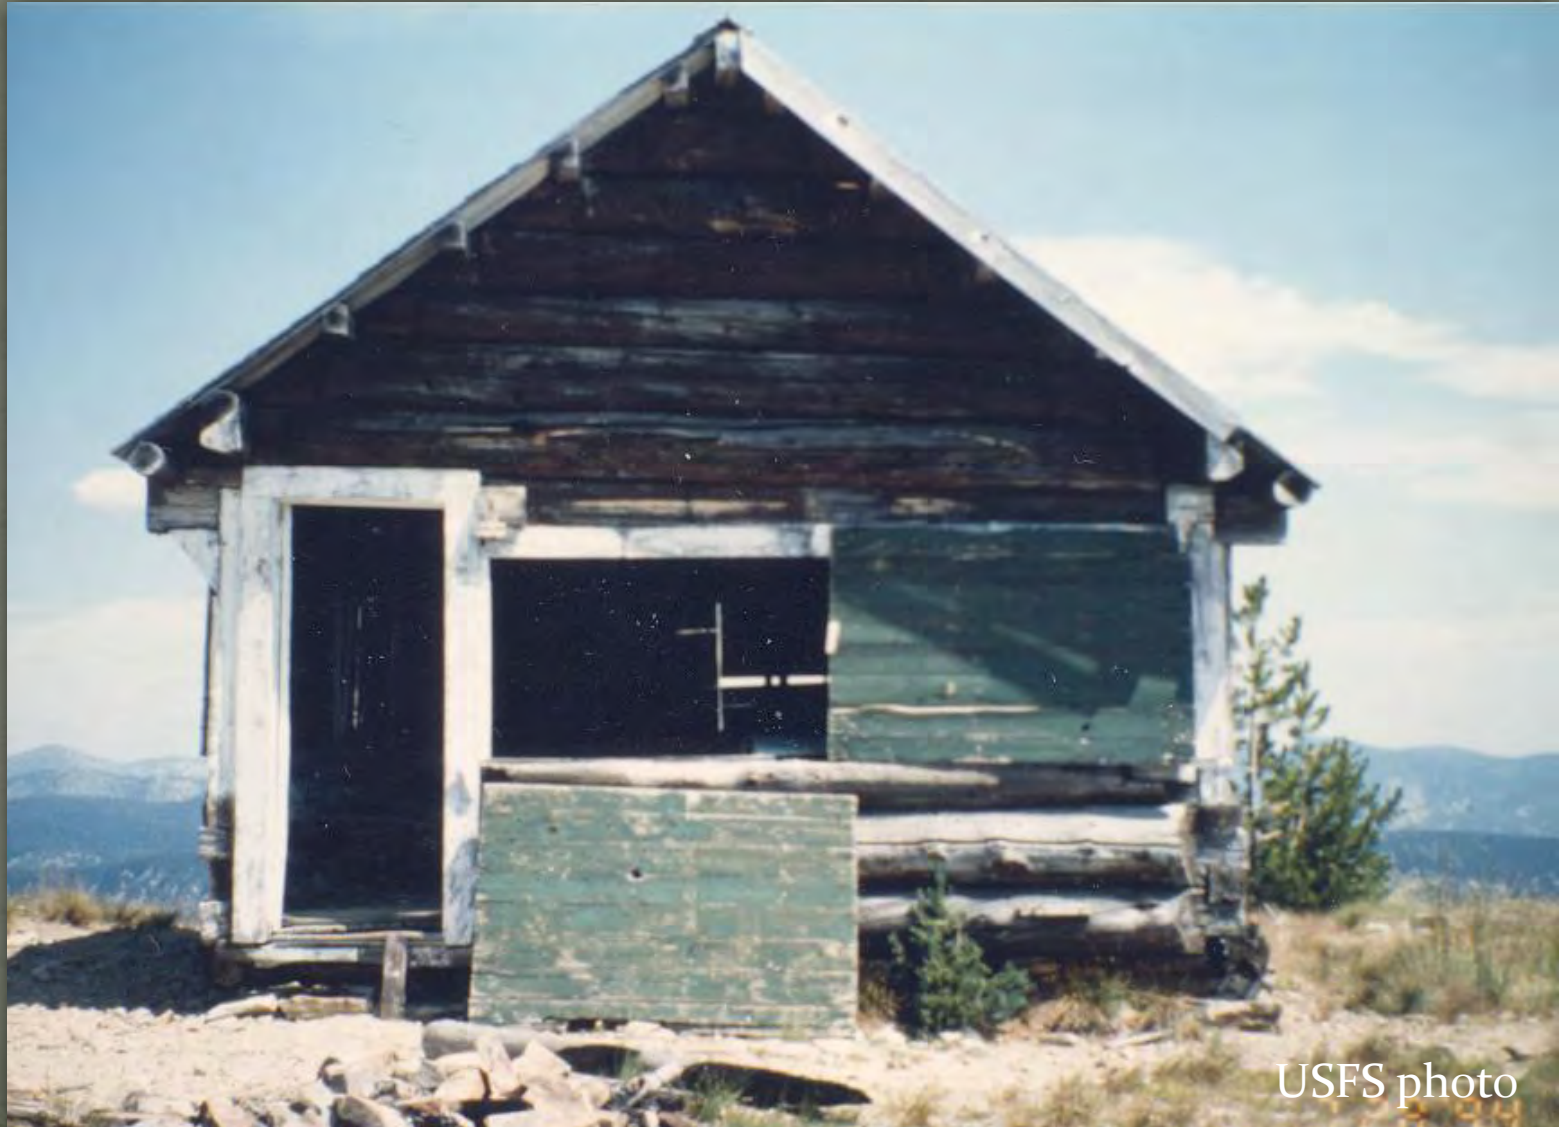
By the late 1990s and after years of neglect, Square Mtn. lookout was in poor condition.

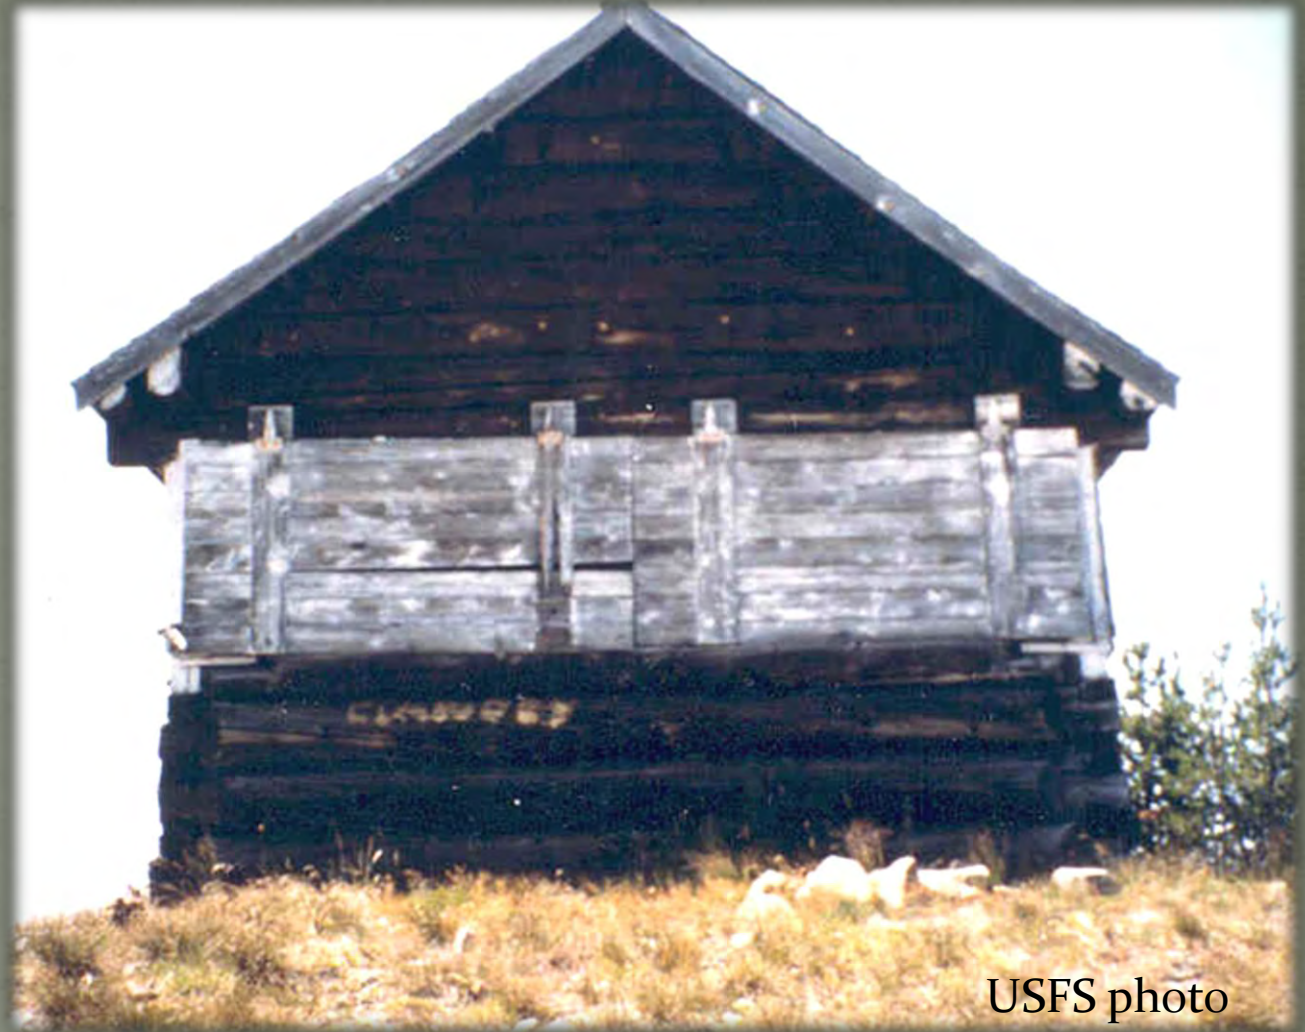
The wall logs were severely decayed requiring that they all be replaced.

The lookout was jacked up and cribbing was placed within the interior to support the weight of the roof and gable logs while all of the wall logs were removed.

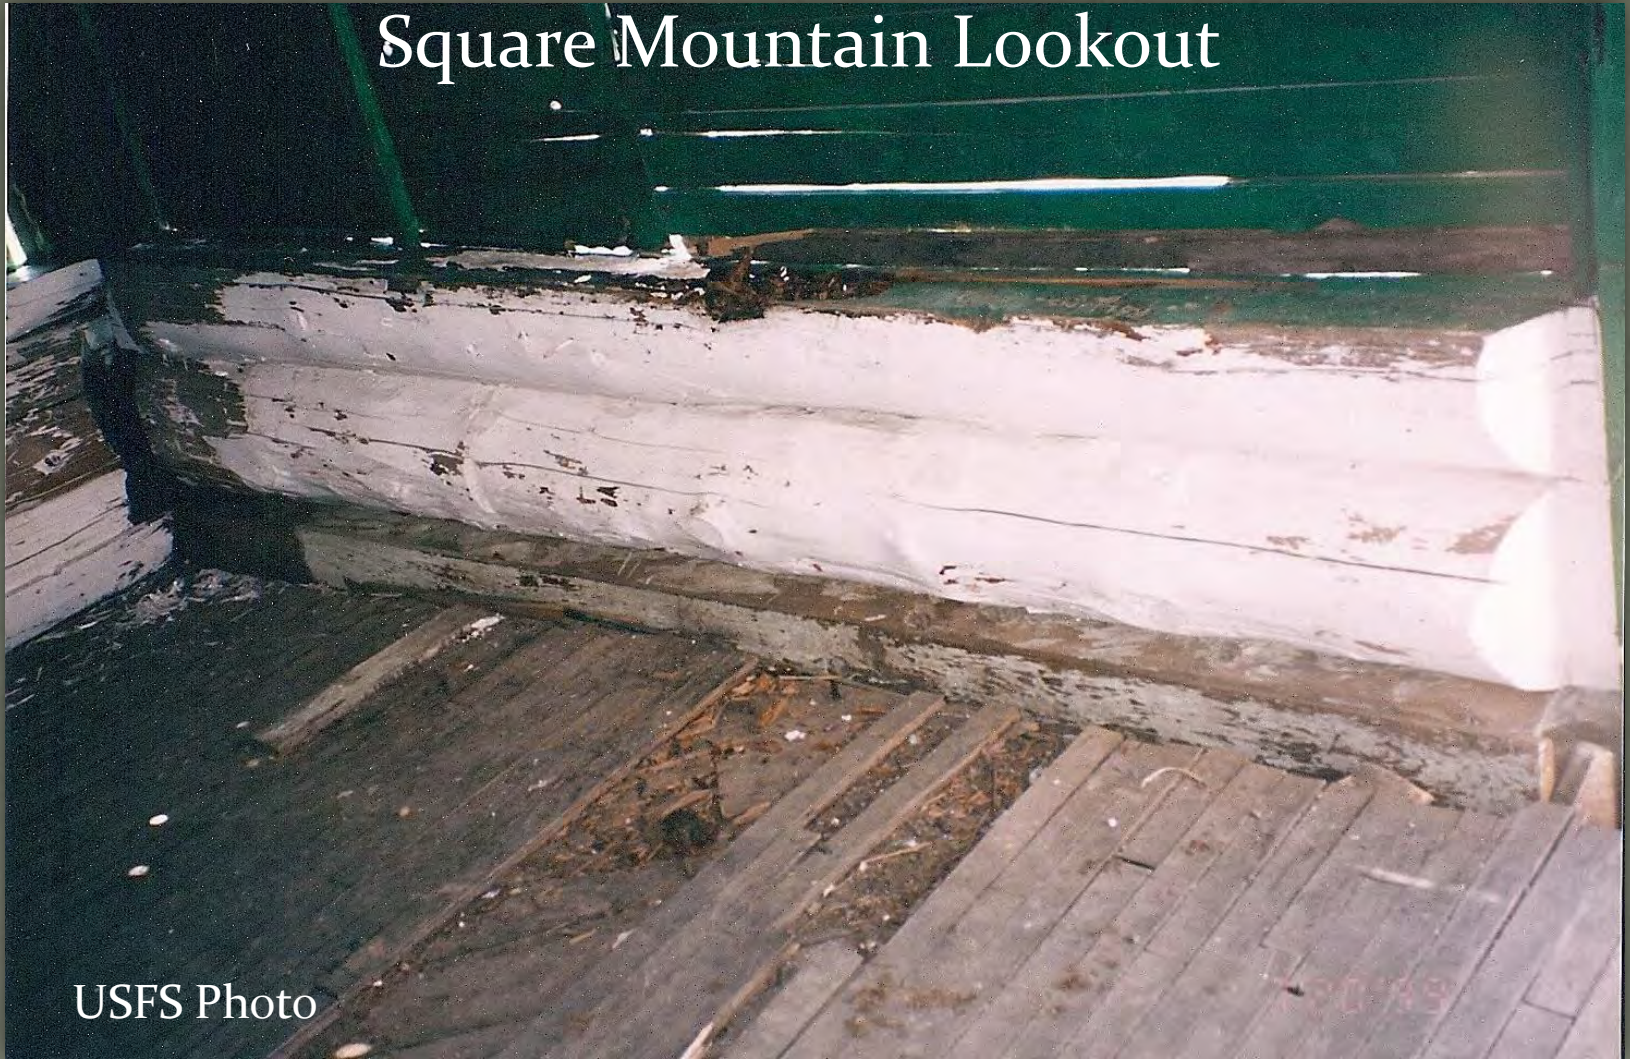
The subfloor and maple flooring were in extremely poor condition requiring replacement.

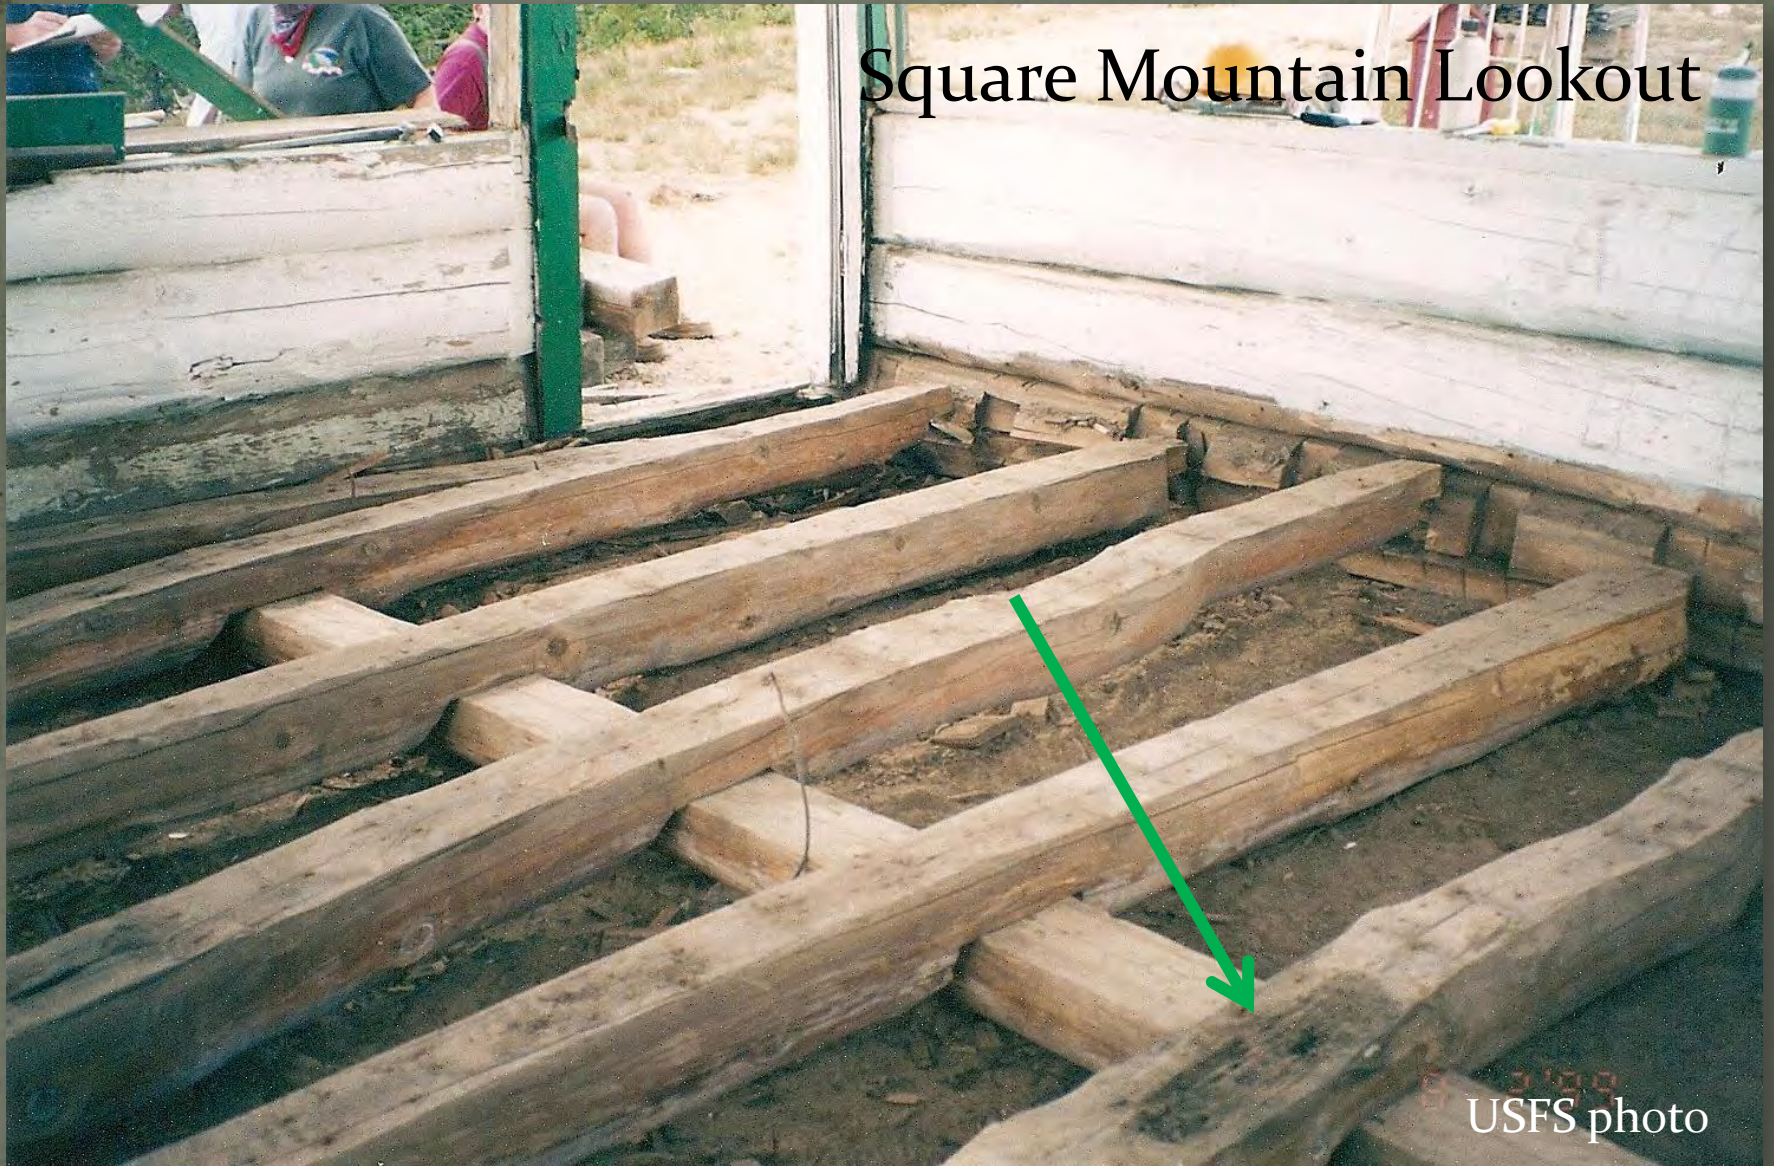
Some floor joists were deteriorated and were replaced.
