## Bear Gulch Fire Burned Area Summary

### Burned Area Report

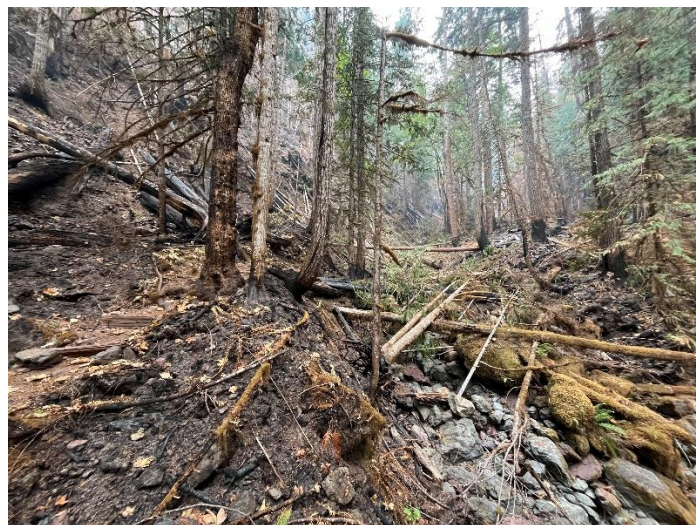
*Photo 1 – A majority of the landscape was a mosaic of low, very low, and unburned in severity. This photo shows both tree survival and mortality seen across the burned area.*

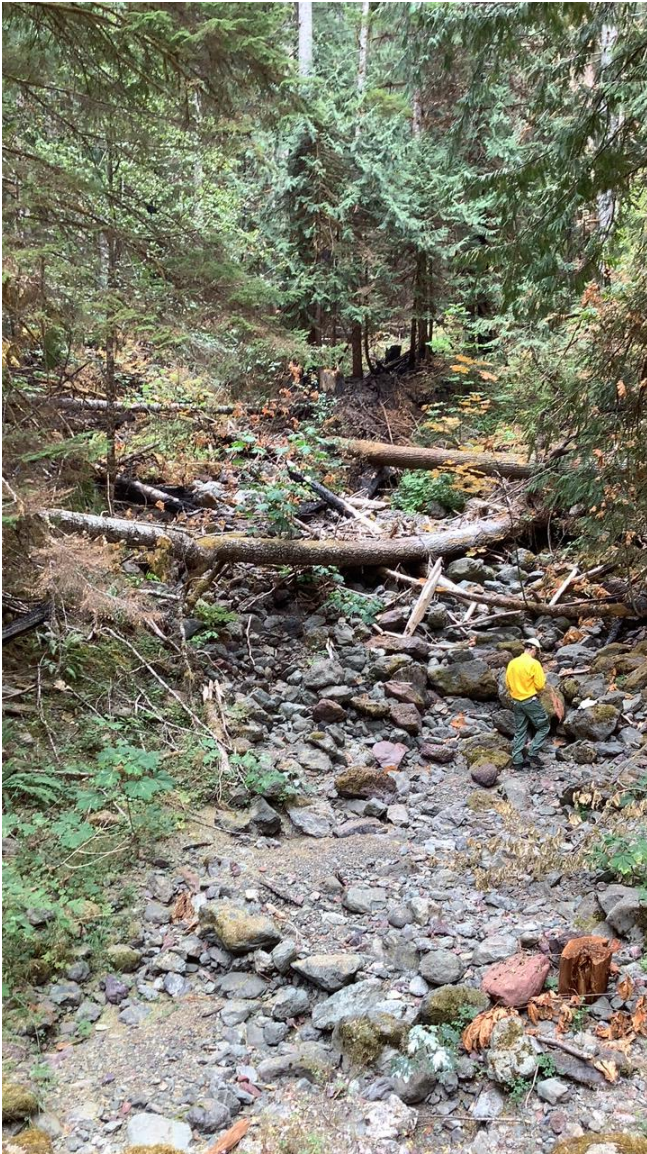
*Photo 2 - Photo of the upstream channel where FSR 2451 crosses Copper Creek showing the range of clasts including large boulders and logs that can impact the functionality of the road-stream crossing infrastructure or be entrained in a debris flow and deposited downstream.*

Roads downstream of burned areas are at risk of damage due to post-fire conditions. The most probable threat due to the fires is clogging of culverts, bridges, and other in-channel infrastructure from the higher levels of floatable debris (especially burned trees) in burned watersheds. Once blocked by debris, road drainage structures no longer function and the stream flows over the road, often causing considerable damage and limiting access. Various measures can reduce this risk, including protecting culvert inlets with debris racks, removing large floatable debris from channels upstream of structures before floods, and making heavy equipment available and readily mobilized during storm events to keep structures clear of debris.

Critical values addressed in the BAER report include Forest Service System Roads and related drainage features. Treatments for the protection of these roads include expanding rockfall protection structures along the road and keeping culverts and ditches cleared of debris throughout the rainy season.

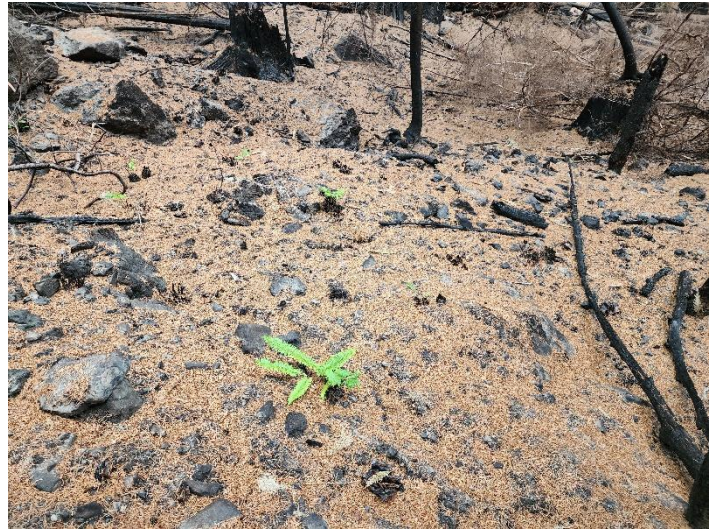
*Photo 3 – Regrowth of vegetation started before winter. With the loss of organic materials, the rocky landscape has become more noticeable. Some areas had large amounts of coniferous needles cast on the ground, which will help reduce further erosion.*
