Dragon Bravo Fire Burned Area Summary

Burned Area Report

Dragon Bravo BAER

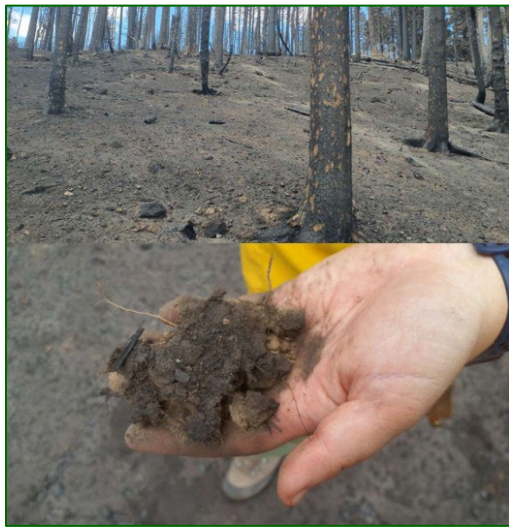
Figure 2 Soil condition sample on moderate soil burn severity (SBS) site in the Dragon Bravo Fire where a majority of the overstory was completely consumed (upper photo) on August 20, 2025.

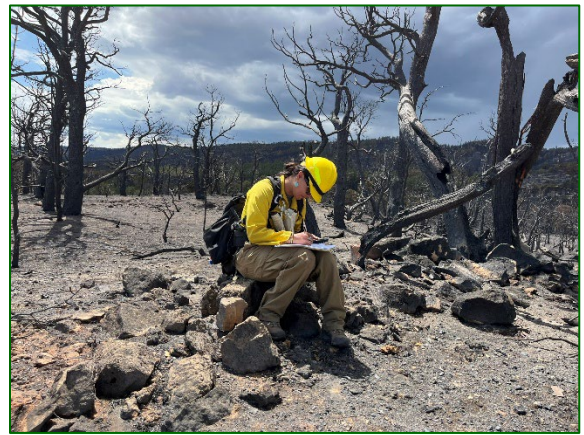
Figure 4 BAER archaeologist Noni Lyndon documents fire effects to a cultural resource site on the Dragon Bravo Fire on August 22, 2025.

The most typical post-fire threats to cultural sites are physical threats such as erosion or damage from (now dead) falling trees. In some cases, newly exposed artifacts are threatened by human activities such as looting or vandalism. Cultural resources were evaluated by the team and treatments proposed as necessary to protect these values from post-fire threats. Treatments are proposed to protect 69 cultural sites through straw wattle installation, seeding and signage, as well as felling of trees at

two sites to prevent further loss to site integrity.
