# Bonneville Fire Burned Area Summary

## Burned Area Report

The Bonneville Fire started on June 20, 2026 in the foothills along the Wasatch Front and was human-caused. The fire reached 572 acres, 319 of which were on National Forest land and 253 were on private land. It reached 100% containment on June 25, 2026.

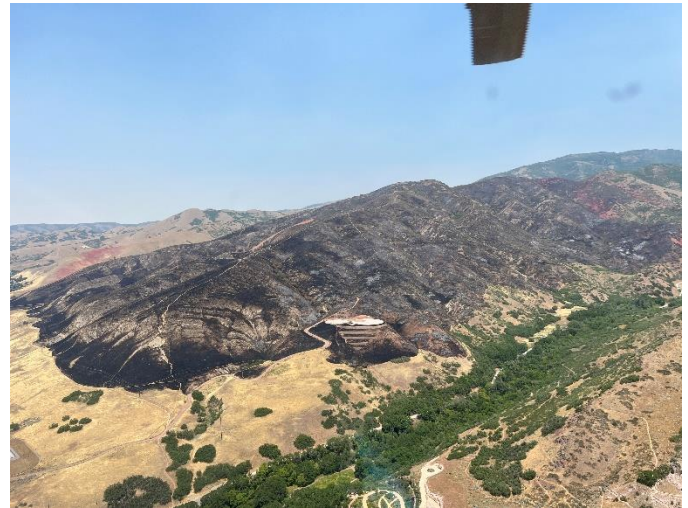
*Figure 4. Aerial view of the Bonneville Fire scar.*

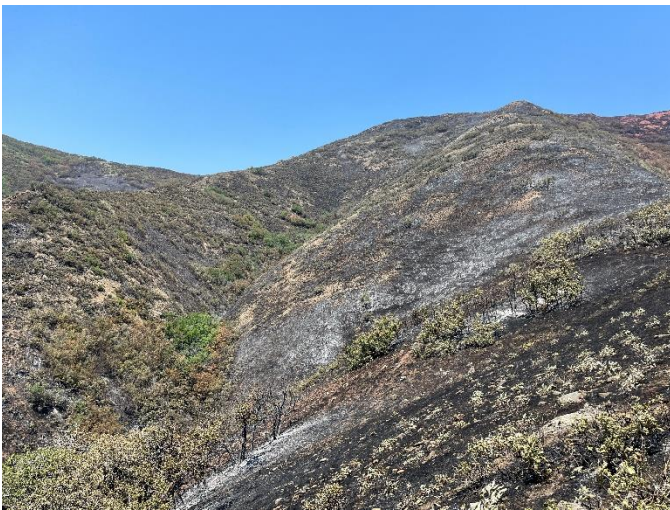
*Figure 5. Bonneville Fire scar from on-the-ground SBS mapping.*
