# **Lower Siuslaw Watershed Analysis**

**Siuslaw National Forest  
Mapleton Ranger District**

**SRI/SHAPIRO/AGCO, Inc.**

**February 13, 1998**

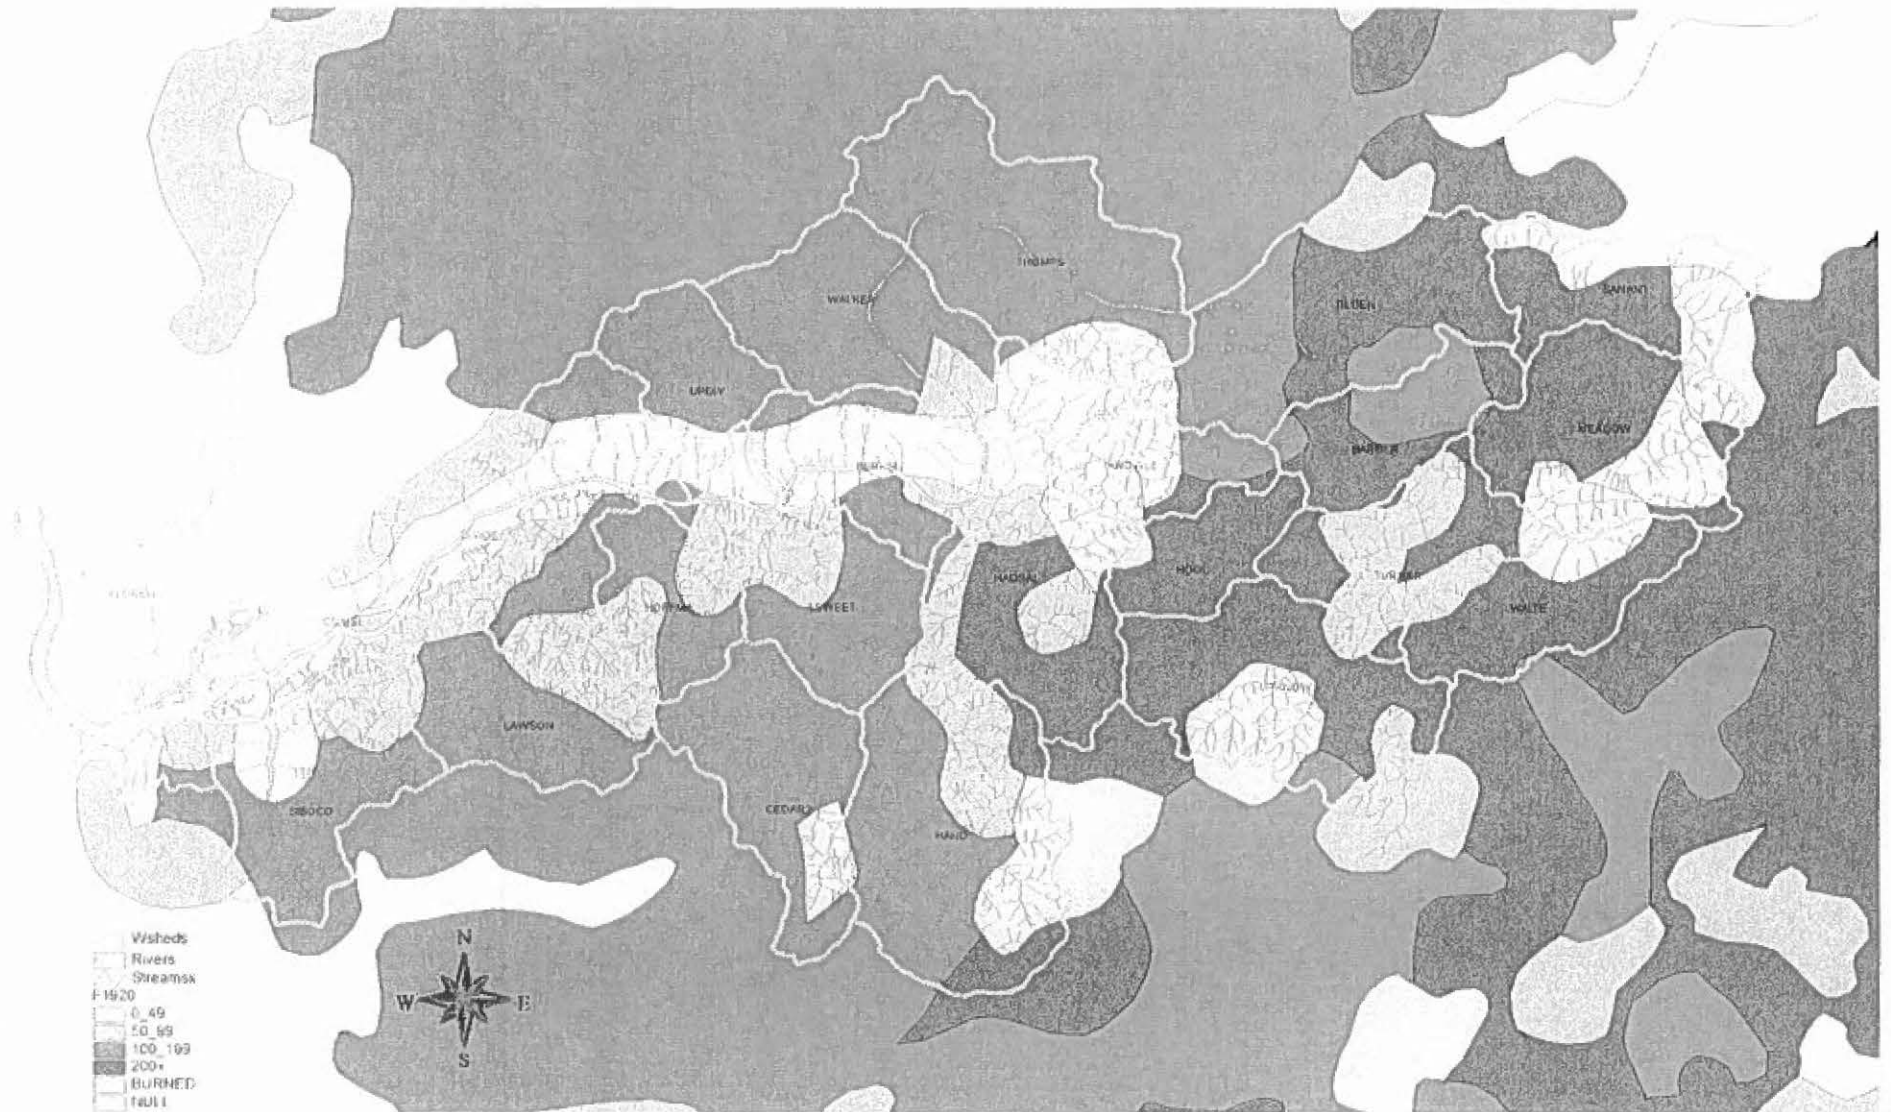
## Historic Vegetation - 1920

Map 5

- The overall vegetation pattern of the watershed is highly fragmented, especially south of the Siuslaw River and on private forest land.
- The historic vegetation pattern in the watershed was formed by wildfires that burned across large areas of the landscape (Maps 4-7).

- The Siuslaw people appear to have used low-intensity fires to clear areas around villages and ridges to permit easy travel, and attract game. In 1835 and 1868, Indians reported large fires that "turned the sky black for two weeks" near the mouth of the Siuslaw (Lane County Historian, 1971). Historic photographs taken prior to 1889 clearly show that the area around Slide Gulch had been burned to the ridge top (Ward, 1982). The source of the fires is unknown but their existence is confirmed by historic vegetation map (Maps 4 to 7).

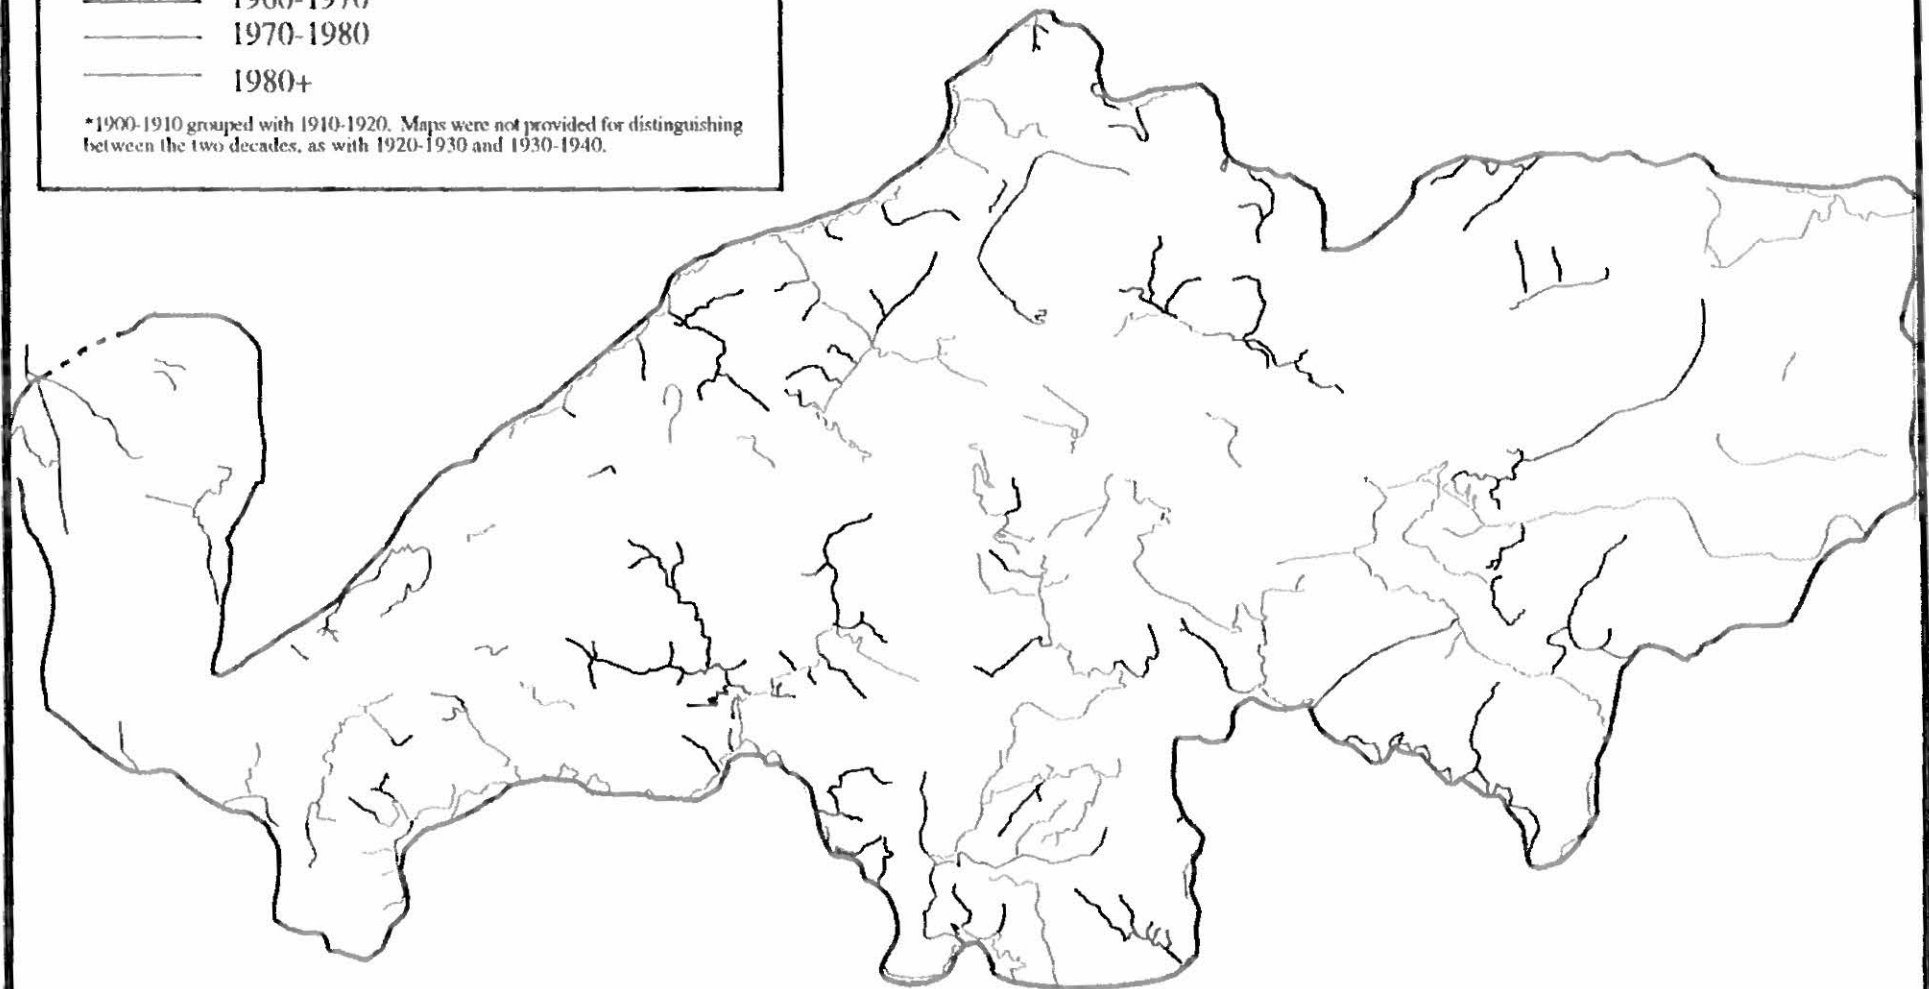
## Lower Siuslaw Watershed Analysis Approximation of Road Construction by Decade\*

- Lower Siuslaw Watershed Boundary
- 1900-1920
- 1920-1940
- 1940-1950
- 1950-1960
- 1960-1970
- 1970-1980
- 1980+

\*1900-1910 grouped with 1910-1920. Maps were not provided for distinguishing between the two decades, as with 1920-1930 and 1930-1940.

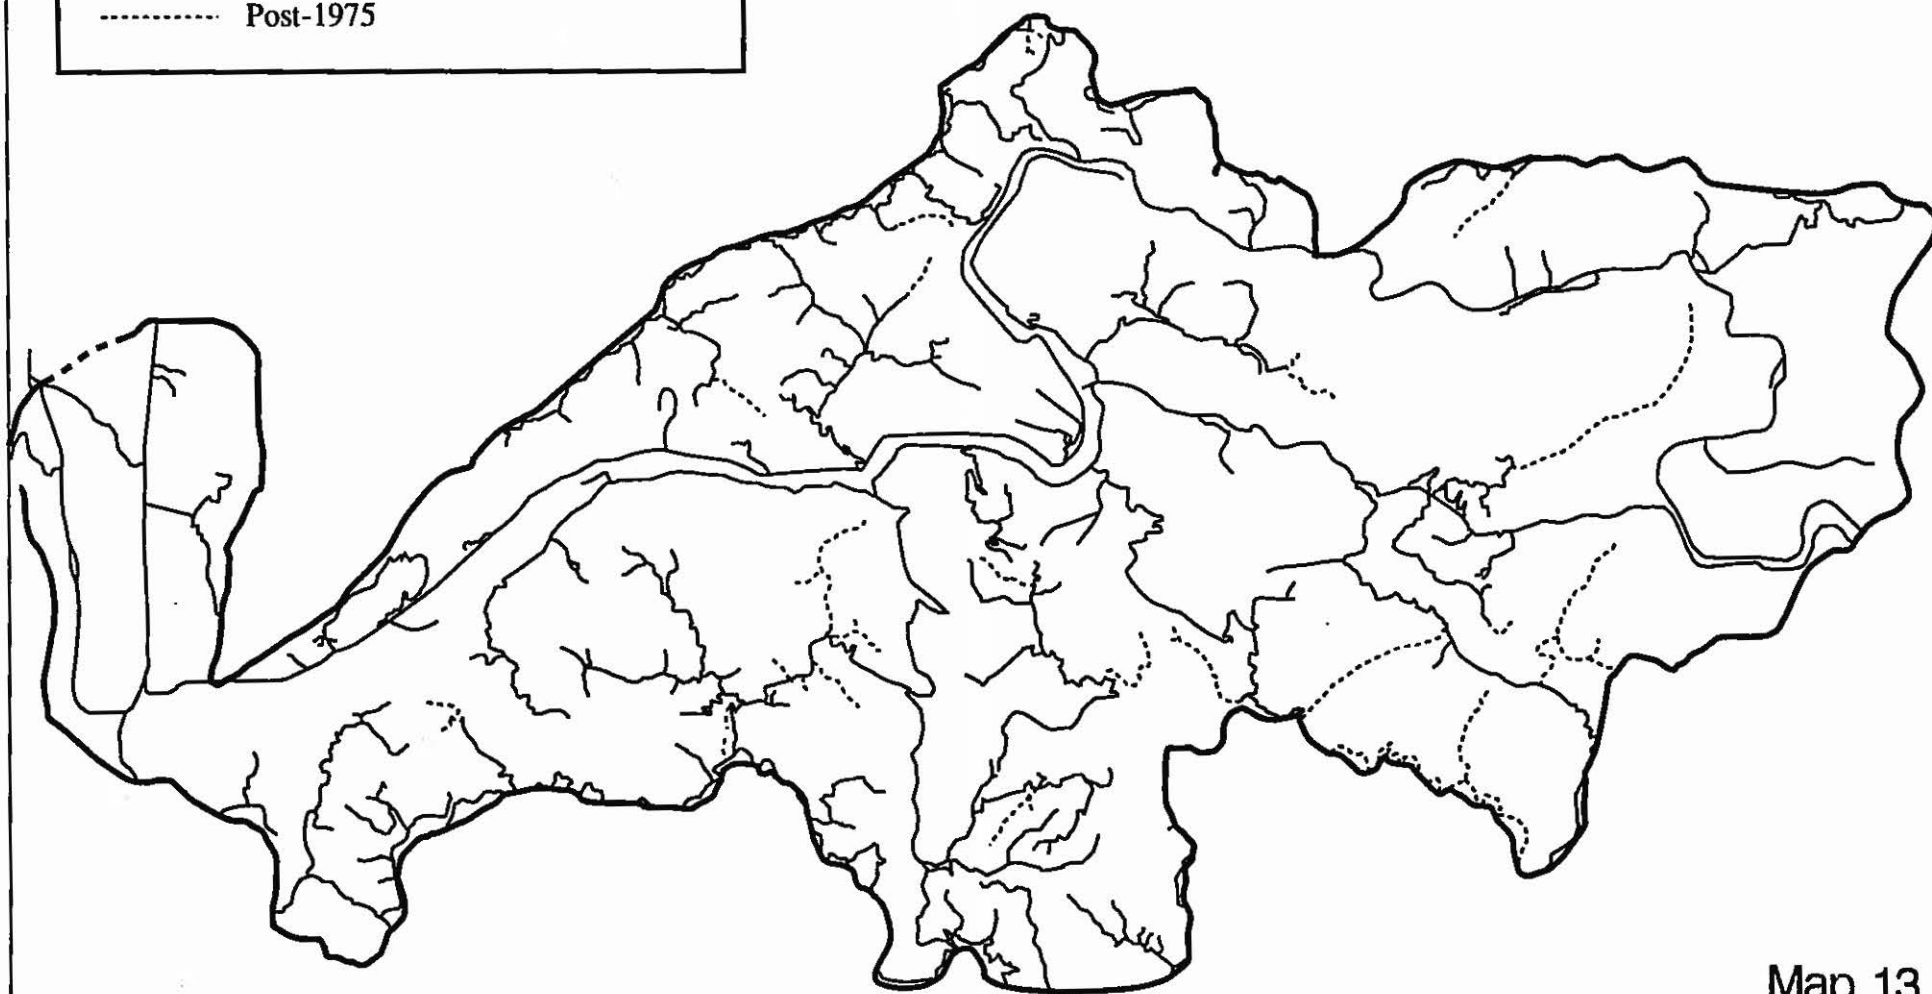
**Lower Siuslaw Watershed Analysis  
Approximation of Road Construction  
Prior To and After 1975**

- Lower Siuslaw Watershed Boundary
- Pre-1975
- Post-1975

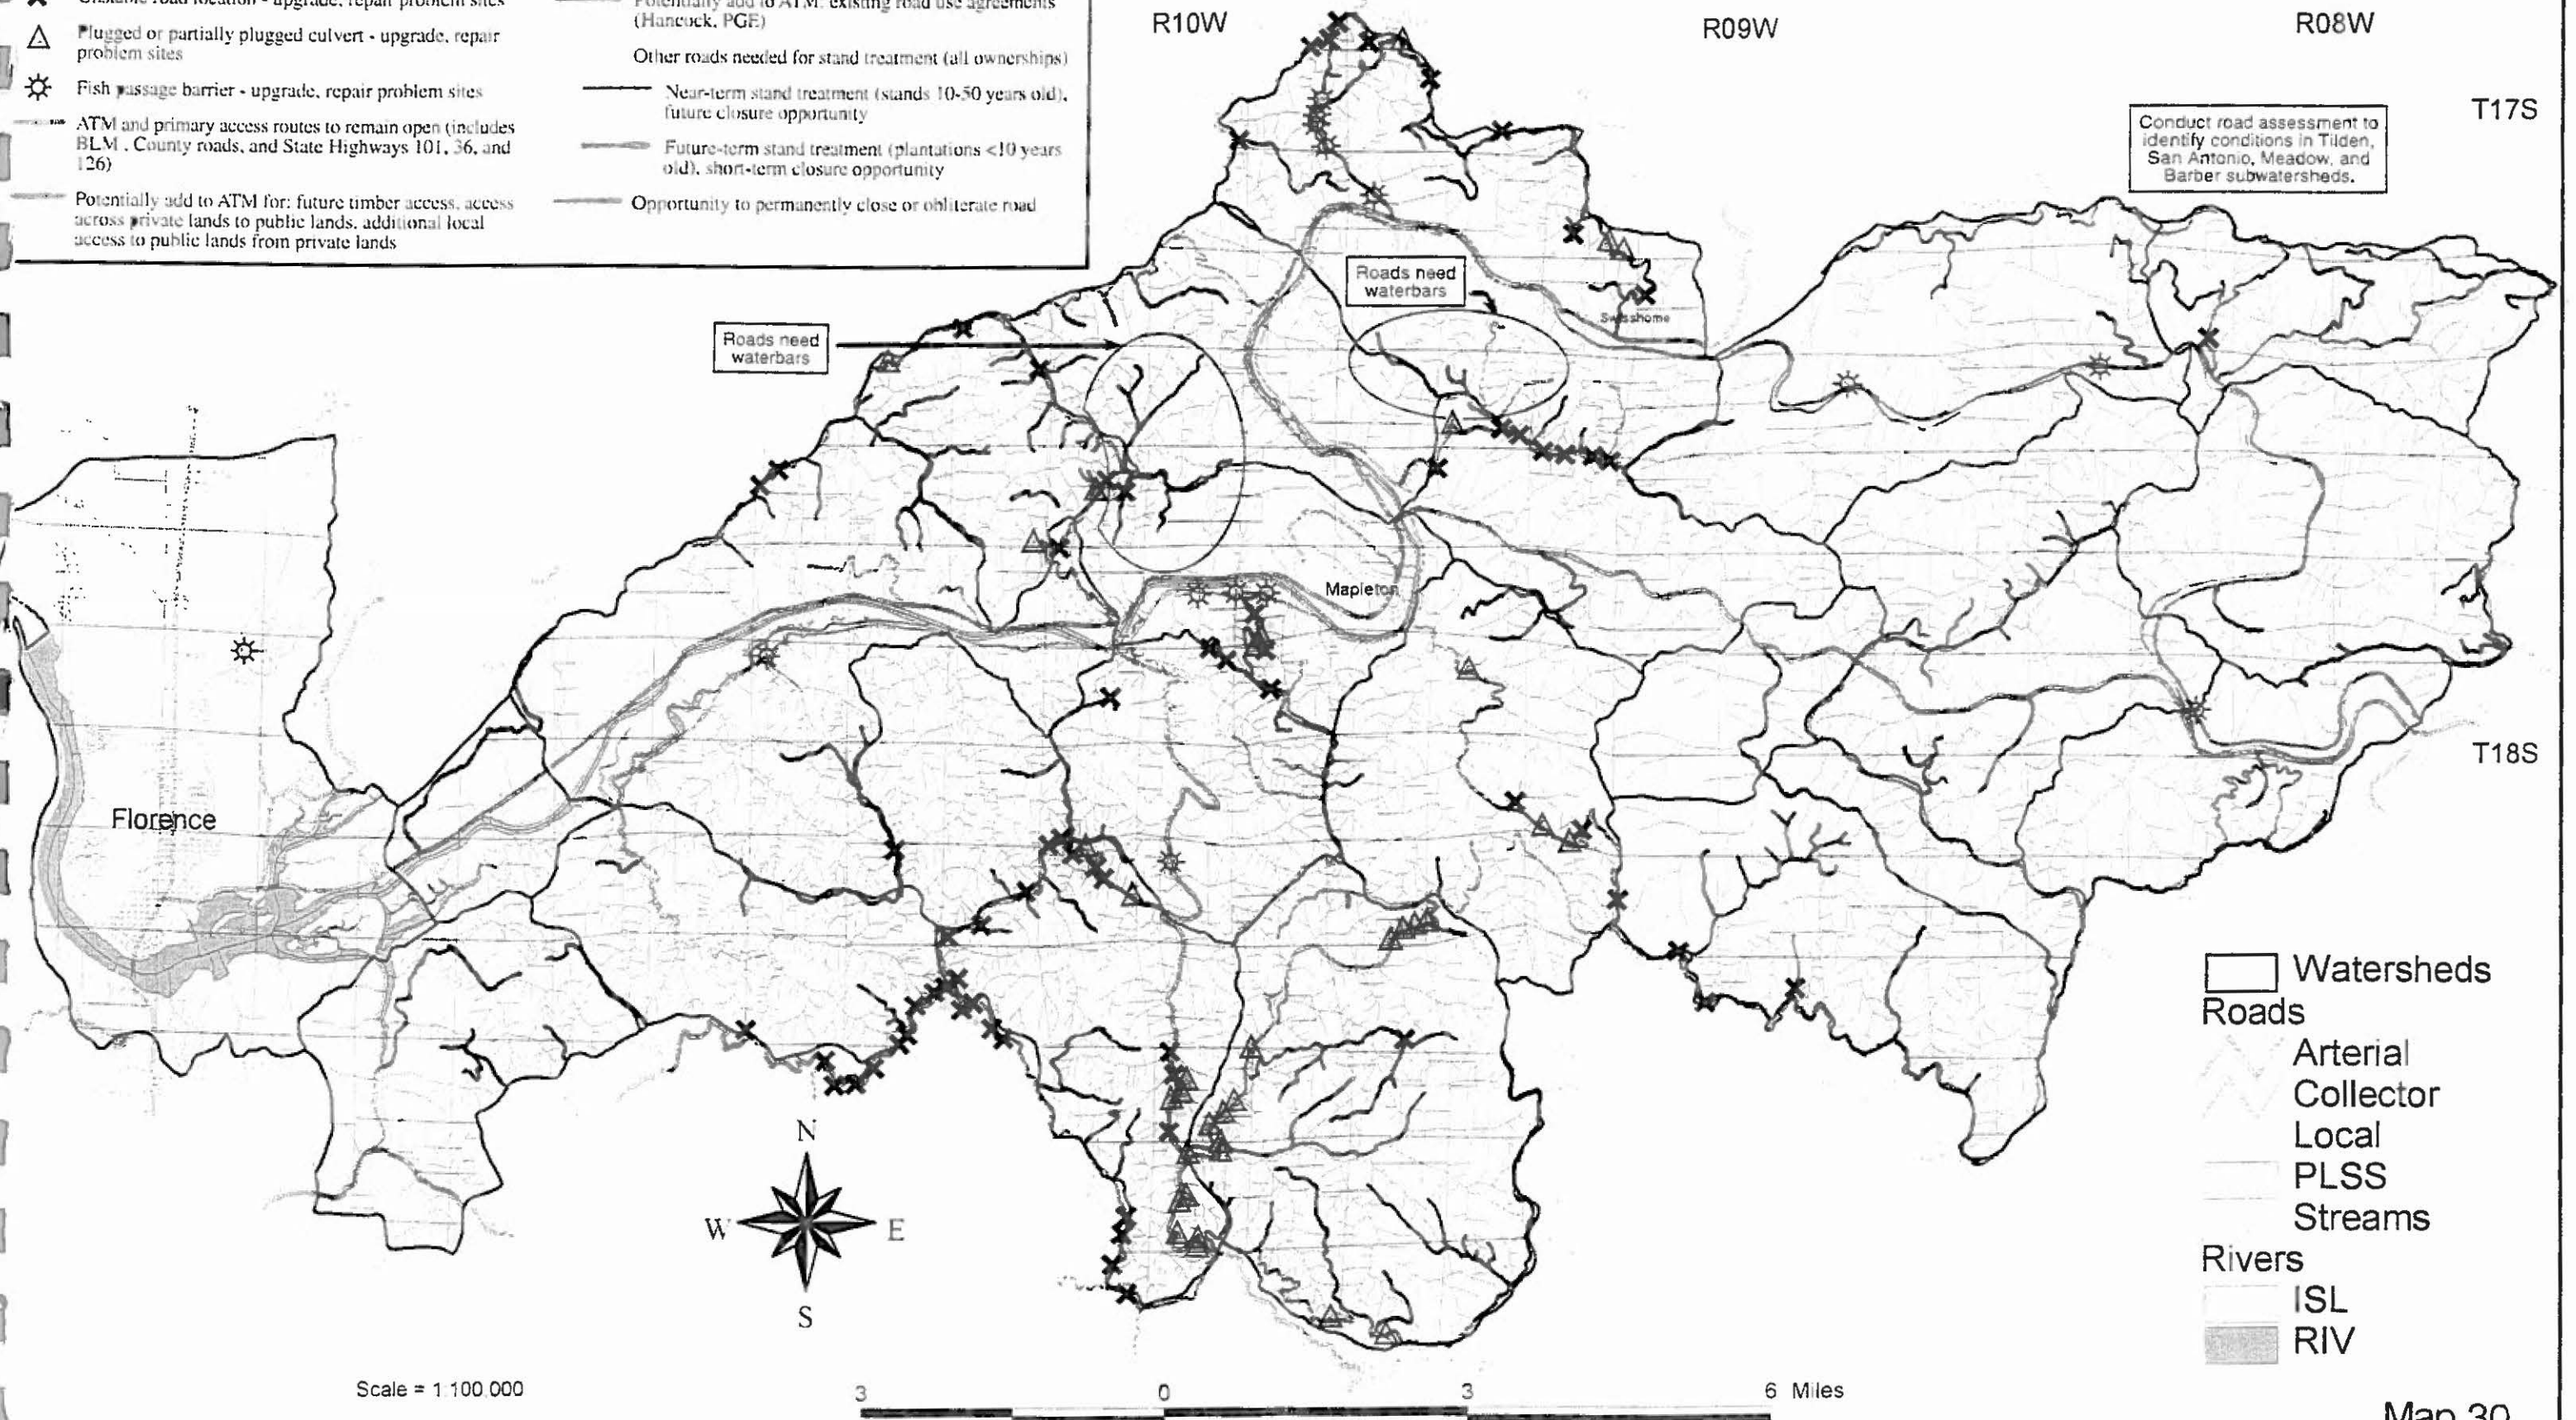
## Road Restoration Opportunities and Priorities

### Road Restoration Opportunities (All Ownerships)

- ✕ Unstable road location - upgrade, repair problem sites
- △ Plugged or partially plugged culvert - upgrade, repair problem sites
- ☼ Fish passage barrier - upgrade, repair problem sites
- ATM and primary access routes to remain open (includes BLM, County roads, and State Highways 101, 36, and 126)
- Potentially add to ATM for: future timber access, access across private lands to public lands, additional local access to public lands from private lands
- Potentially add to ATM, existing road use agreements (Hancock, PGE)
- Other roads needed for stand treatment (all ownerships)
- Near-term stand treatment (stands 10-50 years old), future closure opportunity
- Future-term stand treatment (plantations <10 years old), short-term closure opportunity
- Opportunity to permanently close or obliterate road

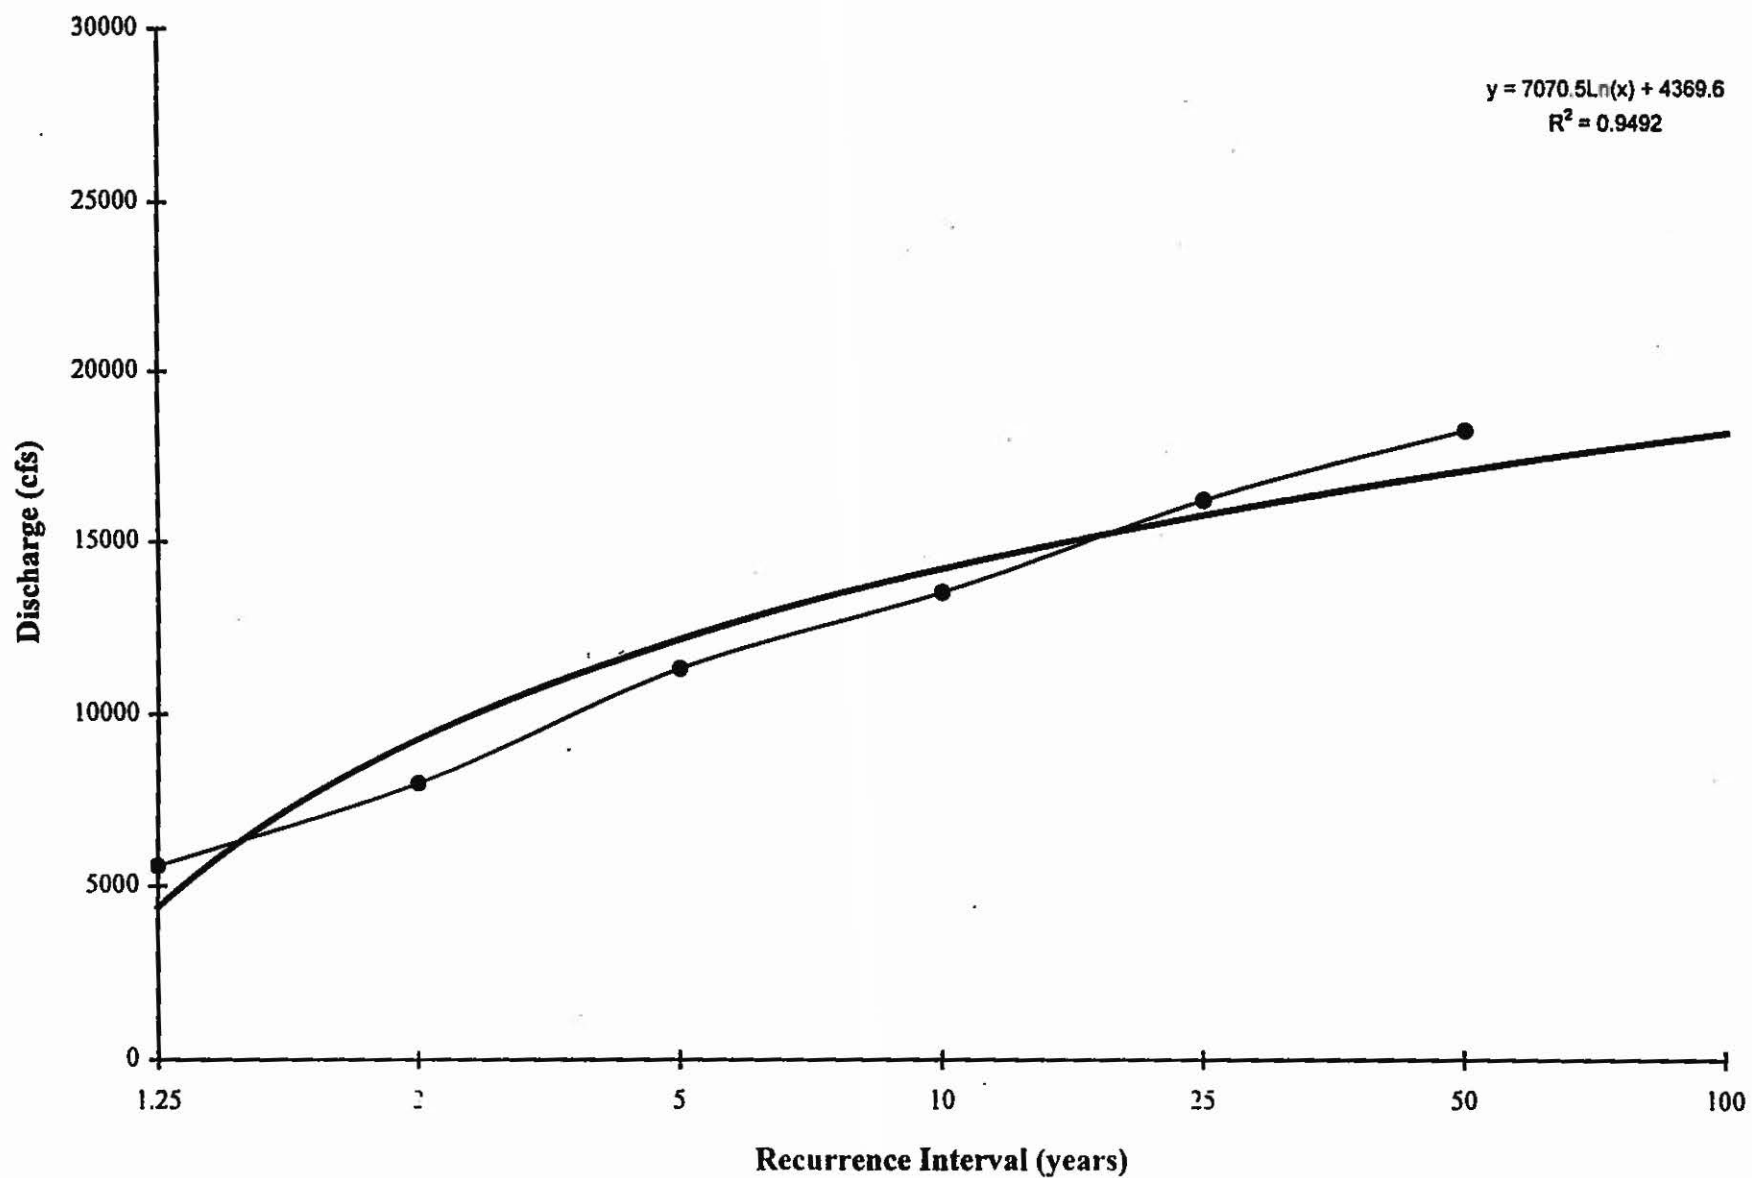
Due to lack of data presented by the USGS, best line fit methodology was used to predict the expected 100-year recurrence interval for discharge for the lower Siuslaw watershed. Extrapolated data from the USGS data for the Siuslaw River Basin (gauging station #14307620) were used to predict the 1.25-, 2-, 5-, 10-, 25-, and 50-year recurrence intervals for discharges (these data are included in this appendix). The data was extrapolated by altering the USGS data to reflect the area of the lower Siuslaw watershed, rather than the entire 558-square-mile Siuslaw River Basin. The 100-year discharge was provided by the USGS using extrapolated data from the 1994 rating curve.

Best line fit graphic depicting 100-yr recurrence interval for the lower Siuslaw Watershed

- A recurrence interval is the probability that a certain magnitude of flood event will occur over a given time period. The USGS has estimated statistical measurements of the 1.25, 2, 5, 10, 25, and 50-year events for the watershed. The 100-year event was not included in the tabular USGS data because of an inadequate period of record. However, the 100-year event was computed by the USGS based on stage discharge relationship for the available years of data (Hubbard, pers. comm., 1998). Data provided by the USGS also were extrapolated from the representative watershed and are presented in Table 7 (for methodology, see Appendix A). Since the gauging station for the representative watershed was discontinued in 1987, data from the 1996 flood were not evaluated and reported. However, based on a mud line created in the dismantled gauging station at Mapleton, Oregon, by the 1996 flooding, it was estimated that the 1996 flood event was just under a 50-year event and produced an extrapolated discharge of 17,205 cfs.

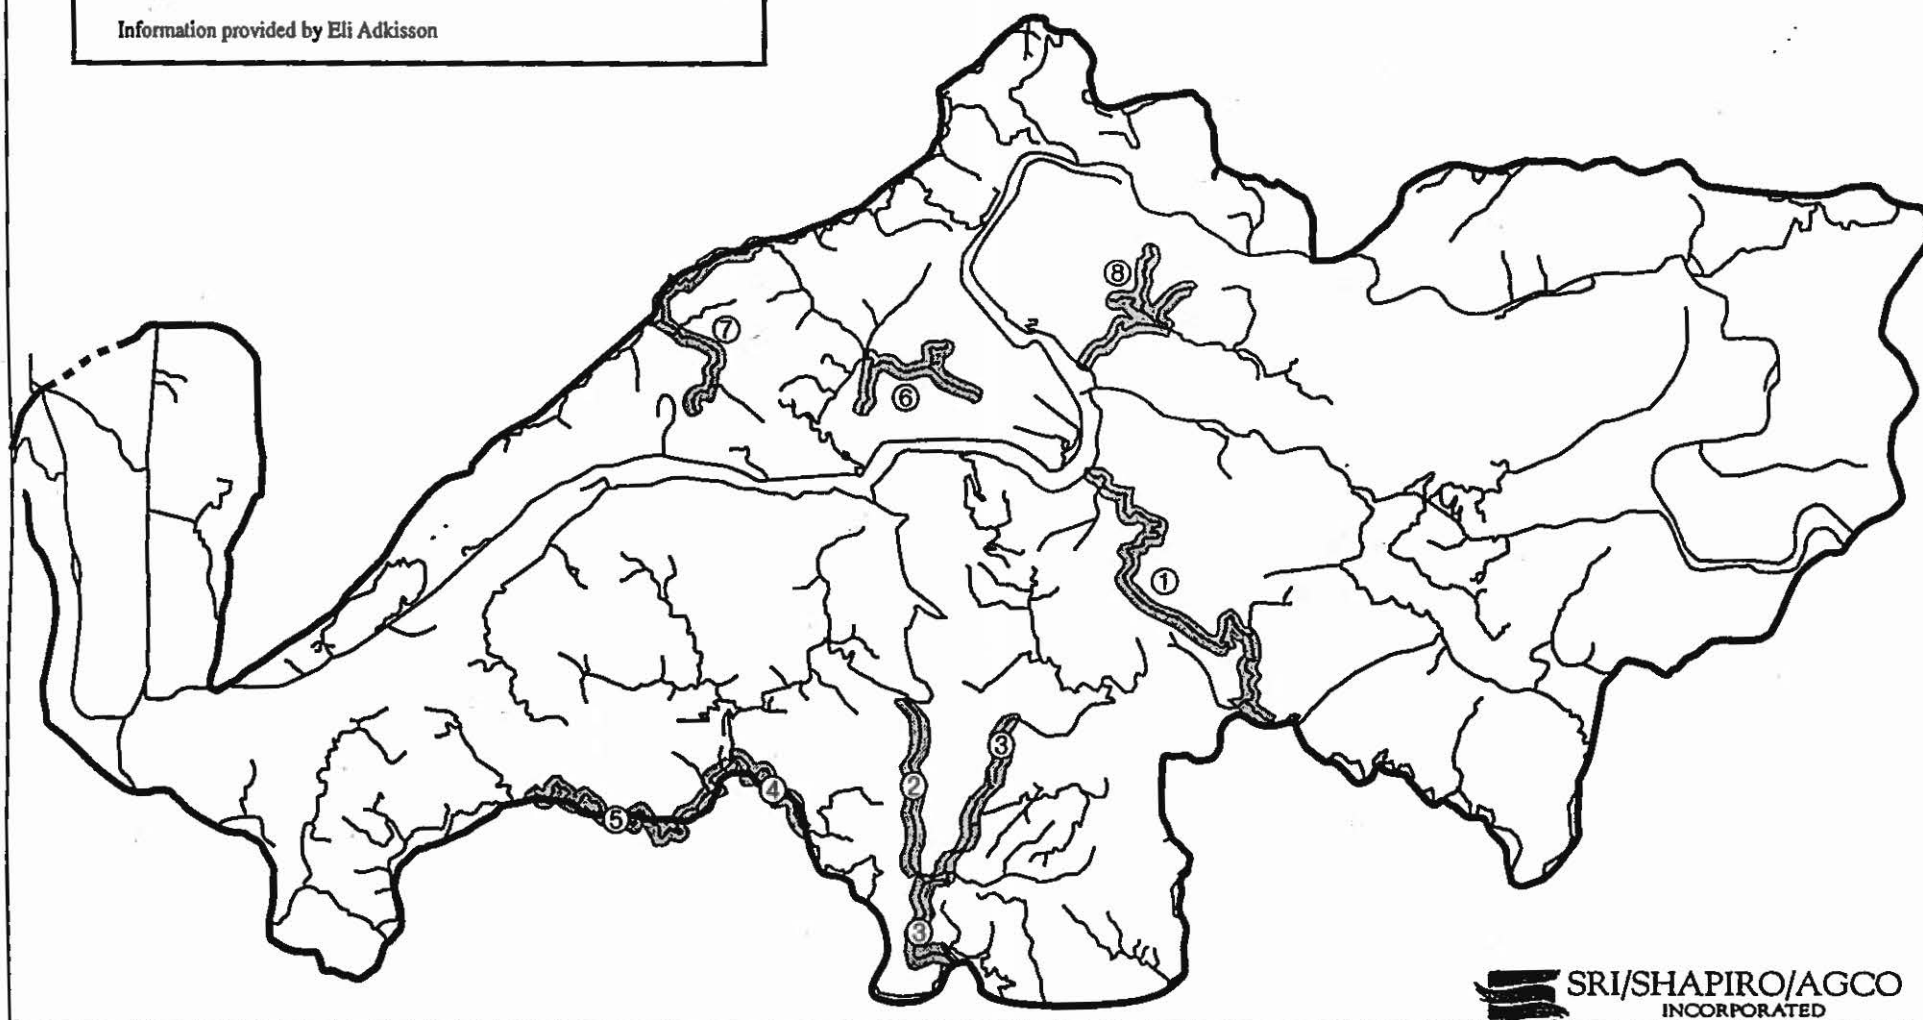
- Lower Siuslaw Watershed Boundary
- ▬ Chronic Road Maintenance Site
- ② Site Identifier

Information provided by Eli Adkisson

- The second, according to the Mapleton Ranger District roads manager, Eli Adkisson, identifies sections of road that consistently require annual maintenance and repair due to similar types of problems as mentioned for the RCA (see Appendix B; chronic road maintenance). Finally, a inventory of landslides that occurred during the 1996 flood identifies slides that were deemed to originate from a road (USDA, 1996).

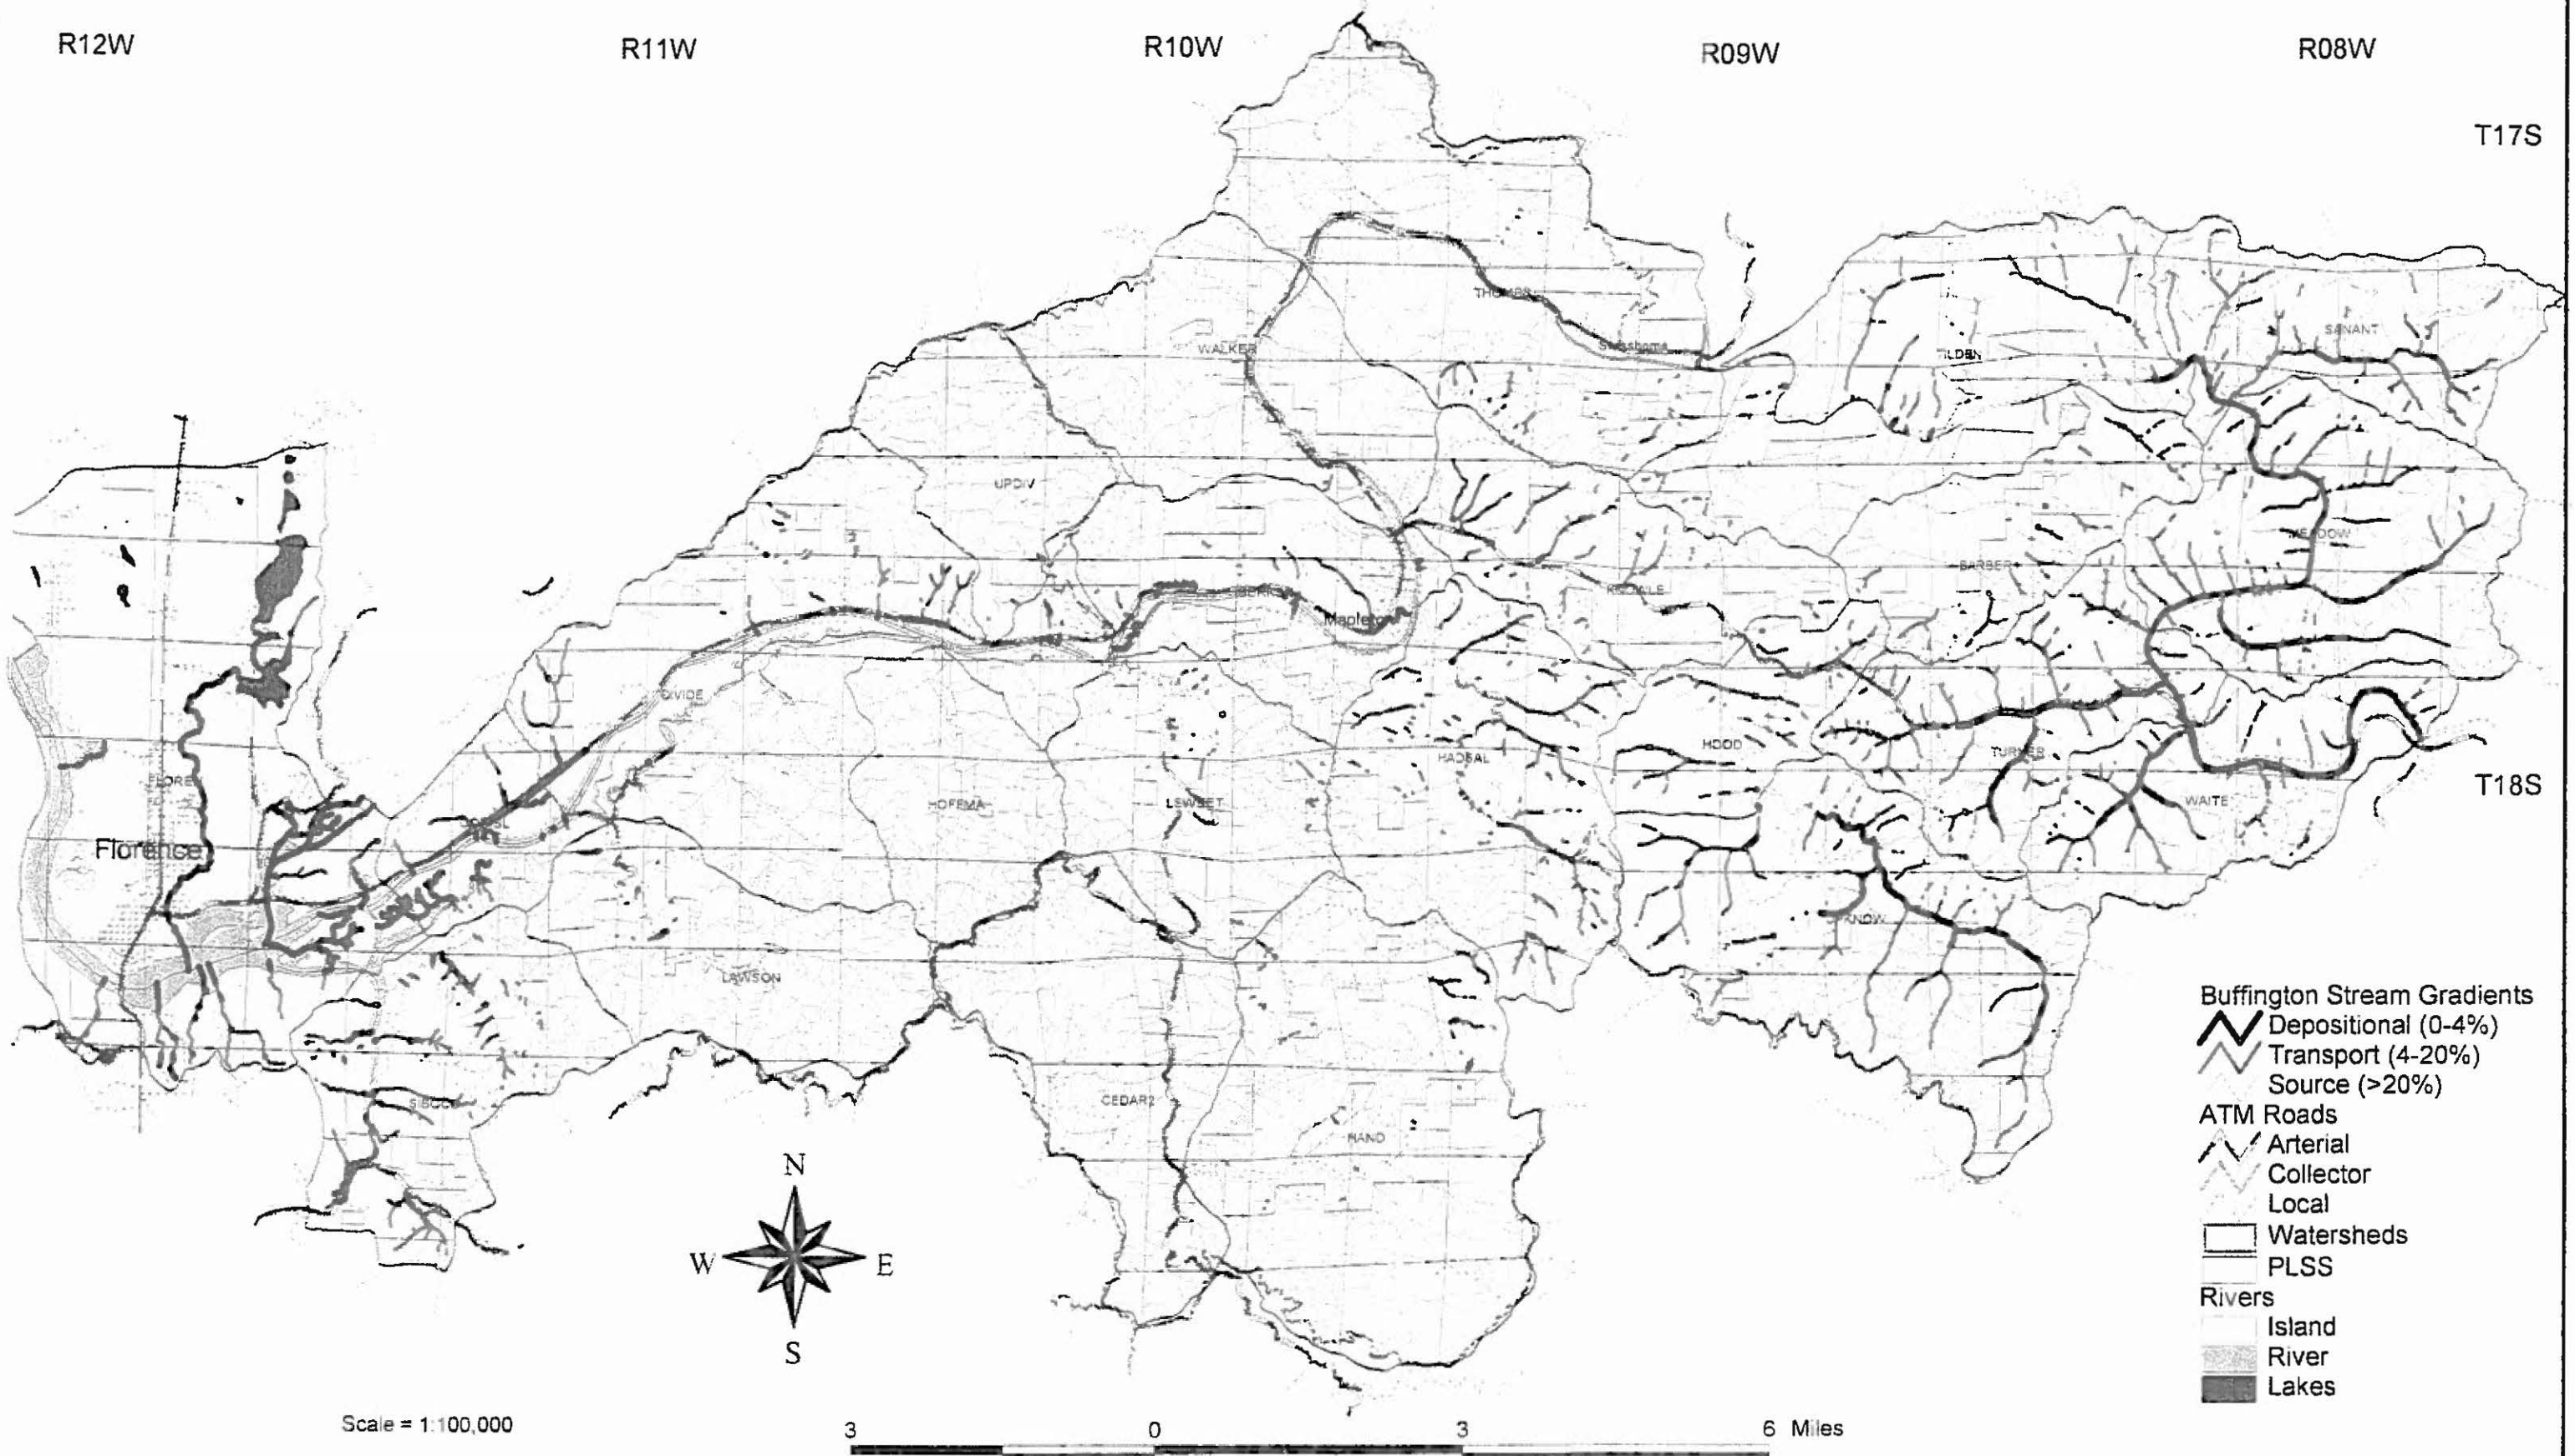
## Stream Gradient (by DEM on Private Lands, USFS Data on Forest Service Land)

### Buffington Stream Gradients

- Depositional (0-4%)
- Transport (4-20%)
- Source (>20%)
