# Tartar Fire Burned Area Summary

## Burned Area Report

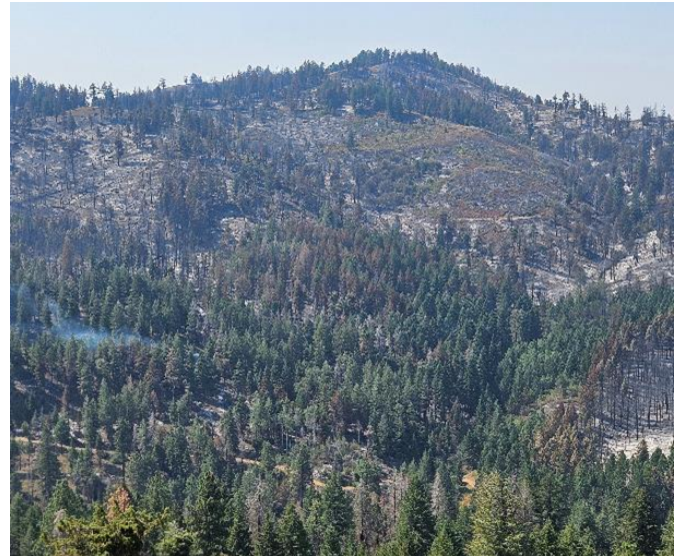
Figure 1 (Above): Example of low to moderate soil burn severity on the Tartar fire.

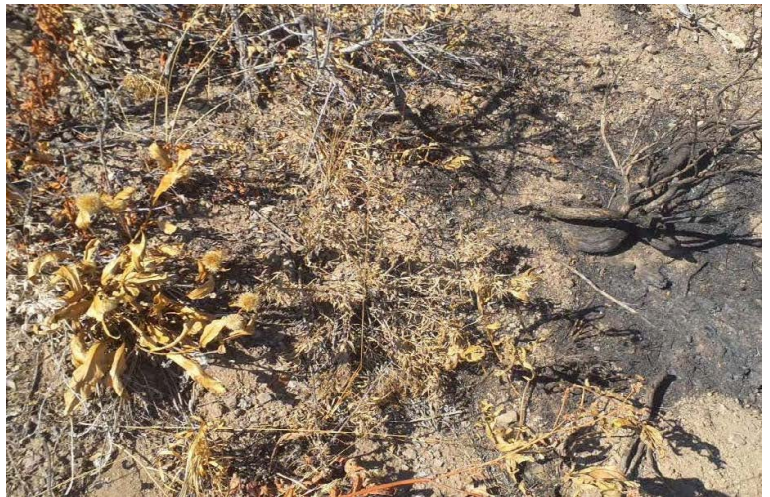
Figure 5: Rare Snake River Goldenweed, partially burnt.

Native and rare plant communities within the Tartar Fire footprint are vulnerable to rapid invasive-weed establishment following disturbance. This is especially true where moderate to high soil burn severity has reduced ground cover and exposed soils. To protect biodiversity and support recovery, the BAER team recommends treating weeds where intact native plant communities overlap within medium to high SBS as well as along suppression disturbance corridors. Targeted treatments (e.g., spot herbicide under existing approvals, timely removal before seed set) will be paired with focused monitoring to catch early emergence, limit seed dispersal, and maintain the ecological integrity of native and rare plant communities as vegetation recovers.
