# McCully Fire Burned Area Summary

## Burned Area Report

## 2026 McCully Fire, Wallowa-Whitman National Forest, Oregon

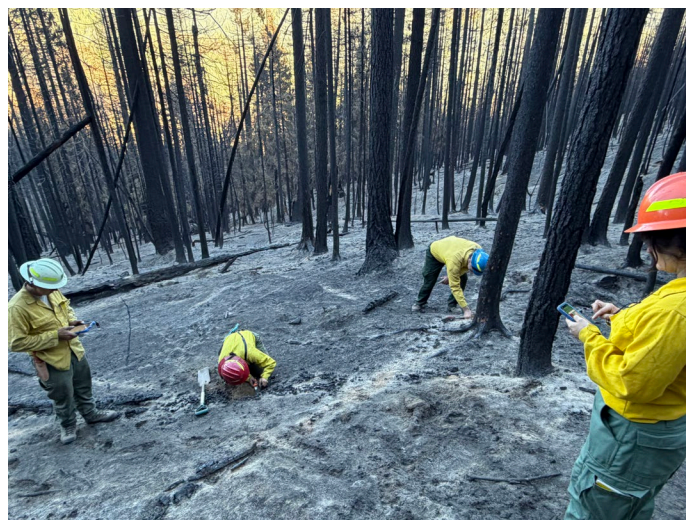
*Figure 1. Hydrologists and Soil Scientists assess soil burn severity in Fruit Creek.*

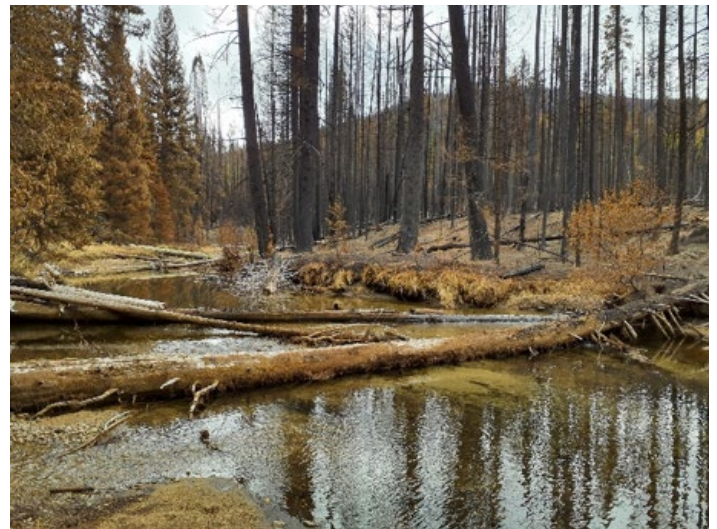
*Figure 2. North Fork John Day River along the fire perimeter.*

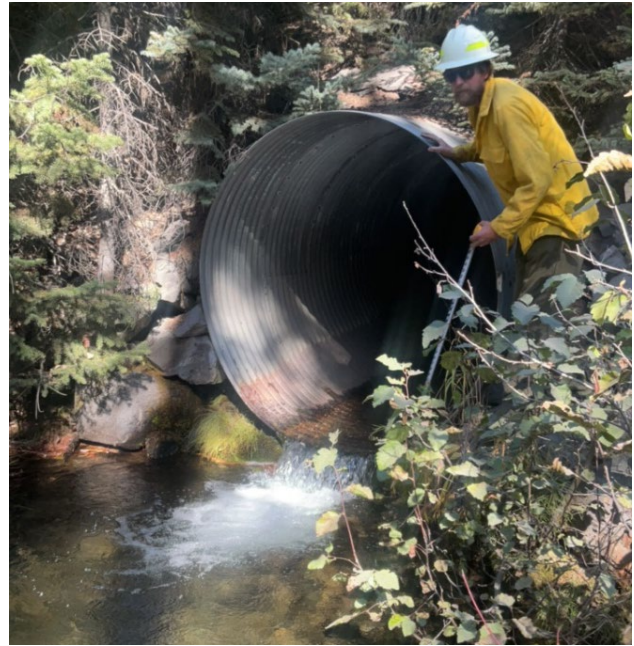
*Figure 3. Fisheries specialist surveying a culvert near the McCully burned area.*

Critical values addressed in the BAER report include Forest Service System Roads and related drainage features. Treatments for the protection of

these roads include storm proofing of existing drainage features, new drainage dip installations, and storm inspection and response during or immediately after high intensity rainfall.

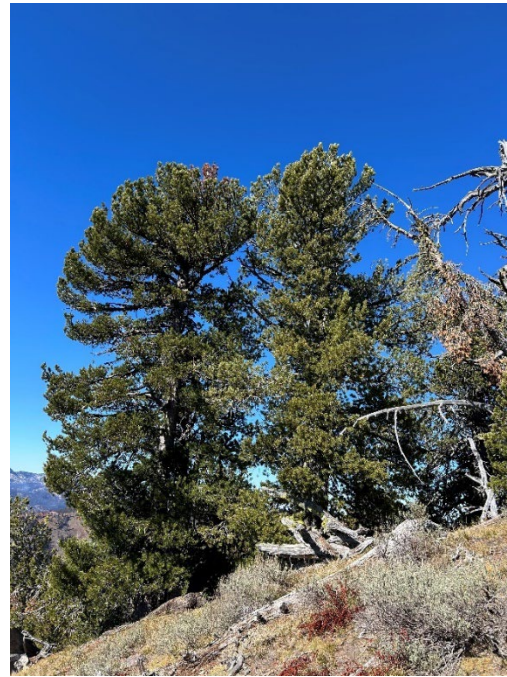
*Figure 4. Federally listed Whitebark Pine within the burned area.*

The Federally listed Whitebark Pine occurs in the McCully fire. The team recommends a treatment of verbenone to address unacceptable risks of mountain pine beetle infestation to surviving mature Whitebark Pine within the burned area.
