# Riley Pass Site Investigation and Data Collection Report

**Custer Gallatin National Forest  
Sioux Ranger District  
North Cave Hills Unit**

February 21, 2017

**Allied Engineering Services, Inc.**  
32 Discovery Drive  
Bozeman, MT 59718  
(406) 582-0221

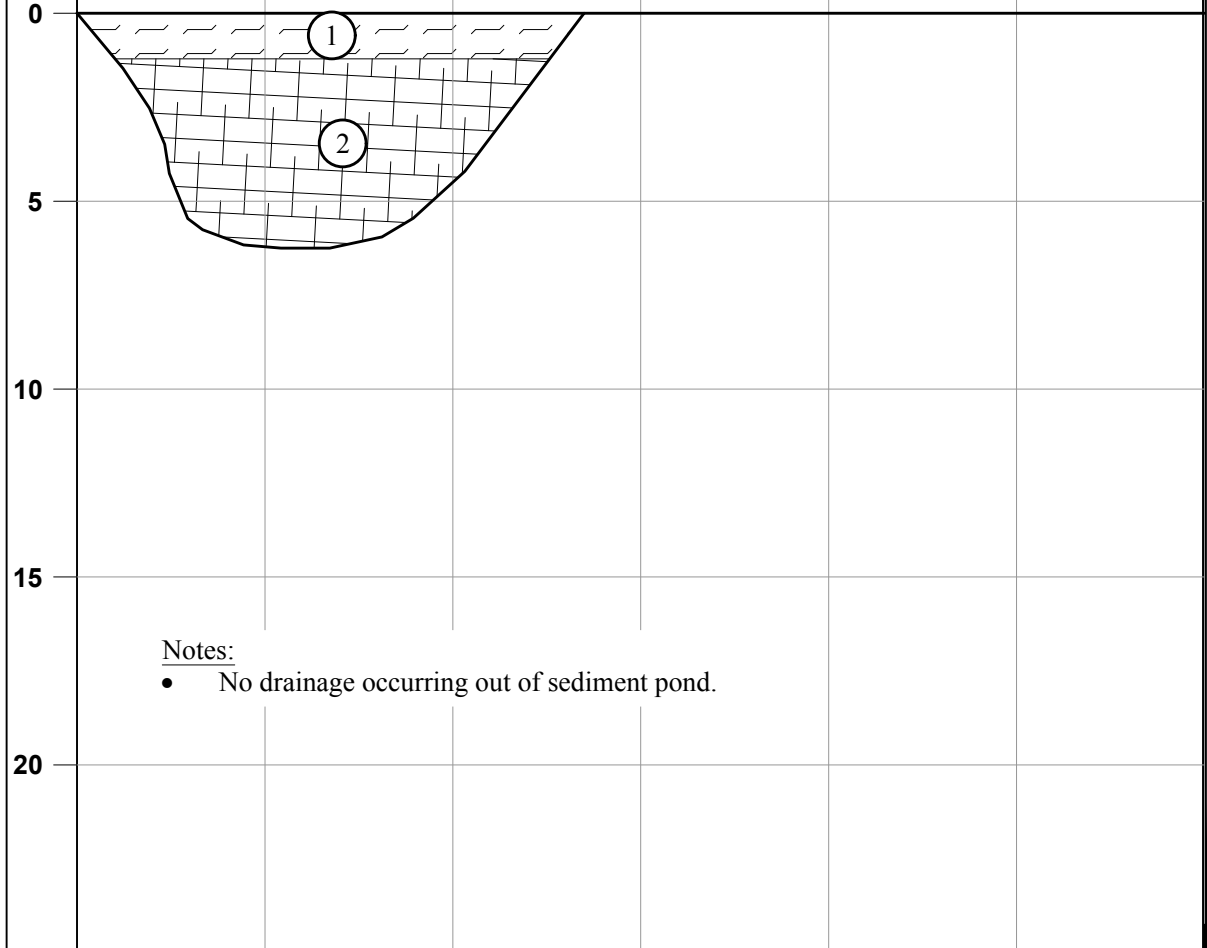
- No drainage occurring out of sediment pond.

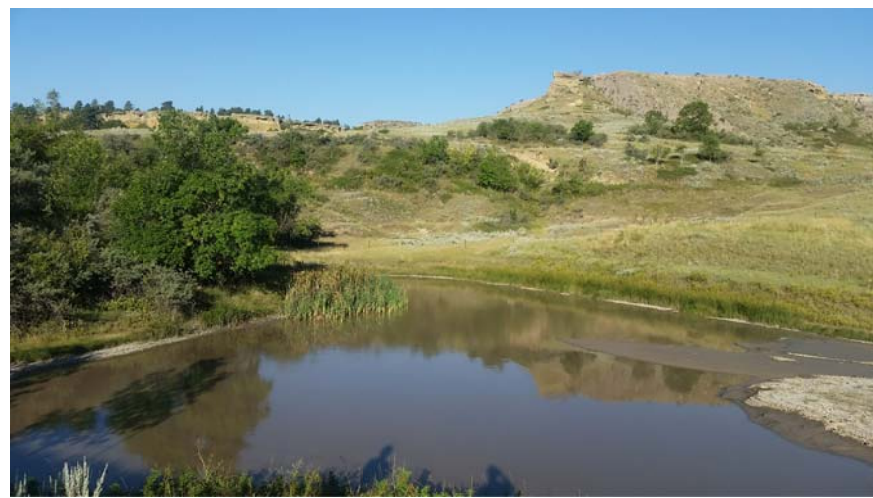
POND 1 - LOOKING WEST

Pond 1 is located on a tributary of upper Pete’s Creek on the northeast side of the Riley Pass divide and was built in 1987 to control sediment runoff from the Riley Pass Mine. Sediment from Pond 1 was last removed in 2009. A significant portion of the sediment in Pond 1 appears to accumulate in a sandy delta along the north edge of the pond. Sediment near the outlet pipe appeared to be well vegetated during the site investigation. The 36-inch diameter CMP standpipe and outlet for the pond is corroded through and is therefore drained below the rim of the standpipe. Test Pit 20 (TP-20) was excavated near the north side of the pond and laboratory test results showed the sediment to be sand and sandy lean clay. The main access road (FSR #3120 also called Tufte Road) to the area crosses over the embankment of Pond 1. Borehole SP1 was drilled to 26 feet deep near the maximum section of the embankment and
