National Register of Historic Places Registration Form

Historic name: Meyers Creek Work Center
 Other names/site number: Meyers Creek Ranger Station, Meyers Creek Station, 24ST0234
 Name of related multiple property listing:
N/A
 (Enter "N/A" if property is not part of a multiple property listing)

Street & number: 101-199 Meyers Creek Road, Custer Gallatin National Forest
 City or town: Nye State: MT County: Stillwater
 Not For Publication: Vicinity:

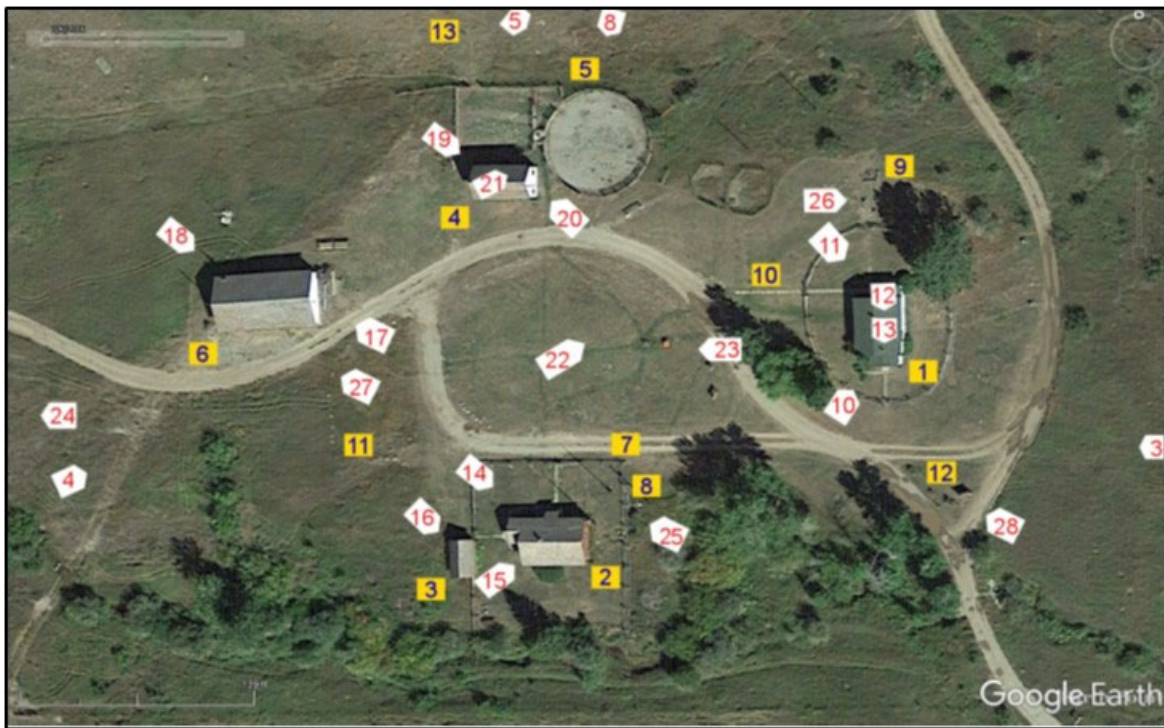
Map 15. Photo Map: View showing the feature and photo locations and directions.
Source: Google Earth

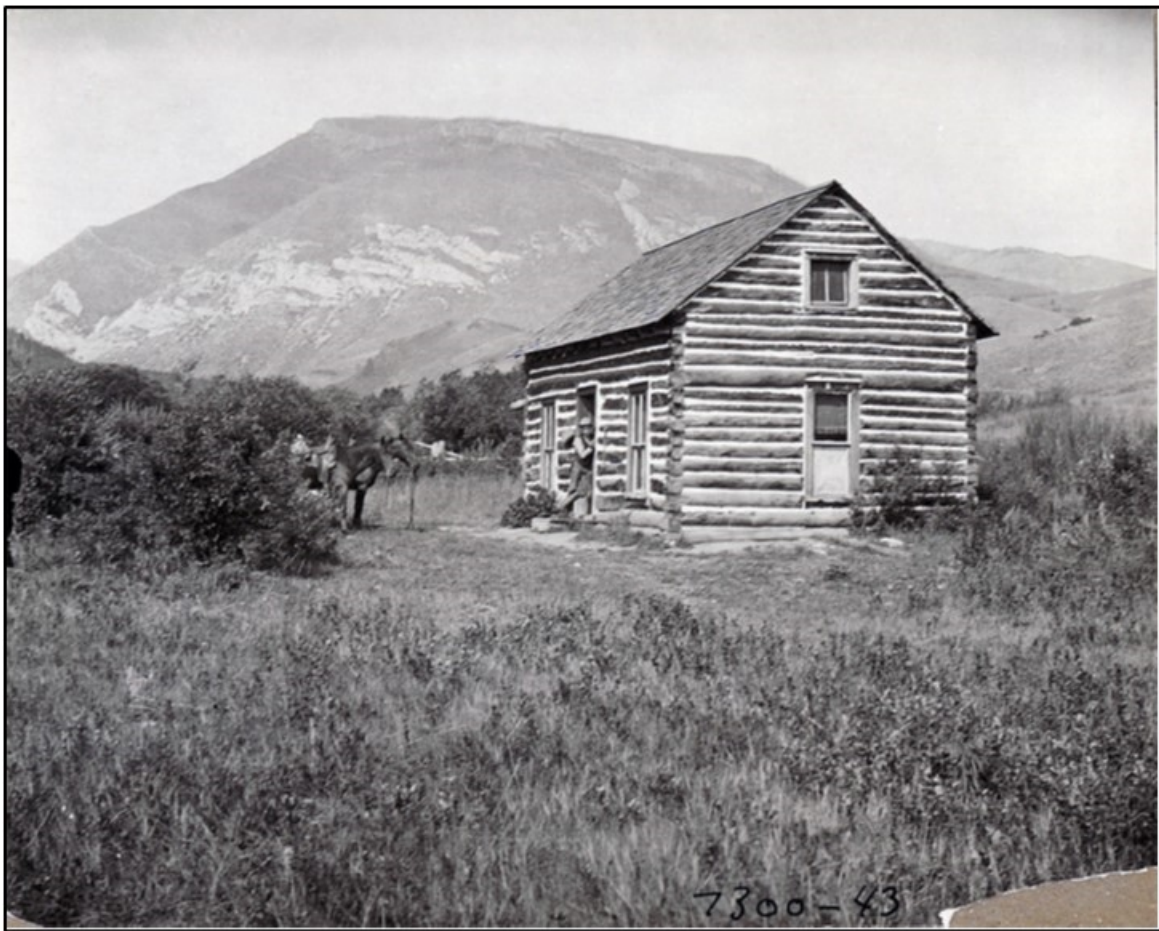
MT_StillwaterCounty_MeyersCreekWorkCenter_0001. The Meyers Creek Ranger Station in the early 1920s, looking northwest-west. (Custer Gallatin National Forest Photo 7300-043)

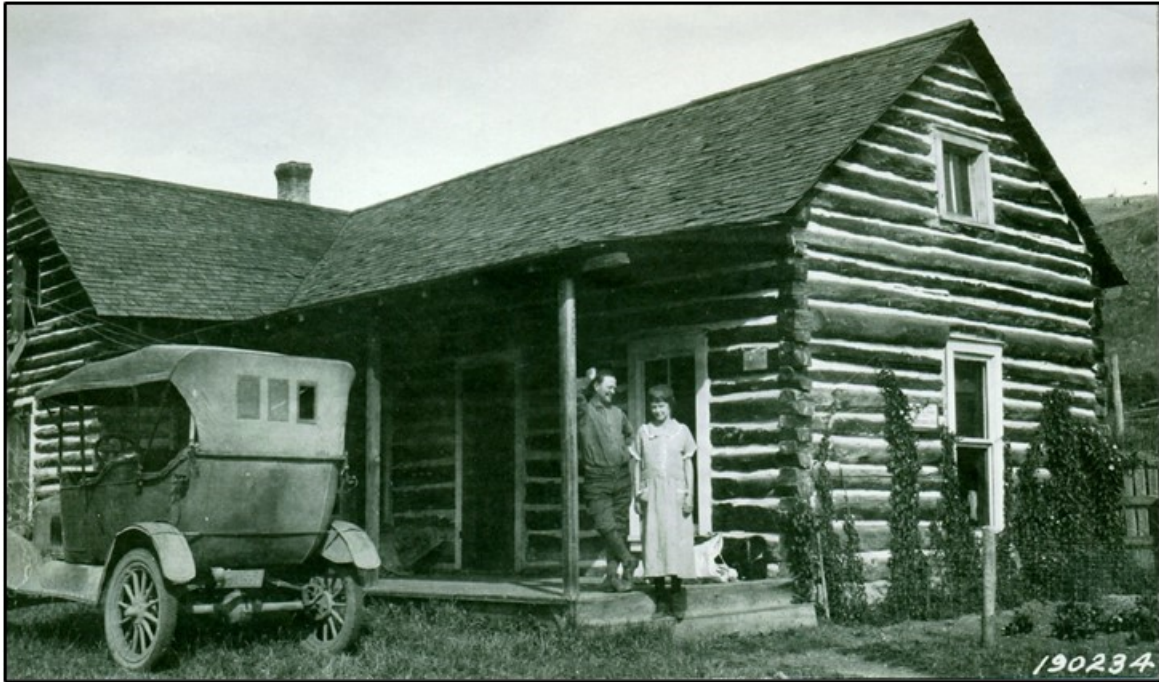
MT_StillwaterCounty_MeyersCreekWorkCenter_0002. Meyers Creek Ranger Station with addition in 1924, looking northwest. (Photographer: M.H. Wolff; Custer Gallatin National Forest Photo GNF190234)

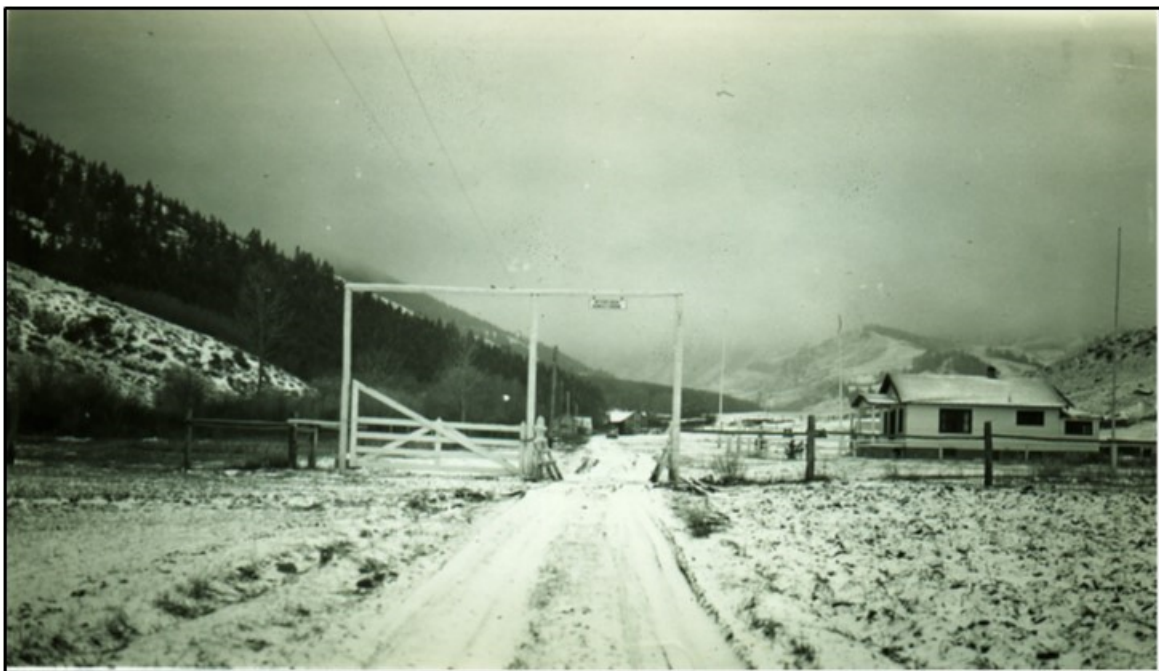
MT_StillwaterCounty_MeyersCreekWorkCenter_0003. Meyers Creek Ranger Station in 1937, looking west toward the old station cabin. (Custer Gallatin National Forest Photo MeyersCreekRS03-1937c)

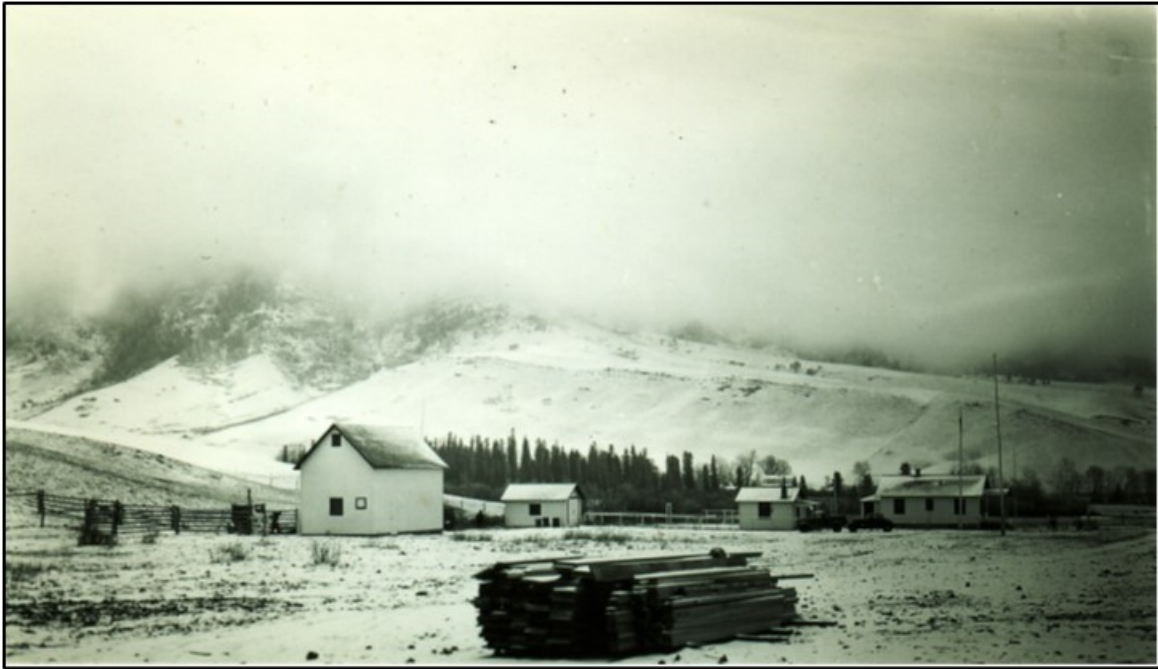
MT_StillwaterCounty_MeyersCreekWorkCenter_0004. Meyers Creek Ranger Station in 1937, looking northeast. (Custer Gallatin National Forest Photo MeyersCreekRS03-1937b)

MT_StillwaterCounty_MeyersCreekWorkCenter_0005. Meyers Creek Ranger Station in 1944, looking southeast. (Photographer: Hokon "Hoke" Grotbo; Custer Gallatin National Forest Photo MeyersCreekRS-1944)

In 1938, the frame B-1 barn (Feature 4) and the C-3 office building (no longer on site), were completed. Both had been included in the improvement plans since 1929 (Map 10). The original 1929 improvement plan stated, “the [original] barn will be condemned and destroyed in the fiscal year 1931 for the reason that it is unsafe and past the status of repair;” it is assumed removal did not occur until the replacement barn had been completed. The office (no longer on site) was “a frame structure 14’ x 16’...exterior walls covered with 6” drop siding, one-third pitch roof and green stained shingles” located in the center of the circular drive to the south west (sic) of the frame dwelling” (Photos MT_StillwaterCounty_MeyersCreekWorkCenter_0004 and MT_StillwaterCounty_MeyersCreekWorkCenter_0005).³¹

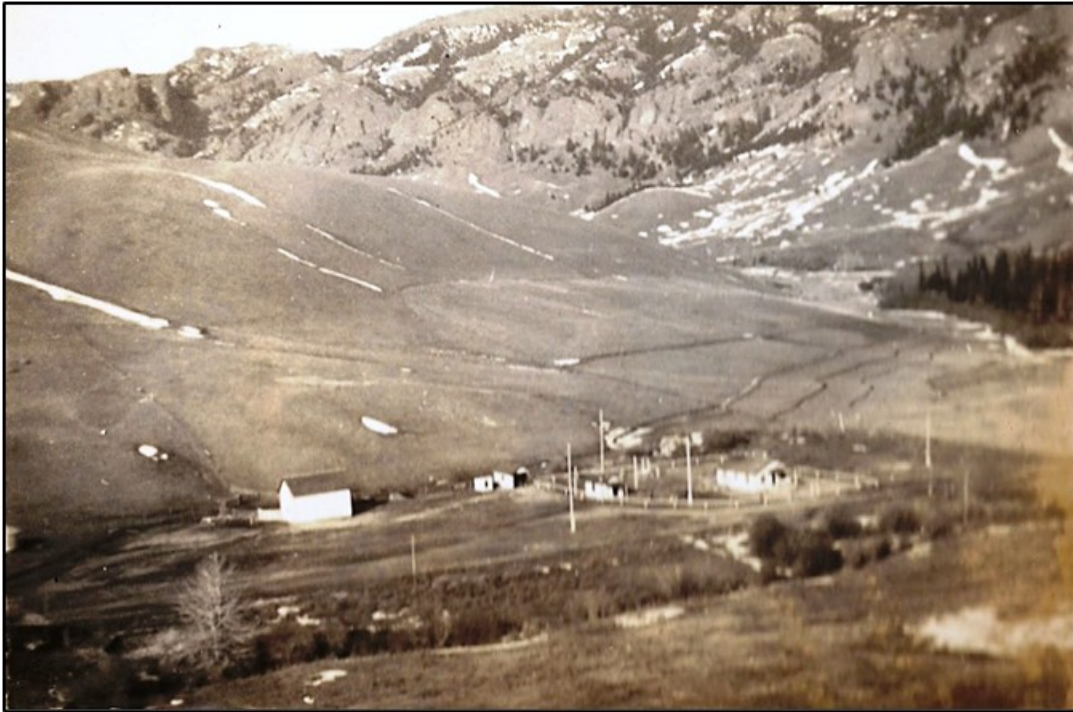
MT_StillwaterCounty_MeyersCreekWorkCenter_0006. Meyers Creek Ranger Station in the late 1940s, looking northeast. (Custer Gallatin National Forest Photo MeyersCreekRangerStation-b)

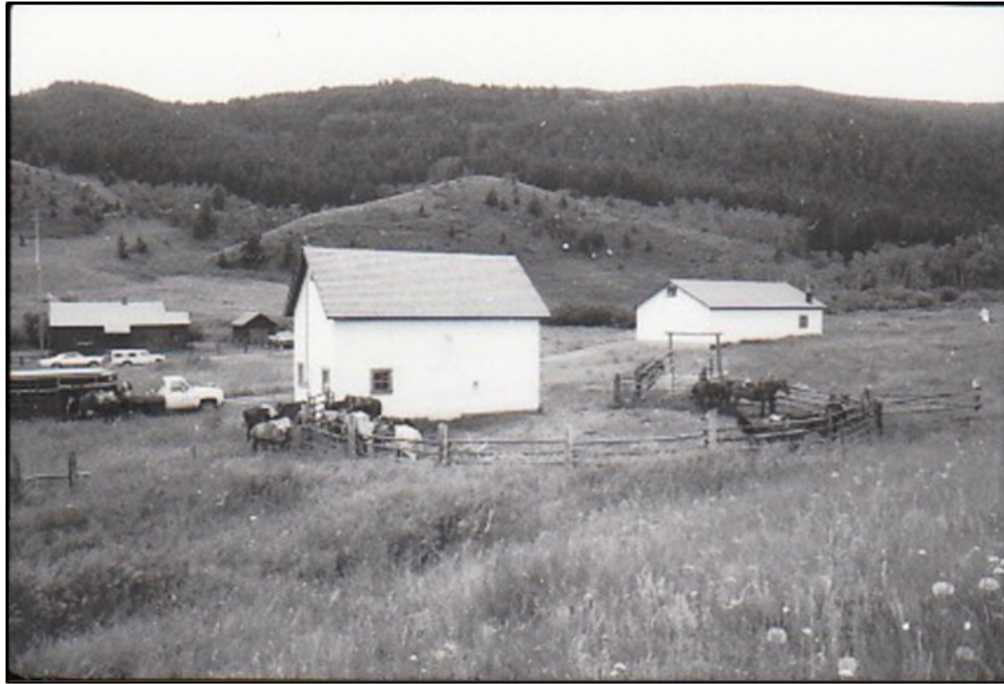
MT_StillwaterCounty_MeyersCreekWorkCenter_0008. Meyers Creek Ranger Station after the additions of the dwelling and garage-shop, July 23, 1989. (Custer Gallatin National Forest Roll-JC-B&W-14-frame-17)

MT_StillwaterCounty_MeyersCreekWorkCenter_0008 of 33	0008 – Meyers Creek Ranger Station after the additions of the log dwelling and garage-shop, looking southwest, Stillwater County, Montana, 1989. Photographer: Custer Gallatin National Forest Roll-JC-B&W-14-frame-17.
MT_StillwaterCounty_MeyersCreekWorkCenter_0009 of 33	0009 – Meyers Creek Work Center with features noted, looking east, Stillwater County, Montana, 2022. Photographer: Tim Urbaniak.
MT_StillwaterCounty_MeyersCreekWorkCenter_0010 of 33	0010 – Front view of Feature 1, looking north, Stillwater County, Montana, 2022. Photographer: Tim Urbaniak.
MT_StillwaterCounty_MeyersCreekWorkCenter_0011 of 33	0011 – Rear view of Feature 1, looking southeast, Stillwater County, Montana, 2022. Photographer: James Busse.
MT_StillwaterCounty_MeyersCreekWorkCenter_0012 of 33	0012 – Interior of Feature 1 from the kitchen into the living room, looking south, Stillwater County, Montana, 2022. Photographer: Tim Urbaniak.

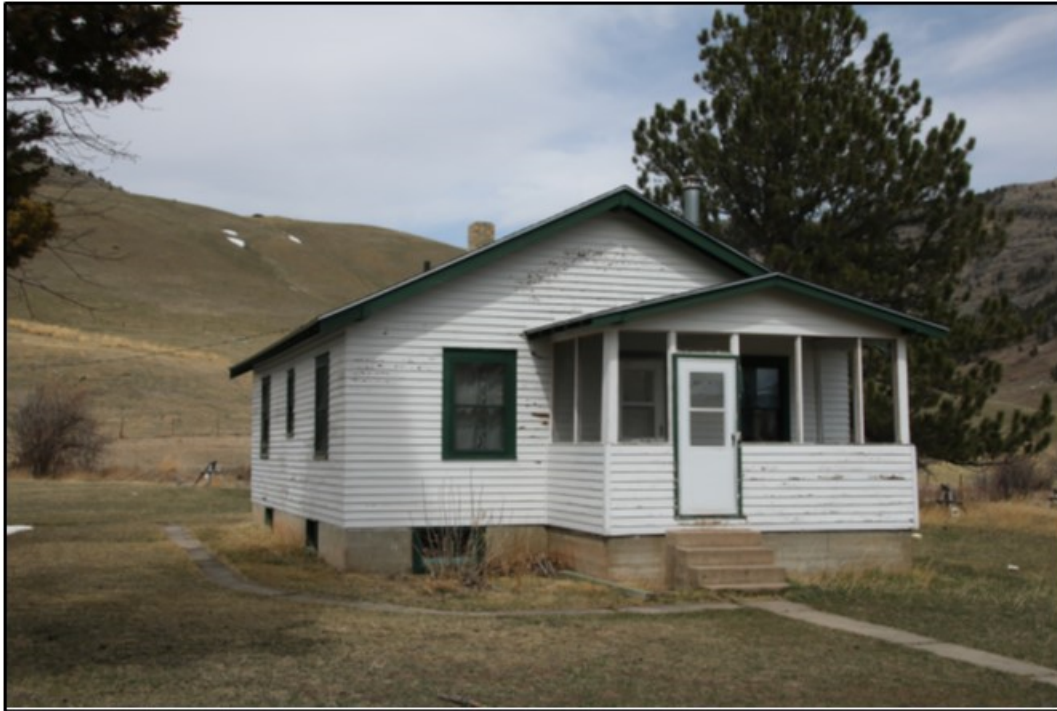
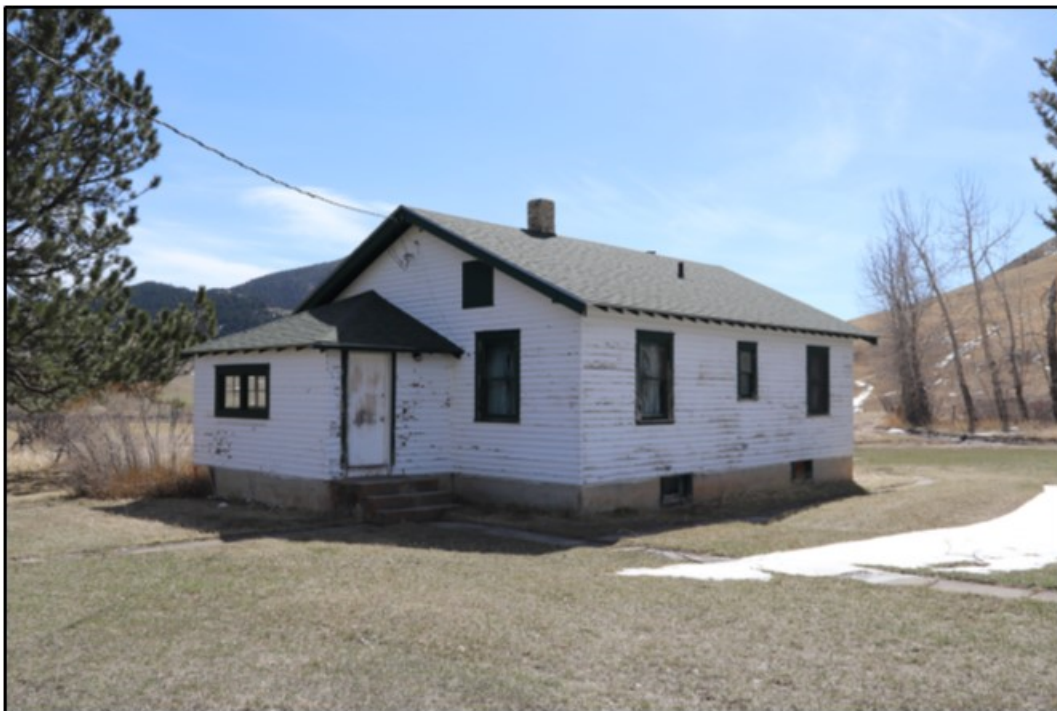
MT_StillwaterCounty_MeyersCreekWorkCenter_0010. Front view of Feature 1, May 19, 2022, View to north. (Photographer: Tim Urbaniak)

MT_StillwaterCounty_MeyersCreekWorkCenter_0011. Rear view of Feature 1, May 19, 2022, View to southeast. (Photographer: James Busse)

The basement extends approximately 24" above the ground surface, providing for two non-egress window openings filled with single-pane wood framed units in the west foundation wall of the house, and three openings in the east foundation wall that hold two single-pane and a four-lite fixed window. The west elevation of the house sports two double-hung windows with a smaller centrally located double-hung unit that aligns with the inside bathroom. Two double-hung windows that match the larger windows in the west elevation occur in the south elevation, one located outside of the gable roof porch, and one contained within and protected by the porch. The east elevation holds a paired double-hung unit that looks out from the living room to the east and a smaller one-by-one six-lite sliding unit positioned in the kitchen; an identical six-lite sliding unit is located on the back (north elevation) porch. The north wall of the back porch holds a two-panel slider window, with an additional double-hung window on the north wall of the house. The north wall of the house also holds a covered opening above the double-hung window that provides access into the attic area.

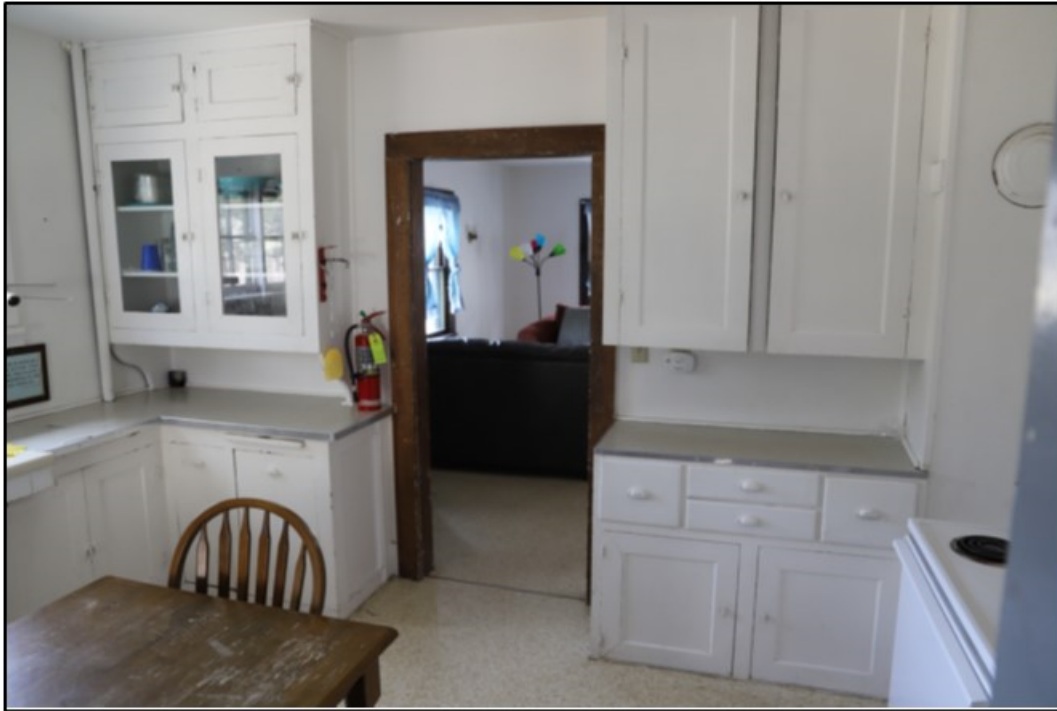
MT_StillwaterCounty_MeyersCreekWorkCenter_0012. Interior of Feature 1 from the kitchen into the living room, May 19, 2022, View to south. (Photographer: Tim Urbaniak)

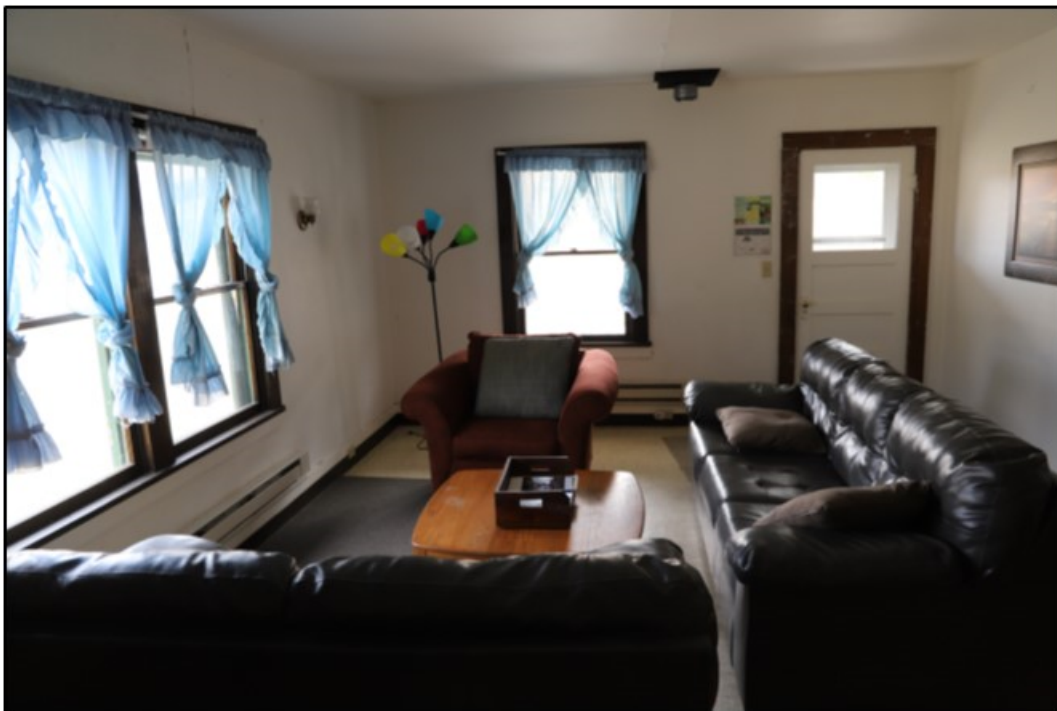
MT_StillwaterCounty_MeyersCreekWorkCenter_0013. Interior view of Feature 1 in the living room, May 19, 2022, View to south. (Photographer: Tim Urbaniak)

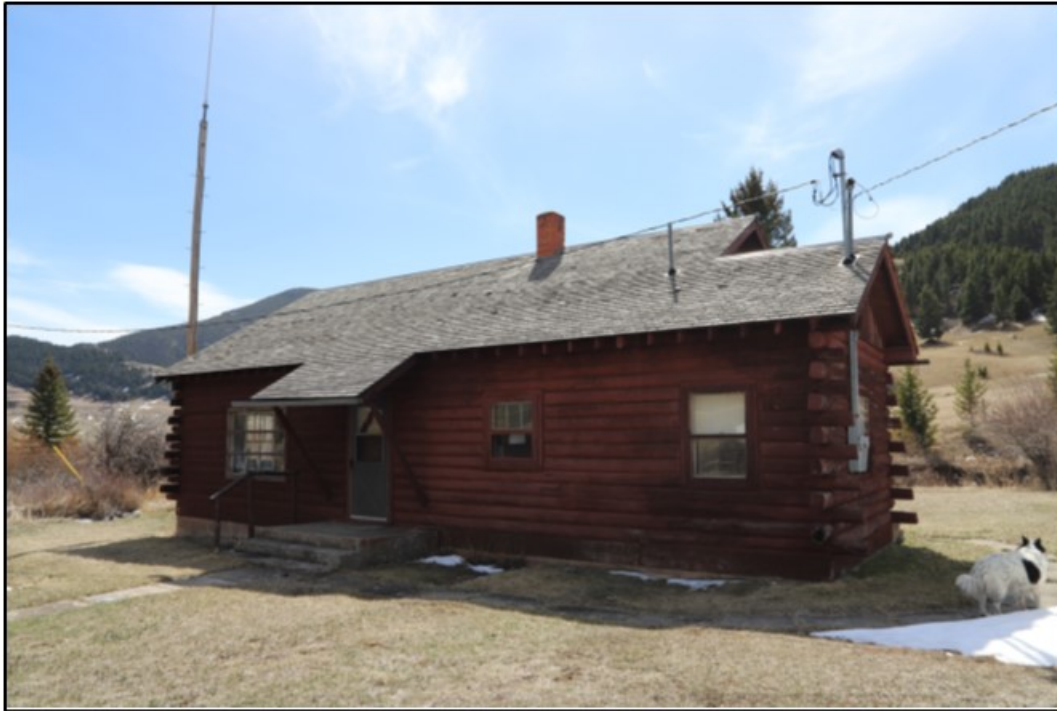
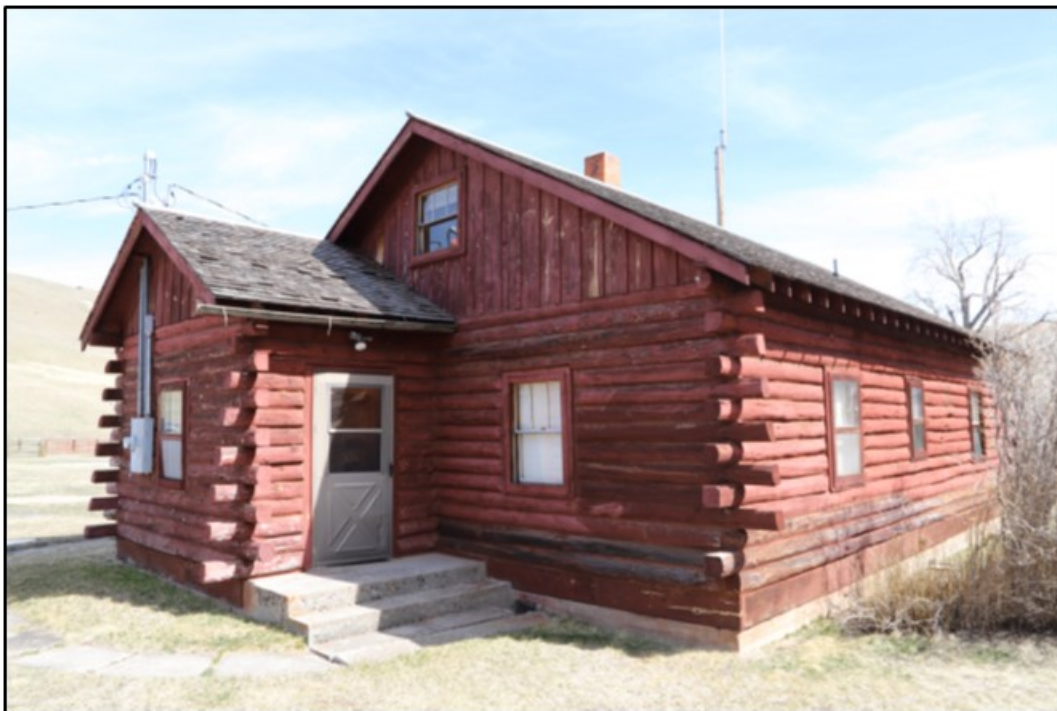
MT_StillwaterCounty_MeyersCreekWorkCenter_0014. Exterior view of the Feature 2 residence, May 19, 2022, View to southeast. (Photographer: Tim Urbaniak)

MT_StillwaterCounty_MeyersCreekWorkCenter_0015. Exterior view of the Feature 2 residence, May 19, 2022, View to northeast. (Photographer: Tim Urbaniak)

Feature 2 (1952) is a 36' x 26' log residence located southwest of Feature 1 and south of the complex. The building aligns east-west with the entry elevation facing north toward the open area of the compound. Built in 1952, the one and one-half story rectangular log-bearing building features a small entry wing built off the west wall.⁴ The gable-roofed structure sits on an 8" concrete wall footing and crawl-space depth foundation. Walls are constructed of logs with butt joint corners with overlapping ends, referred to as "milled D" logs. The log ends extend beyond the plane of the outside wall and cut to taper, narrow at the top and widening at the bottom. The gable ends are finished with vertically oriented boards and battens. The exterior is painted/stained brown. The wood shingle gable roof displays an interior ridge brick chimney, exposed rafter ends, an antenna, and a galvanized ridge roll with globe ends (Photo MT_StillwaterCounty_MeyersCreekWorkCenter_0014). A small shed roof overhang with brackets covers the front (north) elevation's main entry.

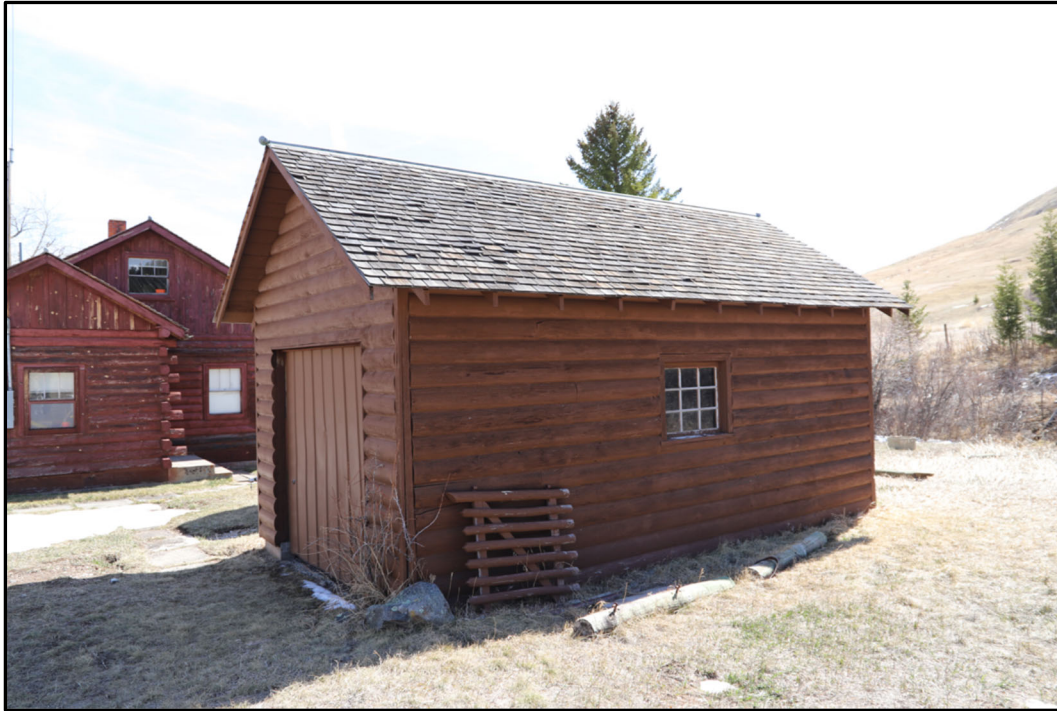
MT_StillwaterCounty_MeyersCreekWorkCenter_0016. Exterior view of the Feature 3 garage, May 19, 2022, View to east. (Photographer: Tim Urbaniak)

Feature 3 (1954), located immediately to the west of the log house, is a 20' x 12' single-room garage built in 1954 (Photo MT_StillwaterCounty_MeyersCreekWorkCenter_0016).⁵ The one story, wood frame building has a rectangular floor plan with the long axis oriented north-south. The building sits on a concrete wall foundation with a concrete slab. The exterior walls of the garage are finished with log slab siding and painted/stained brown. The steep gable roof is covered with wood shingles and displays exposed rafter ends and a galvanized ridge roll with

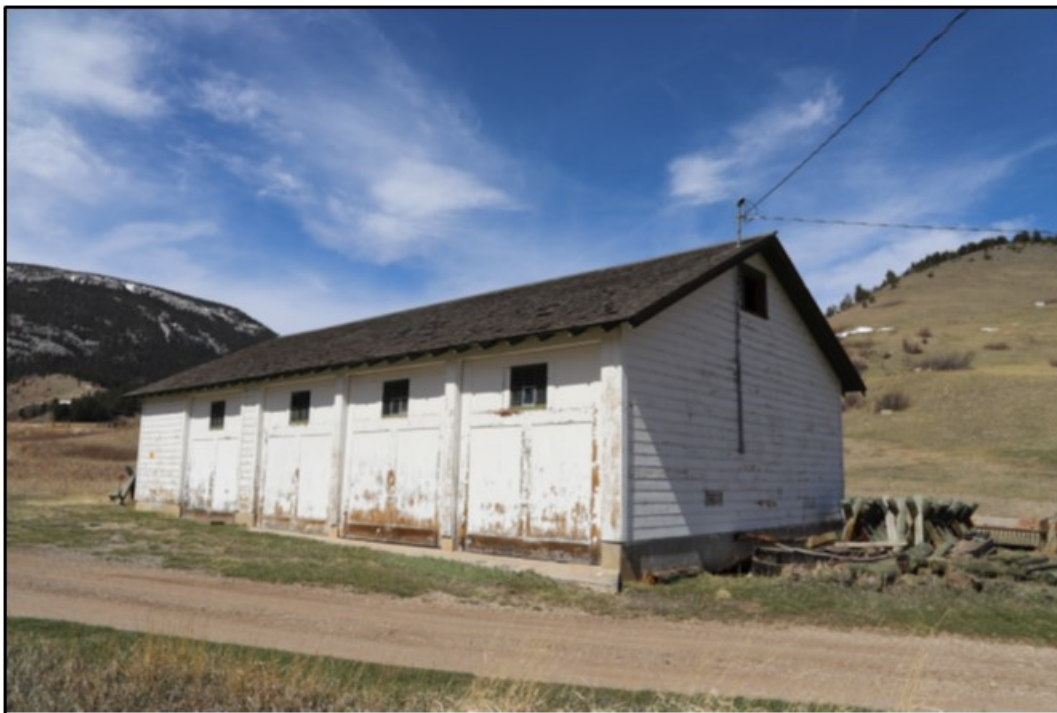
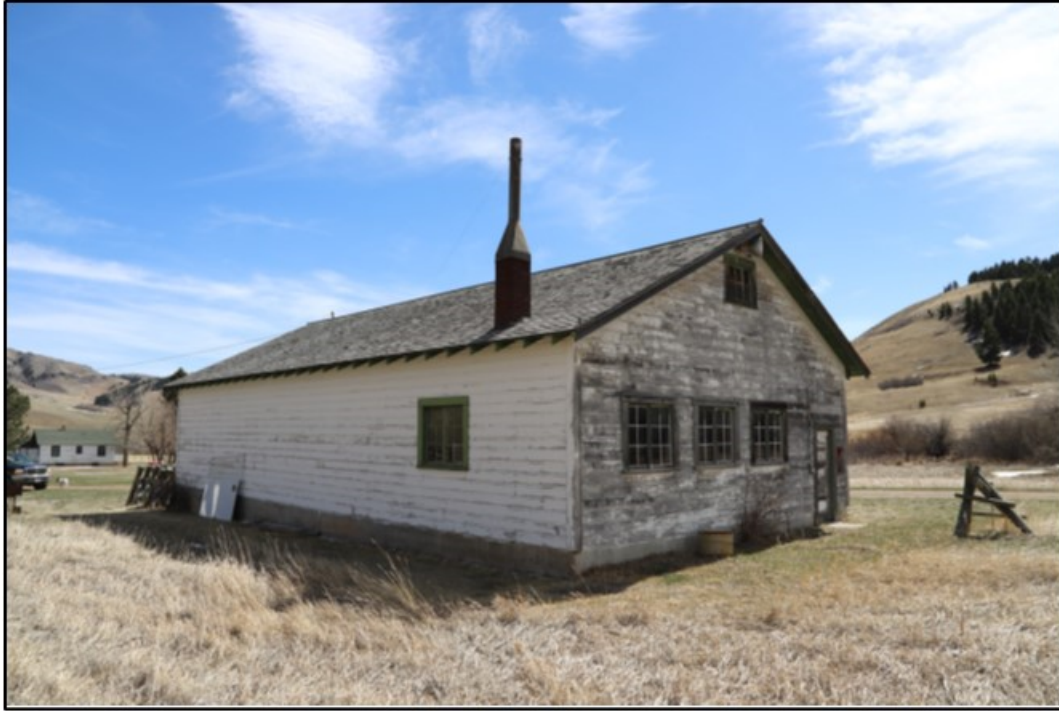
MT_StillwaterCounty_MeyersCreekWorkCenter_0017. Exterior view of the Feature 6 garage-shop, May 19, 2022, View to northwest. (Photographer: Tim Urbaniak)

MT_StillwaterCounty_MeyersCreekWorkCenter_0018. Exterior view of the Feature 6 garage-shop, May 19, 2022, View to southeast. (Photographer: Tim Urbaniak)

Feature 6 (1937) is a garage/shop built in 1937 located to the west of the residence. It is a one and one-half story, wood frame building with a 56' x 30' rectangular floor plan. The east-west aligned building holds interior stalls (Photos MT_StillwaterCounty_MeyersCreekWorkCenter_0017 and 0018).⁷ The garage/shop sits on a concrete wall footing and foundation with a concrete floor slab. The exterior walls are covered with wood drop siding with corner board trim that match the door and window openings. The steep gable roof is covered with wood shingles and displays an interior slope brick chimney, exposed rafter ends, and a galvanized ridge roll with globe ends. A yard light is positioned in the gable of the west wall. The south elevation holds four overhead garage doors, each with a six-lite fixed window in the top center of the door. A single entry five-panel person door is in the west elevation. A recessed box that holds a fire extinguisher is mounted near the west door on the southwest corner. The west wall contains three paired six-lite fixed (3/3) windows, and a six-lite fixed unit in the gable. The north wall holds a single fixed 12-lite unit positioned toward the west end of the building and the east wall contains a single six-lite fixed unit installed in the gable. The interior of the structure is unfinished. The garage/shop continues to be used for its primary historical function and is a contributing building.

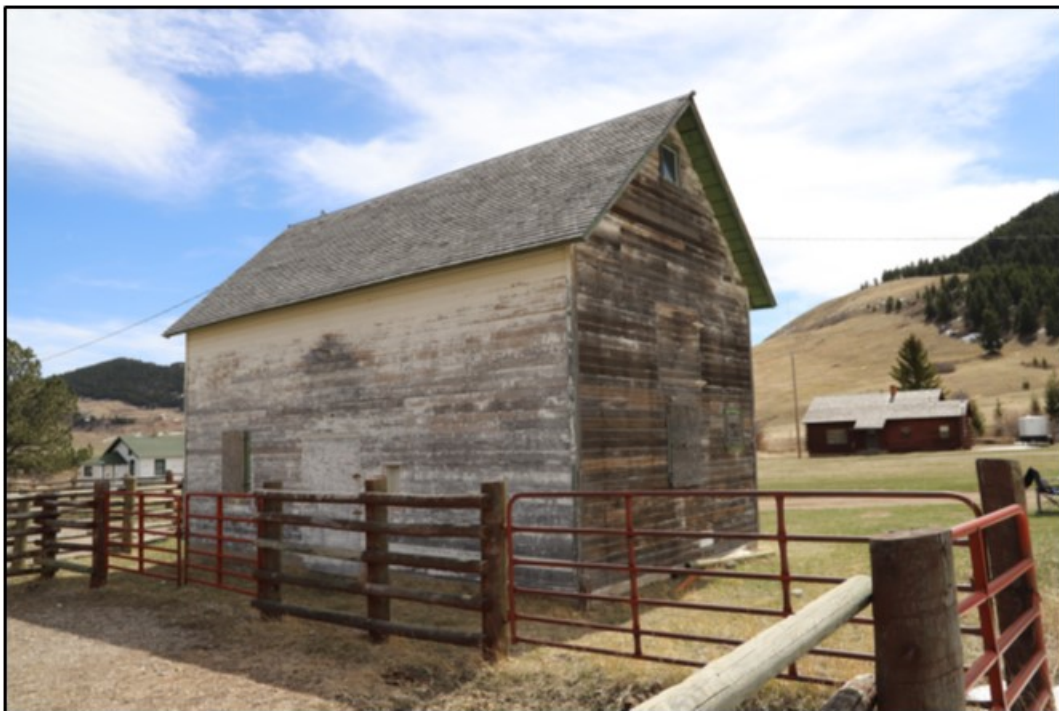
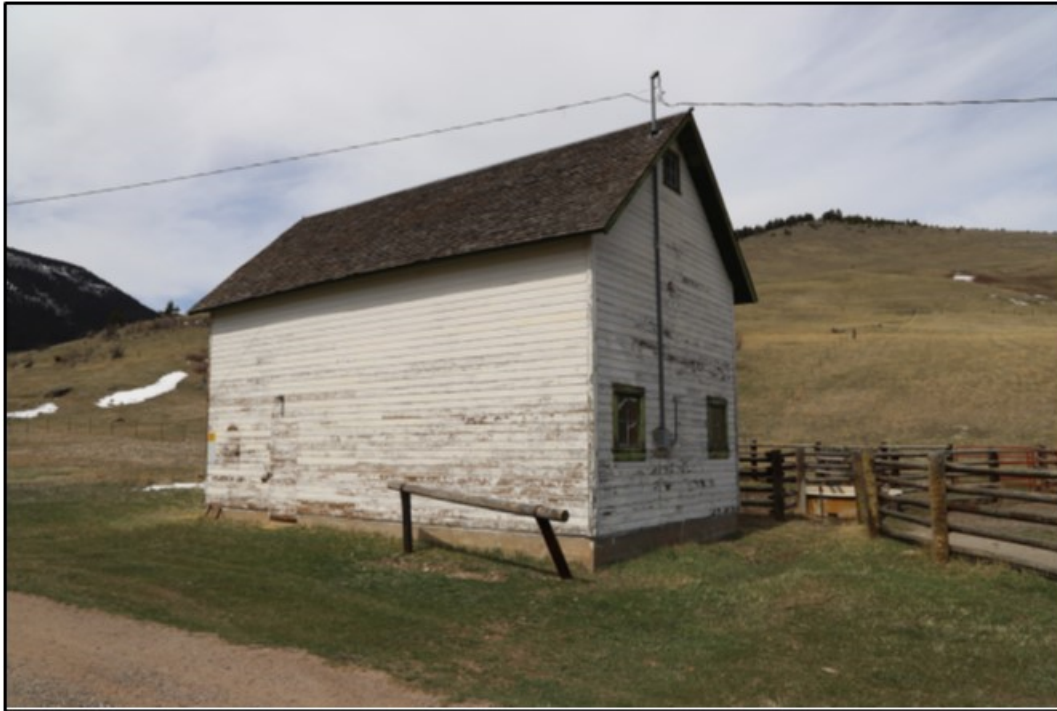
MT_StillwaterCounty_MeyersCreekWorkCenter_0019. Exterior view of the Feature 4 barn, May 19, 2022, View to southeast. (Photographer: Tim Urbaniak)

MT_StillwaterCounty_MeyersCreekWorkCenter_0020. Exterior view of the Feature 4 barn, May 19, 2022, View to northwest. (Photographer: Tim Urbaniak)

Feature 4 (1938) is a livestock barn constructed in 1938.⁶ The barn sits north of the log house (Feature 2) and northwest of the main house (Feature 1). It is a one and one-half story, 32' x 18' wood frame building with a rectangular floor plan with the long axis oriented east-west (Photos MT_StillwaterCounty_MeyersCreekWorkCenter_0019 and 0020). The barn sits on a concrete wall footing and foundation. Exterior walls are covered with drop siding with corner board trim. The steep gable roof is covered with wood shingles and sports a galvanized ridge roll with globe ends. The barn holds a board-and-batten Dutch door in the center of the north elevation that opens toward the corral area. On the west elevation, a small ground floor door opens to the exterior from the inside and a wood door in the west gable provides access for hay loading/unloading. A boarded-over fixed 6-lite window is positioned in the center of the wall. The south elevation of the barn holds a person entry door positioned toward the west end of the wall. The doors present the same exterior cladding as the walls and lack trim. The east elevation of the barn has three windows, two fixed four-lite in the ground level and one fixed four-lite in the gable. The building is painted white with green trim around the windows and roof. The post-and-beam interior of the barn contains three stalls in the west end and a tack room in the east end (Photo MT_StillwaterCounty_MeyersCreekWorkCenter_0021). The barn is a contributing building.

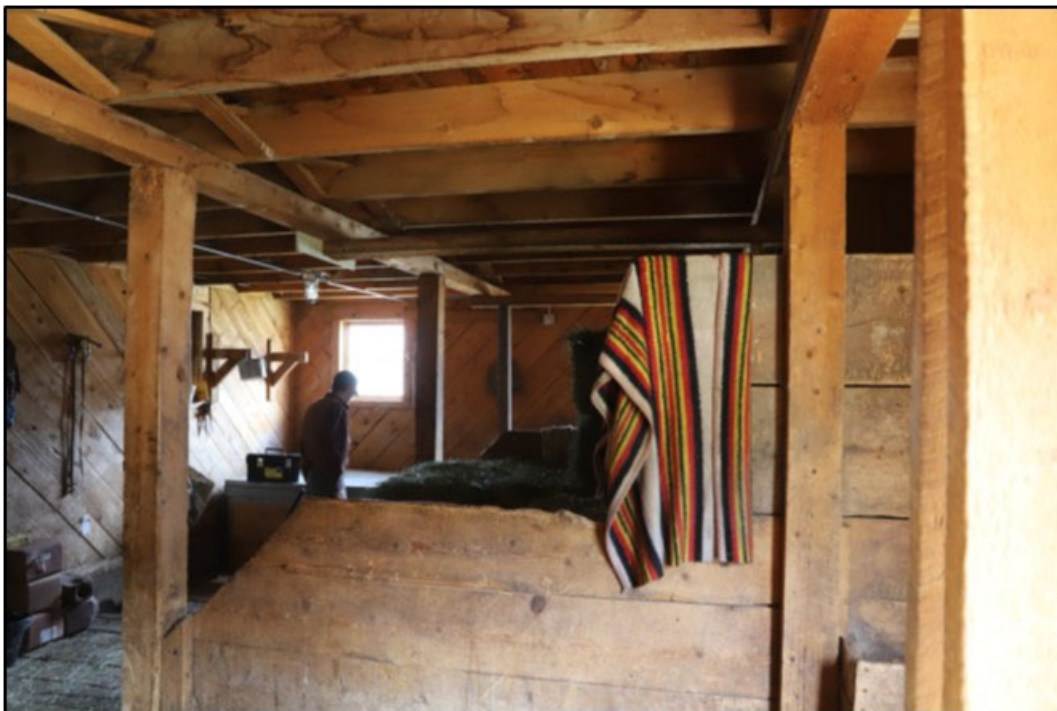
MT_StillwaterCounty_MeyersCreekWorkCenter_0021. Interior view of the Feature 4 barn tack room, May 19, 2022, View to east. (Photographer: Tim Urbaniak)

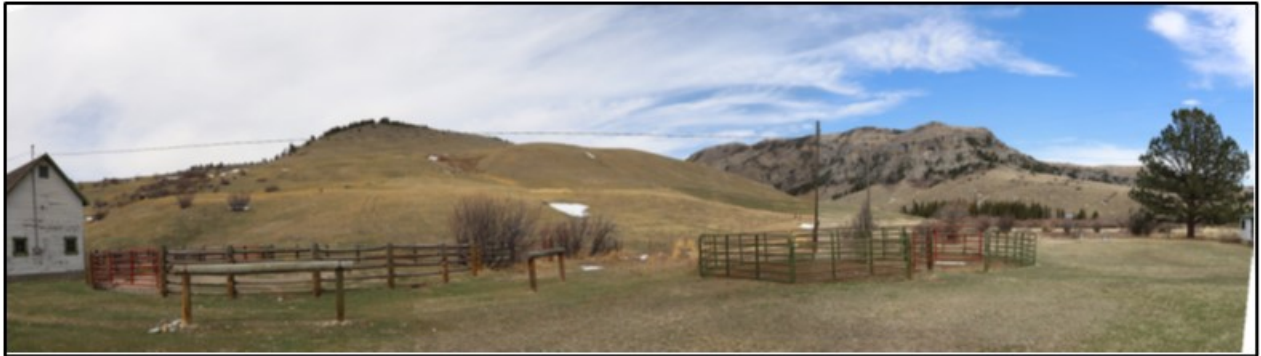
MT_StillwaterCounty_MeyersCreekWorkCenter_0022. Corrals with the barn and the station visible, May 19, 2022, View northwest (left) to northeast (right). (Photographer: Tim Urbaniak)

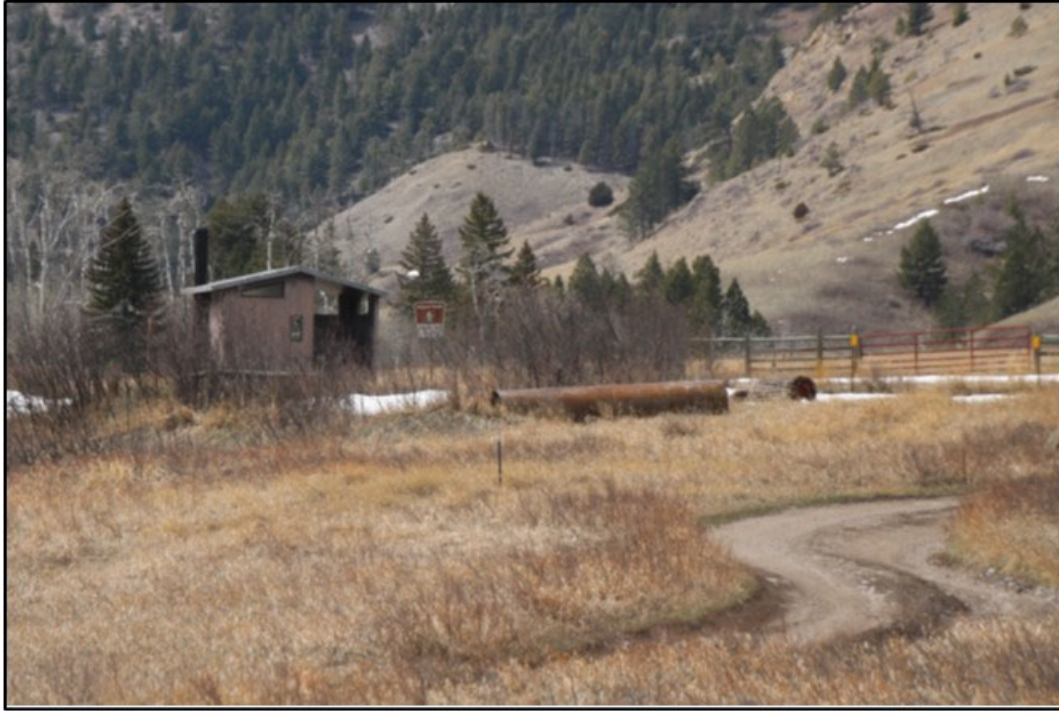
MT_StillwaterCounty_MeyersCreekWorkCenter_0024. View of the noncontributing latrine (Feature 14) at the Meyers Creek Trailhead, May 19, 2022, View to west. (Photographer: James Busse)

By the 1950s, facility improvements were needed. The log residence (Feature 2) was constructed in 1952 and the one-car garage (Feature 3) in 1954. Since the 1950s, the only additional structure added to the property is a precast concrete vault toilet toward the western edge of the work center and near the parking area for the Meyers Creek Trailhead. This vault toilet replaced an earlier latrine located at the southwestern corner of the property (Photo MT_StillwaterCounty_MeyersCreekWorkCenter_0024).

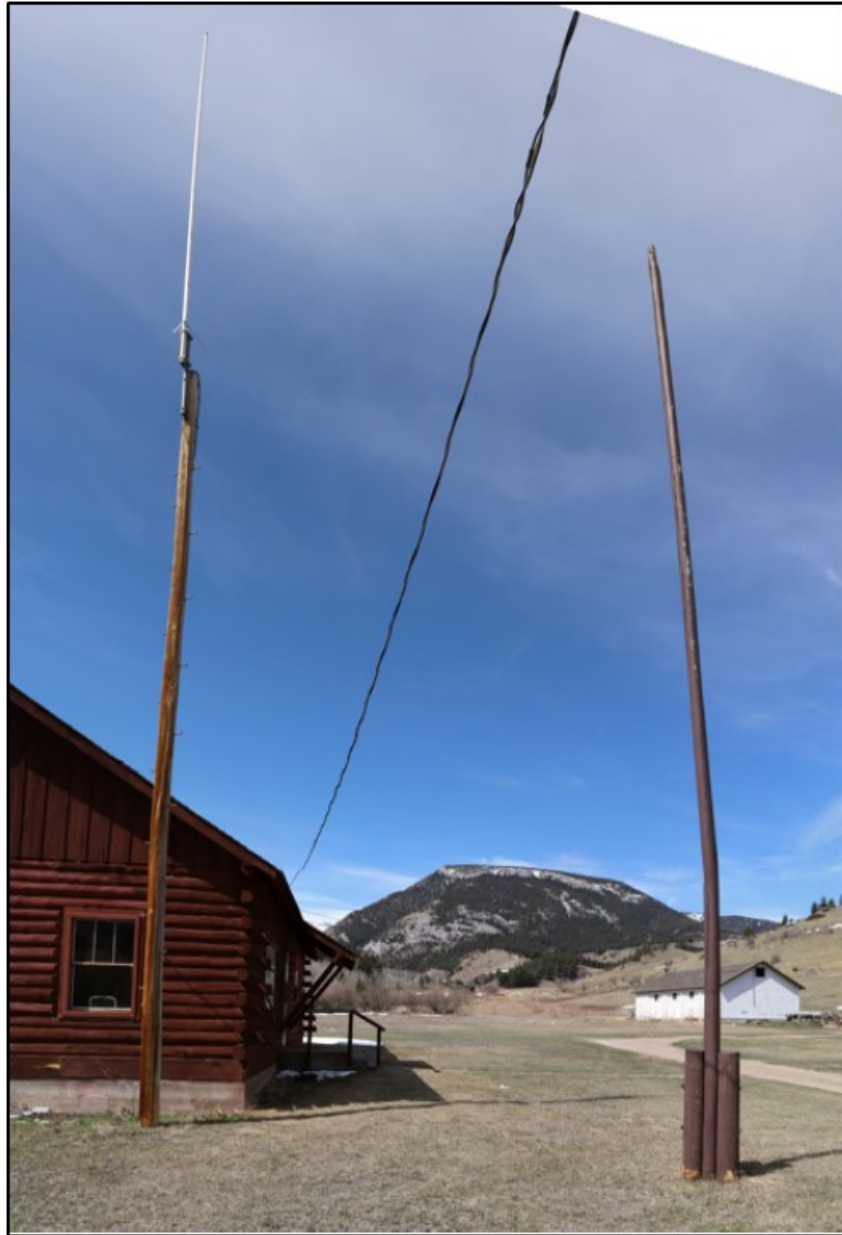
MT_StillwaterCounty_MeyersCreekWorkCenter_0025. Stitched image view of the flagpole and communication antenna, May 19, 2022, View to west. (Photographer: Tim Urbaniak)

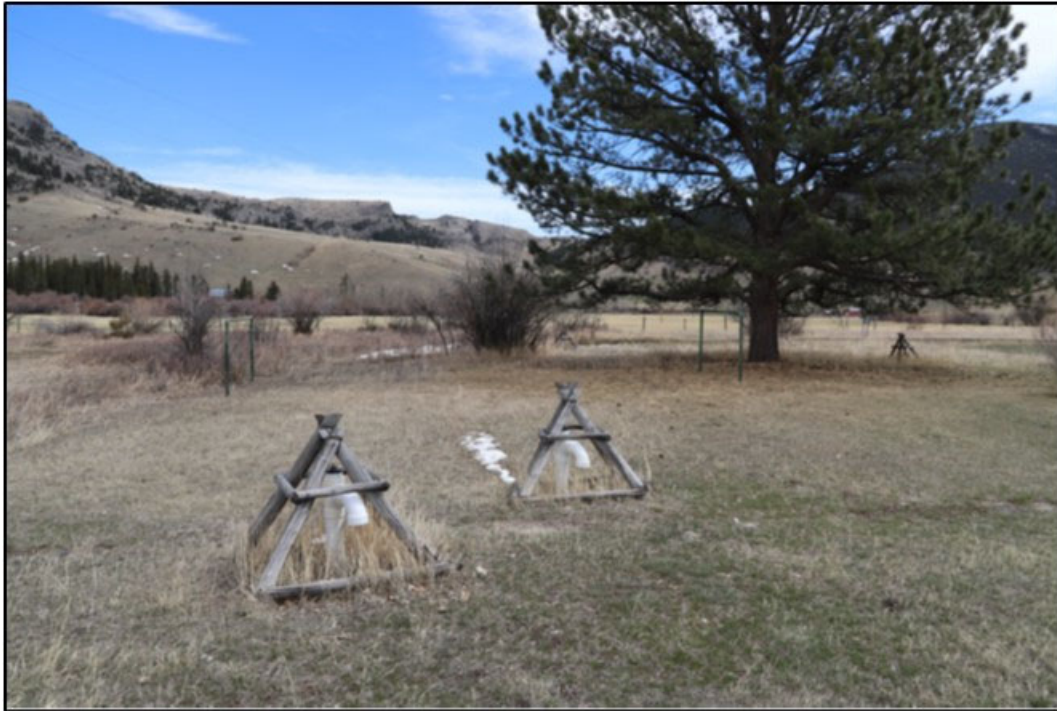
MT_StillwaterCounty_MeyersCreekWorkCenter_0026. View of the protective log buck structures at site water and effluent fixtures, May 19, 2022, View to east. (Photographer: Tim Urbaniak)

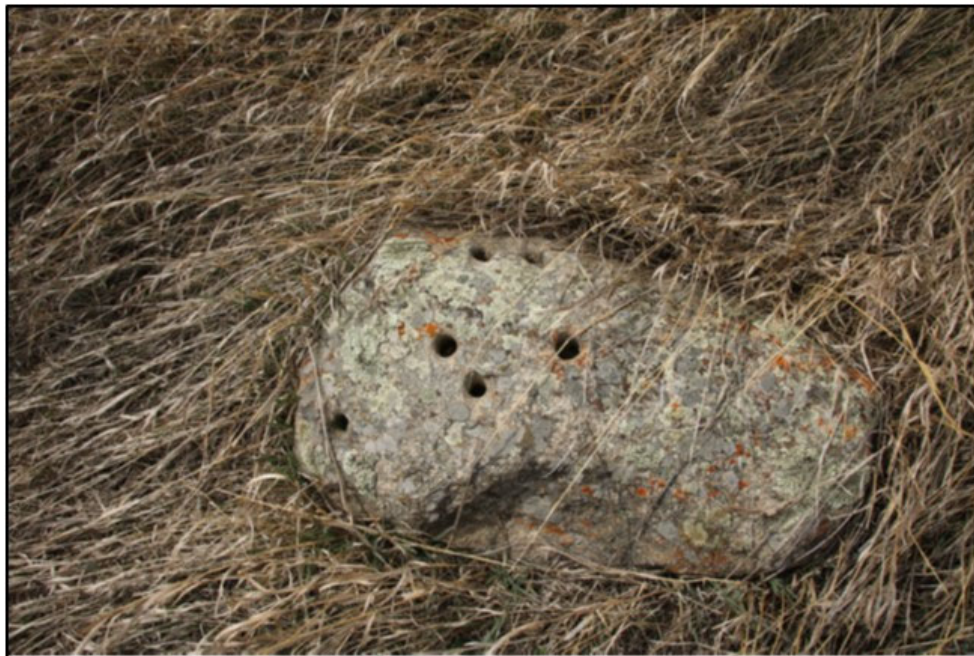
MT_StillwaterCounty_MeyersCreekWorkCenter_0027. Drilled holes in one of the many granite stones used to define a parking area, May 19, 2022, View to west. (Photographer: James Busse)

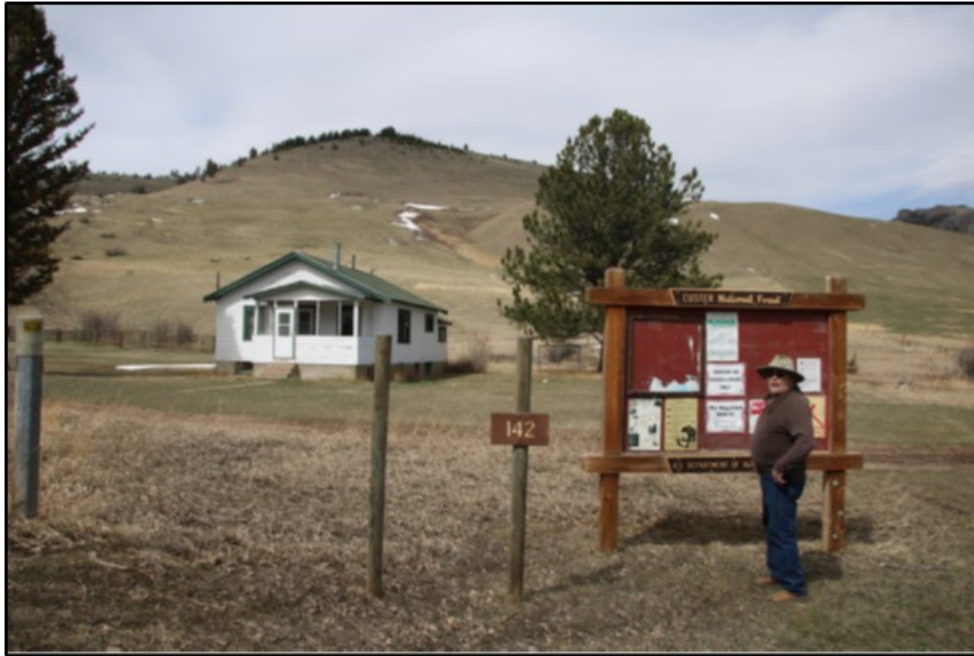
MT_StillwaterCounty_MeyersCreekWorkCenter_0028. Associated Forest Service signage positioned at the entry to the Meyers Creek Work Center, May 19, 2022, View to north. (Photographer: James Busse)

Feature 12 (post-1972) consists of the associated Forest Service signage primarily located at the entrance to the Meyers Creek Work Center (Photo MT_StillwaterCounty_MeyersCreekWorkCenter_0028). These kiosks and associated signage represent recognizable primary points of contact for the public and have long been an important initial source of information for those entering the area. Distributed signage at Meyers Creek may contain limited objects associated with the period of significance, however, the oldest still appear to be replacements of the original(s). Therefore, the signage is considered a noncontributing structure.
