National Register of Historic Places Registration Form

Historic name: Meyers Creek Work Center
 Other names/site number: Meyers Creek Ranger Station, Meyers Creek Station, 24ST0234
 Name of related multiple property listing:
N/A
 (Enter "N/A" if property is not part of a multiple property listing)

Street & number: 101-199 Meyers Creek Road, Custer Gallatin National Forest
 City or town: Nye State: MT County: Stillwater
 Not For Publication: Vicinity:

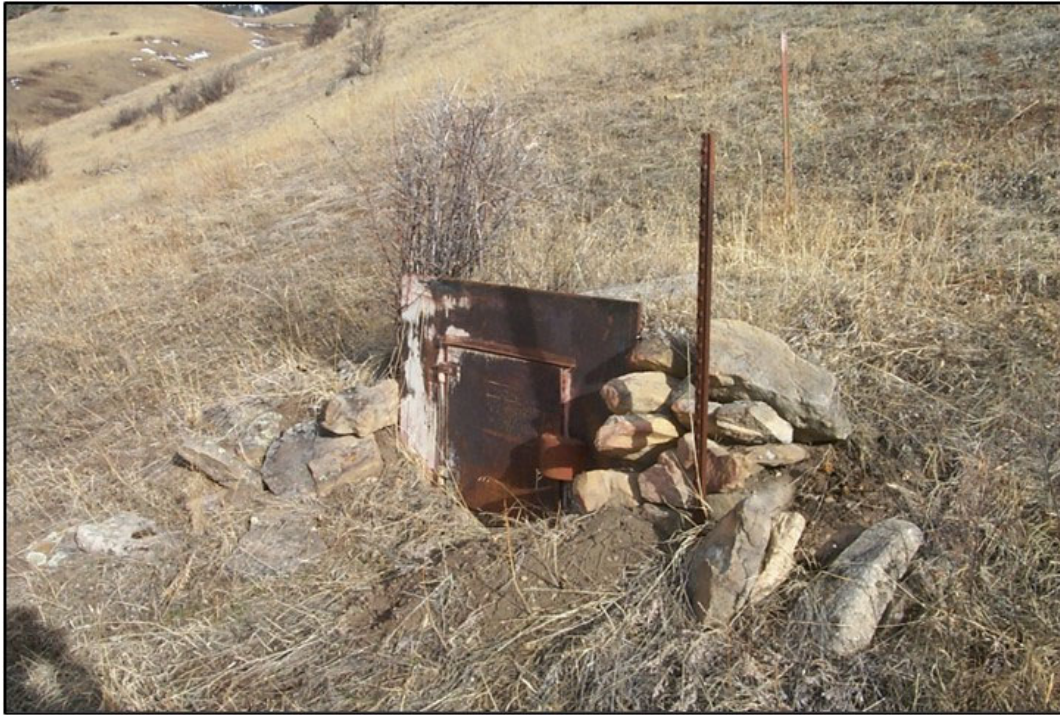
MT_StillwaterCounty_MeyersCreekWorkCenter_0030. The Feature 15 explosives storage structure, March 27, 2002, View to west. (Photographer Mike W. Bergstrom)

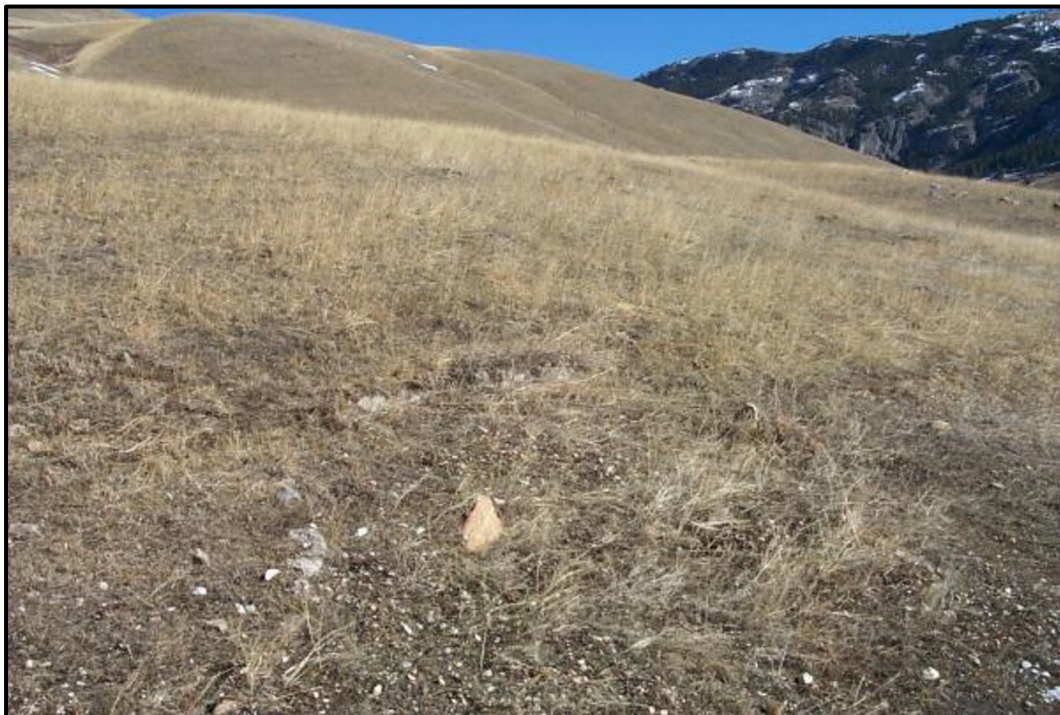
MT_StillwaterCounty_MeyersCreekWorkCenter_0031. Remains of the Feature 13 root cellar, March 29, 2002, View to northeast. (Photographer Mike W. Bergstrom)

Feature 13 (circa 1926) consists of the remains of a root cellar concrete wall foundation located on the slope north of the barn (Photo MT_StillwaterCounty_MeyersCreekWorkCenter_0031). The collapsed root cellar is associated with the earliest days of the Station and is considered a contributing site.
