CHAPTER 3. THE HOMESTAKE MINE (24PA875)

This site was a significant mining operation in the New World Mining District between 1887 and 1929. The mine was in operation from 1887 to about 1890 and again from 1921 to 1929, with limited open pit mining occurring in the late 1940s. It was associated with the Gold Dust Mine (24PA874) and was connected to that mine by a 700-foot long aerial tram (24PA879). Most, if not all, structures remaining at the site are associated with the 1921 to 1929 period of operation.

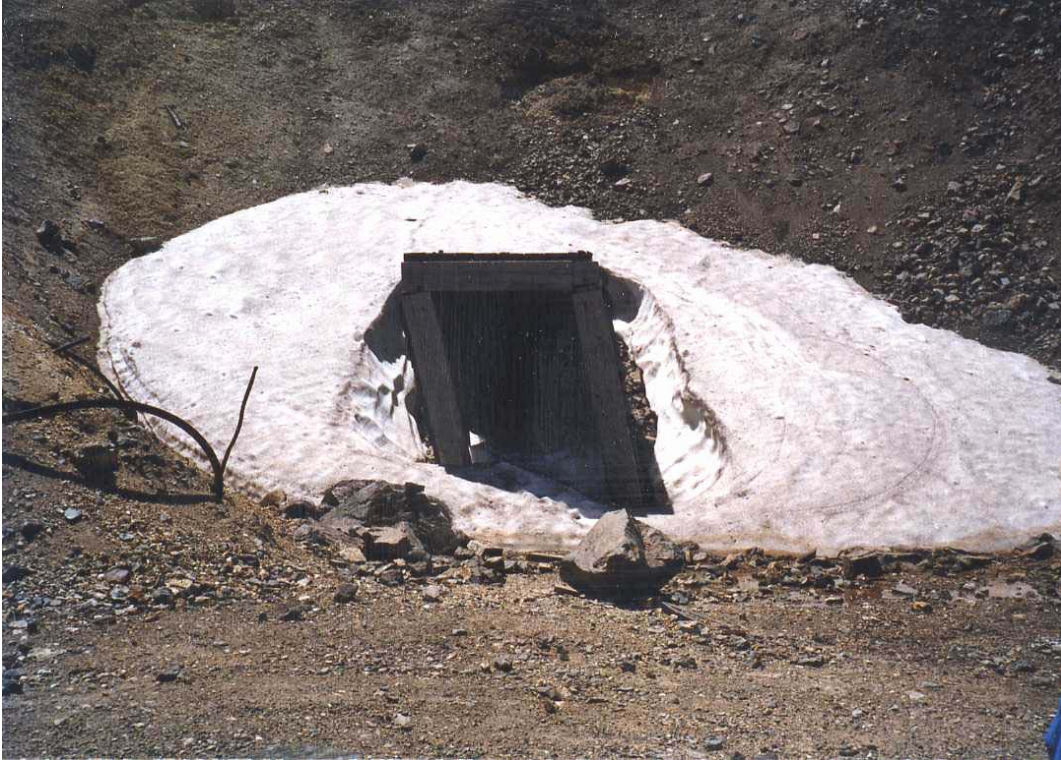
Feature 1 is the remaining open adit that opens to the northeast and is located on a steep north-facing mountainside (Figure 3-4). The adit has been closed with wooden timber portal sets and a locking steel gate. Feature 2 is an ore load-out and pilothouse. It measures 19.6 x 32.8 feet and is oriented southeast to northwest. It has heavy wood beam construction with vertical board and batten siding on the load-out and pilothouse. The ore chute has wood walls and faces northeast, while the pilothouse has a shed roof with exposed rafters supporting the overhanging eaves. Windows are on the southeast and northwest walls. The northwest window has a portion of window frame intact indicating that they were casements. The structure is built into the mountainside on a heavy wood frame foundation. Horizontal board and batten siding is on the facade of the load-out. This structure might have loaded trucks, for transport by road, or ore cars for transfer to the tram-loading terminal, designated as Feature 3. Figures 3-5 to 3-7 show the load out structure.

Figure 3-4. Feature 1, main adit looking south.

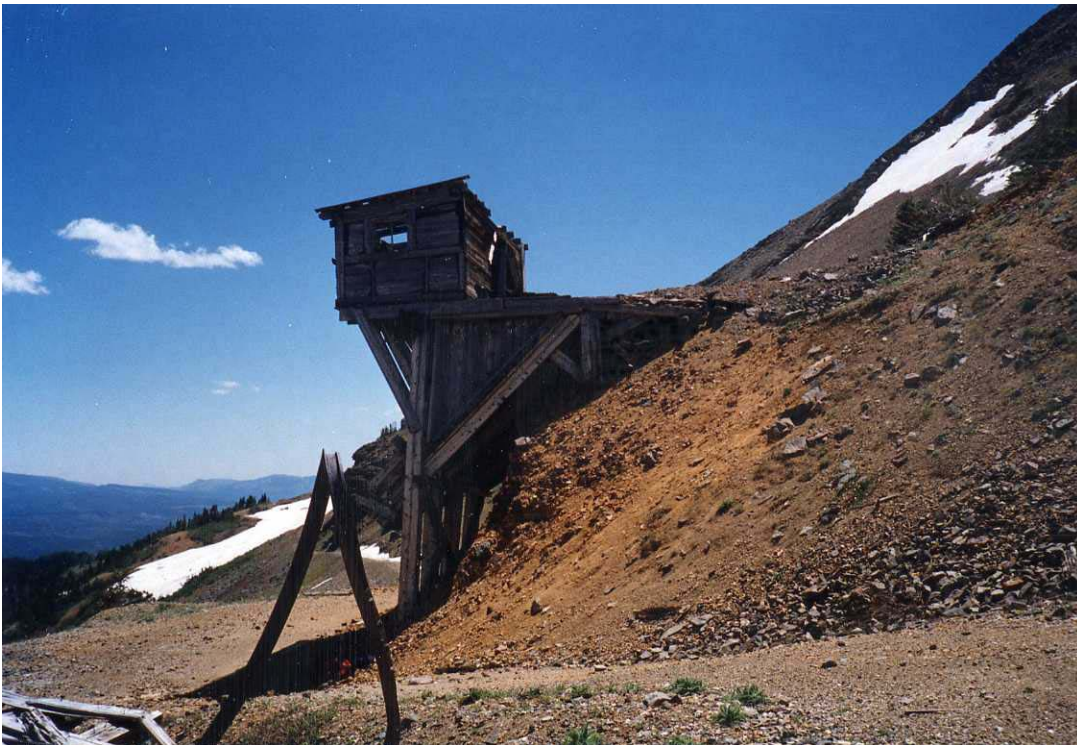
Figure 3-5. Feature 2, ore load-out and pilothouse, looking southeast.

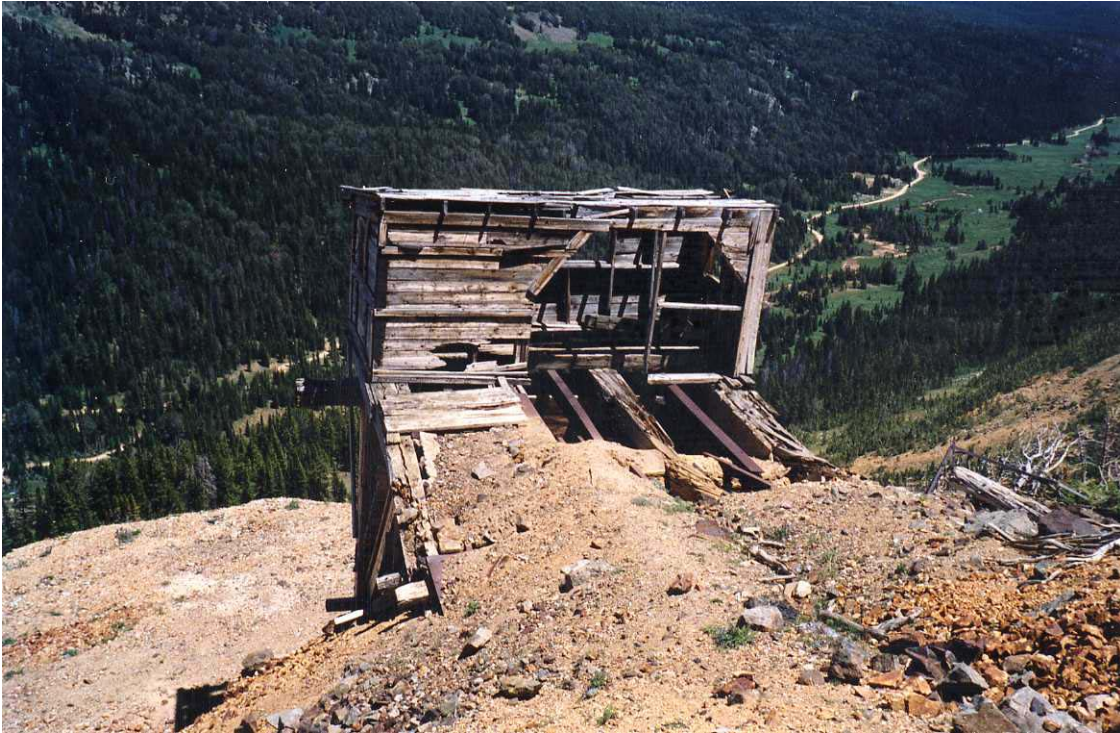
Figure 3-6. Feature 2, ore load-out and pilothouse, looking northeast.

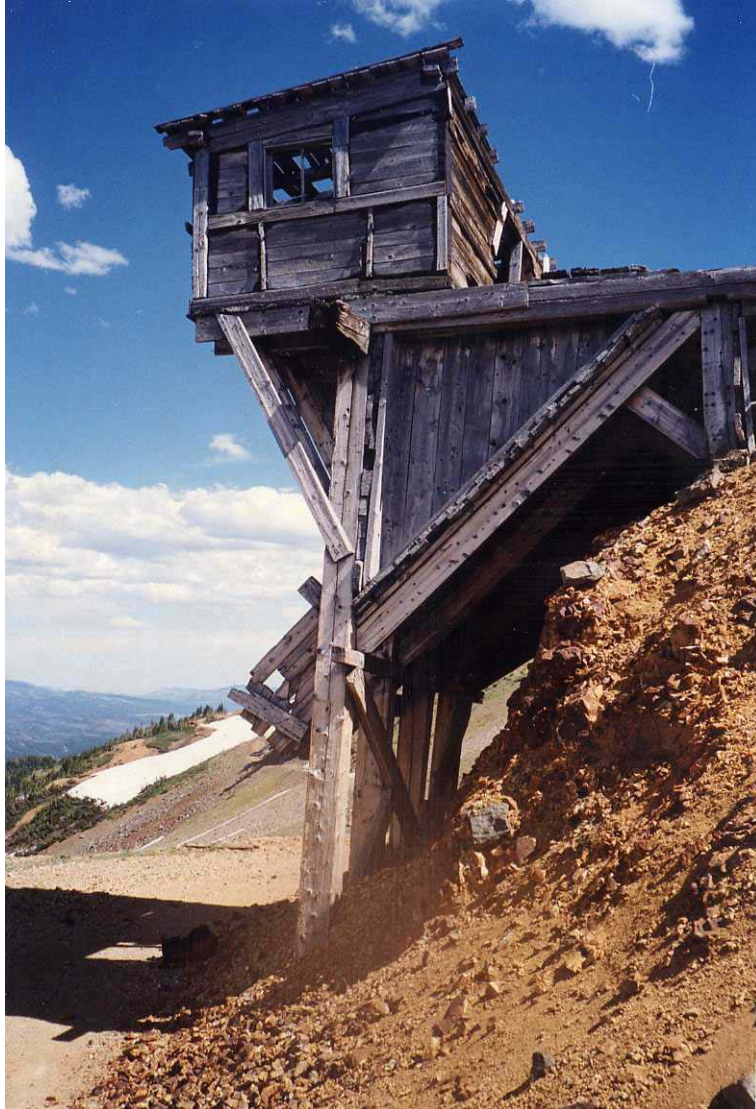
Figure 3-7. Feature 2, ore bin, load-out and pilothouse, looking southeast.

This structure handled ore from an adit that is now covered with waste rock from the open cut mining activity. Ore from this bin may have been hand carted to the tram loading terminal, or it may have been loaded on trucks from this hopper. The modification of the site during the late 1940s has left this transfer mechanism in doubt.

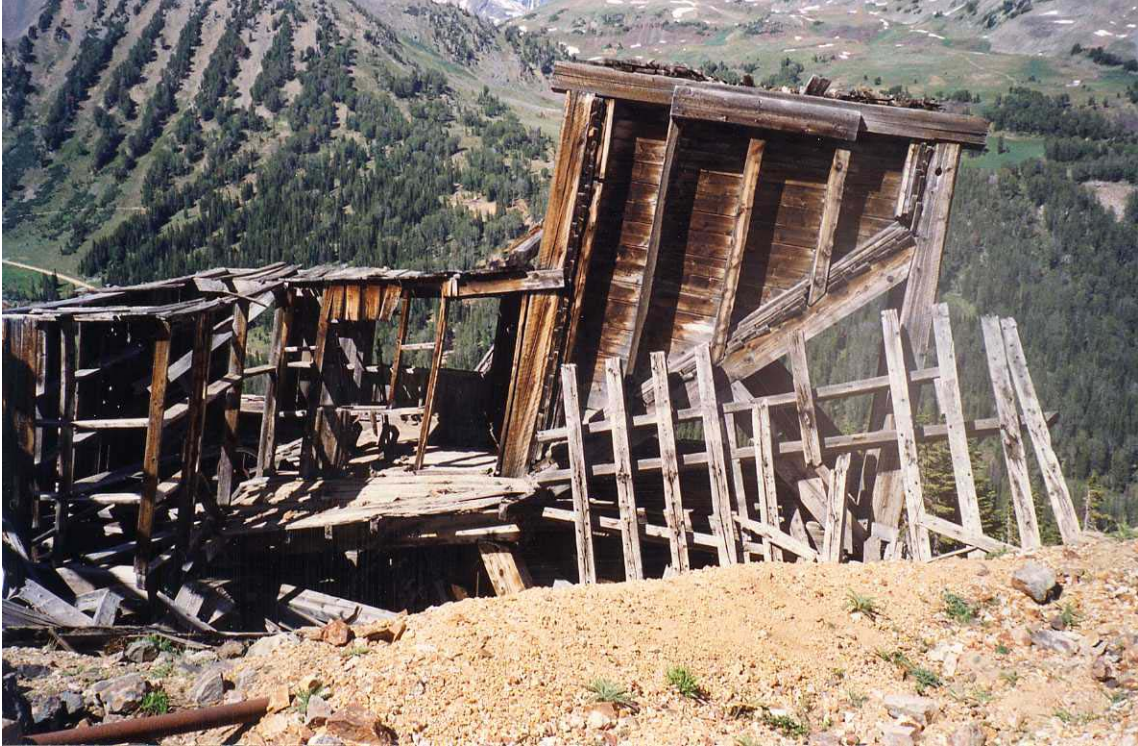
Figure 3-8. Feature 3, upper tram loading terminal, viewing north. Ore bin to right, operator's room in center, bull wheel structure to left. The collapsed loading deck is seen leaning against the ore bin.

Feature 3 is the upper tram loading terminal. It had heavy wood beam construction with trusses. The tibble has horizontal board siding, while the tram operator's house is flat-roofed with vertical board and batten siding. Entry is gained on the south (structure faces north). A single window is located west of the entry on the rear facade. The entry was reached by a wood deck that is now collapsed. There is board roofing on the terminal and the entire structure has a wood beam foundation. A tram cable support on the northwest side of the structure consists of wood trusses and metal cable guides. The bull wheel and break wheel are intact in the terminal, along with a reduction gearing system (possibly a speed retarding mechanism) and an ore feed chute with its control mechanism. The cables are lying more or less in place and can be seen leading down the steep slope to the Gold Dust Mine (24PA874) some 700 feet below. The entire structure is deteriorated. Figures 3-8 to 3-11 show the tram loading terminal.

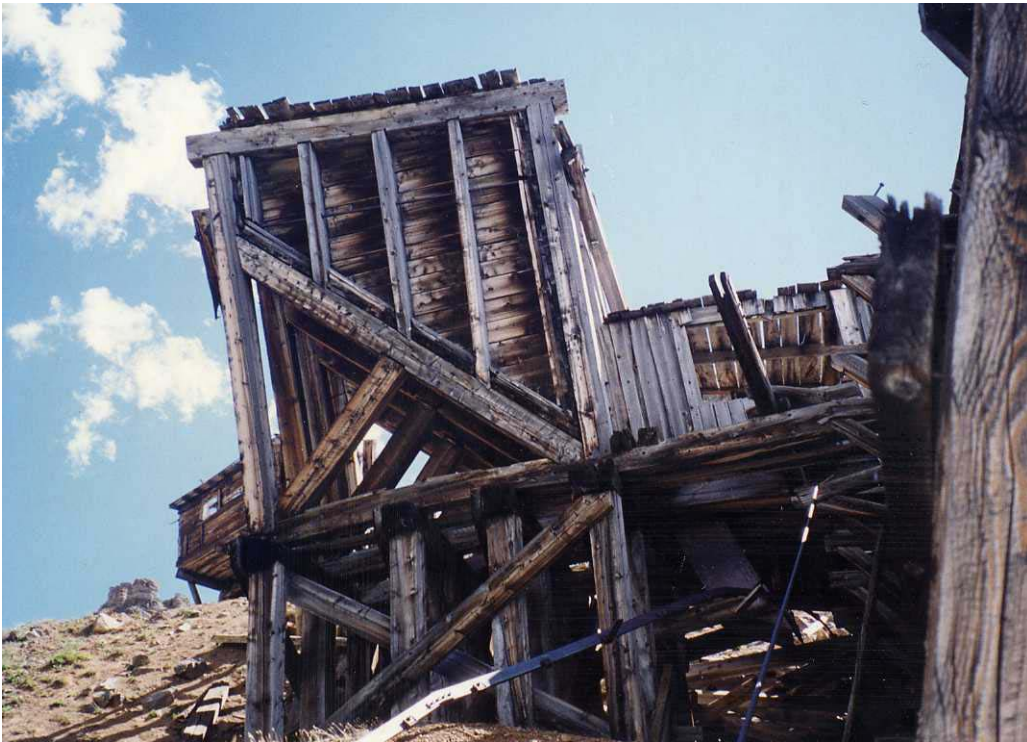
Figure 3-9. Feature 3, upper tram loading terminal, viewing north. Ore bin to left, operator's room in center.

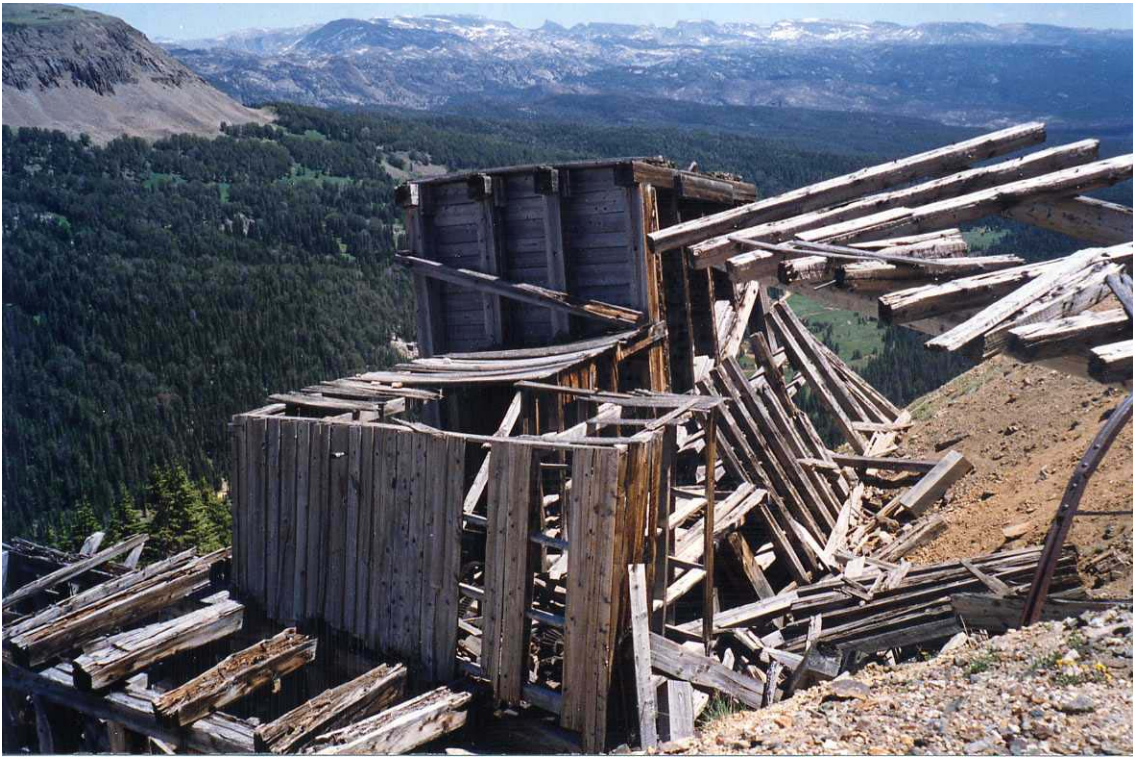
Figure 3-10. Feature 3, upper tram loading terminal, viewing east. Operator's room in center. Portion of Feature 4, trestle in upper right foreground.

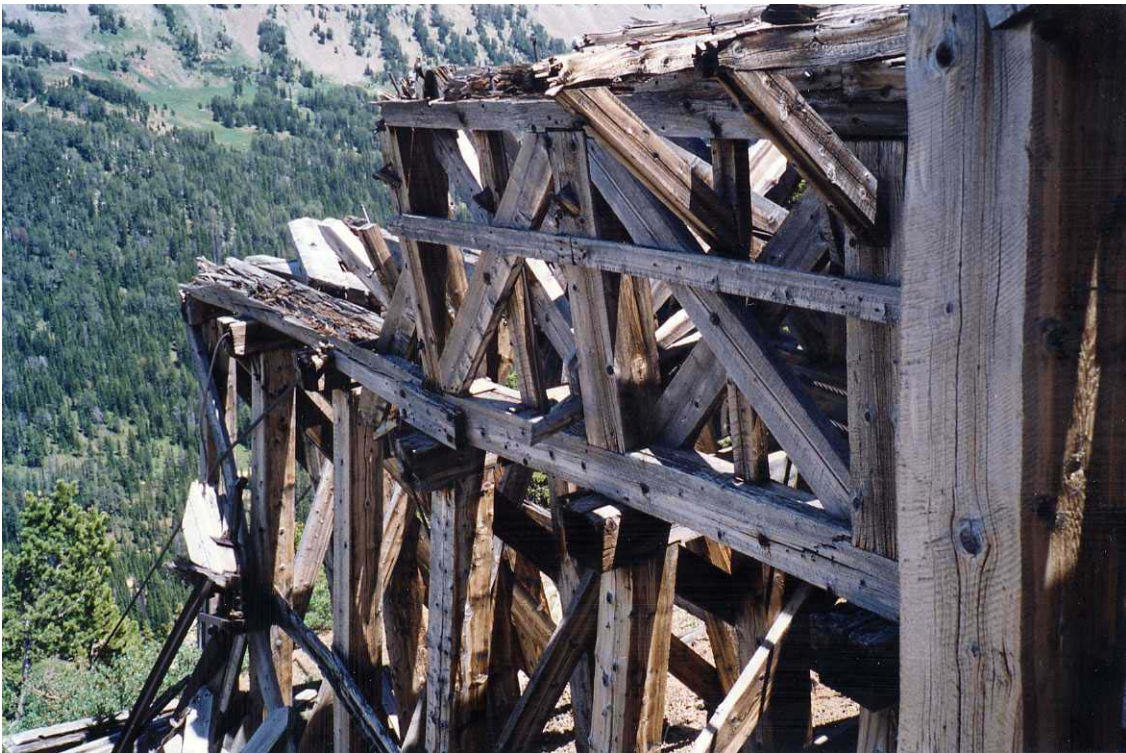
Figure 3-11. Feature 3, upper tram loading terminal, viewing northeast. Bull wheel support structure.

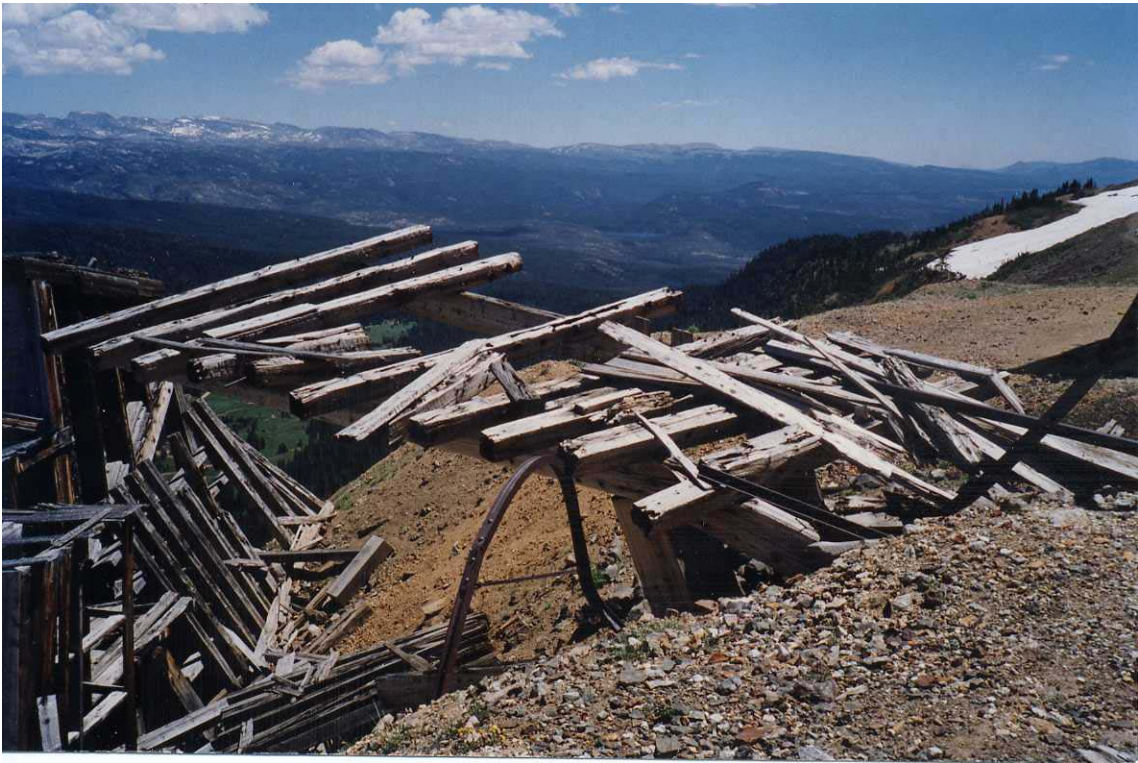
Feature 4 is a wood ore car load-out trestle with narrow gauge rails oriented northeast to southwest (Figure 3-12). It is deteriorated and is associated with the main adit (Feature 1). Feature 5 is an area of open pit mining. Located about 60 feet above the buildings, this area is accessed by a switchback road. It is hard to tell the extent of this open cutting as there may be some subsidence from the collapse of the adits and much of the natural rock fall and talus is hard to discern from the mine workings. Features 6, 7 and 8 are collapsed adits. These are nearly covered by subsequent workings or rock falls.

Figure 3-12. Feature 4, trestle from main adit. It appears discontinuous from the tram loading facility; its functional relationship is unknown. It may predate the terminal.
