## TECHNICAL MEMORANDUM

**RE:** 2002 Reclamation Monitoring  
New World Mining District Response and Restoration Project

**PHOTOGRAPHS**

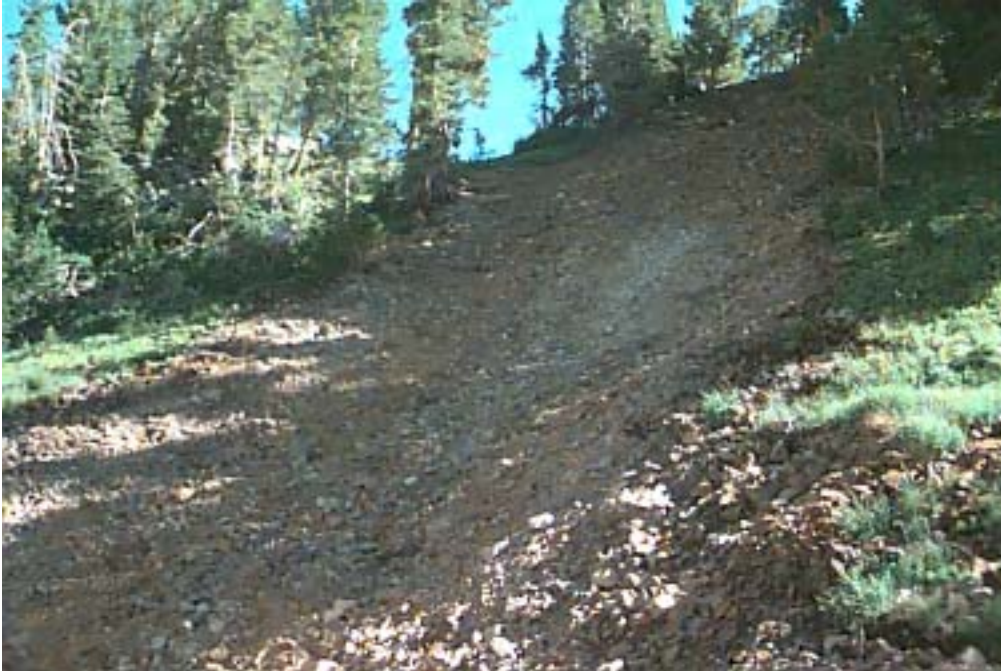
Photo 1. Upper Tredennic Dump 1.

Revegetation on Upper Tredennic Dump One was extremely sparse and uneven, primarily resulting from the approximately 80% rock cover of 3-inch plus rocks. The slope is stable with small patches of grasses growing in crevices on the lower portion of the dump. Though this area was seeded, the quantity and size of the surface rock does not provide a suitable growth substrate. A small depression is centrally located in the slope. The rock surface is iron- and manganese-stained in some places.

One soil sample, FCSI-96-15 (Attachment C), was collected from the Upper Tredennic Dump One. The saturated paste pH of the dump is ultra acid (2.6 standard units), which likely precludes the opportunity for vegetation to establish on the rocky surface. The low pH is due to the fact that lime and topsoil could

not be applied to the reclaimed surface because there was no access to the steep slope with equipment. Total metals concentrations in the sample are below human health cleanup guidelines, but copper (372 milligrams per kilogram [mg/kg]) and lead (611 mg/kg) concentrations are higher than phytotoxicity guidelines. Arsenic, cadmium, and zinc concentrations are below phytotoxicity guidelines.

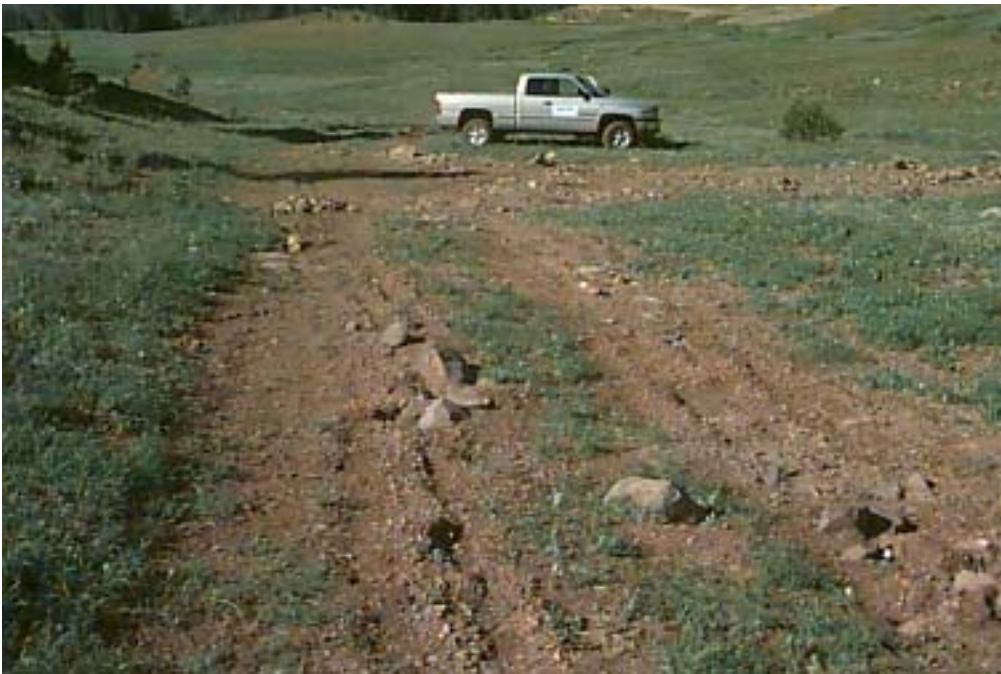
Photo 2. Upper Tredennic access road.

The Upper Tredennic access road contained sparse to very sparse vegetation. Tufted hairgrass and alpine bluegrass (*Poa alpina*) were the dominant species, although a substantial number of new species were growing within the roadbed. The roadbed contained minor rilling and impacts from vehicle traffic.

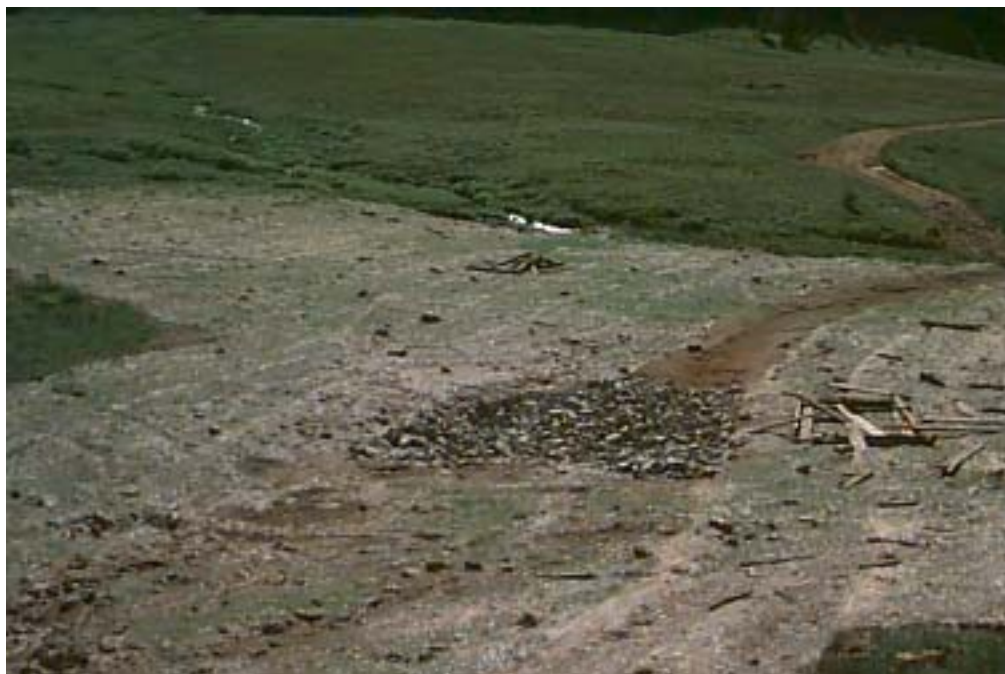
Photo 3. Middle Tredennic Dump.

New plant growth was even, though sparse in some areas, and there were no large bare areas present. Diverse, native species are present on edges of the dump. Erosion mat is holding well below the backfilled adit. Above the backfilled adit, some minor rilling is occurring under the erosion mat and some water pooling is occurring. Sediments contain some iron and manganese staining.

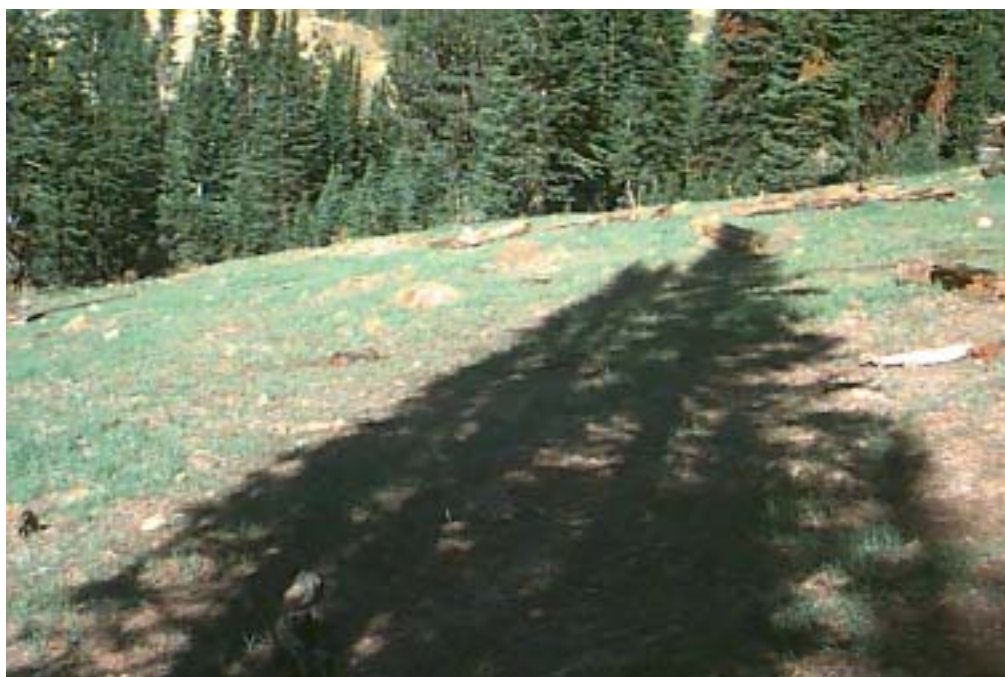
Photo 4. Lower Tredennic Dump.

Revegetation is excellent at the Lower Tredennic Dump. Slender wheatgrass (*Agropyron trachycaulum*) is fairly abundant, covering approximately 15 to 20 % of the area. Few tufted hairgrass plants are present. Lewis monkeyflower (*Mimulus lewisii*) occurs within the rock-lined channel. Vegetation is sparser in areas without erosion mat.

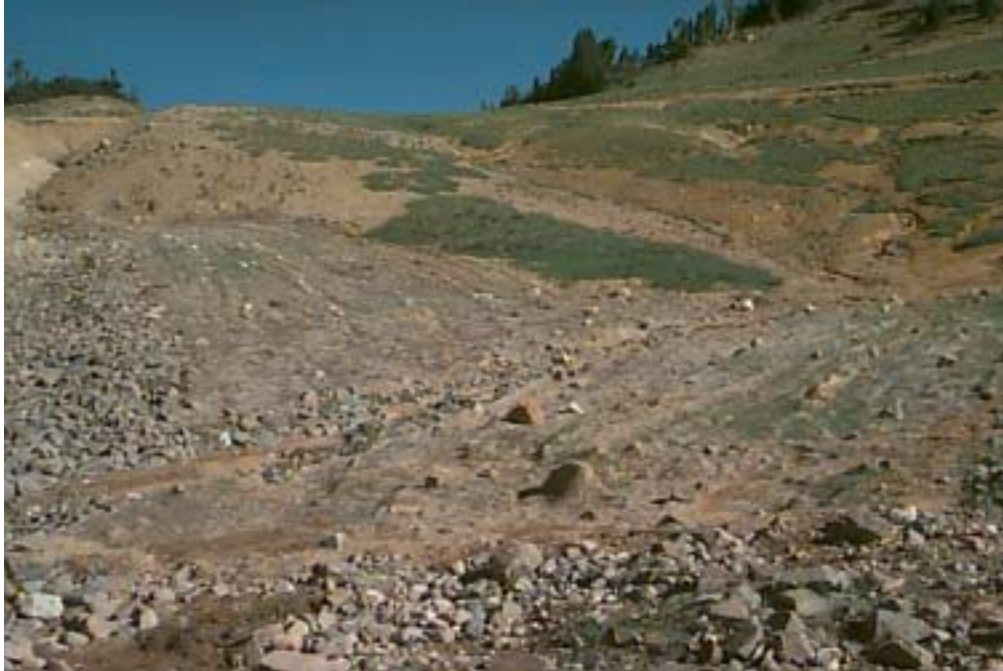
Photo 5. Small Como Dump.

Overall, revegetation at the Small Como Dump was poor at the time of monitoring as vegetation cover was sparse and patchy. Areas with erosion mat contained slightly more vegetation cover; areas without erosion mat contained little or no vegetation cover. Based on visual observations of Forest Service personnel, revegetation cover improved later in the summer on the reclaimed area, largely due to the frequent rains that fell in August.

Rills and gullies located adjacent to the northern edge of the reclaimed site are beginning to erode onto the reclaimed site. Surface water flow appears to be limiting vegetation growth in the lower portion of the dump and soil chemical properties appear to be affecting plant growth on the upper portion of the dump.

The soil sample collected from the bare area at the upper end of the Small Como Dump (Attachment C) exhibits a neutral pH and levels of phosphorous and potassium that are adequate for vegetation. Organic matter content (3.4%) is higher than the design specification of 3%, but nitrate-nitrogen content is in the

very low range. Total metals concentrations were below human health cleanup guidelines and below phytotoxicity guidelines except for copper, which was measured at 206 mg/kg. This concentration of copper is slightly higher than the phytotoxicity guideline of 125 mg/kg.

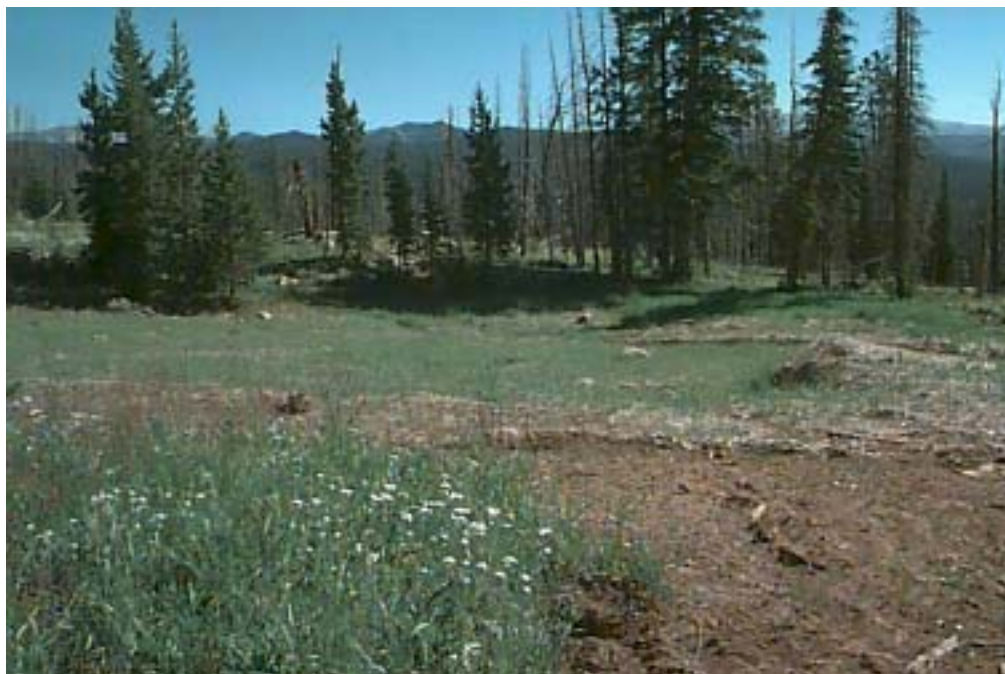
Photo 7. Soda Butte Tailings.

Revegetation on the Soda Butte Tailings is excellent. Vegetation cover is approximately 20 to 25%, with the grasses six to eight inches tall. Slender wheatgrass and tufted hairgrass are the most successful species. Water appears to be pooling, creating small areas barren of vegetation. Revegetation on the road is successful though patchy.

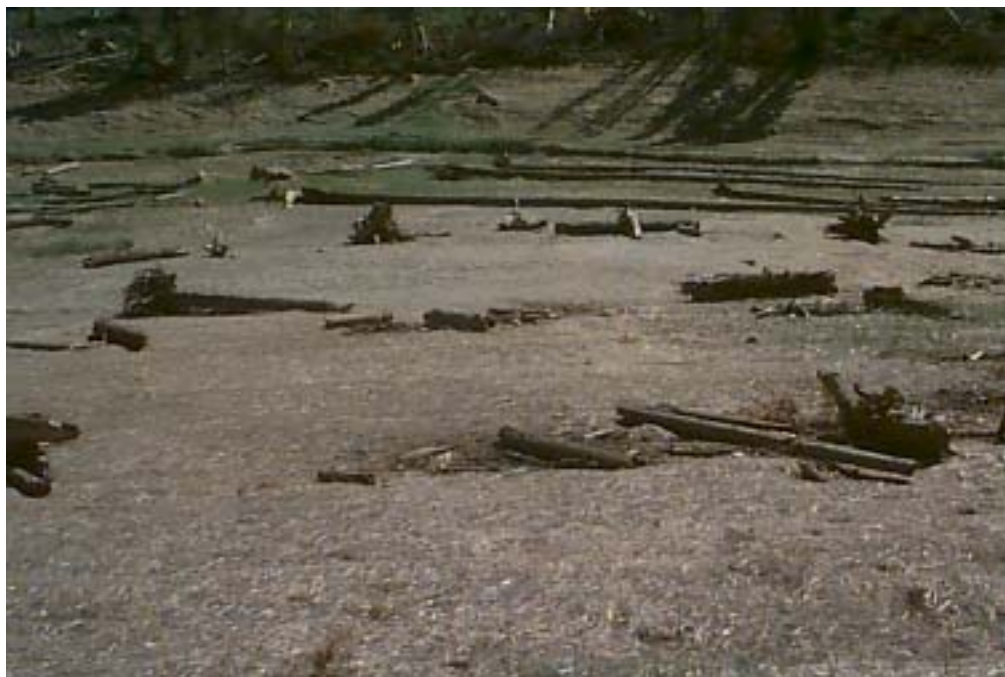
Photo 8. Rommel Tailings

Revegetation is excellent in most areas, although a large barren area occurs in the south central portion of the site. Site limiting factors appear to be lack of fine soil and abundant surface rock. Construction debris present earlier in the season has been removed. The large barren area was apparently used for storing erosion mat and has been reseeded. The access road is thoroughly obstructed with logs and boulders. Revegetation on the road is good, although the most successful species appears to be timothy (*Phleum pratense*), an exotic pasture grass easily mistaken for alpine timothy (*Phleum alpina*), which was the species specified in the construction contract. Timothy appears to be invading adjacent vegetation, although it is unlikely this species will persist for long due to adverse environmental conditions.

The soil sample collected from the bare area at the Rommel site exhibits a neutral pH (7.5 s.u.), a relatively high coarse fragment content of 75.4%, and relatively low fertility and organic matter levels. No human health guidelines were exceeded for any of the metals, and only total copper, which was measured at 325 mg/kg, exceeds a phytotoxicity guideline.

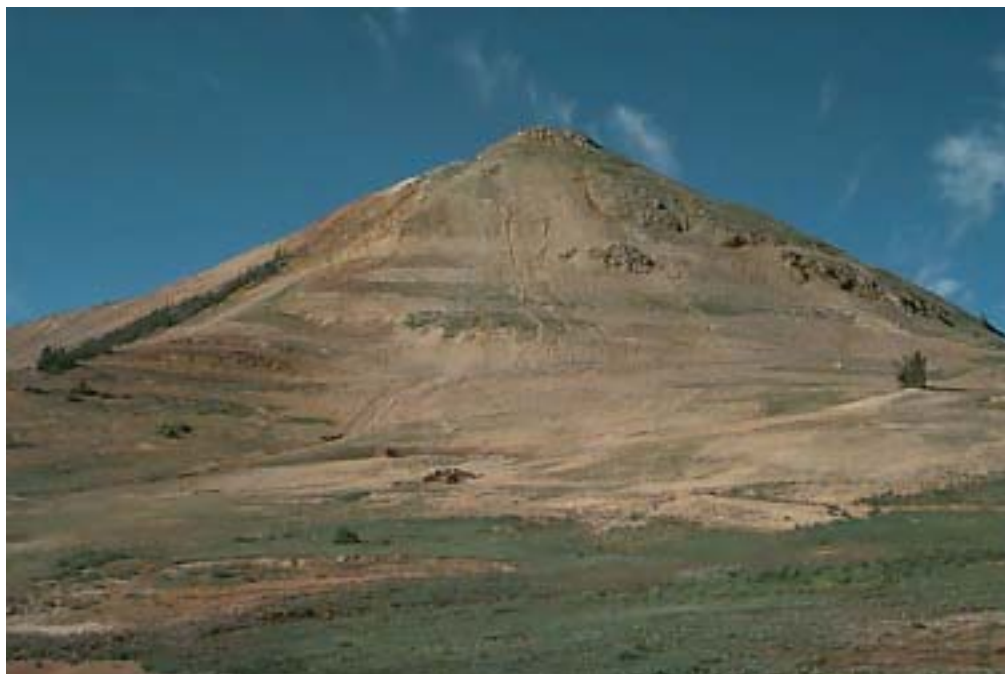
Roads in the higher elevation road strata occur along exposed scree slopes. Revegetation in these areas is, for the most part, unsuccessful, due to the lack of fine soil and abundance of rock. After recontouring, these roads appear similar to the surrounding terrain, which lacks vegetation as well. Three roads were visited, Forest District Road (FDR) 18, 15, and 112. Percent rock on these roads ranged from 90 to 100%. Isolated patches of native species, tufted hairgrass, fireweed (*Epilobium angustifolium*), smooth woodrush (*Luzula hitchcockii*), and sedge (*Carex spp.*) were scattered in areas with accumulated fine soil. Forbs are an insignificant portion of the vegetative cover.

Gullies are present on the north face of Fisher Mountain above the Como Basin. Reclaimed roads (FDR numbers 14, 25, 12, the lower portion of 18, and 28) cross this area.

Photo 9. Erosional Features on Road Strata 1, FDR 28, 25, and 14.

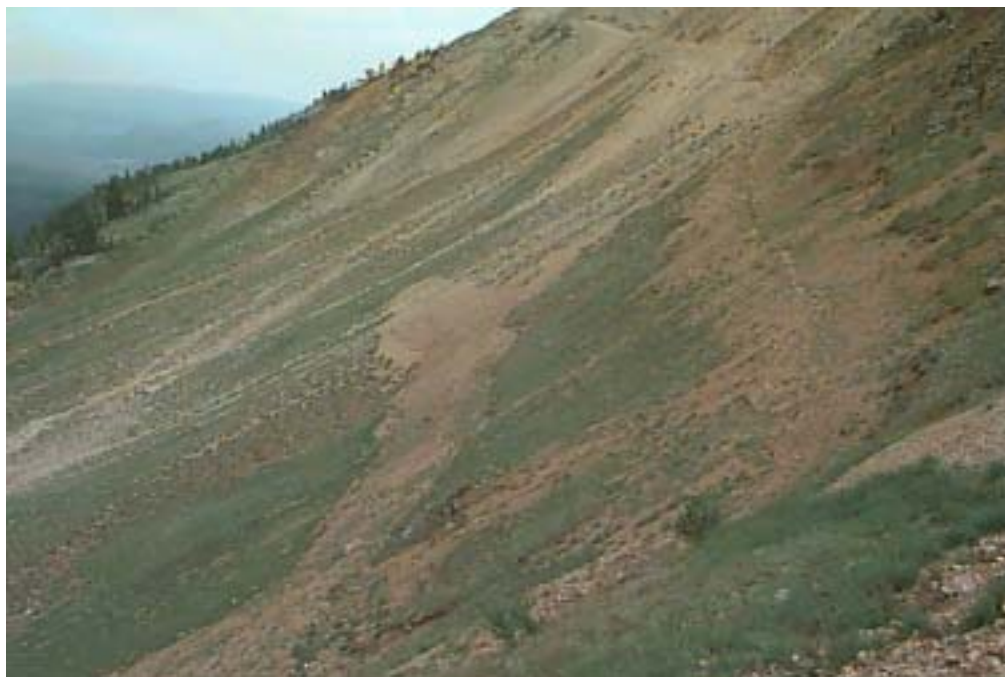
Photo 10. Road Strata 2, FDR 44.

Roads in the mid-elevation road strata frequently occur adjacent to conifer stands and typically contain much more vegetation than the upper elevation road strata. Three roads were visited, FDR 45, 44, and 38. These roads contained 5 to 15% vegetation cover. Obvious species are tufted hairgrass, alpine bluegrass (*Poa alpina*), smooth woodrush, and fireweed. Fine soil ranged from 50 to 70 % of the soil surface. Surface rock ranged from 15 to 50 % of the soil surface. Significant erosional features were not evident in this road strata.

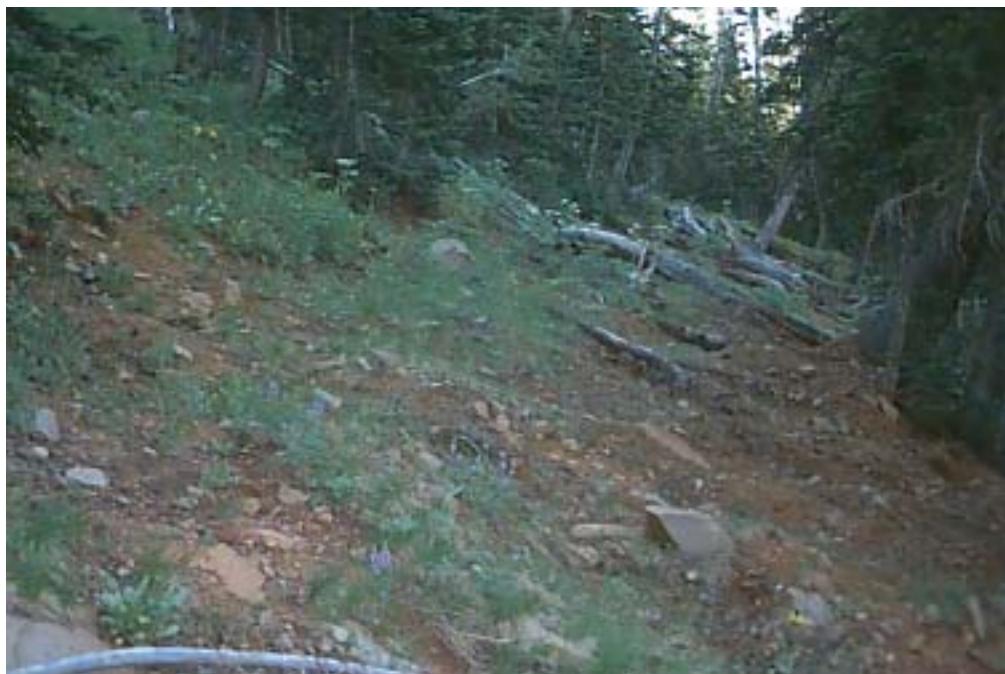
Photo 11. Road Strata 3, FDR 70.

Roads in the lower elevation road strata are typically very well vegetated and lacked notable erosional features.

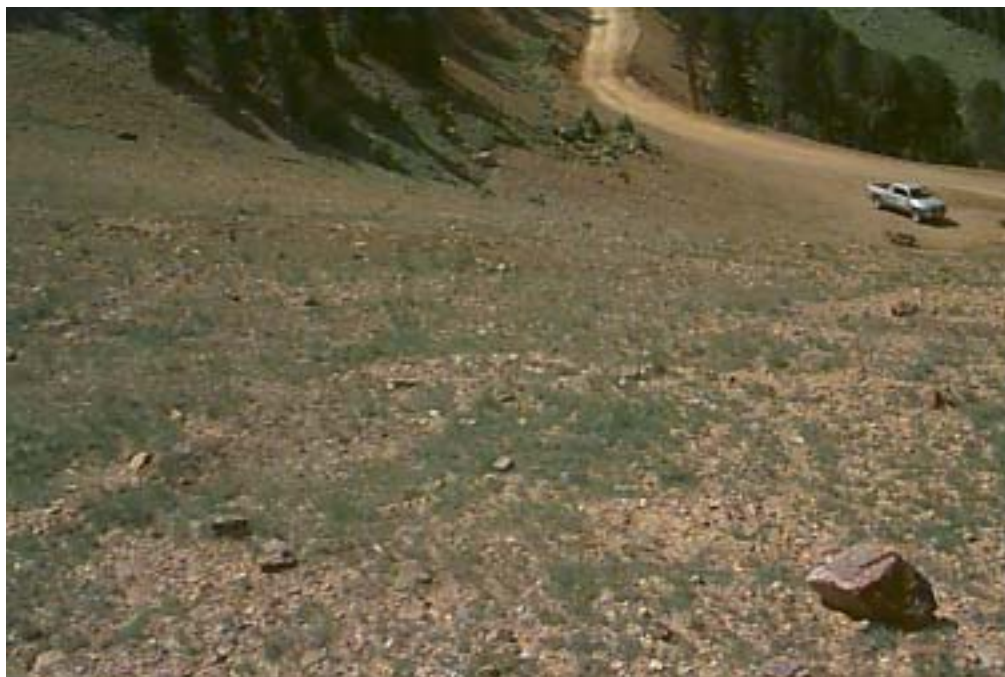
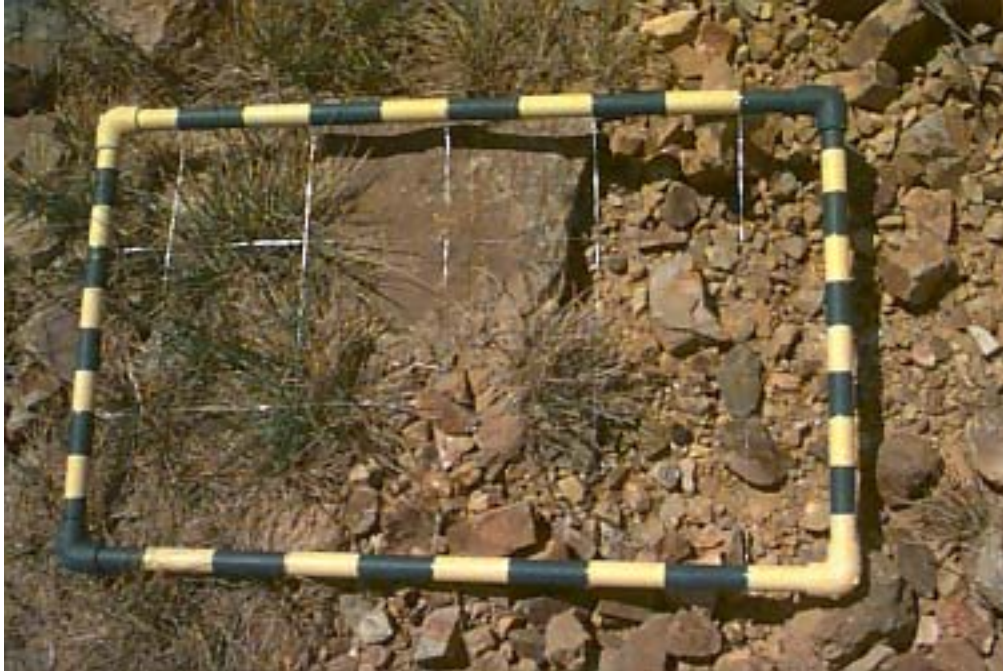
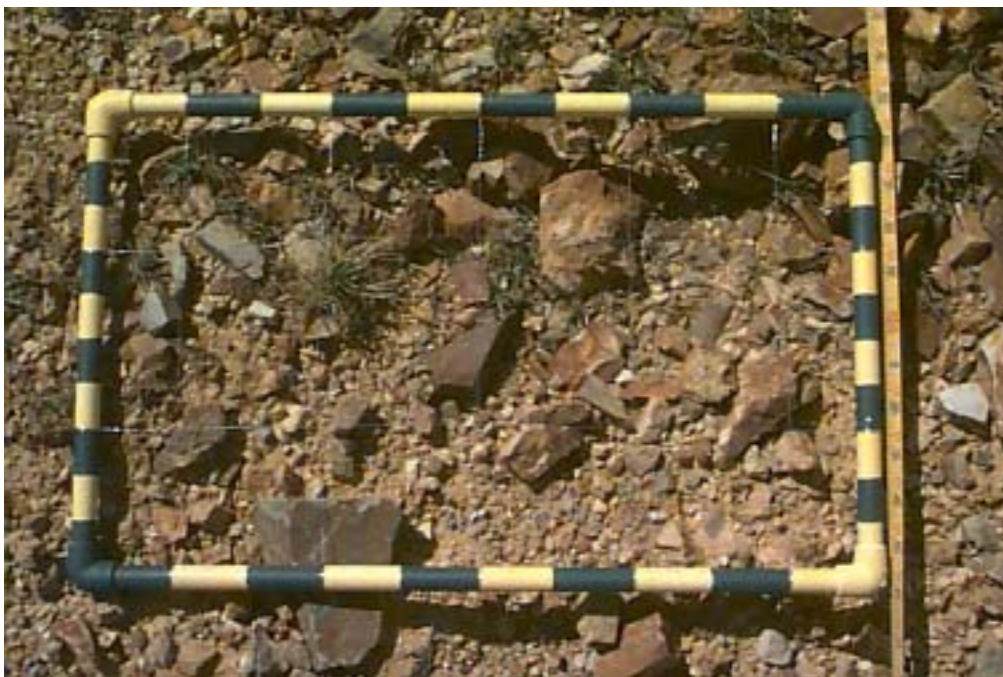
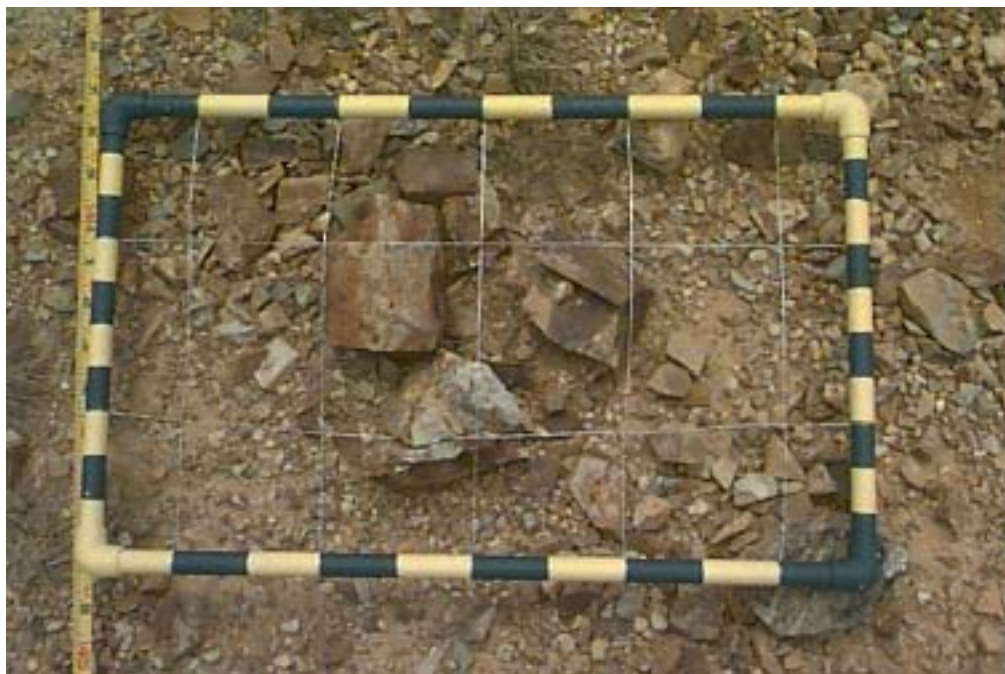
At the McLaren Triangle, Maxim sampled 131 vegetation quadrates on nine transects. Attachment A contains the field data sheets, which are summarized in Table 1. Photographs of the McLaren Triangle and randomly selected quadrates are contained in Attachment B. Successful species are tufted hairgrass, alpine bluegrass and an unidentified moss. Alpine bluegrass was most abundant averaging 6.3% cover; moss and tufted hairgrass were less frequently encountered and averaged 4.5 and 4.3% cover, respectively. Overall percent cover of vegetation was 15.0%. Sedge and fireweed occurred infrequently across the site.

Fine soil or bare ground accounted for 49% of the soil surface. Rock covered approximately 24% of the soil surface and litter covered approximately 11%.

Data from long term revegetation monitoring in 1999 and 2000 (Maxim 1999, Maxim 2000) indicated that percent cover is very low and has not improved. Overall percent cover in 1999 and 2000 was 11.3% and 16.6%, respectively.

The composite soil sample collected from the McLaren Triangle exhibited a strongly acid pH of 4.5 s.u. Coarse fragment content is relatively high at 67.4%. Organic matter was measured at 1%, and fertility levels are adequate for phosphorus, but in the low to very low range for potassium and nitrate as nitrogen.

Vegetation cover at the McLaren Triangle could be improved with fertilizer, reseeding, and addition of organic matter applied in the fall of 2003. Seeding and fertilizing should occur after September 15<sup>th</sup>. Recommended seeding rates are specified in Table 2 and follow rates established by Brown et al (1996).

Brown et al. (1996) recommends refertilization to increase biomass on reclaimed mine soils. Fertilizer rates are specified for nitrogen and phosphorus. Nitrogen should be applied at a rate of 100 lbs N per acre in a balanced (16-16-16 N-P-K) granular fertilizer. In terms of bulk fertilizer, approximately 625 pounds (100/0.16) of 16-16-16 bulk granular fertilizer will produce approximately 100 lbs of elemental nitrogen. Seeding should be done using broadcast methods.

In addition to seeding and fertilizing at the McLaren Triangle, a topical application of agricultural limestone would help to partially alleviate acid conditions in the seedbed (upper inch of soil). The limitation for topical application is necessary because incorporating the limestone amendment would damage the existing vegetation. A suggested rate for topical application is 1,000 pounds per acre. The topical application could be spread with a fertilizer spreader towed behind a small tractor. To minimize damage to existing vegetation, limestone and fertilizer could be spread in one operation prior to seeding after September 15<sup>th</sup>.

Following seeding, fertilizer, and limestone application, lightweight erosion mat (North American Green 75BN or equivalent) should be installed. Erosion matting will add a moderate amount of organic matter and reduce the loss of seed that can occur during windy periods.
