416 Fire Burned Area Emergency Response (BAER) Executive Summary

San Juan National Forest, Durango, Colorado

February 26, 2019

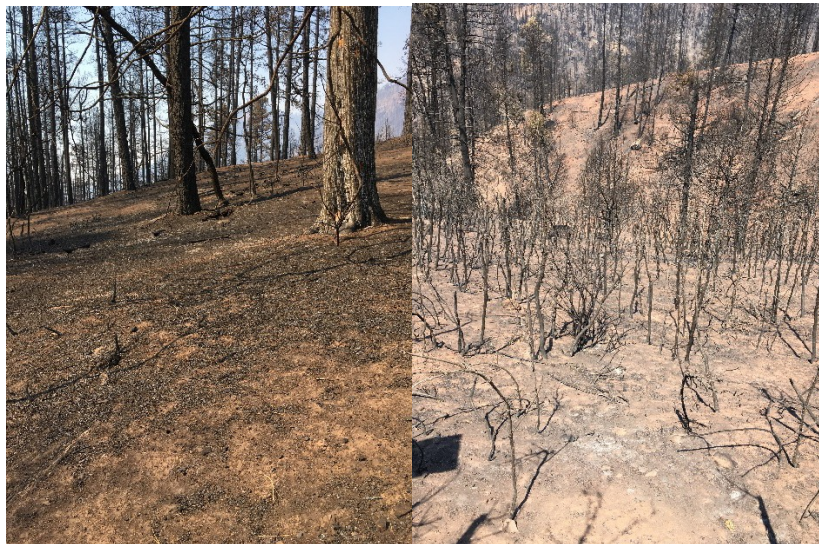
Moderate Soil Burn Severity

An estimated 33% of the area within the 416 Fire perimeter had high or moderate SBS and may have developed water repellent soils as a result of the fire. Water repellent soils develop when organic material (dead plant debris) on the soil surface burns during a fire, releasing waxy substances that coat soil particles—basically “shrink-wrapping” the soil and filling in the pores that would normally allow water to soak in during rain events. When water can’t infiltrate into the soil because the pores are blocked, water runs over the surface causing erosion and increased flood potential.
