# Tonto National Forest

## East Verde River Headwaters Watershed Restoration Action Plan

Payson Ranger District, Tonto National Forest  
Gila County, Arizona

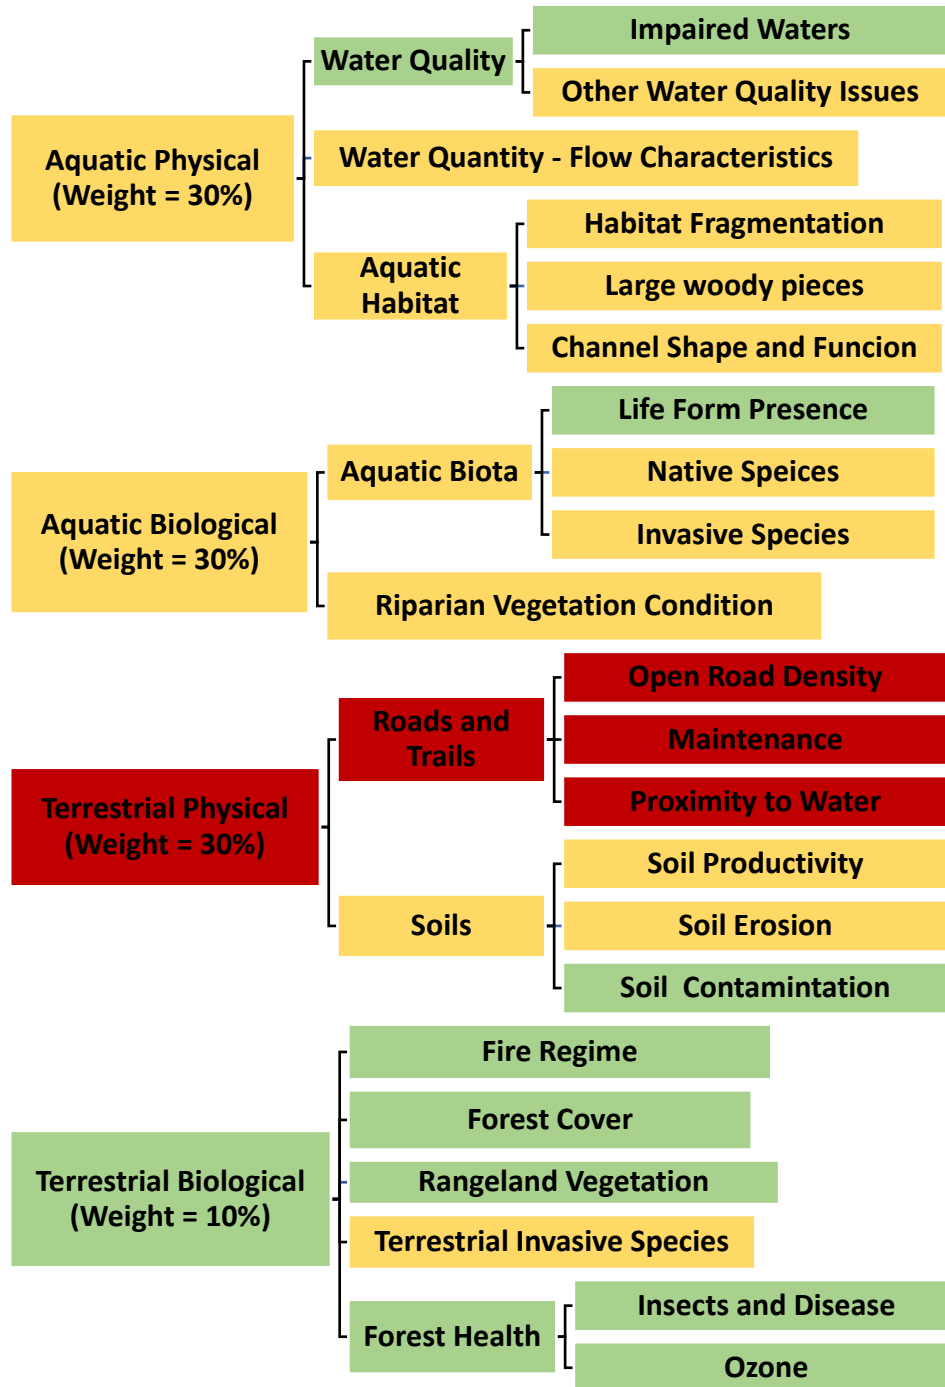
Figure 7: Summary of current condition for all watershed attributes  
green = good, yellow = fair, and red = poor

Figure 7 displays all 12 indicators and their attributes, color coded by their current condition score. Detail on how each score was determined is included in this section. The indicator and category scores are the simple average of all attributes. The overall watershed condition class is weighted as follows: aquatic physical, aquatic biological and terrestrial physical scores make up 30% each and terrestrial

biological constitutes the remaining 10% of the score. The current condition class of the watershed is Class 2 – Functioning at Risk based on a weighted score of 1.9.<sup>6</sup>
