# Tonto National Forest

## Green Valley Creek Watershed Restoration Action Plan

**Payson Ranger District, Tonto National Forest  
Gila County, Arizona**

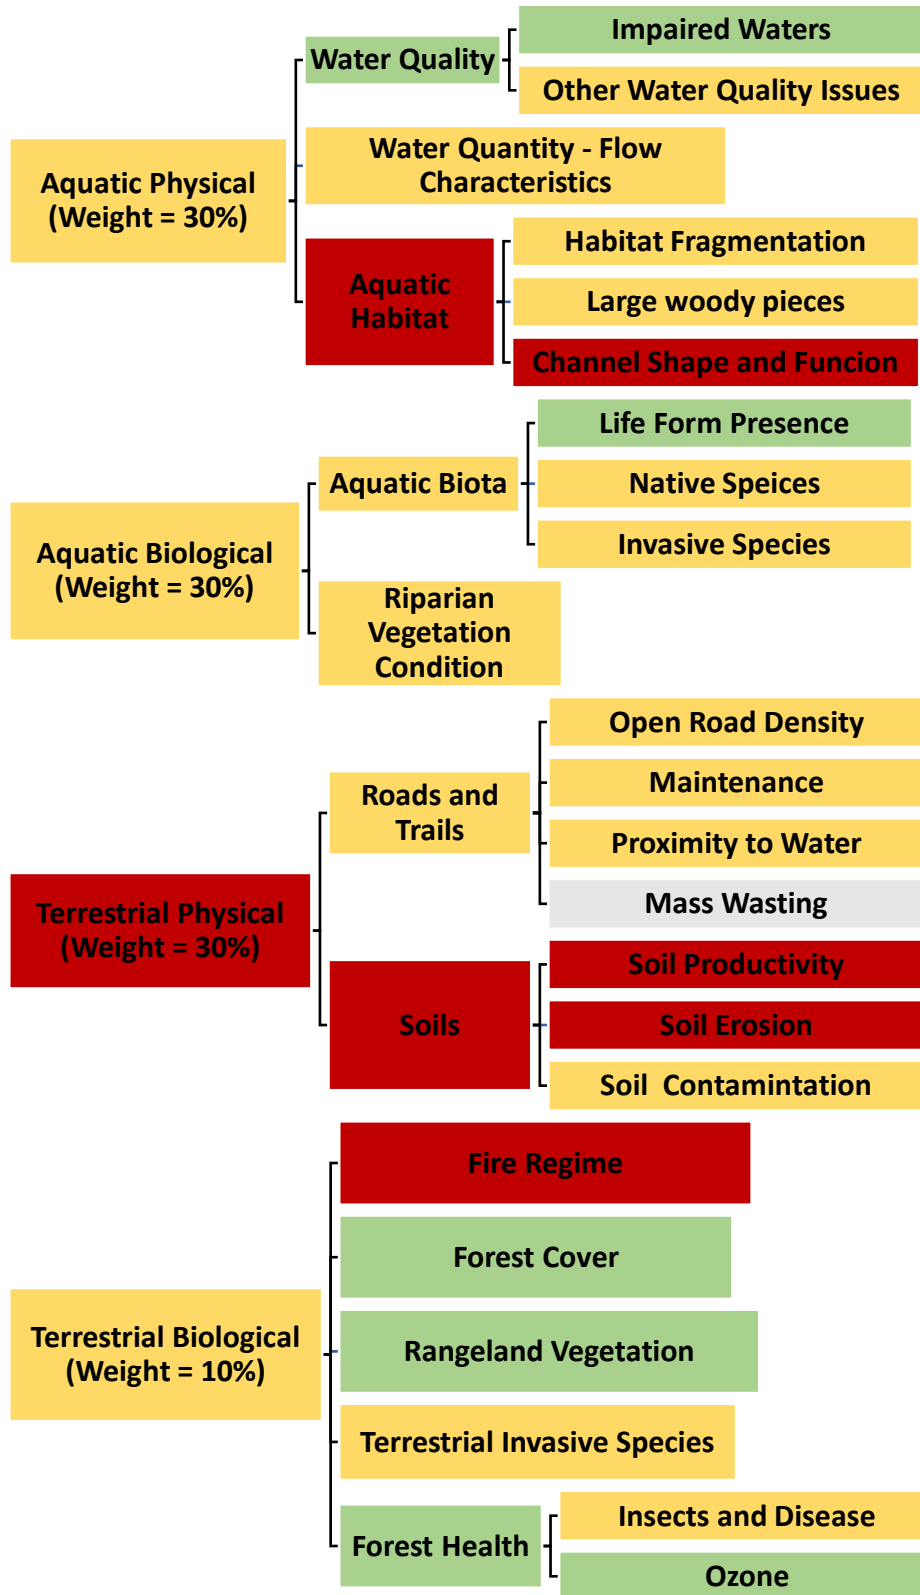
The current overall condition class of the watershed is Class 2 – Functioning at Risk based on a weighted score of 2.0.<sup>8</sup> This class is based on the scores (good, fair, or poor) for the 23 attributes in 12 indicator categories. The following section provides detail on how each indicator score was determined and Figure 5 summarizes all 12 indicators of watershed condition and their attributes, color coded by their current condition score. The indicator and category scores are the simple average of all attributes. The overall watershed condition class is weighted as follows: aquatic physical, aquatic biological and terrestrial physical scores make up 30% each and terrestrial biological constitutes the remaining 10% of the score. Figures 6 through 12 are recent images (taken in 2019 and 2020) of Green Valley Creek starting above the fen to the bottom of the historically perennial portion of the stream.

Figure 3: Summary of current condition for all watershed attributes  
green = good, yellow = fair, and red = poor

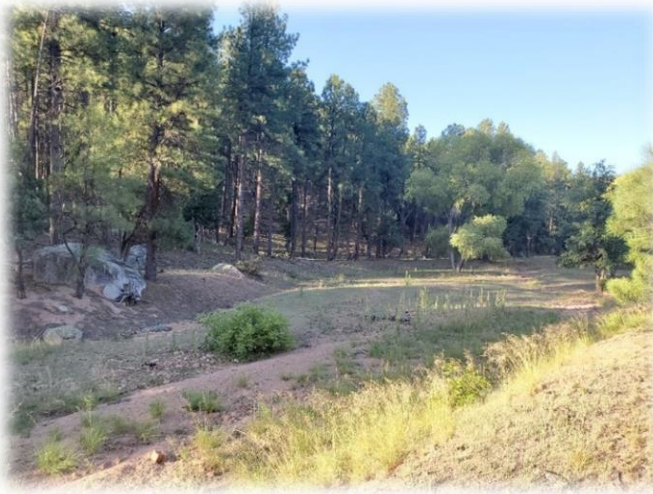
Figure 4: Uppermost-portion of Green Valley Creek – above Fen and perennial reach. Looking upstream.

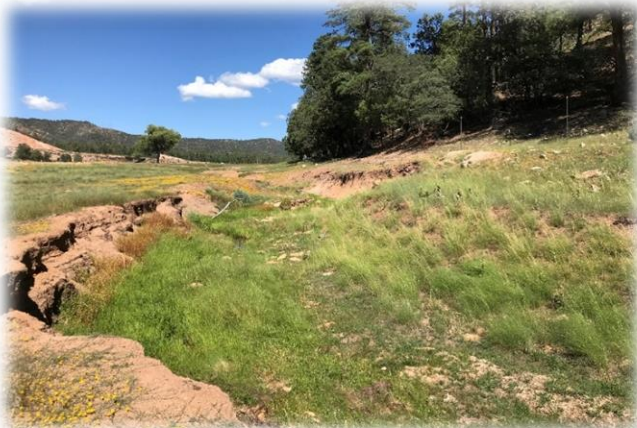
Figure 8: Middle portion of the Little Green Valley Fen (looking upstream)

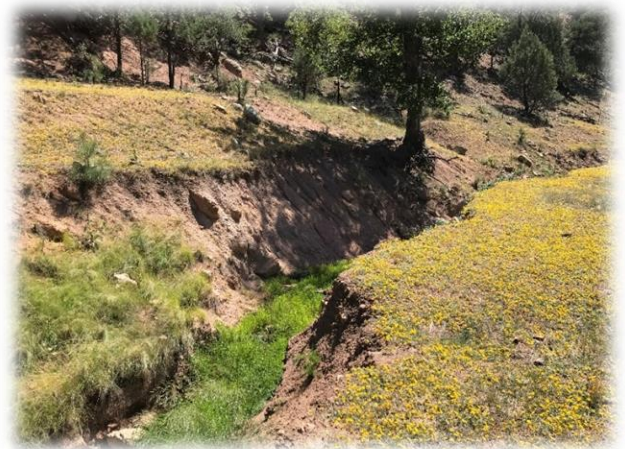
Figure7: Deepest portion of gully on Little Green Valley Fen (looking downstream)

While the watershed is free from diversion structures and impoundments, the baseflow in Green Valley Creek is altered by the gully on the fen. The watershed also contains 16 active wells that have the potential to alter

**Project description:** Restore wet meadow function to the portion of the Little Green Valley Fen on USFS land. Specific design plans will be created once the elk fence is in place and the forest is able to observe improvement through natural recovery for at least one year. It is anticipated that this project would include improving and maintaining the riparian vegetation condition on the fen as well as Green Valley Creek's channel shape and function.

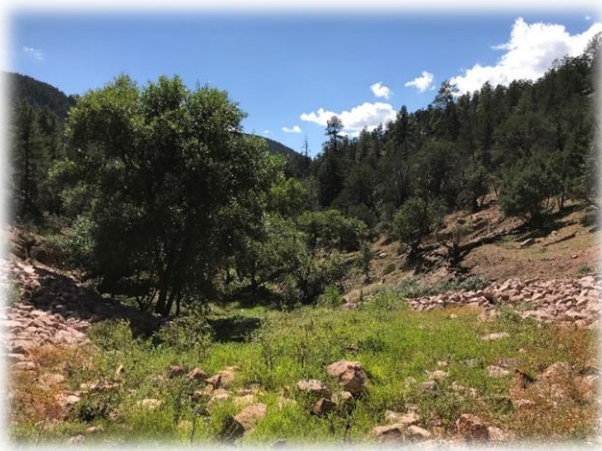
Figure 9: Location of large head cut (rock placed to arrest head cut can be seen on left and right of the photo)

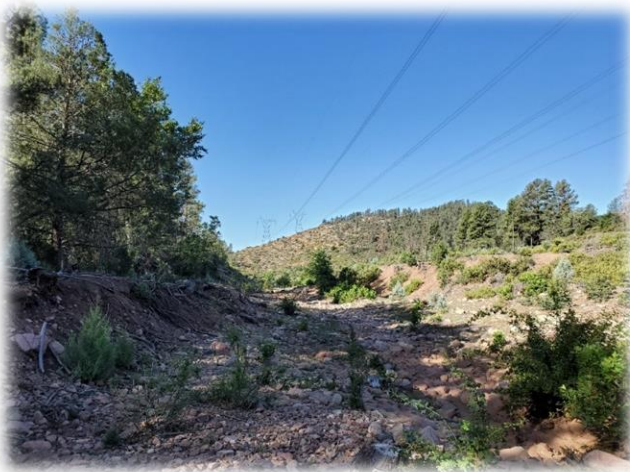
depth on the fen. Beyond the fen, Green Valley Creek is impacted by vegetation removal for a utility corridor and by two low water crossings on Green Valley Creek. In addition to the fen itself, two other perennial portions of Green Valley Creek have been periodically monitored since the 2000s. Most recently, survey data for these reaches indicate they are F-type (highly erosive) and either fair or poor in Pfankuch stream stability ratings for F-type streams. The overall rating for aquatic habitat is fair because of habitat fragmentation from road crossings and the fen gullies, a less than natural rate of recruitment of large wood pieces because of riparian health, and because of poor stream bank stability.

Figure 11: Green Valley Creek within utility corridor

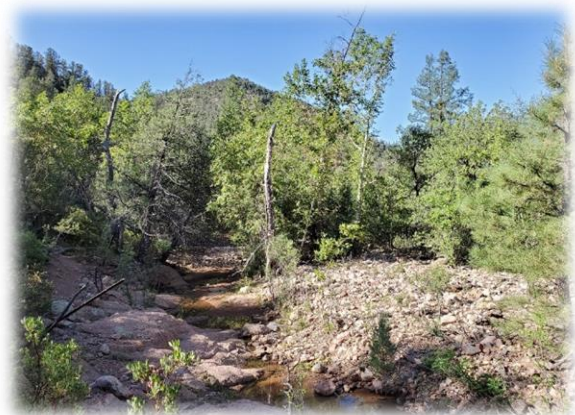
Green Valley Creek has experienced ongoing stressors such as cattle and large ungulate species grazing the available vegetation and denuding the bank stabilizing within the fen and the riparian area below the fen. These stressors have eroded the banks of the stream creating an incision in some places more than 10 feet in

Figure 10: Green Valley Creek 0.25 miles below the fen

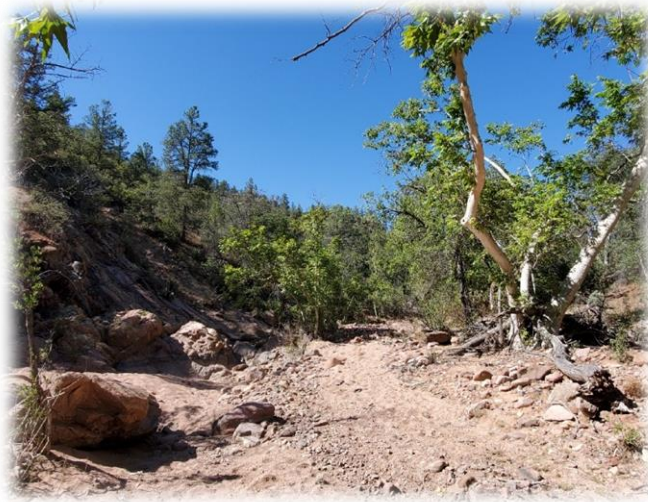
Figure 12: Green Valley Creek at bottom of what was historically the perennial reach

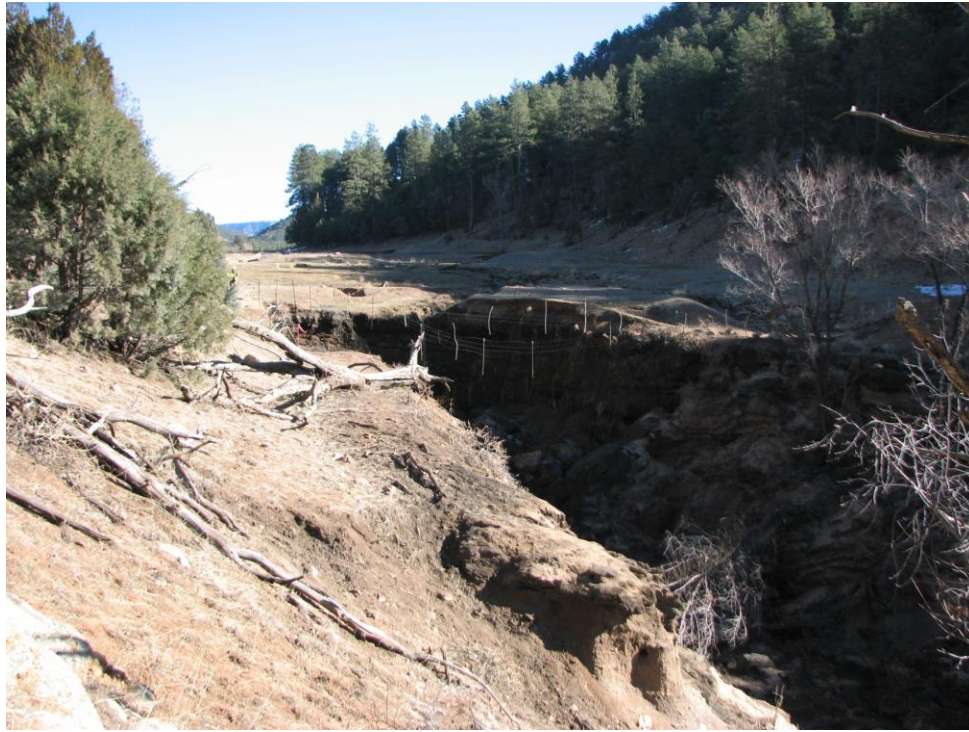
*View of head cut prior to restoration in 2011 (looking upstream)*

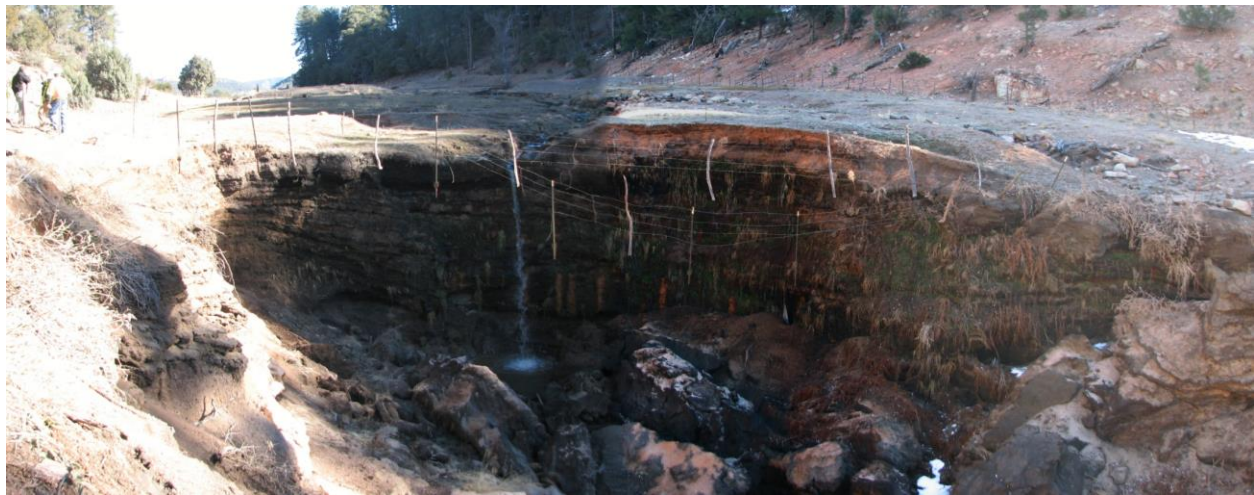
*View of head cut prior to restoration in 2011 (looking upstream)*

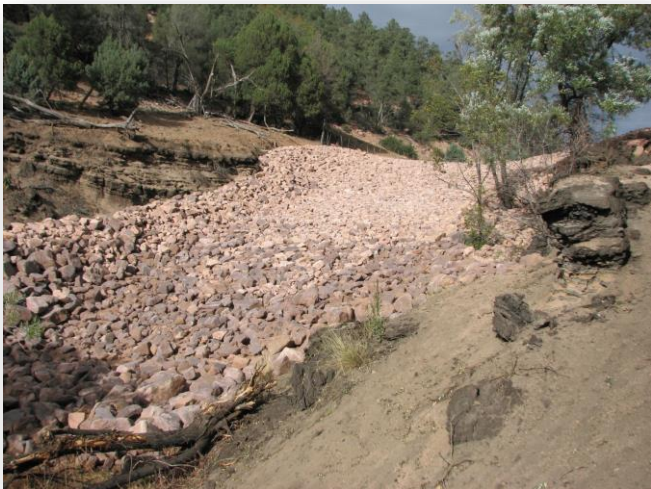
*Head cut immediately after restoration in 2011 looking upstream. Cottonwood tree in right-hand corner can also be seen in 2019 photo.*

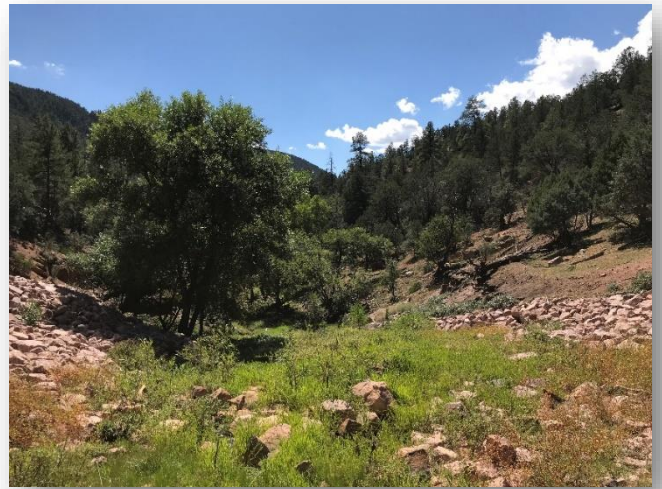
*Head cut in 2019 looking downstream.*
