FIRE AND SPRINGS: REESTABLISHING THE BALANCE ON THE WHITE MOUNTAIN APACHE RESERVATION

Jonathan Long, Mae Burnette, and Candy Lupe

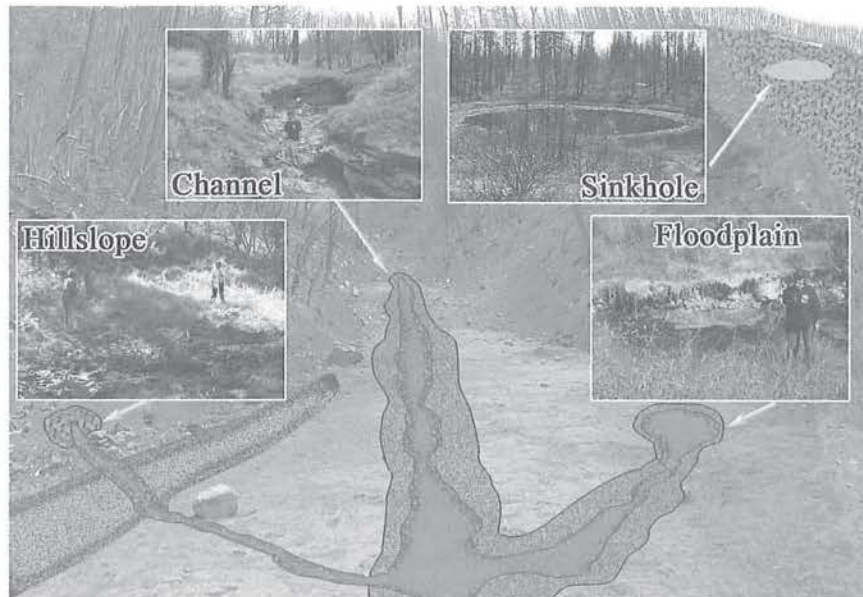
Figure 2. Examples of the four topographic types of wetlands in the study area.

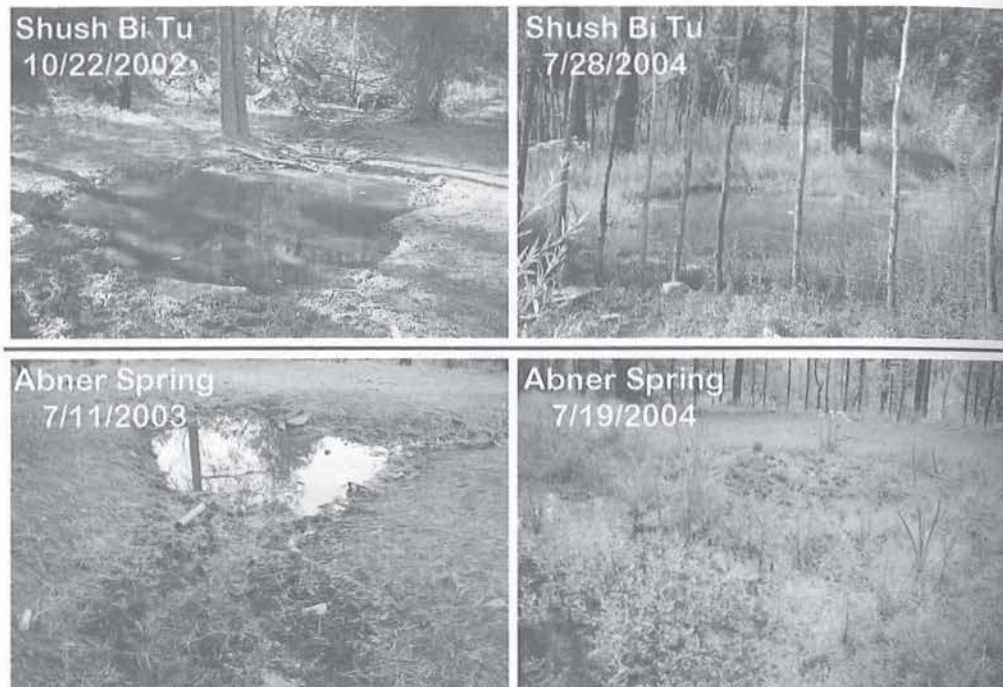
The rehabilitation plan deferred livestock grazing from the burned area after the fire. Many areas had already not been grazed by livestock due to the ruggedness of the terrain. The rehabilitation plan also directed the removal of feral horses, which had been problematically common in the area. We attributed reduced plant vigor and undesirable soil impacts to ungulate grazing and trampling at 21 of the 43 lotic sites. We recommended fencing those areas to reduce impacts from the remaining ungulates, chiefly elk. Within the first year after fencing treatments began in the summer of 2003, several sites exhibited rapid growth of wetland vegetation, as shown in repeat photographs (Figure 4).

Figure 4. Two spring-fed wetlands were fenced to exclude ungulates because heavy use after the Rodeo-Chediski wildfire appeared to limit vegetative growth (left). These sites responded to the fencing treatment within a year (right).

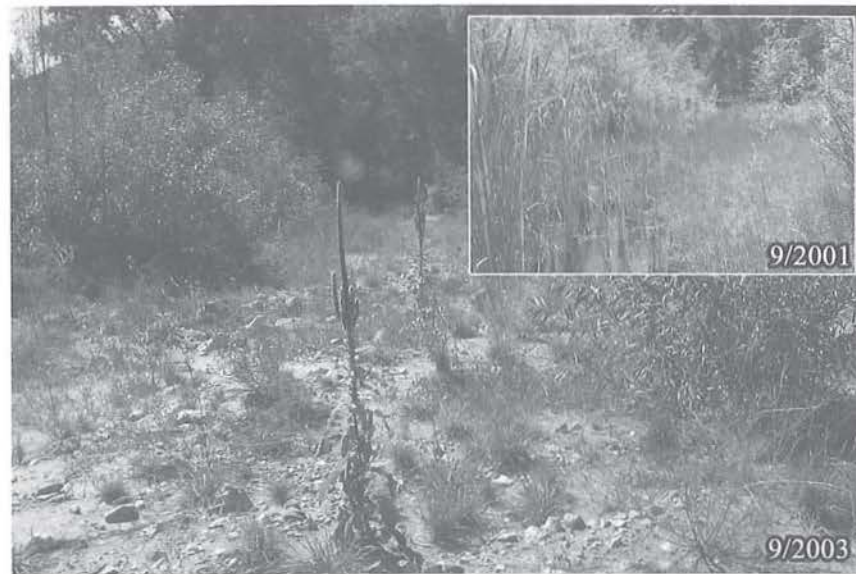
Riparian wetlands along a spring-fed creek in Limestone Canyon withstood the initial summer floods, but flooding on September 11, 2002 caused extensive scouring of the main stem and debris flows down side canyons. The main channel deepened by 0.6 m and doubled in width to 17.4 m (Long et al. 2003b). A debris flow from a side canyon

Figure 5. Wetland habitat that existed in Limestone Canyon one year before the Rodeo-Chediski wildfire (inset) was dried out after post-fire debris flows and floods caused the stream channel to divert from this reach and incise.

induced a channel avulsion that left a formerly productive wetland high, dry, and buried with sediment (Figure 5). We did not prescribe in-channel treatments at Limestone Canyon because the large watershed could deliver overwhelming flows. The channel continued to adjust by lateral movement and changes in substrate, but it did not continue to incise.

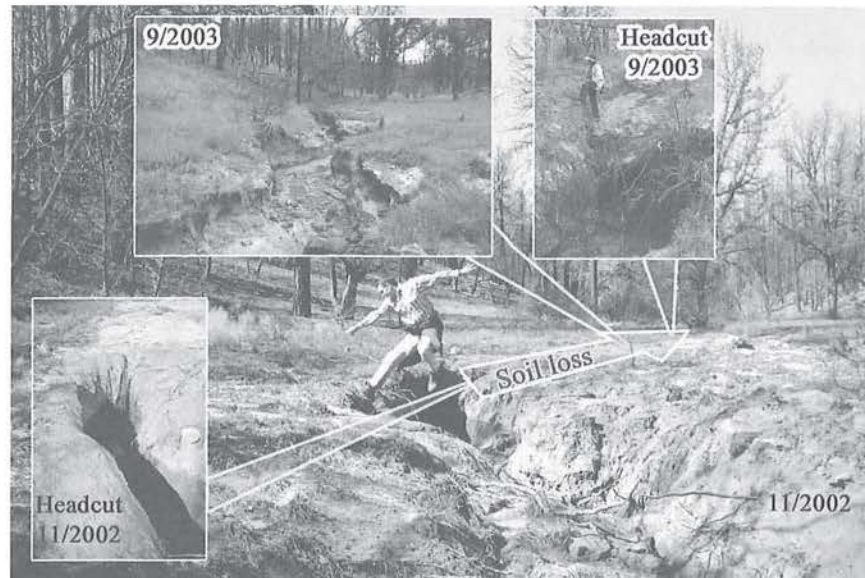
Turkey Spring was another large wet meadow in a severely burned canyon.

Headcutting at this site from November 2002 to September 2003 formed a trench approximately 2.0 m wide, 1.5 m deep, and 50 m long (Figure 6), representing an estimated loss of more than 200 metric tons of sediment. Channel incision at the site was discontinuous, as a short (20 m), uneroded, and well-vegetated reach remained 60 m downstream of the uppermost nickpoint. However, the stream plunged off a second, 2.0 m tall nickpoint below the stable reach into another deeply incised reach. Roads paralleling the stream channel appeared to have induced or greatly exacerbated the instability by concentrating runoff and forming new gullies. Headcutting continued through May of 2004, when active treatment began.

Figure 6. The channel at Turkey Spring formed deep, discontinuous gullies as headcuts (insets) eroded through hundreds of meters of wetland soils within the first 2 years after the Rodeo-Chediski wildfire.

Due to the persistent instability at Turkey Spring and Swamp Spring, we proposed placing riffle formations along 400 m and 300 m segments at the respective sites. Spacing between formations averaged 20 m; each formation was approximately 0.8 m tall, 6 m long, and 3 m wide; and the median particle size (intermediate diameter) was 0.5 m (see Figure 3). We adjusted the size and spacing of individual formations to the dimensions of each reach, so that formations were larger in more deeply incised reaches and closer together in steeper reaches. We prescribed especially large formations at the bottom of

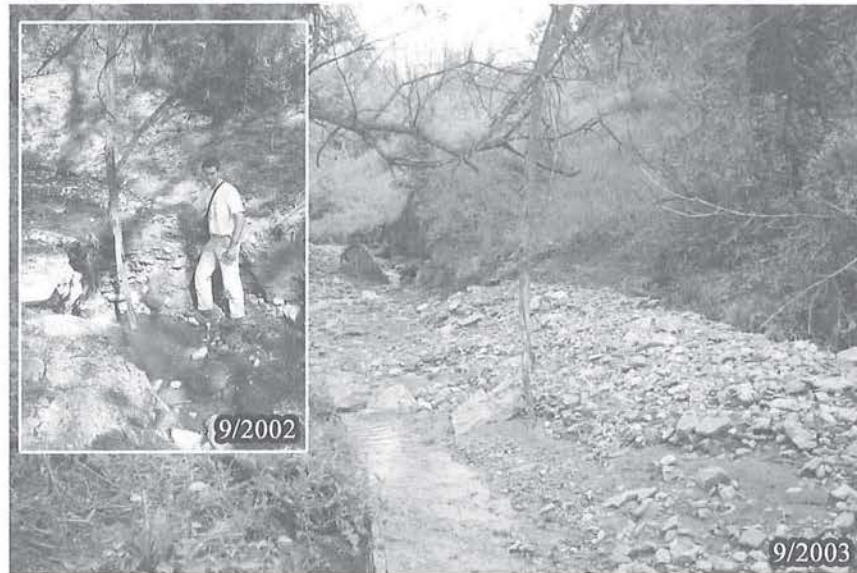
The channel at Swamp Spring was deeply incised with steep nickpoints (inset photo in Figure 7) and deposits of slumped materials from the adjacent wet meadow. Erosion of the site appeared to predate the fire, as indi-

cated by relatively continuous downcutting, extensive deposits of slumped materials with some vegetative growth, and an old culvert that showed where a stream crossing had washed out. However, post-fire flooding accelerated upstream migration of nick-points (Figure 7), exposed fine hardpan bed material in the channel, and increased lateral erosion by undermining the toes of the streambanks.

Figure 7. The channel bed at the Swamp Spring site adjusted rapidly following the Rodeo-Chediski wildfire, resulting in migration of nickpoints and extensive bank erosion.
